14 January 2019

Project 182094 – Building Enclosure Investigation and Consulting Services, City of Stamford Public Schools, Stamford, CT

Per your request, this report provides the results of our investigation of the reported water leakage at the Julia A. Stark Elementary School in Stamford, CT. It includes our summary of background information provided by others, a summary of our field observations and test results, a discussion of pertinent issues, conclusions as to the sources of the water leakage, and conceptual recommendations for remedial repair options.

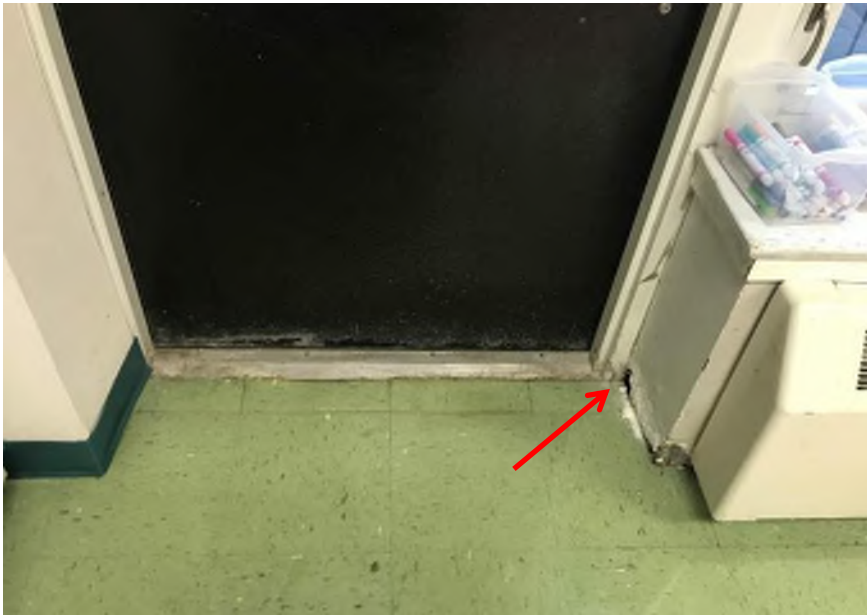
Photo 1

Deteriorated interior finishes above floor at door jamb in Room 104 (red arrow).

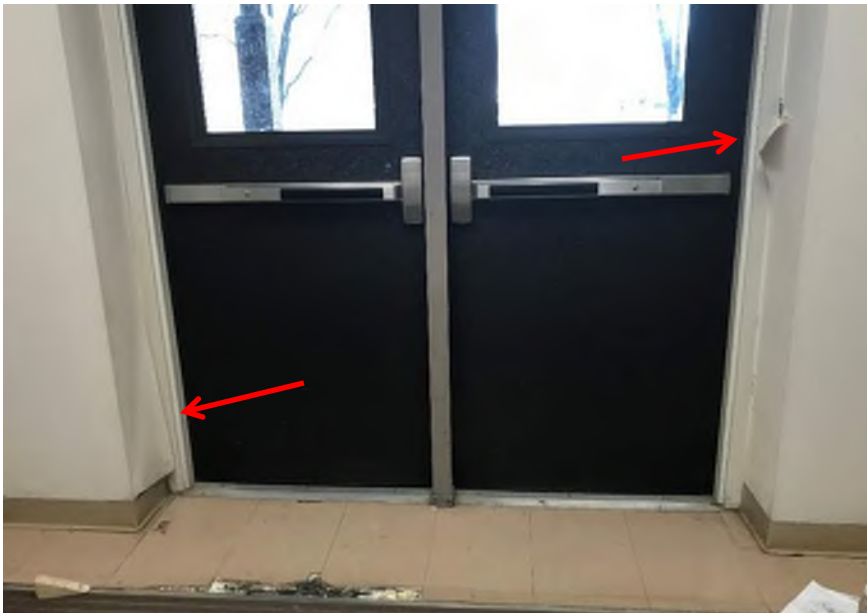
Photo 2

Deteriorated interior finishes at door jambs in 1997 addition hallway (red arrows).

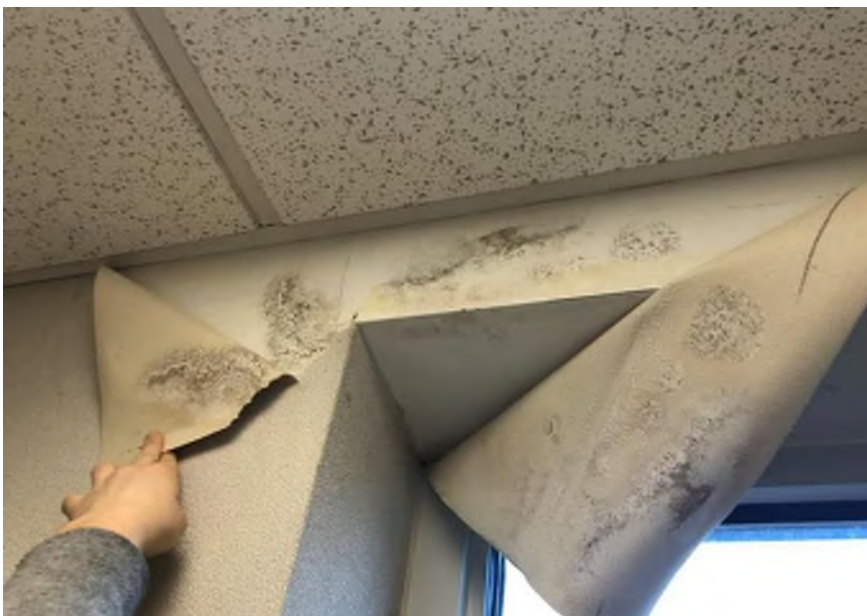
Photo 3

Deteriorated interior finishes above the door in Room 102.

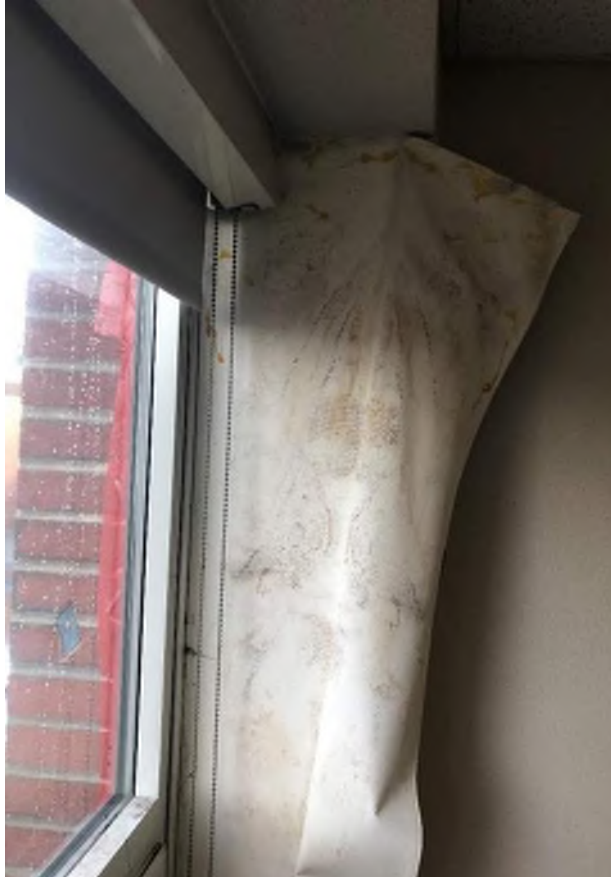
Photo 4

Deteriorated interior finishes along the window jamb in Room 172, 1997 addition.

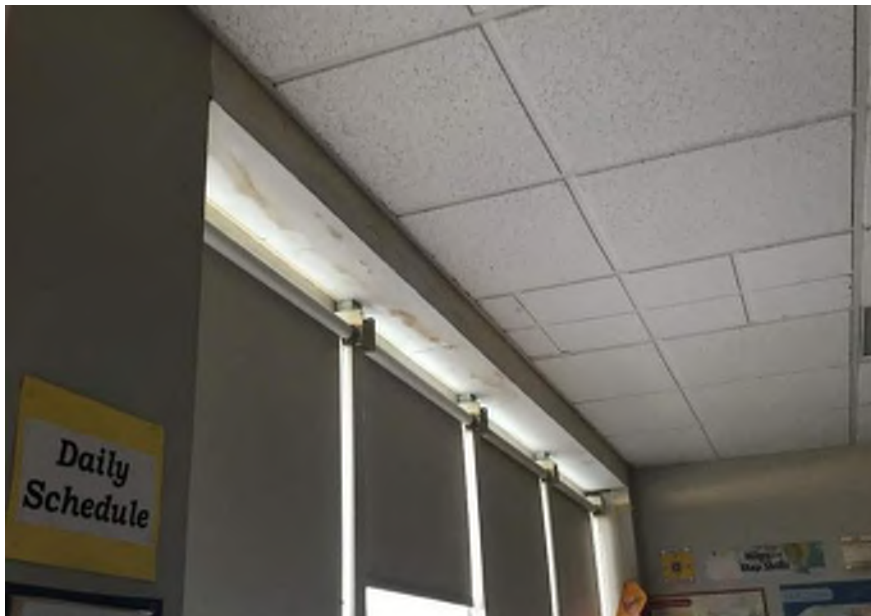
Photo 5

Deteriorated interior finishes above a window in Room 170, first addition (wallpaper removed prior to our reviewing this room).

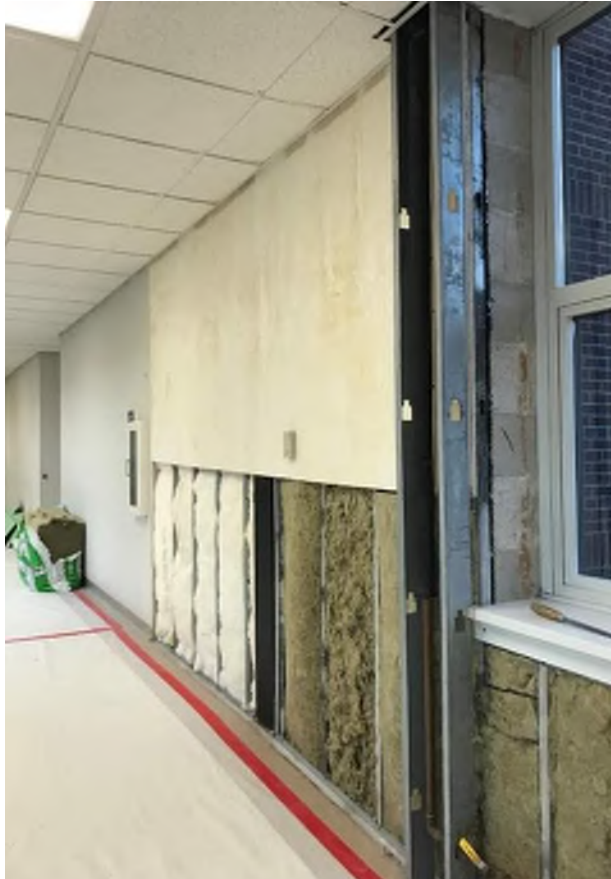
Photo 6

- We observed removed GWB below windows, at window jambs, and extending approximately 4 ft up from the floor between windows (Photo 6).
 - The existing interior wall construction is as follows, from exterior to interior:

Area of abatement in the north hallway on the second floor. Note interior wall construction exposed at a window jamb.

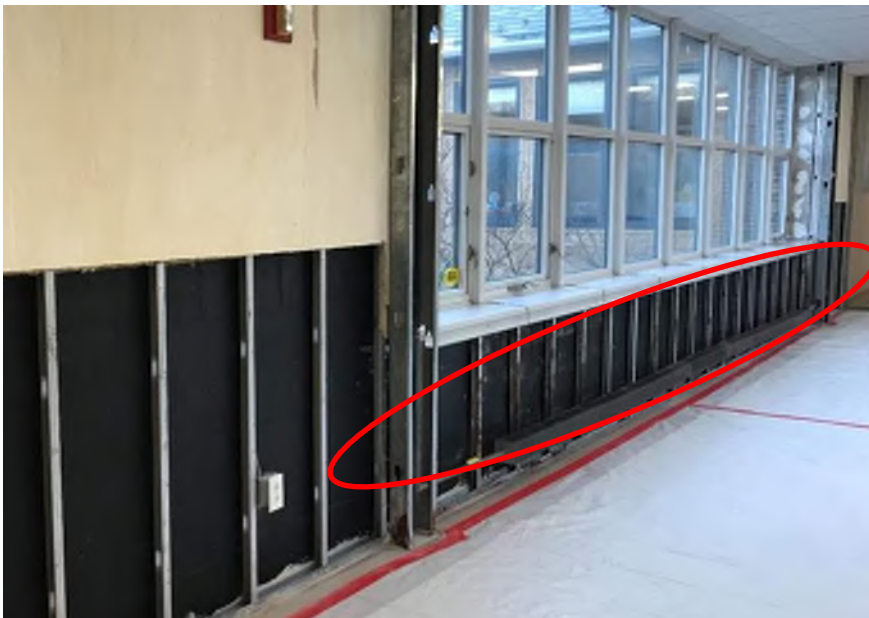
Photo 7

- 8 in. thick CMU.
 - Light-gage steel-framing infilled with 1-1/2 in. mineral wool insulation.
 - Two layers of GWB (Photo 6).
- The light-gage steel framing is corroded at the base of the wall on both floors of the south hallway (Photo 7). On the first floor, the corrosion is more severe adjacent to the exterior door (Photo 8).

Corrosion on light-gauge steel framing on the first floor of the west hallway.

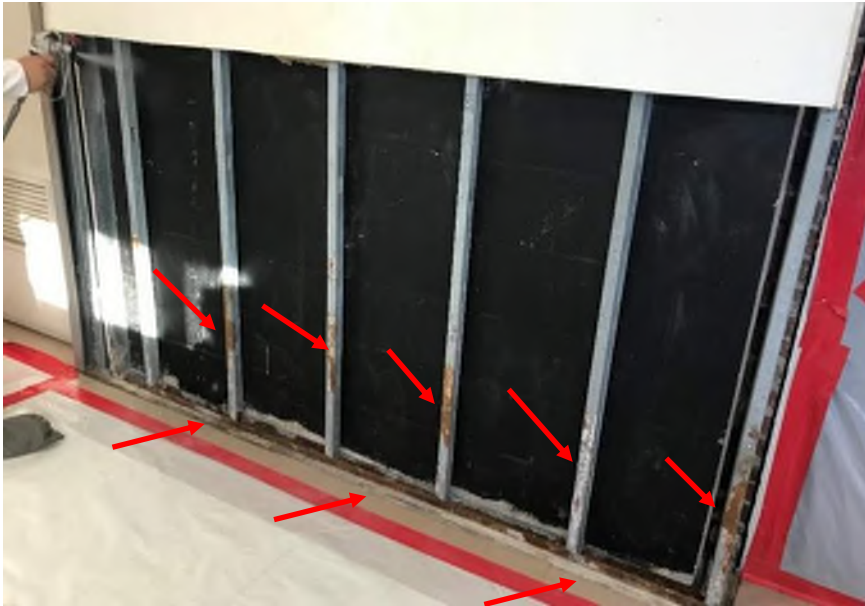
Photo 8

Corrosion on light-gage steel framing on the second floor of the west hallway.

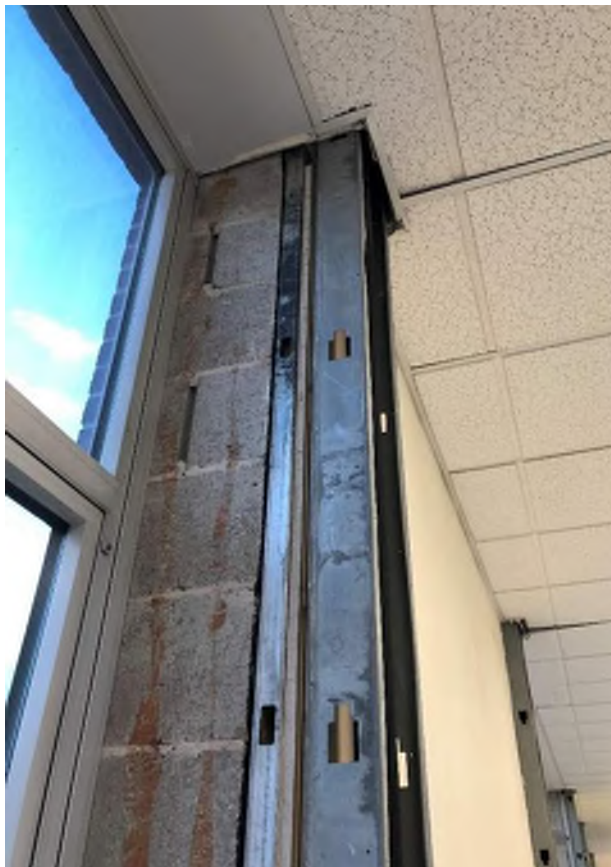
Photo 9

Typical construction at window jamb in 1997 addition. No WRB or flashing membrane turns into the rough opening over the CMU.

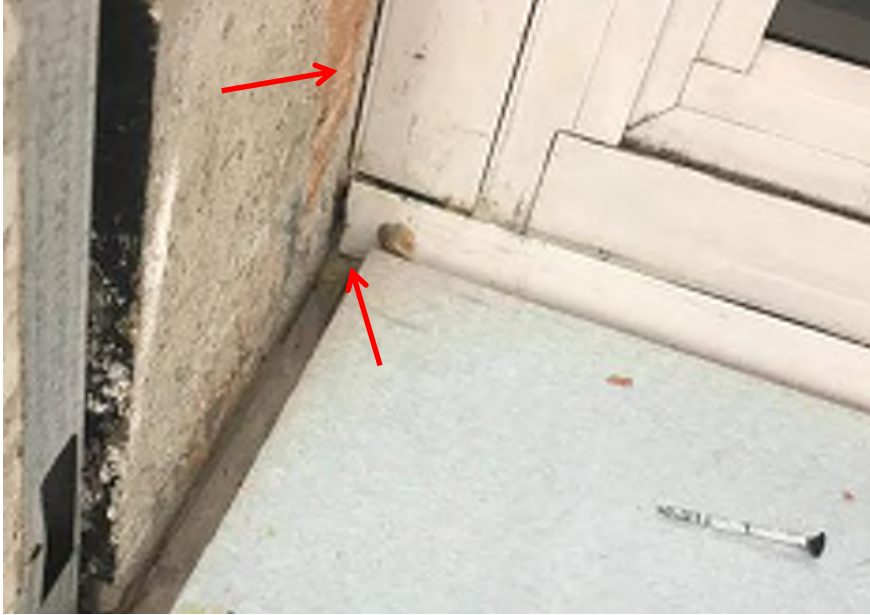
Photo 10

Window frame is not sealed to CMU (red arrows). Note lack of sill flashing below window frame.

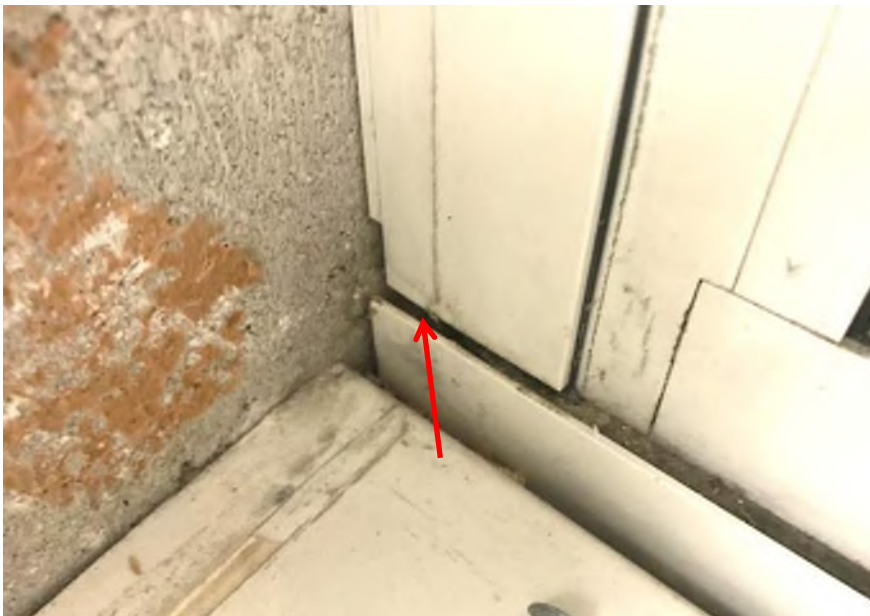
Photo 11

Where present, a sill receptor below the window can act as a sill flashing to collect and drain water that penetrates the windows; however, to function properly, the sill receptor must have sealed and fastened end dams where it terminates at the jambs. The end dams contain water that flows down onto the sill receptor and prevent it from flowing off the ends of the receptor into the interior wall cavity at the window jambs (rather directing it to weeps to the exterior). We observed missing end dams and water leakage from the ends of the sill receptors at two of our window water test locations, showing that the window system allows water penetration and that the missing end dams allow this water to leak to the interior.

Sill receptors lack end dams at window jambs (red arrow).

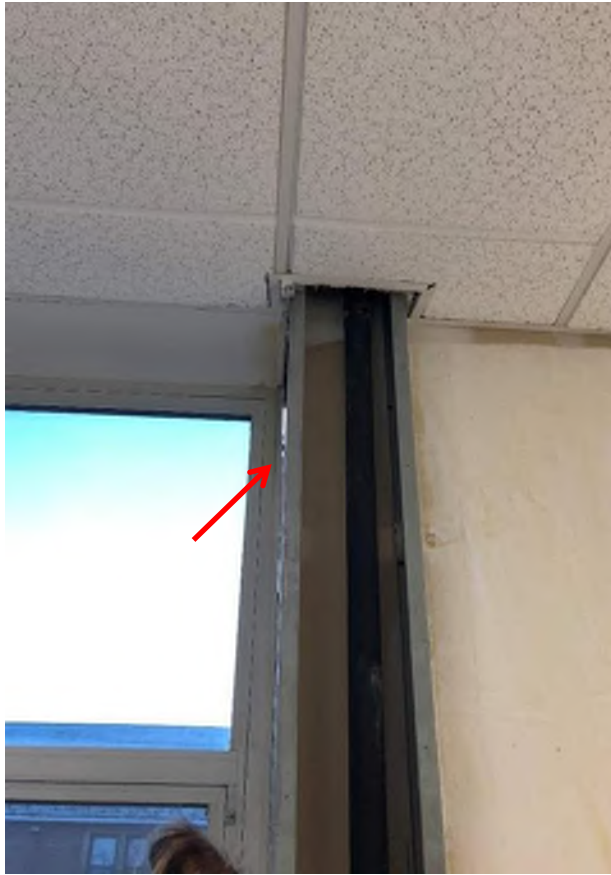
Photo 12

- Daylight is visible at window jambs between the window frame and CMU in numerous locations where interior finishes are removed (Photo 12).
- We observed removed interior trim from an intermediate vertical mullion on the 1997 addition's second floor. The mullions have aluminum reinforcement (Photo 13) and the sill receptors are continuous below the intermediate mullions (Photo 14). We observed a gasket installed between the upturned leg of the sill receptor and the window sill frame (Photo 15). The windows in the second-floor south hallway of this addition do not have gaskets between the sill receptors and window units.

Daylight visible between the window frame and CMU (red arrow).

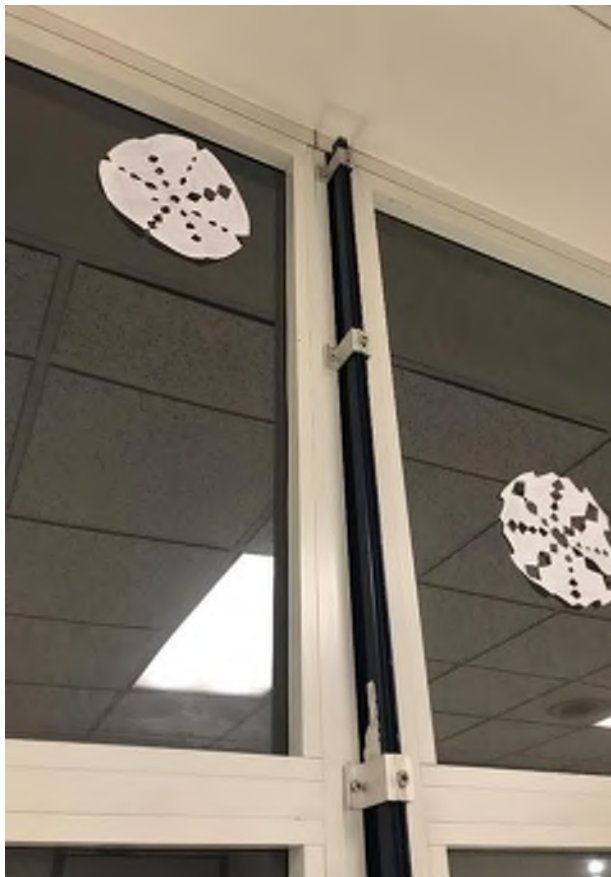
Photo 13

Steel reinforced intermediate mullion at location where interior trim was removed.

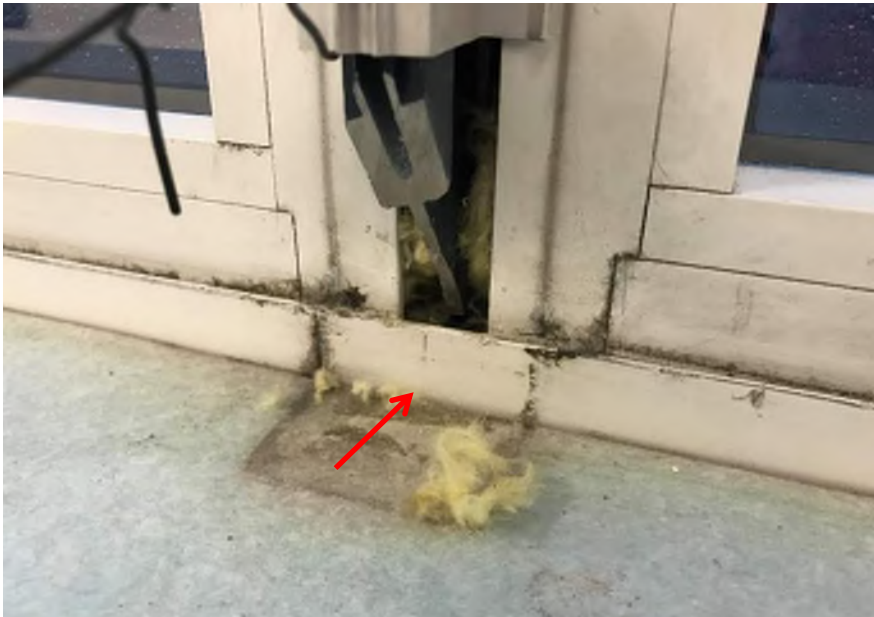
Photo 14

Steel reinforced intermediate mullion at location where interior trim was removed. Note that the sill receptor is continuous below the intermediate mullion (red arrow).

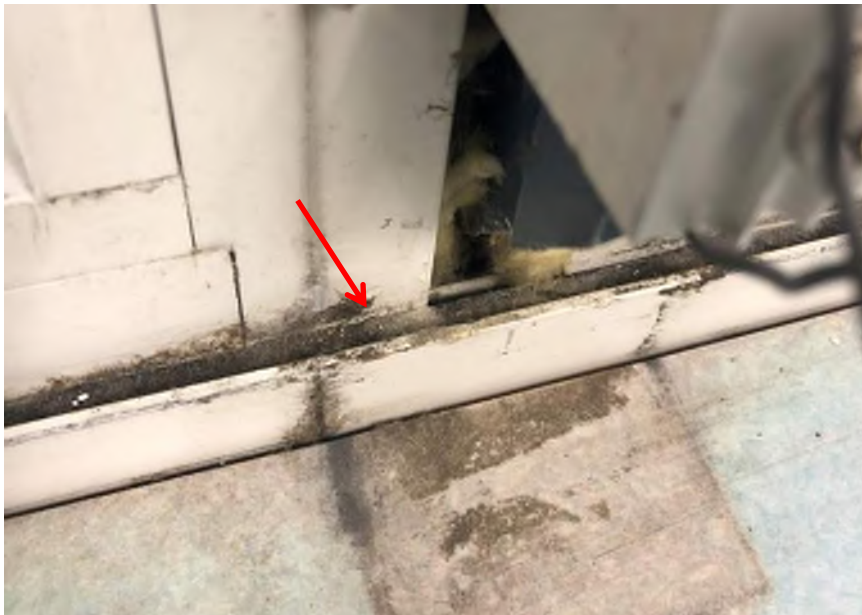
Photo 15

Gasket between sill receptor and window units (red arrow).

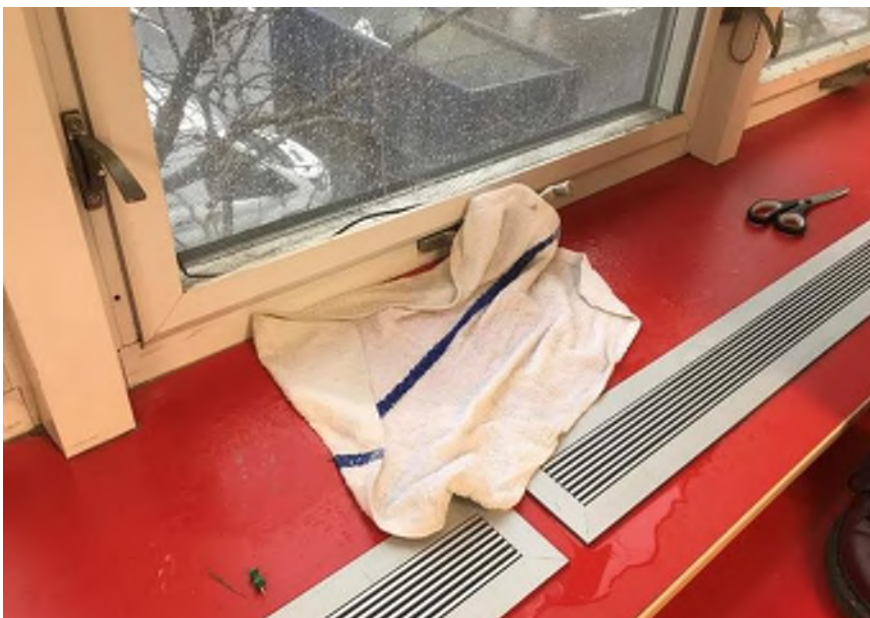
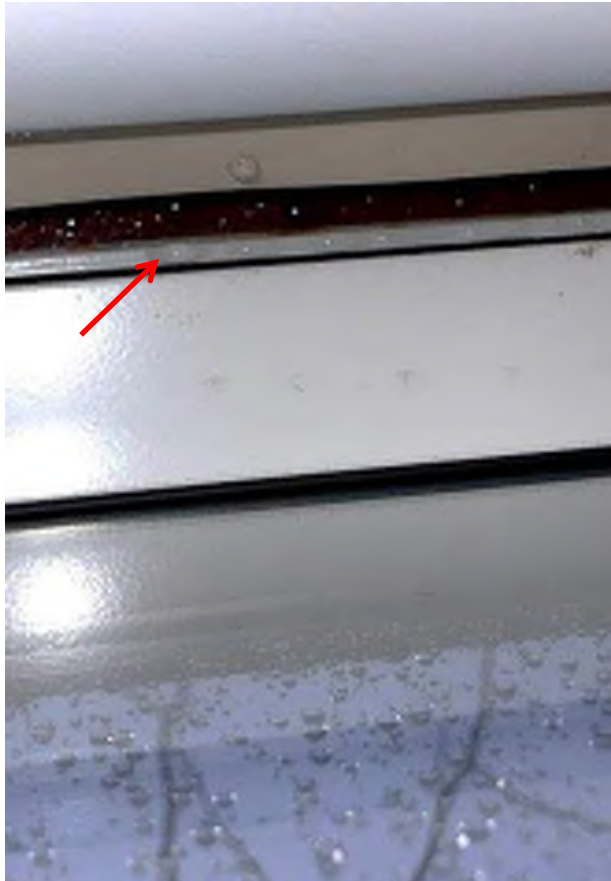
- Water leakage to the interior from the head of the westernmost window in Room 251 during the 28 December 2018 rain event (Photos 16 and 17).
- Water leakage to the interior through the door glazing in the 1997 addition's first-floor south hallway and in Room 102 during the 28 December 2018 rain event.

Leakage into Room 251 on 28 December 2018 due to rain.

Leakage into Room 251 on 28 December 2018 due to rain (red arrow).

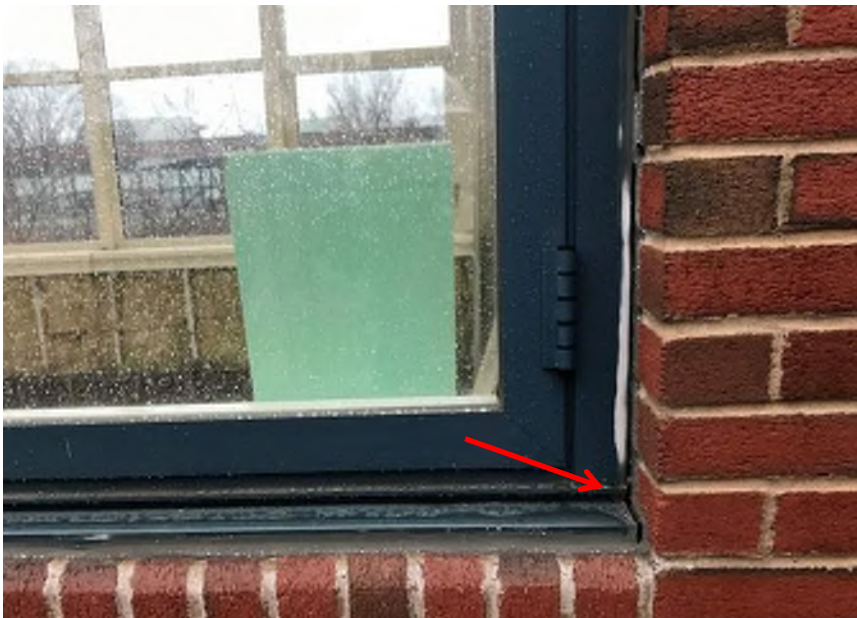
Photo 18

Open sealant joint at window jamb (red arrow).

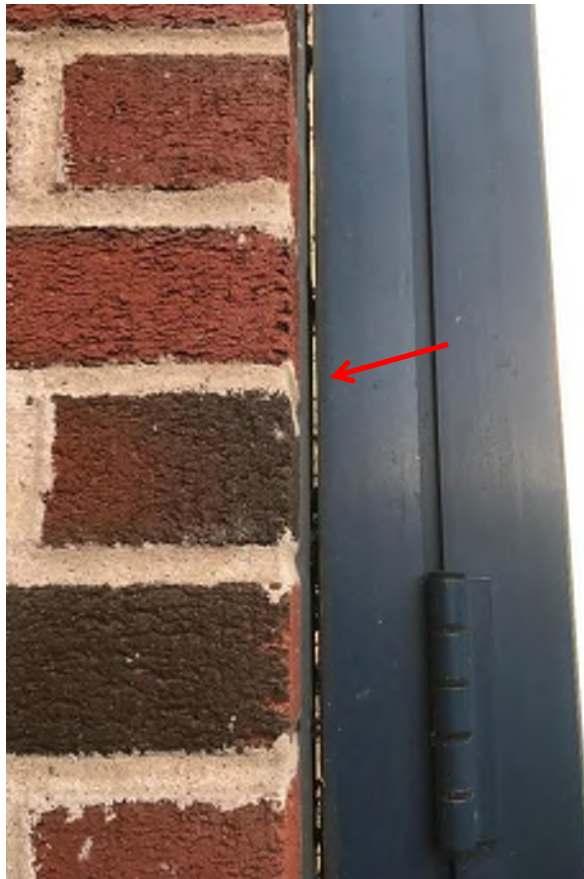
Photo 19

Open sealant joint at window jamb. Note that interior is visible through sealant joint (red arrow).

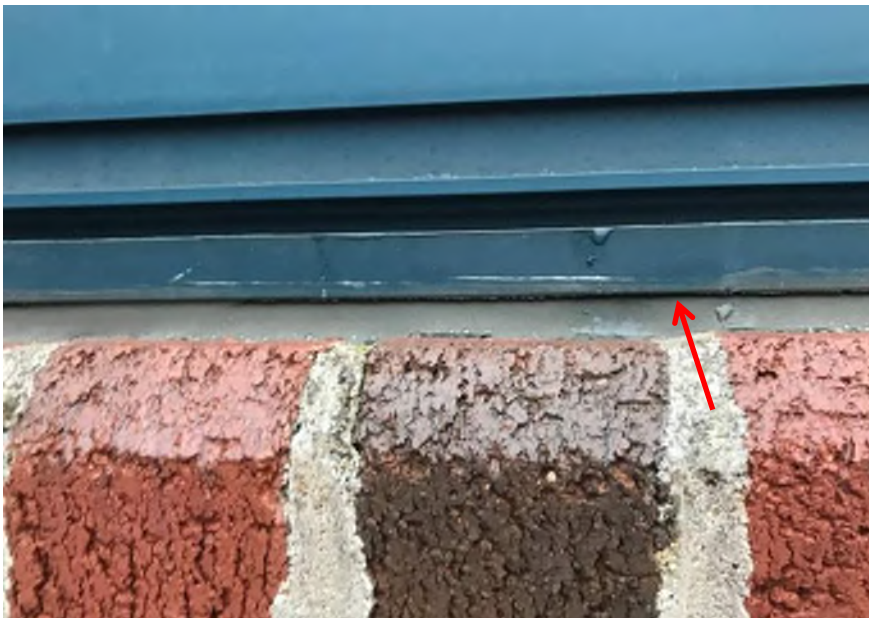
Photo 20

Area of unadhered sealant at window sill (red arrow).

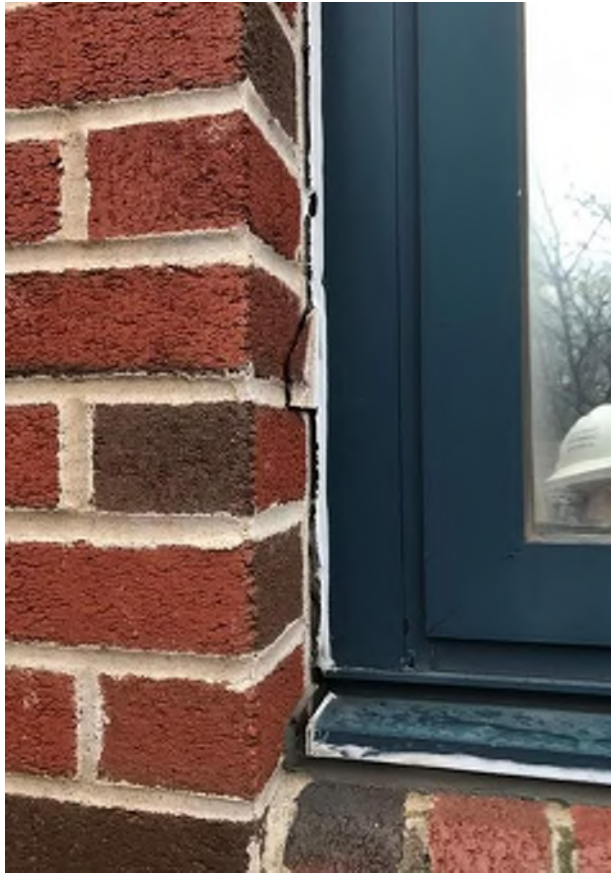
Photo 21

- Various apparent sealant repairs on the building (Photo 21). In many locations, the sealant repairs have also failed.
- Sealant joints around the window and door perimeters on the west elevation of the original building are generally in good condition (Photo 22).

Failed sealant repair at window jamb.

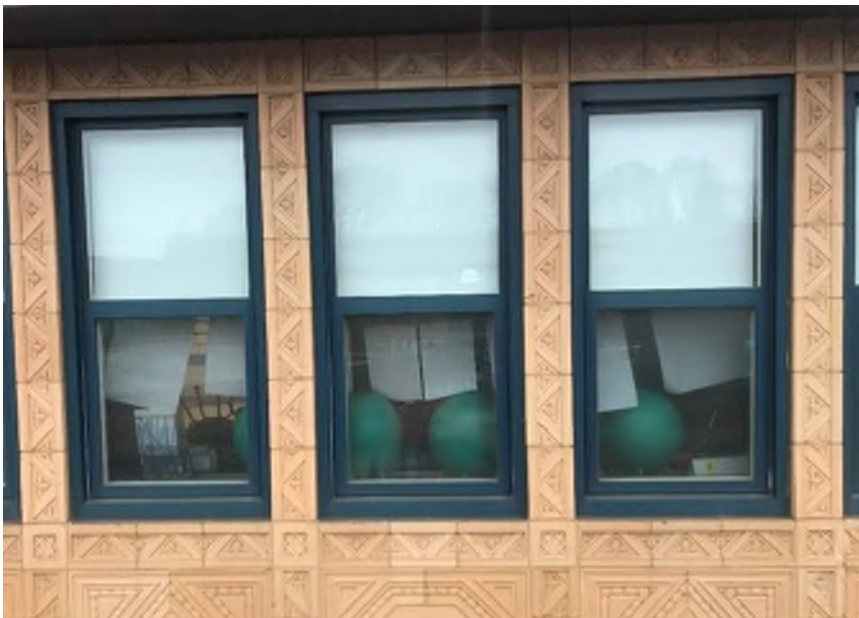
Photo 22

Sealant joints around window perimeters in original building are generally in good condition.

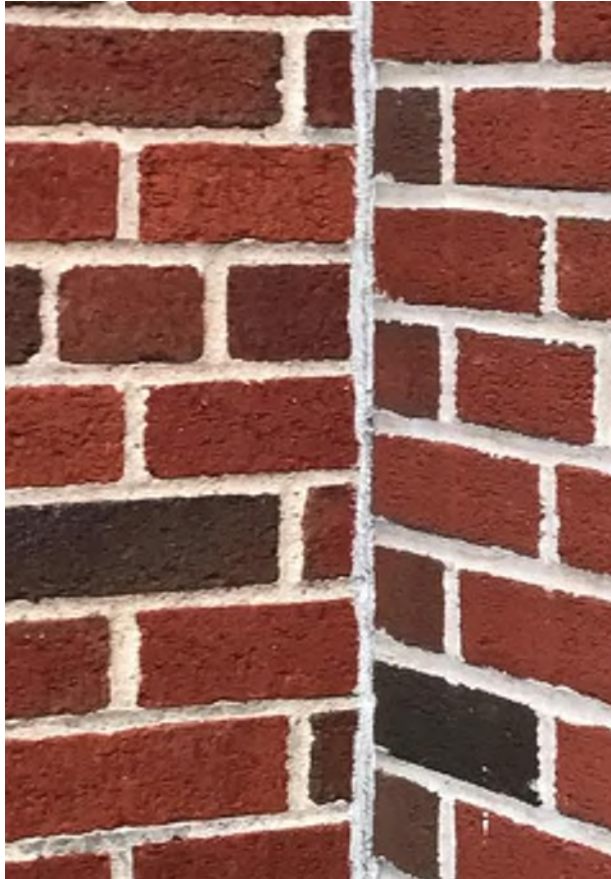
Photo 23

- Sealant joints in masonry expansion joints are generally cracked, crazed, and deteriorated in all three wings (Photo 23).
- Flexible EPDM flashing membrane is exposed at the edges of the steel lintel above the windows. Lintels stop short of the window jambs. The flashing membrane extends past the lintel's termination and into the brick masonry at the window jamb (Photo 24). The brick masonry above the flashing is typically wept using either rope or plastic weep tubes (Photo 25). We observed several locations with no weeps.

Deteriorated sealant expansion joint in brick masonry cladding.

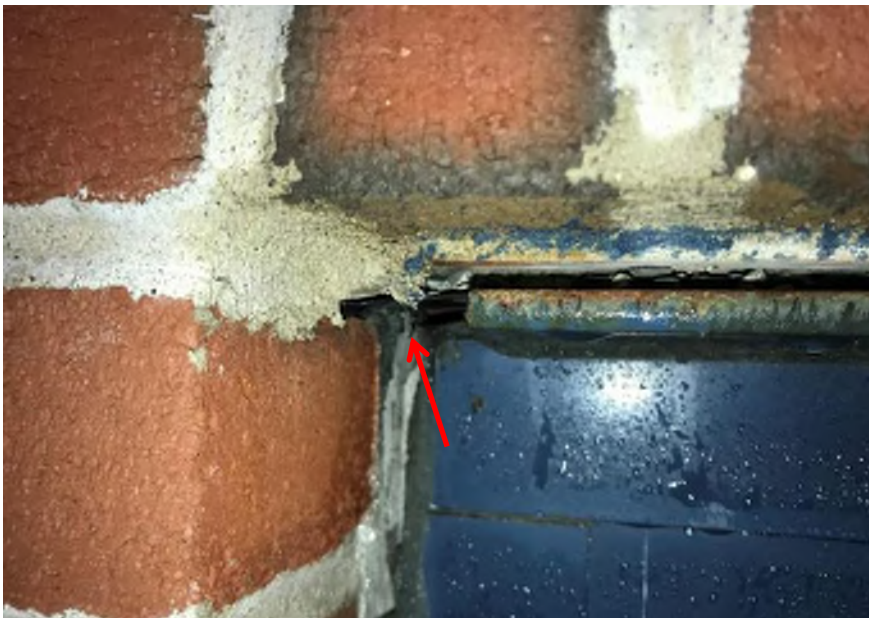
Photo 24

EPDM membrane flashing between steel lintel and brick masonry at window jamb (red arrow).

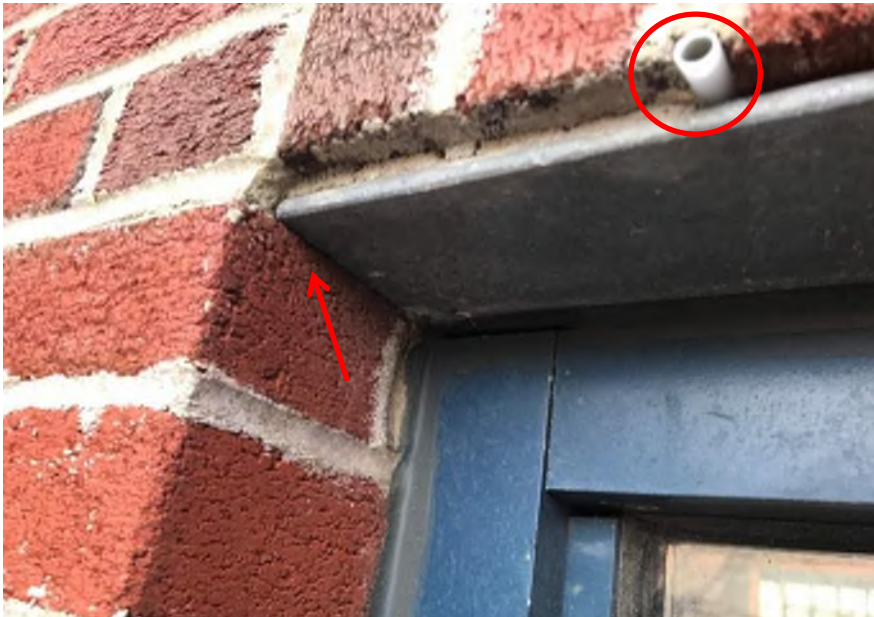
Photo 25

Weep tube above window head flashing (red circle).

Photo also shows steel lintel above the door extends into the brick masonry at the jamb (red arrow).

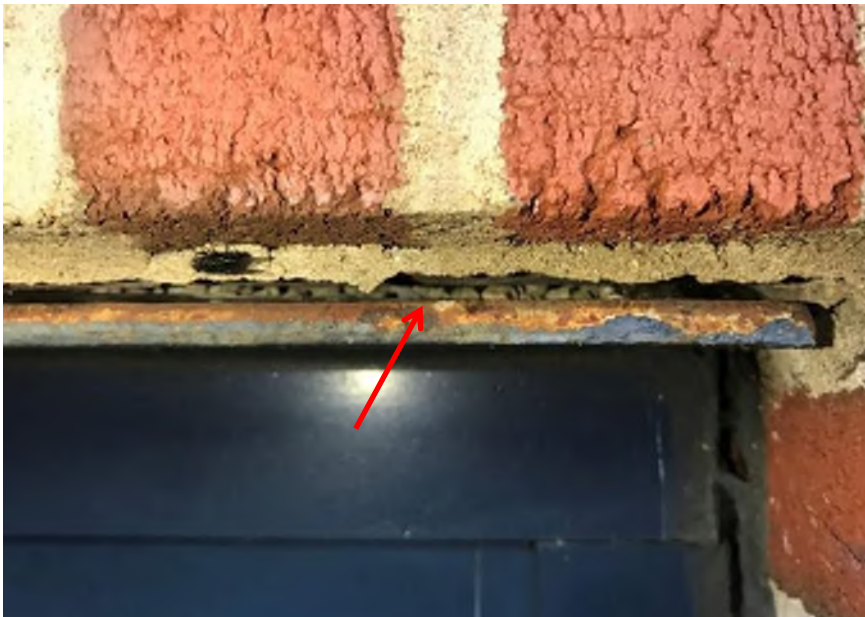
Photo 26

Pea stone between EPDM flashing membrane and brick masonry (red arrow).

Photo also shows open sealant at window jamb.

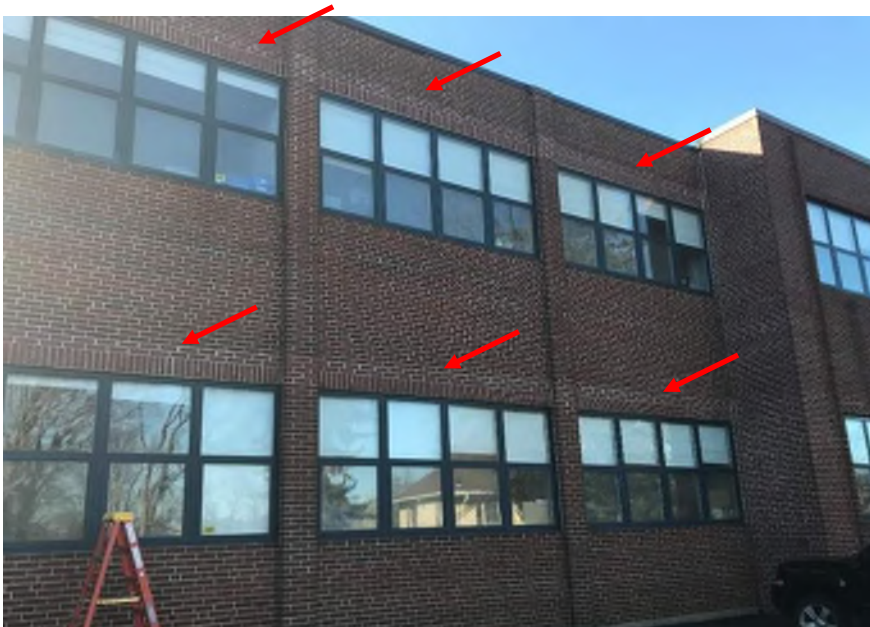
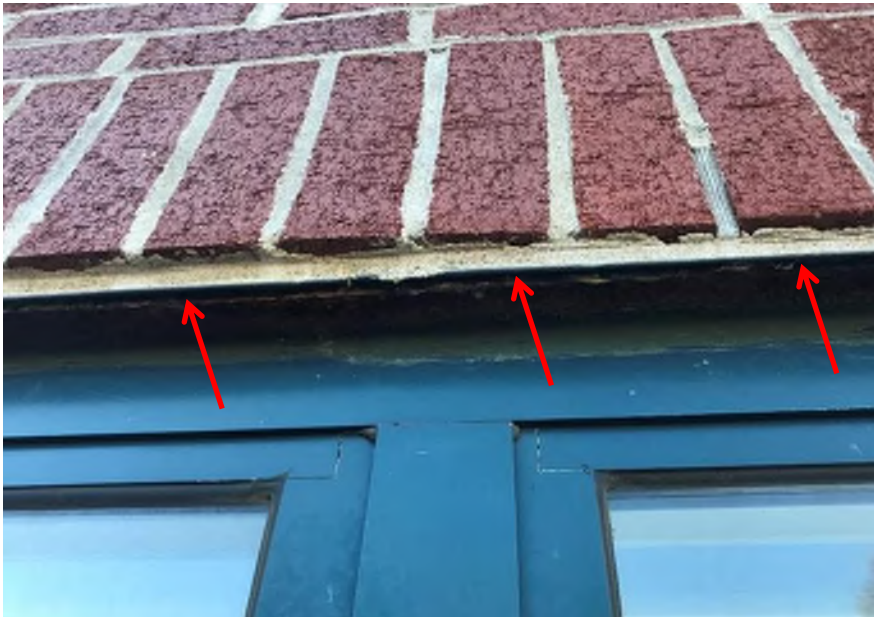
- Sheet metal through-wall flashing above the windows on the north elevation within the first addition at Rooms 168, 170, 252, and 254, where building management personnel reported that flashing repairs were previously performed (Photos 27 and 28).

Windows on the east elevation where masonry and flashing repairs were previously performed. Note lighter mortar above window heads (red arrow).

Sheet metal through-wall flashing installed above windows on the east elevation.

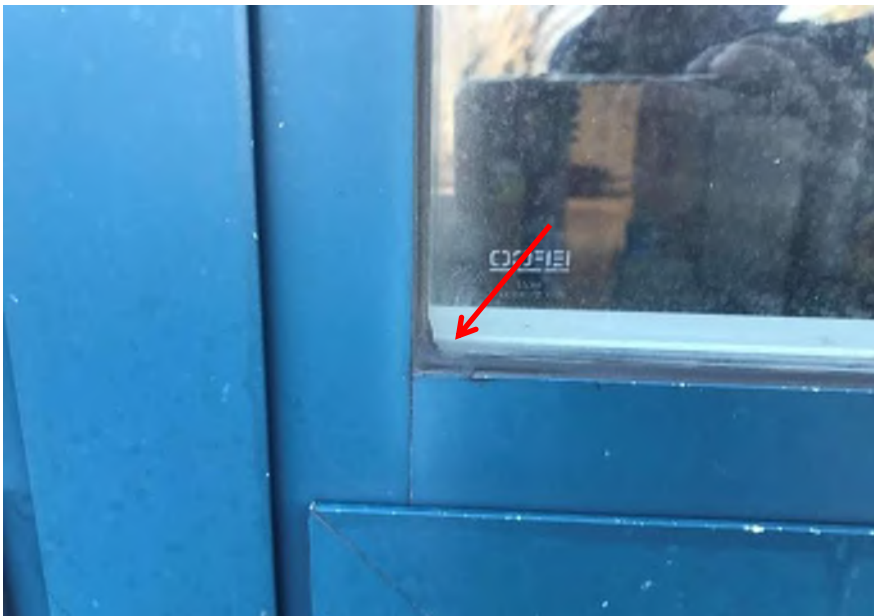
Photo 30

Typical "wet glazing" seal between glass and window sash (red arrow).

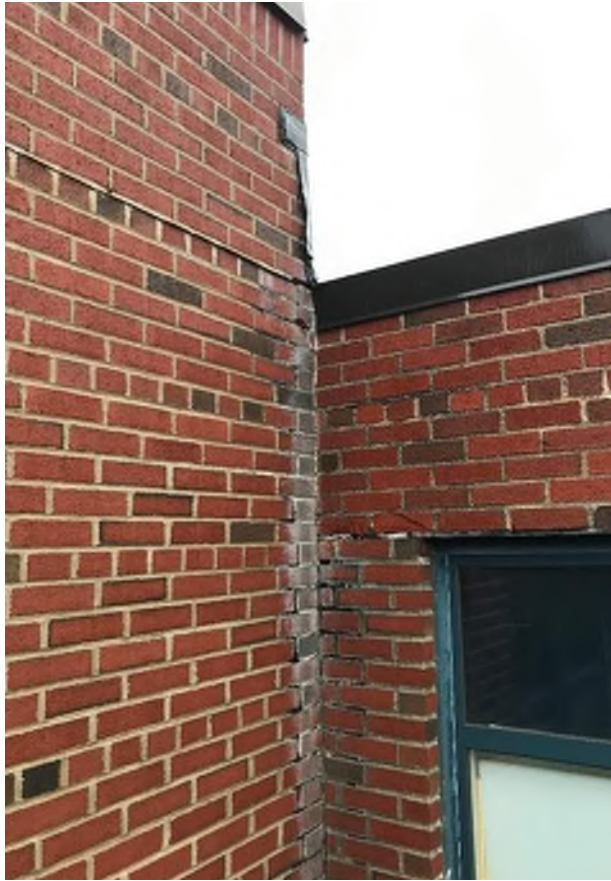
Photo 31

Deteriorated masonry at interior building corner between bridge and first building addition.

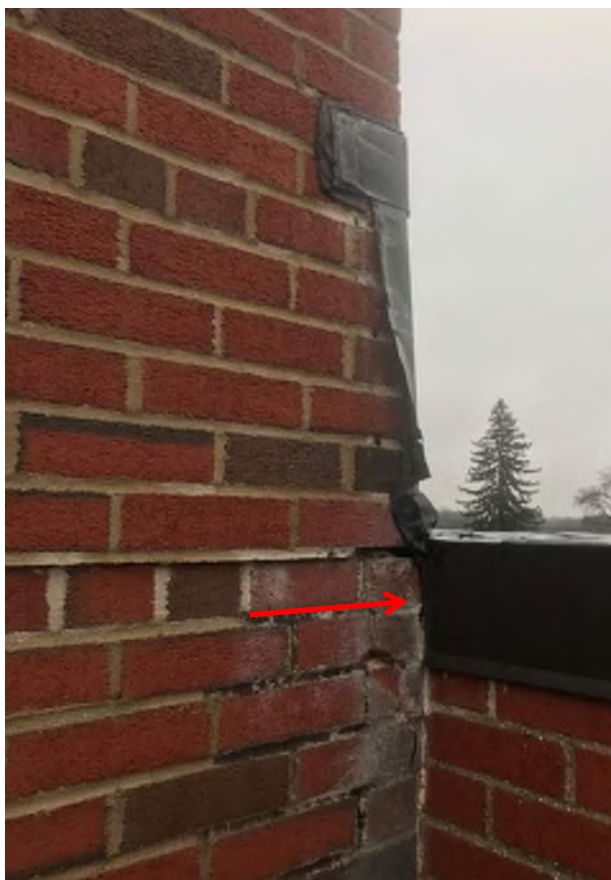
Photo 32

We did not perform water testing of the roof expansion joint where Stark Facilities reports water leakage. However, our observations of this expansion joint show that its membrane flashings lack a mechanical anchorage (i.e., termination bar) and sheet metal counterflashings. As a result, the expansion joint is vulnerable to leakage through peeling flashing membrane or at the wall expansion joint's integration with the roof expansion joint. Replacing the peeling membrane with new flashing membrane that includes sealed termination bars and riveted and soldered sheet metal counterflashings will improve this expansion joint's resistance to water penetration.

Expansion joint termination on masonry wall. Note that flashing is not secured or integrated with roof edge flashing and is peeling (red arrow).

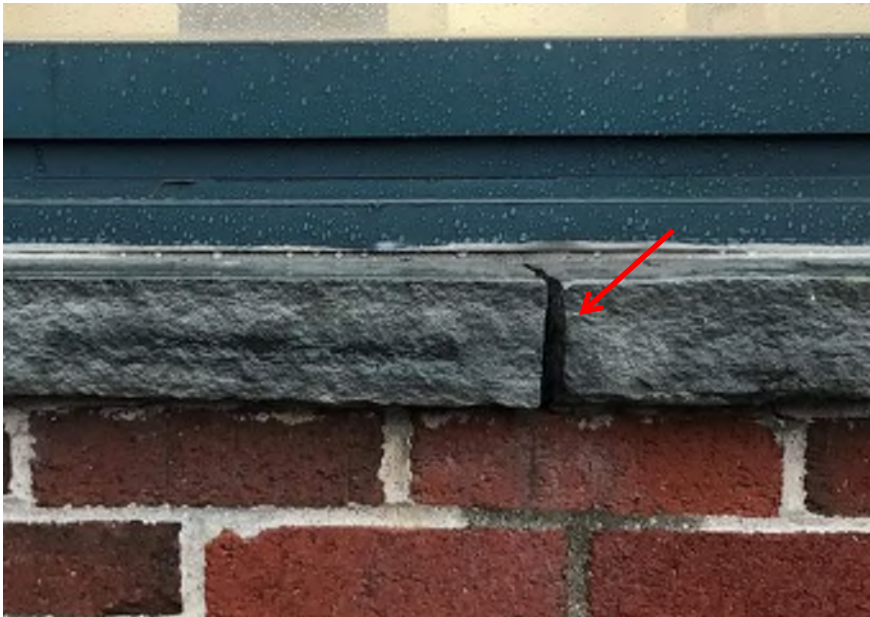
Photo 33

- Stone sills below windows in the first addition. The transverse joints between the stones are open (Photo 33).
- Areas of deteriorated brick masonry cladding in several locations on the building additions including deteriorated mortar joints, cracked mortar joints, step cracking, and displaced brick units (Photos 34 and 35). This deterioration generally occurs adjacent to where steel lintels or shelf angles are shown in the construction drawings.

Open transverse joint at stone sill on first building addition (red arrow).

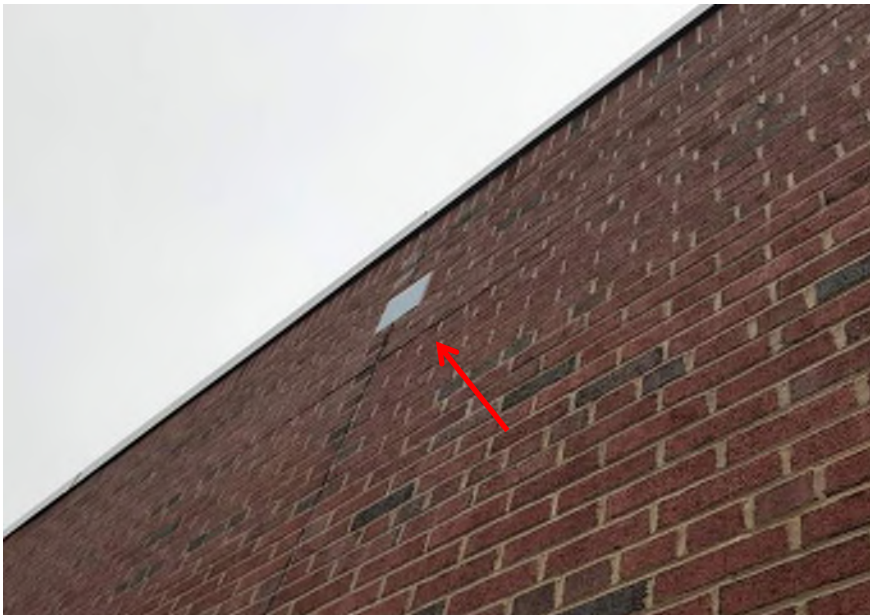
Photo 34

Cracked and displaced mortar joint on the south elevation of the bridge in the 1997 addition (red arrow).

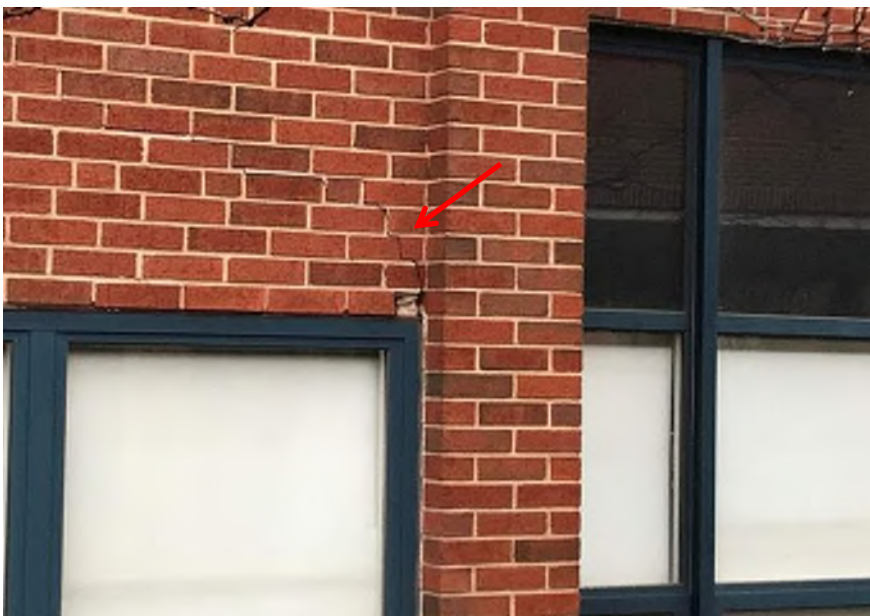
Photo 35

Missing brick and step cracking at head of window on the west elevation of the first addition.

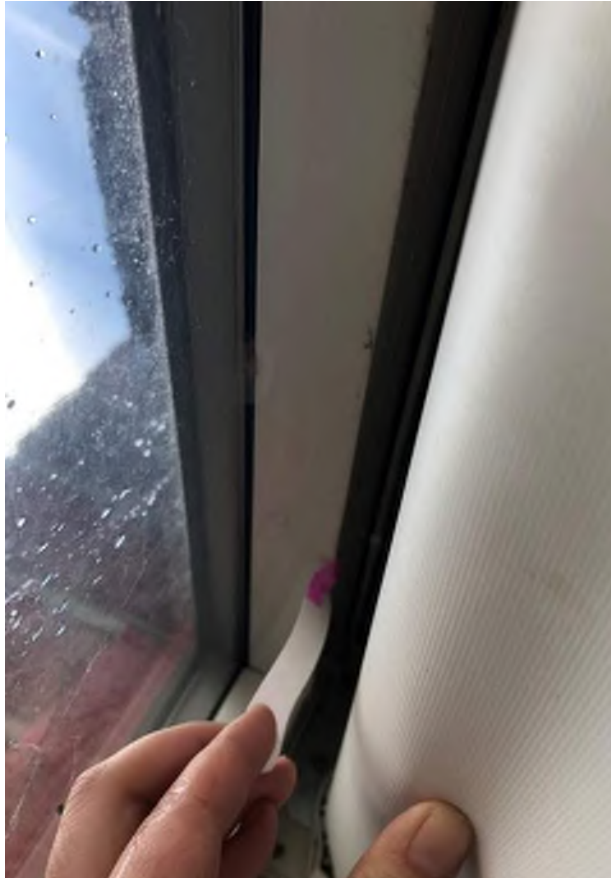
Photo 38

Water leakage to interior above window at Room 172 (water-indicating paper turns pink when it contacts water).

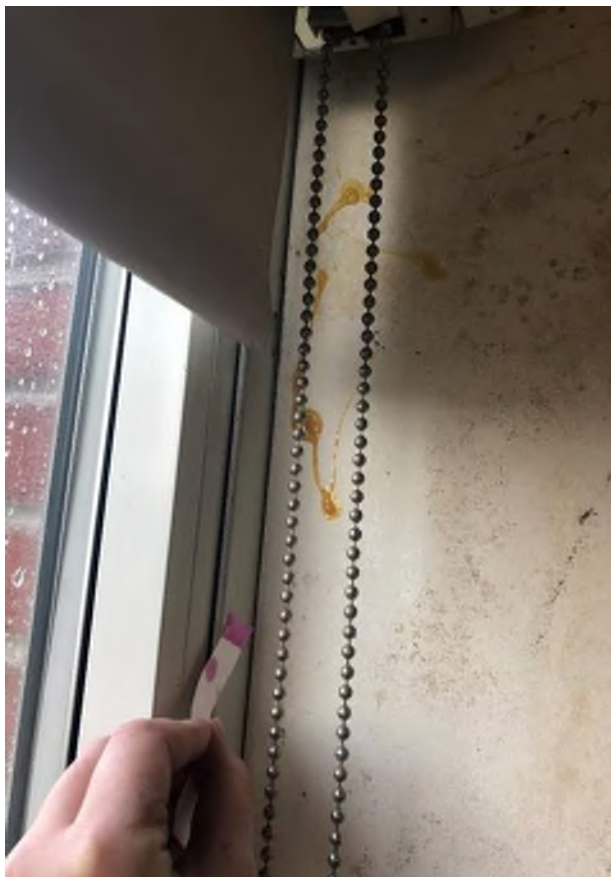
Photo 39

Water leakage along window jamb through open/deboned exterior sealant joint at Room 172.

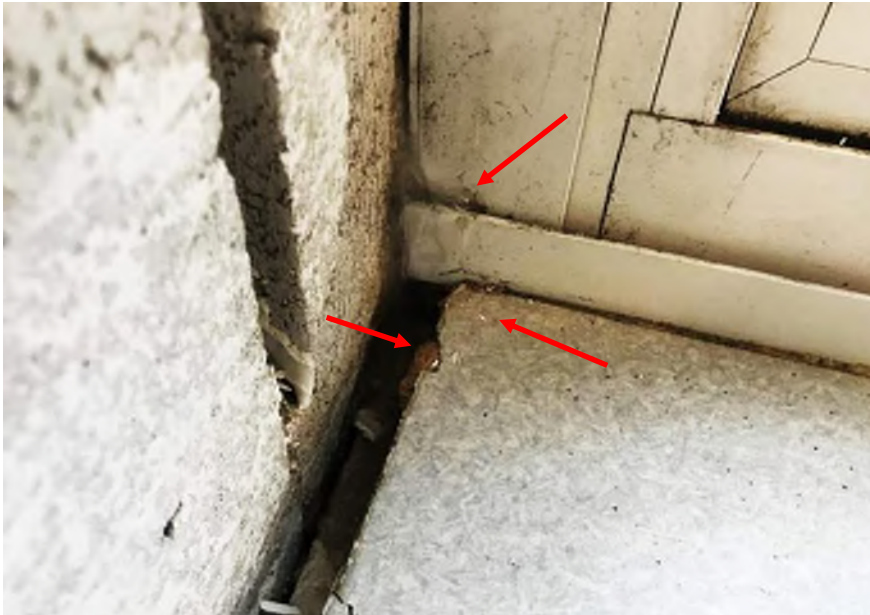
Photo 40

Water leakage to interior through open/deboned exterior sealant joint at first-floor west hallway.

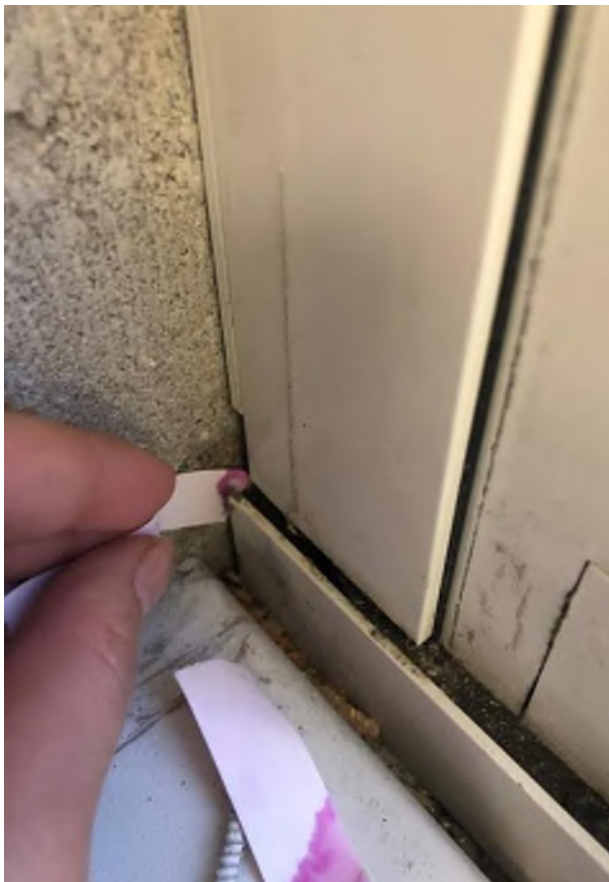
Photo 41

Water leakage to interior from end of sill receptor at window on second-floor north elevation of the bridge.
