14 January 2019

Project 182094 – Building Enclosure Investigation and Consulting Services, City of Stamford Public Schools, Stamford, CT

Per your request, this report provides the results of our investigation of the reported water leakage at the Julia A. Stark Elementary School in Stamford, CT. It includes our summary of background information provided by others, a summary of our field observations and test results, a discussion of pertinent issues, conclusions as to the sources of the water leakage, and conceptual recommendations for remedial repair options.

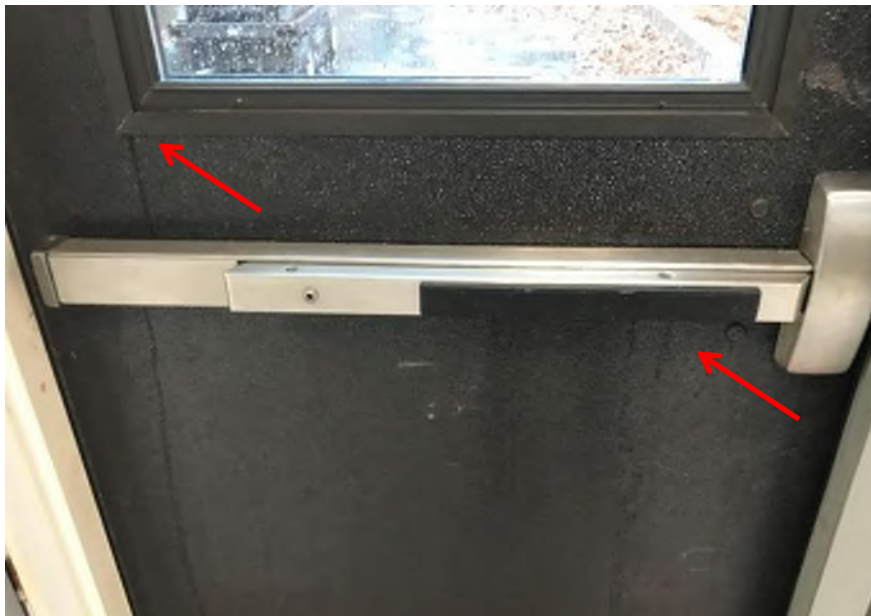
Photo 45

Leakage through window in exterior door (red arrows).

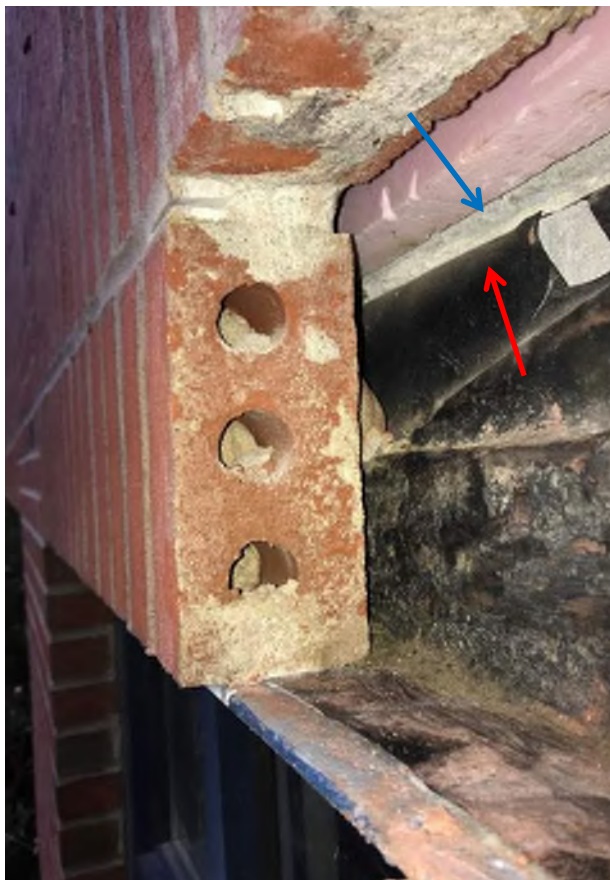
Photo 47

Exterior Opening No. 1.
Note that the flashing membrane extends into the bed joint of the CMU (red arrow) and the CMU lacks a WRB (blue arrow).

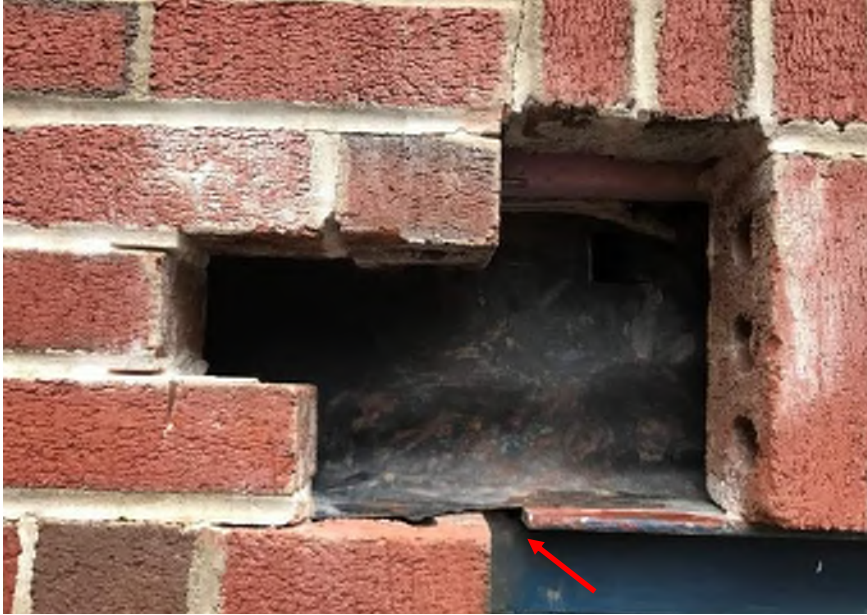
Photo 48

Exterior Opening No. 2.
Steel lintel terminates short
of window jamb.

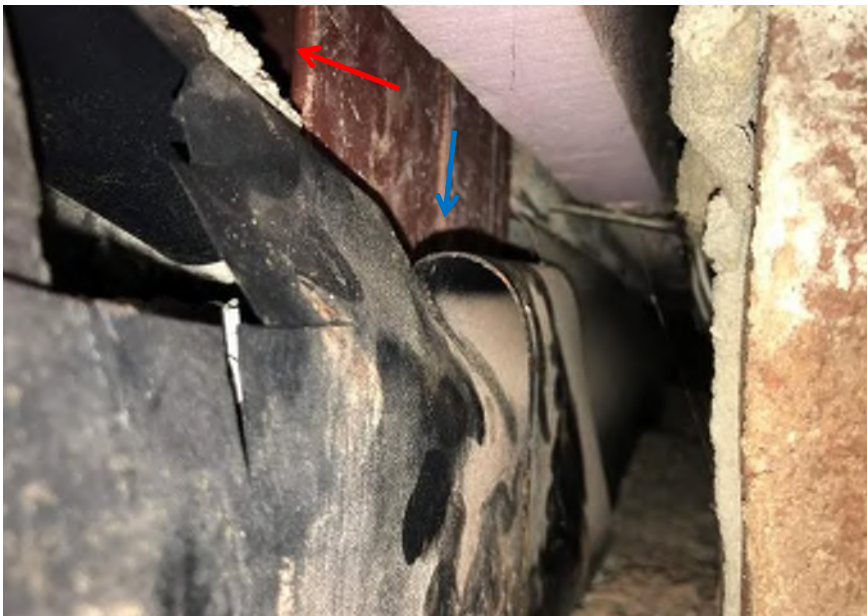
Photo 49

Flexible flashing membrane
at steel hanger penetration.
Note gap between CMU and
steel hanger (red arrow) and
between flashing membrane
and steel hanger where
flashing membrane is folded
over (blue arrow).
