Client: City of Stamford Mold Task Force Job Number: S-2087-033

**Site:** Julia A. Stark Elementary School

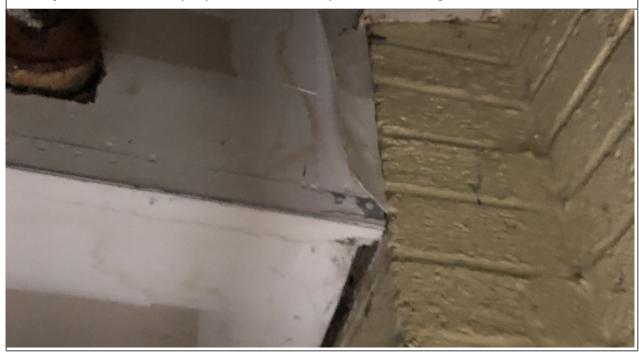
**Description:** Cafeteria Entryway—Water Stained Drywall Above Ceiling Tiles

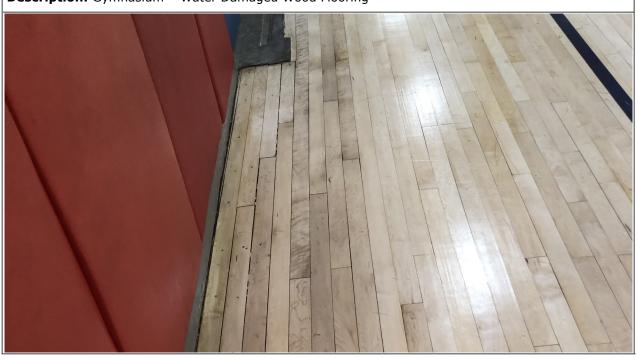
Photograph No.: 5 | Date: 11/14/18 | Direction Taken: -

**Description:** Gymnasium— Water Damaged Wood Flooring

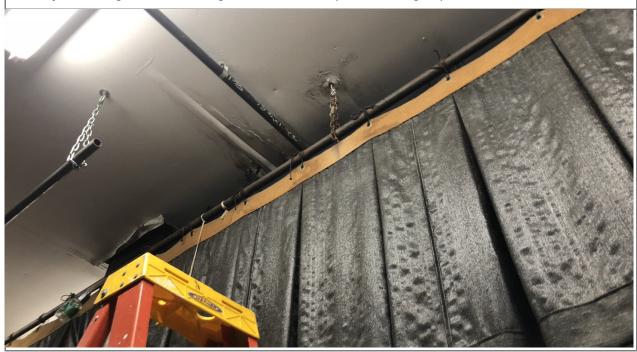
Photograph No.: 6 Date: 11/14/18 Direction Taken: —

**Description:** Stage—Water Damaged and Growth Impacted Ceiling Drywall

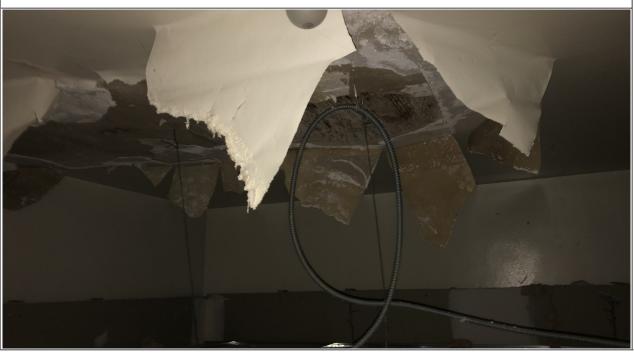
Photograph No.: 11 Date: 11/14/18 Direction Taken: —

**Description:** Room 230—Water Stained and Damaged Ceiling Plaster above Ceiling Tiles

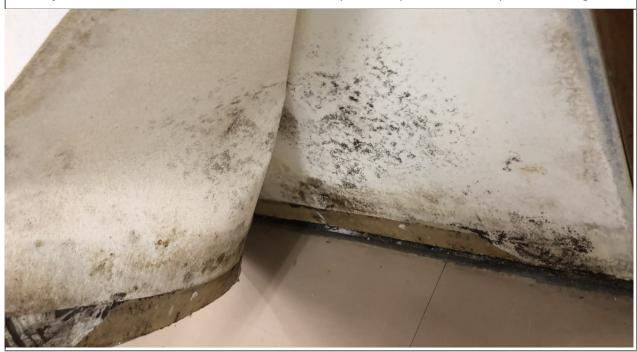
Photograph No.: 12 Date: 11/14/18 Direction Taken: —

Description: Corridor at Room 230—Black Growth Impacted Drywall Behind Vinyl Wallcovering

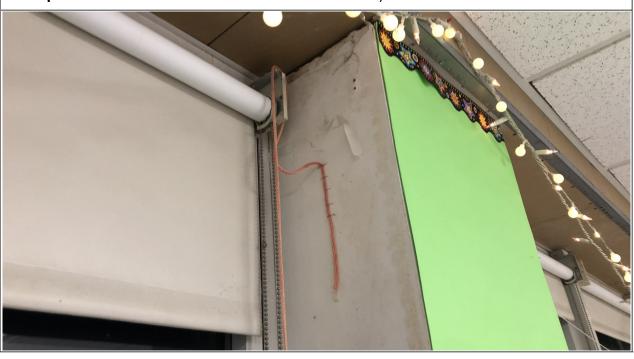
Photograph No.: 15 Date: 11/14/18 Direction Taken: —

**Description:** Room 252 — Black Growth on Window Jamb Drywall

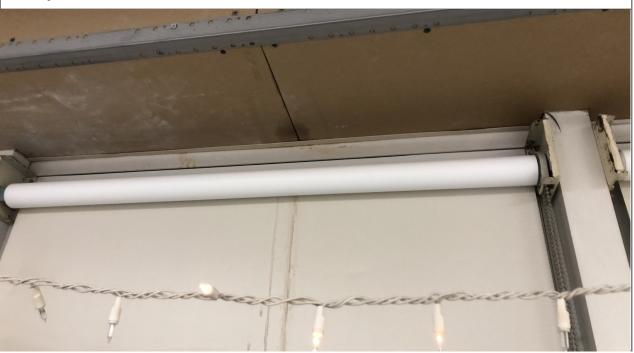
Photograph No.: 16 Date: 11/14/18 Direction Taken: —

Description: Room 252—Black Growth on Window Header

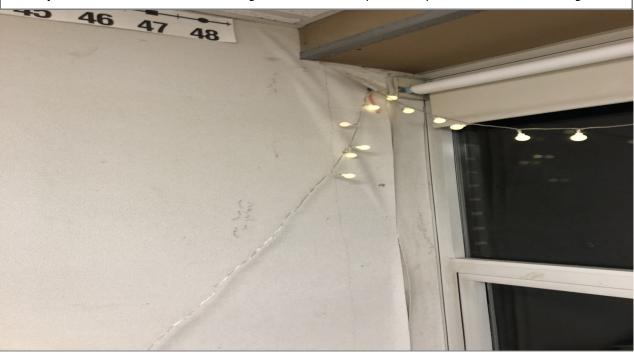
Photograph No.: 17 Date: 11/14/18 Direction Taken: —

**Description:** Room 252 — Water Damaged and Growth Impacted Drywall Behind Wallcovering

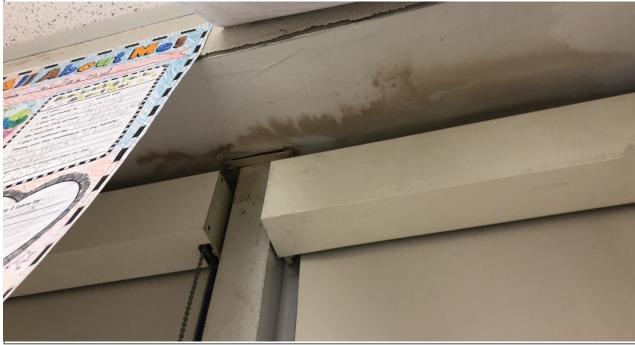
Photograph No.: 18 Date: 11/14/18 Direction Taken: —

Description: Room 168—Water Stained and Growth-Impacted Drywall at Window Header

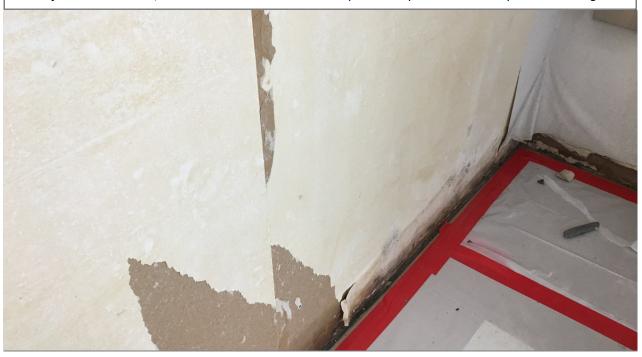
Photograph No.: 19 Date: 12/26/18 Direction Taken: —

Description: Corridor b/t Room 219 & 211—Growth Impacted Drywall behind Vinyl Wallcovering

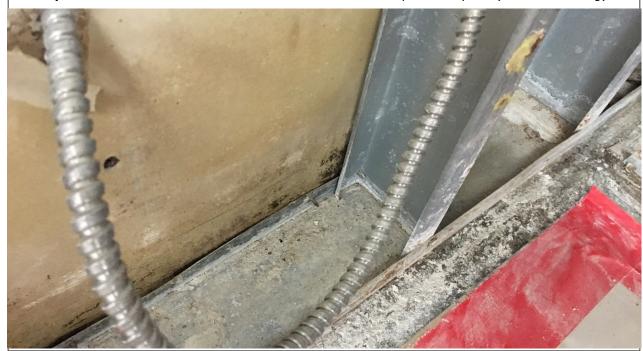
Photograph No.: 20 Date: 11/14/18 Direction Taken: —

**Description:** Corridor Wall at Room 212 Kiln Room—Growth Impacted Drywall (Prior to Cleaning)

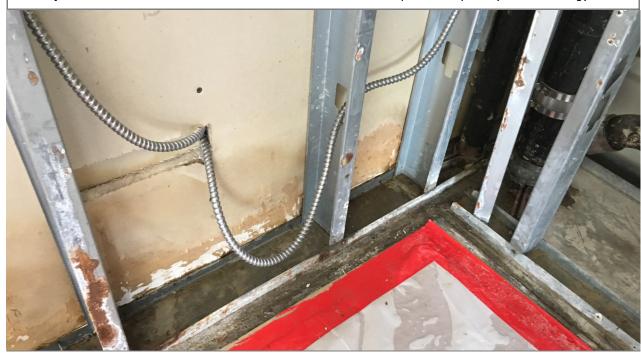
Photograph No.: 21 Date: 12/26/18 Direction Taken: —

**Description:** Corridor Wall at Room 212 Kiln Room—Growth Impacted Drywall (Post-Cleaning)

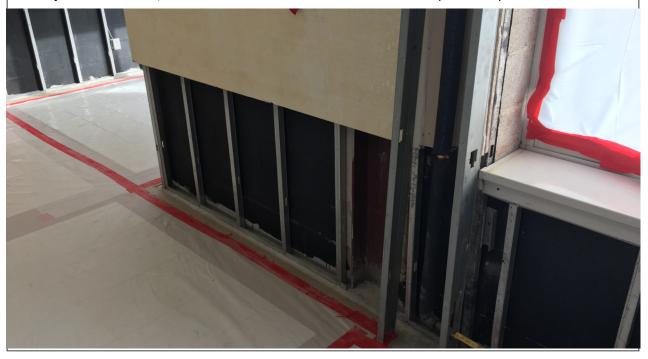
Photograph No.: 22 Date: 12/26/18 Direction Taken: —

**Description:** Corridor b/t Room 219 & 211—Post-Removal Growth Impacted Drywall

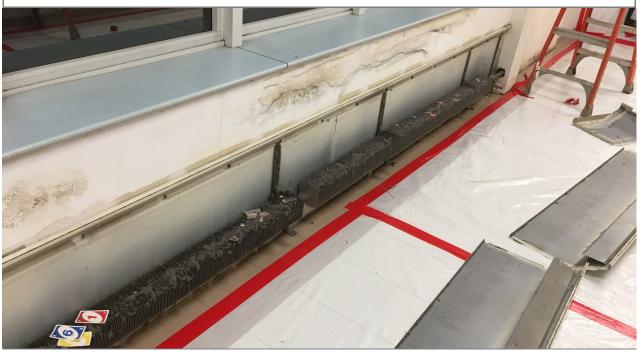
Photograph No.: 23 Date: 12/26/18 Direction Taken: —

Description: Corridor b/t Room 2003 & 246 —Growth Impacted Drywall behind Vinyl Wallcovering

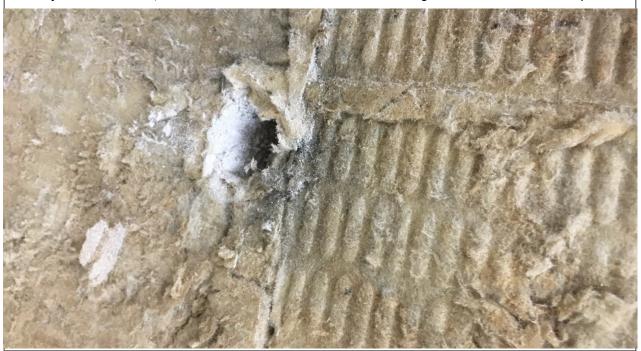
Photograph No.: 24 Date: 12/26/18 Direction Taken: —

**Description:** Corridor b/t Room 203 & 246— Black Growth on Fiberglass Insulation Behind Drywall

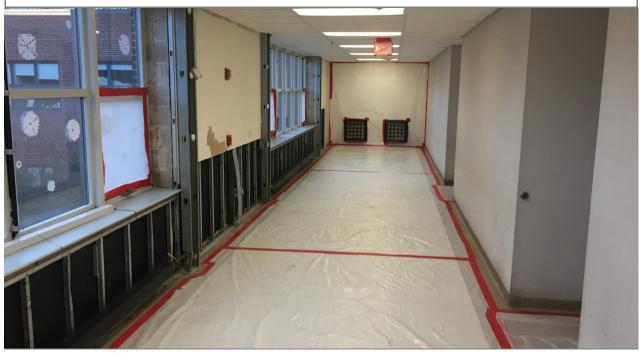
Photograph No.: 25 | Date: 12/26/18 | Direction Taken: -

**Description:** Corridor b/t Room 203 and 246—Post-Removal Growth Impacted Drywall

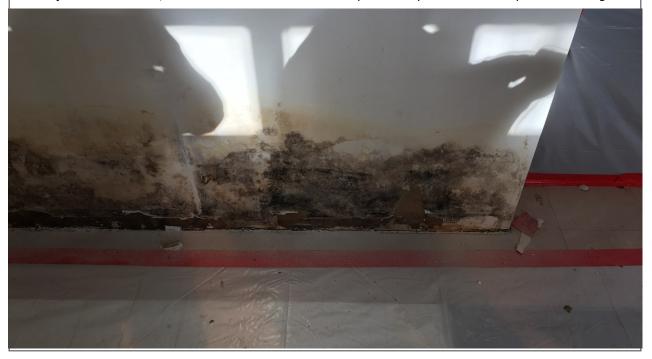
Photograph No.: 26 Date: 12/26/18 Direction Taken: —

Description: Corridor b/t Room 103 & 117— Growth Impacted Drywall behind Vinyl Wallcovering

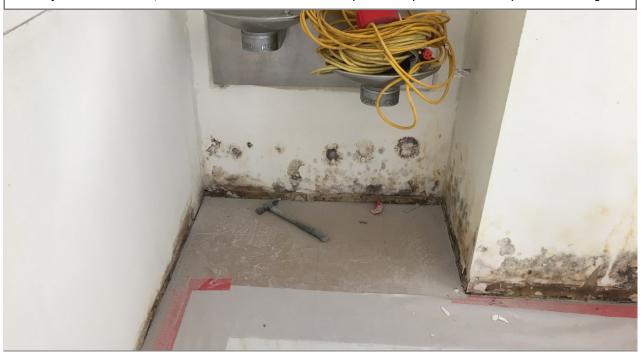
Photograph No.: 27 | Date: 12/26/18 | Direction Taken: —

Description: Corridor b/t Room 103 & 117— Growth Impacted Drywall behind Vinyl Wallcovering

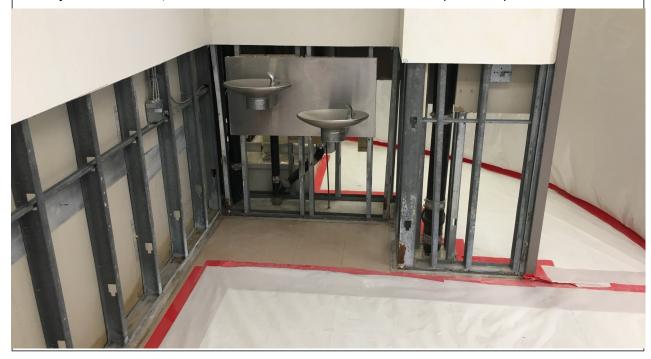
Photograph No.: 28 Date: 12/26/18 Direction Taken: —

**Description:** Corridor b/t Room 103 & 117—Post-Removal Growth Impacted Drywall
