FACILITIES NEEDS ASSESSMENT

STAMFORD PUBLIC SCHOOLS

Facilities Needs Assessment of JULIA A. STARK ELEMENTARY SCHOOL 398 Glenbrook Road Stamford, Connecticut 06906

EMG Project #: 88166.09R-013.017
Date of Report: August 29, 2009
On site Date: March 9, 2009 and March 10, 2009

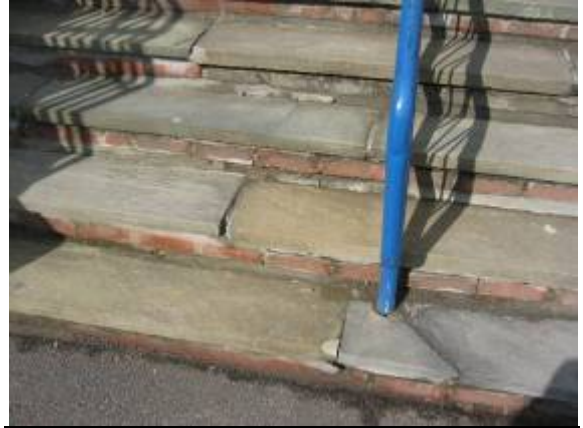
Photo #2: Detail view of the bluestone stair treads, open joints and cracked mortar exist

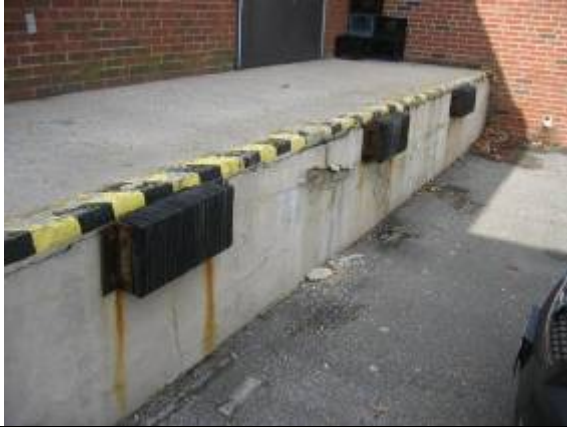
Photo #7: View of the concrete loading dock - concrete and bumper repairs are needed

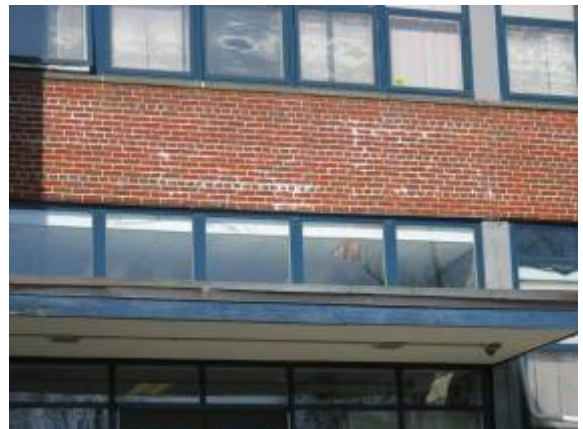
Photo #10: Several of the entrance canopies have peeling paint on the perimeter wood trim

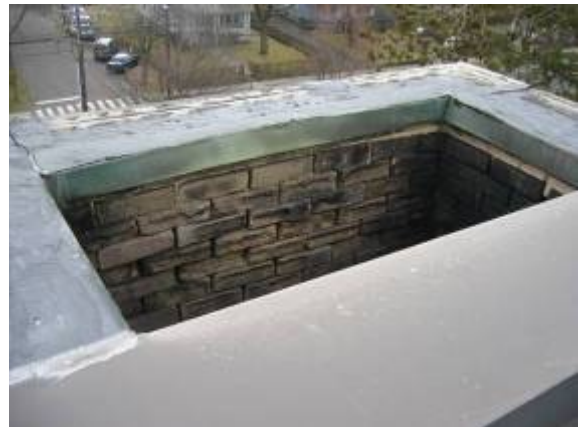
Photo #12: Open joints were noted at the top of the chimney

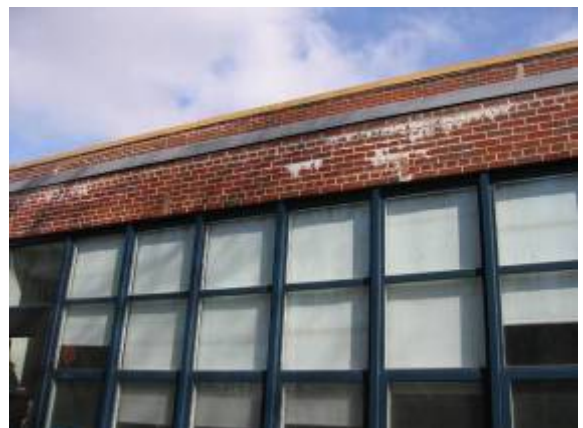
Photo #18: Isolated sections of brick; efflorescence observed

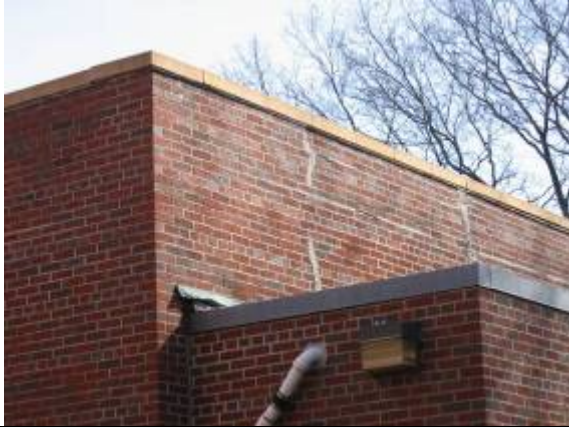
Photo #19: Isolated vertical and step cracking exists at several of the brick facades

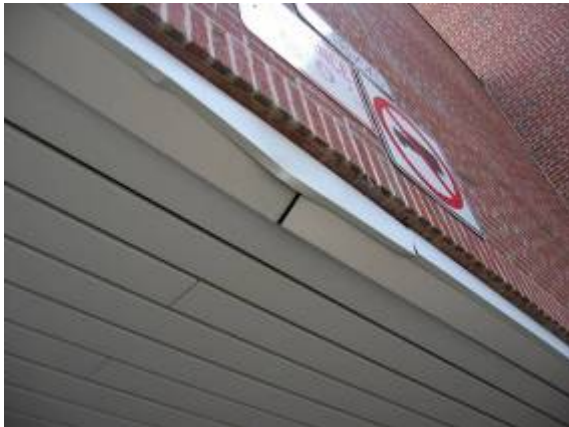
Photo #21: Minor vehicle contact damage was observed at the canopy edges

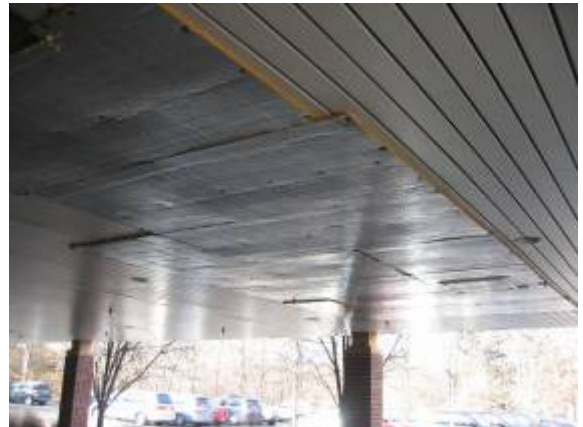
Photo #22: A section of the aluminum slat canopy ceiling is missing due to an emergency fire sprinkler repair

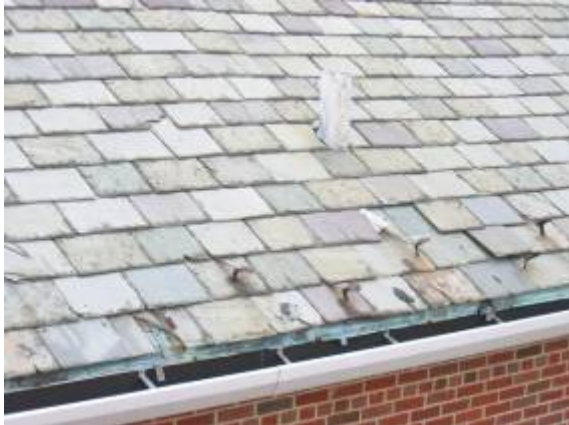
Photo #25:	Most of the ice/snow stops are damaged or missing
------------	---

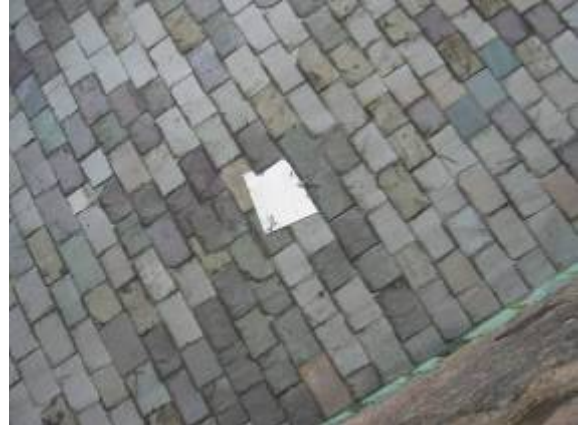
Photo #26:	Previous slate tile damage has been repaired with sheet metal pieces
------------	--

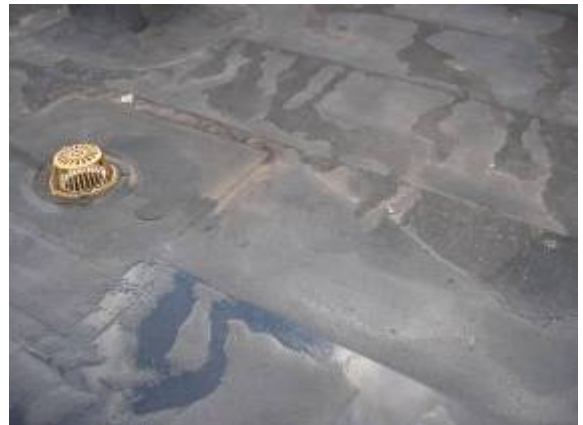
Photo #30:	Widespread blistering and trapped water pockets were noted
------------	--

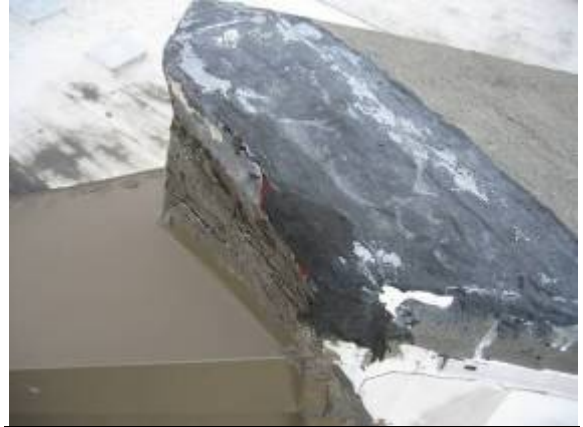
Photo #32: A few isolated open coping joints and failed mastic were observed

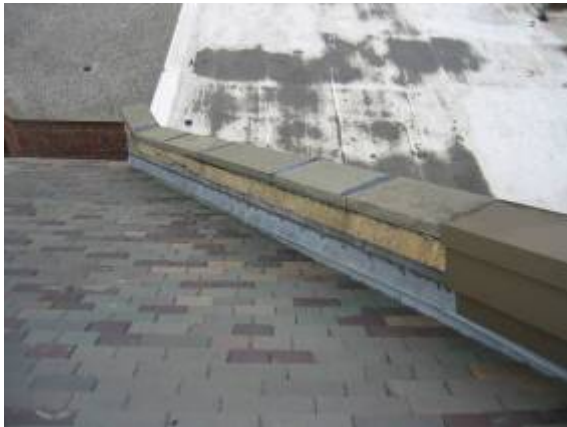
Photo #33: The pitched parapet at the slate end walls is missing metal copings

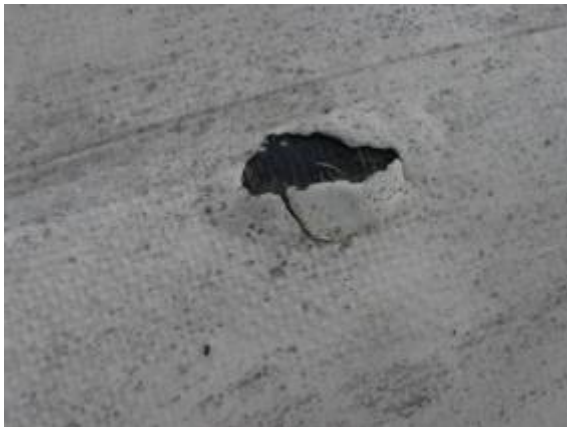
Photo #35: Several isolated tears were noted at the white EPDM roof sections

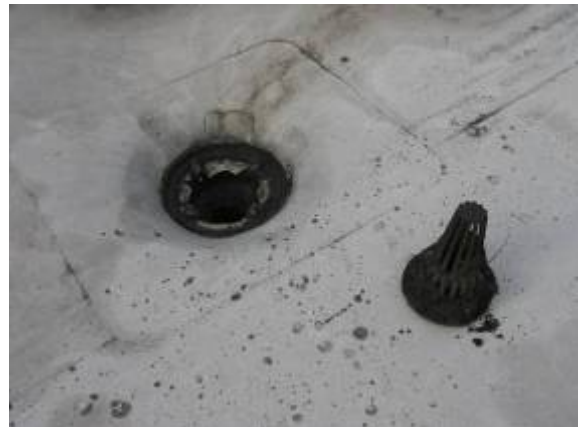
Photo #36: Several roof surface drains are missing domed strainers

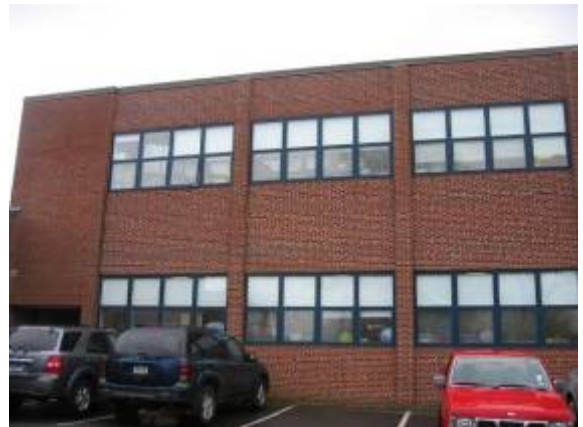
Photo #42: 2nd floor windows at the 4th grade wing experience chronic leaks

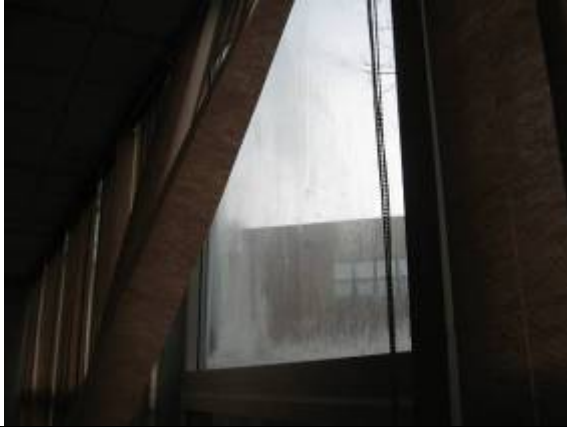
Photo #43: One failed window sash was noted with fogging at the media center

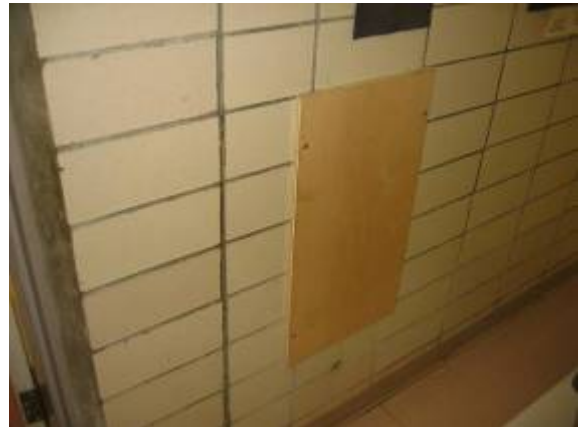
Photo #46: One of the corridor student drinking fountains is missing and boarded up

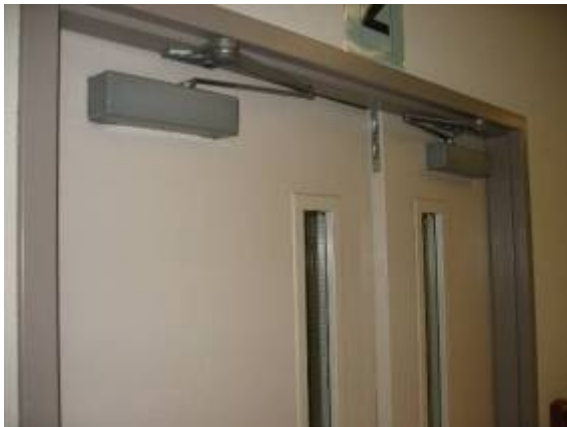
Photo #47: Three sets of stair fire doors do not close properly

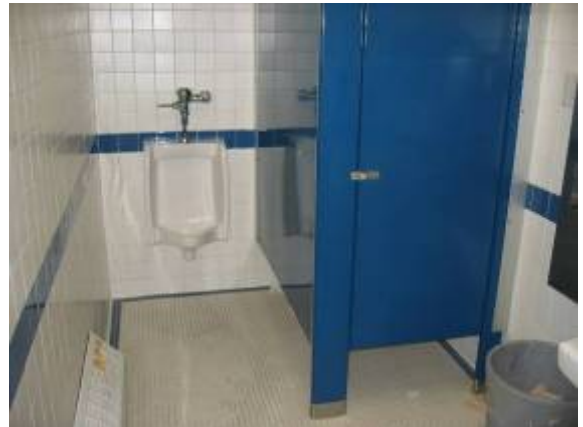
Photo #52: Many common toilet rooms do not provide handicapped access

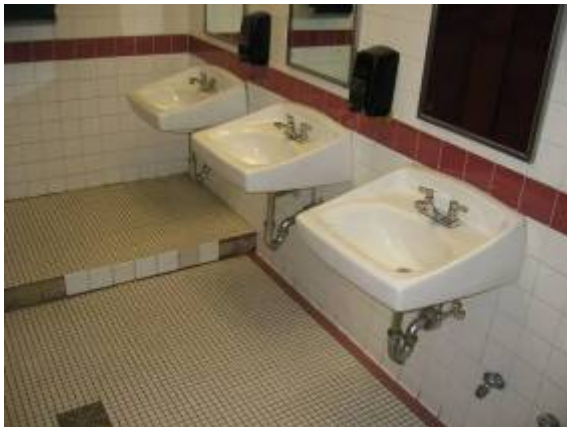
Photo #53: Some toilet rooms require ceramic tile repairs

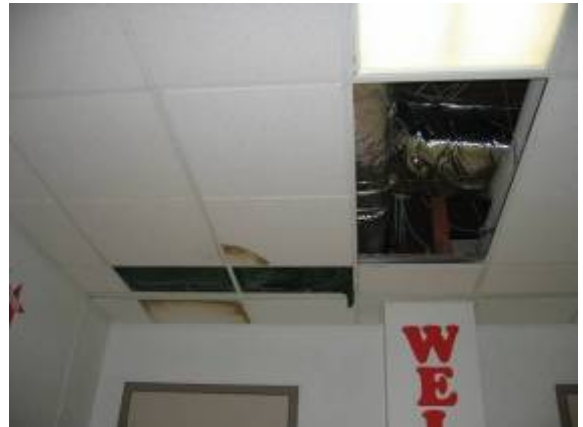
Photo #58:	Limited sections of the acoustic ceiling tiles were damaged/ missing
------------	--

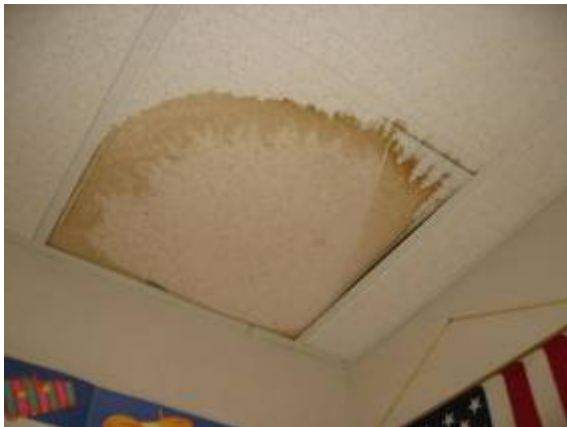
Photo #59:	Several isolated acoustic ceiling tiles were noted to be stained
------------	--

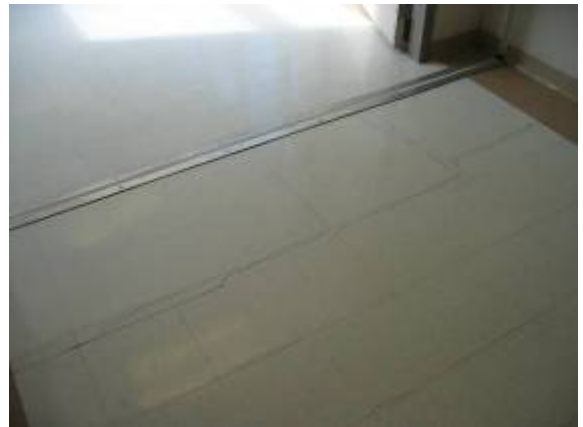
Photo #60:	Limited sections of the VCT floor tiles were noted to be cracked
------------	--

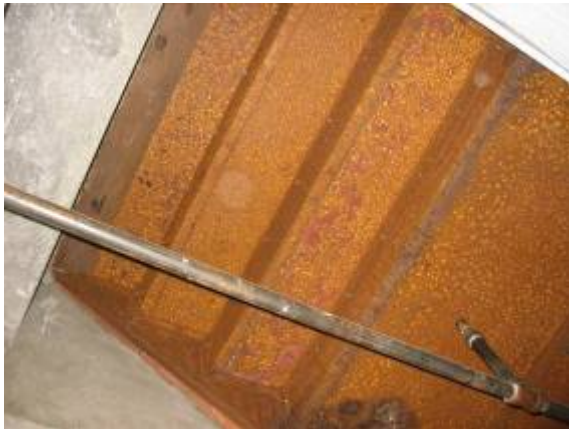
Photo #69: One basement stair was noted to be badly rusted

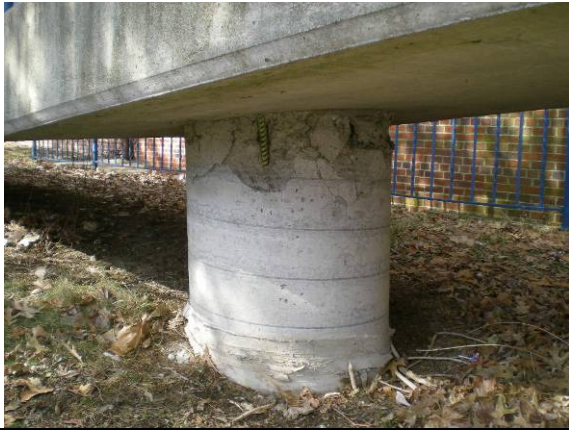
Photo #73: Column condition under ramp

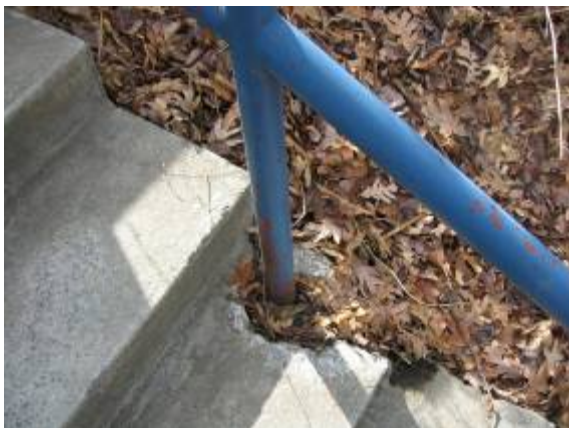
Photo #77: Detail of damaged connection between handrail and concrete steps.

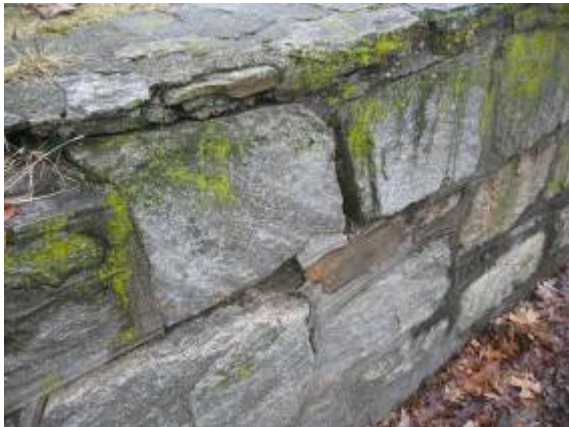
Photo #81: Detail of deteriorated mortar on retaining wall

5.2	1878	Remove and replace asphalt path 4' wide		15	10	5	3500	LF	\$17.27	\$60,461					\$60,461					\$60,461
5.4	3511	Stone masonry wall to 8' - joint repair/pointing		20	20	0	1500	SF	\$6.54	\$9,809										\$9,809

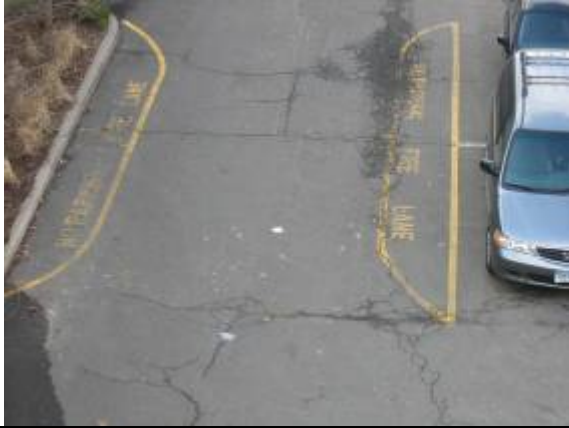
Photo #85: View of deteriorated asphalt pavement

5.2	1792	Repair and Seal Coat asphalt		5	5	0	4	10000 SF	\$5,848.92	\$23,396					\$23,396					\$46,791
5.2	1794	Cut & Patch asphalt		10	10	0	2500	SF	\$3.01	\$7,529										\$7,529

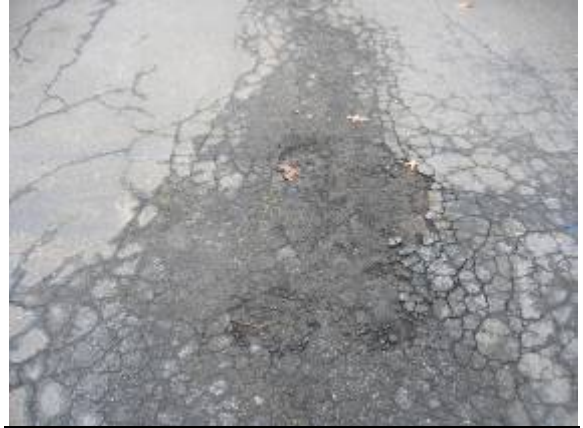
Photo #86: View of deteriorated asphalt pavement

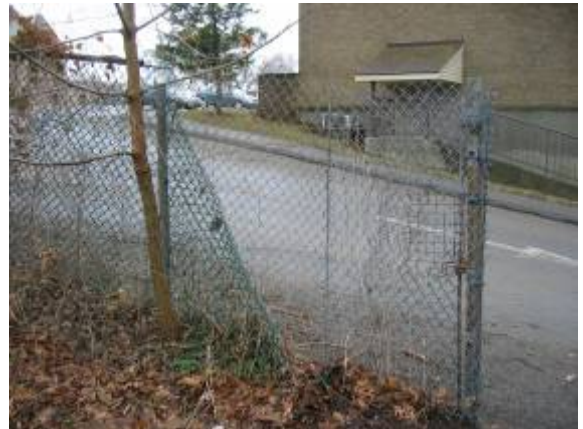
Photo #88: View of deteriorated chain link fencing

5.5	1881	Replace chain link fence, 6-foot high		20	15	5	1600	LF	\$37.31	\$59,694					\$59,694					\$59,694
5.5	1880	Repair damaged chain link fence		10	10	0	2	10 FT	\$232.91	\$466										\$466
