## **Site Assessment—Photographic Log**

Client: City of Stamford Mold Task Force

**Site:** KT Murphy—Elementary School

**Job Number:** S-2087-033

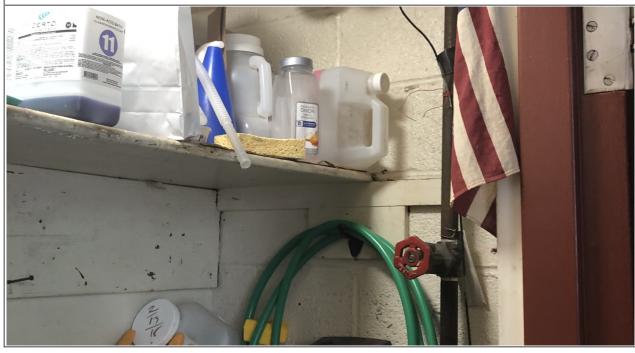
Photograph No.: 1 Date: 5/29/19 Direction Taken: —

Description: Kitchen Custodian Closet—Uninsulated Piping

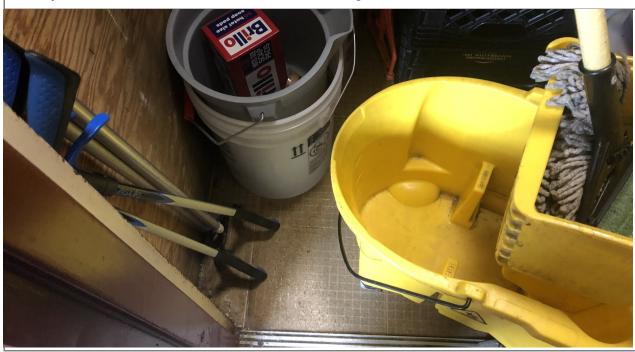
Photograph No.: 2 Date: 5/29/19 Direction Taken: —

**Description:** Kitchen Custodian Closet—Asbestos Flooring

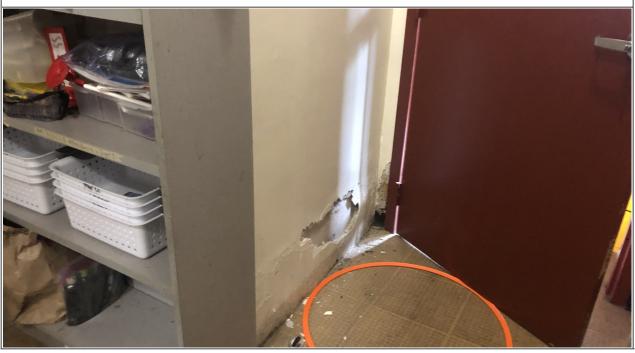
Photograph No.: 3 | Date: 5/29/19 | Direction Taken: -

**Description:** Gym Office—Damaged Wall Plaster and Growth Impacted Drywall

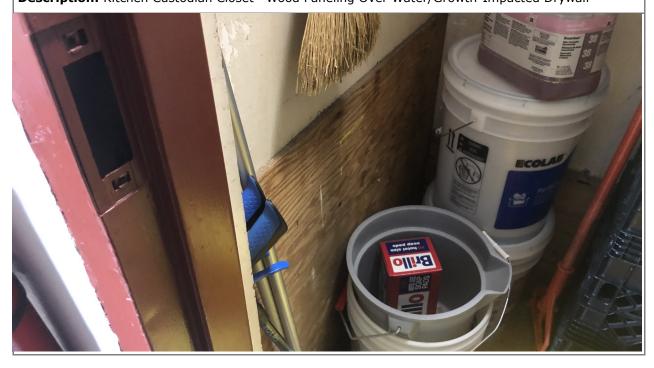
Photograph No.: 4 Date: 5/29/19 Direction Taken: —

**Description:** Kitchen Custodian Closet—Wood Paneling Over Water/Growth-Impacted Drywall
