On February 18 and 19 of 2019 Silver/Petrucci and Associates visited Newfield Elementary School, Julia Stark Elementary School, Hart Elementary School, Toquam Magnet School and KT Murphy Elementary School. We conducted an assessment of the existing conditions related to the mechanical equipment in order to find deficits which may contribute to the current mold situation. Additionally, we made observations of the general installation of the systems in each school. The following report lists our observations along with supporting photographs. We will issue an additional report with further recommendations on how to improve or fix the current situation.

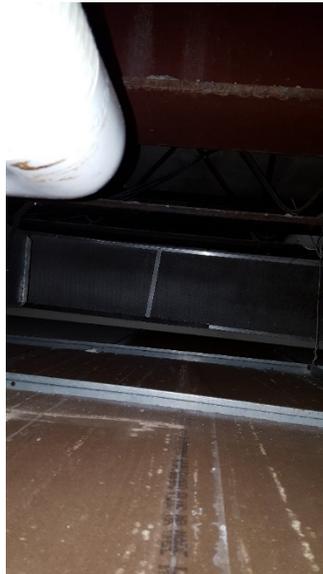
Room 31

- No return grille serving the system.
- There is a return duct, or possibly an outside air duct, however it does not appear to be connected to anything.
- The unit has no return duct connected to a return grille. It effectively draws air from the plenum.

Air Handling Unit with No Ducted Return:

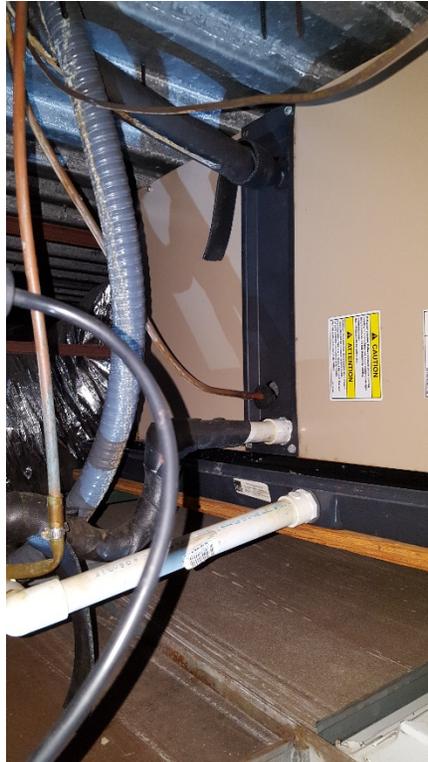
Rm 1 – Air Handling Unit

- Appears there was a leak where the refrigerant piping goes through the roof.
- Unit does not appear to be installed level which will make condensate draining potentially difficult depending on the configuration of the unit.
- The drain pan was pitched too far forward and the drain was in the center of the pan. The pan would have to fill up about half way before the condensate could be drained.

RM 1 AHU condensate drain pan:

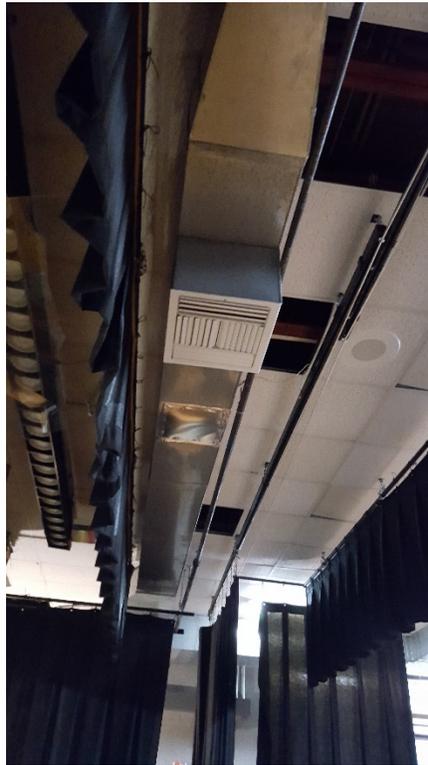
Auditorium

- Appears that separate exhaust fans are used for pressure relief. These need to be tied into the outside air intake damper. If they were running but the outside air was not open they system would be drawing air in from other spaces.
- The ductwork above the stage was not insulated.

Uninsulated auditorium ductwork:

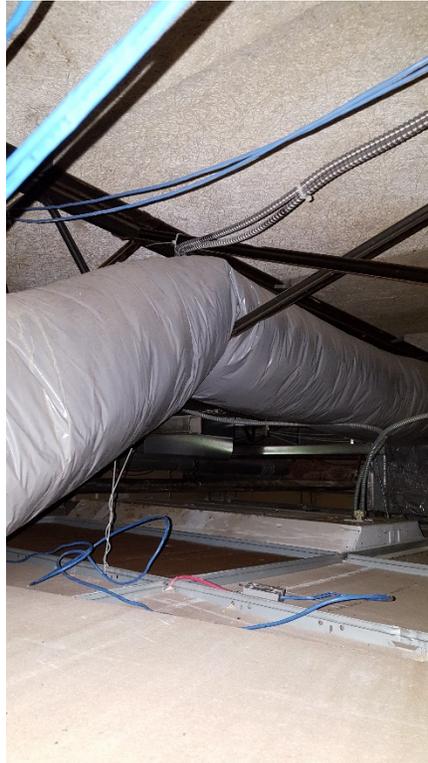
- Ducts were connected such that sharp elbows had to occur in order to tap off the branches. This will restrict airflow.
- Ductwork did not appear to be sealed. Air movement was observed above the ceiling.

Restricted Media Center ductwork:

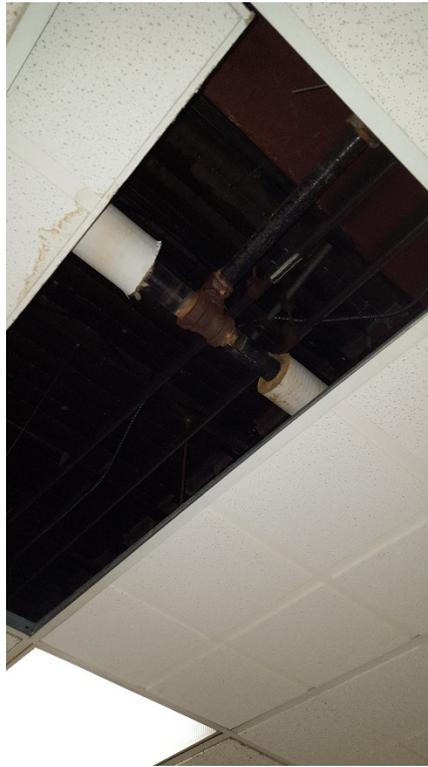
We observed several gaps in the piping insulation on heating piping. It is possible that leaks were repaired, and the piping was never reinsulated. Gaps in heating piping insulation should not cause any potential mold issues however if there were piping leaks water could accumulate at these gaps on the ceiling.

Uninsulated section of piping:

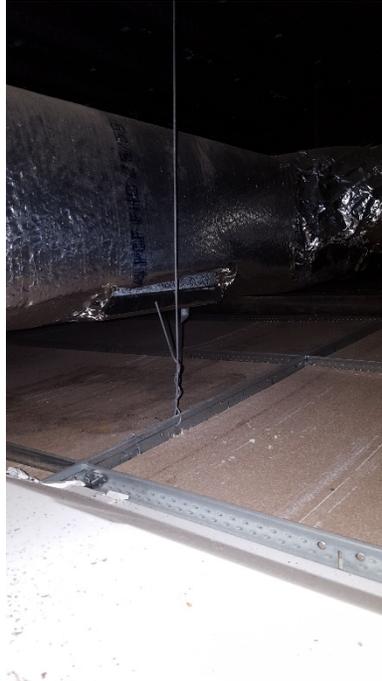
Rm101

There appear to be stains from condensation below the supply ductwork serving the classroom. We verified the size of the ductwork as well as the supply and return grilles. The system, which uses zone dampers as opposed to conventional VAV boxes, appears to be sized for approximately 4 tons of cooling load. Due to the condensation stains it is likely that the ductwork insulation is not completely sealed in a vapor tight manner. There is a heavy concentration of condensation below an access panel in the ductwork. The insulation does not appear to be sealed around it. Cool air leaks out and condenses in the warm, humid air above the ceiling. Further evaluation will have to determine if this condition is being repeated in other classrooms.

Water stain below access hatch in ductwork:

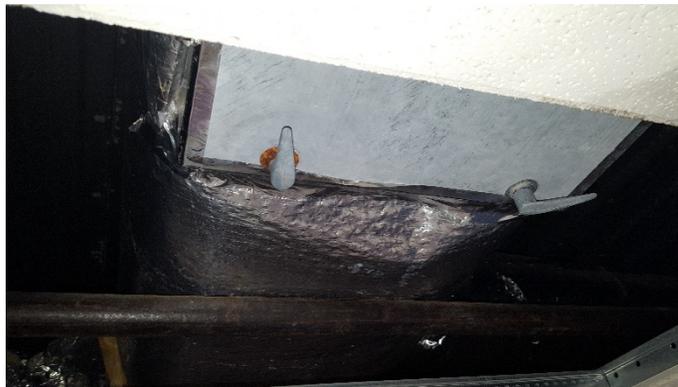
Underside of access hatch. Note the rusting on the handle:

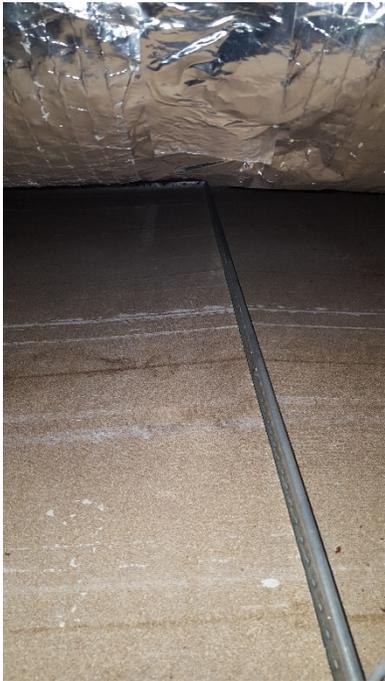
Insulation with tear in it, leading to water staining below:

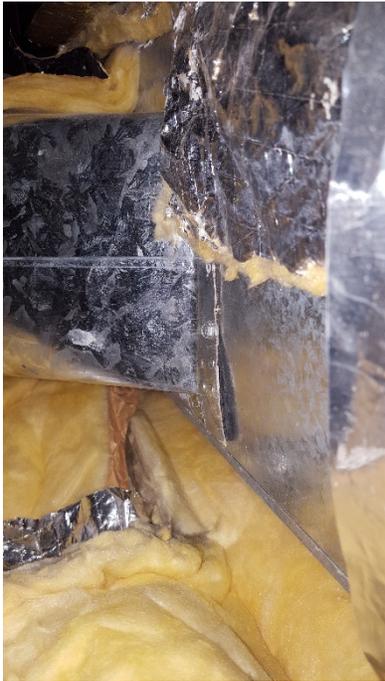
Branch ductwork connection not sealed:

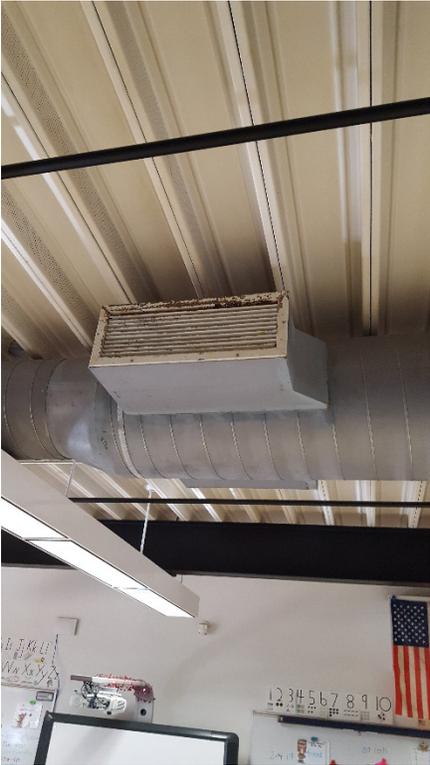
The air handling units serving the classrooms have a capacity of 5 tons and use chilled water as the cooling source. There is significant rusting on the supply grilles and the maintenance staff states that condensation occurs on the outside of the ducts during the cooling months. The supply ducts are not insulated. The mechanical code at the time stated that if the duct serving the space was located within the space, insulation is not required. Issues may occur on startup when the system has been off during the unoccupied mode and the space becomes warm and humid. During startup moisture may condense on uninsulated surfaces. Additionally, the unit is provided fresh air by a roof mounted ventilator. It was unclear during the initial inspection how the outside air is balanced.

Rusted supply grille:

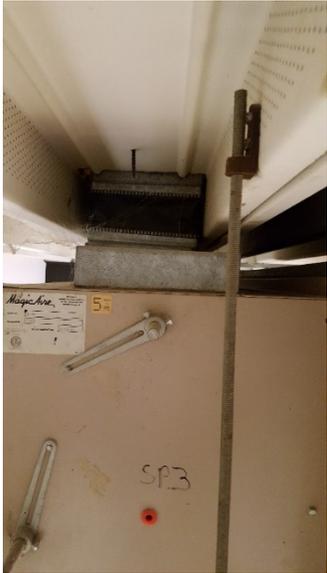
Outside Air Connection:

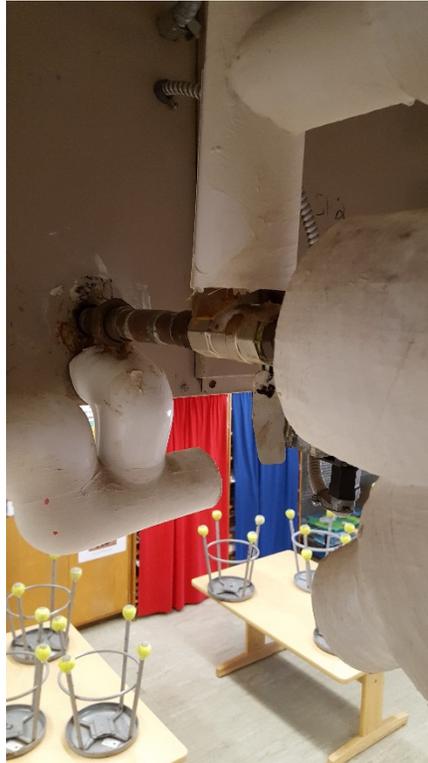
Uninsulated Piping:

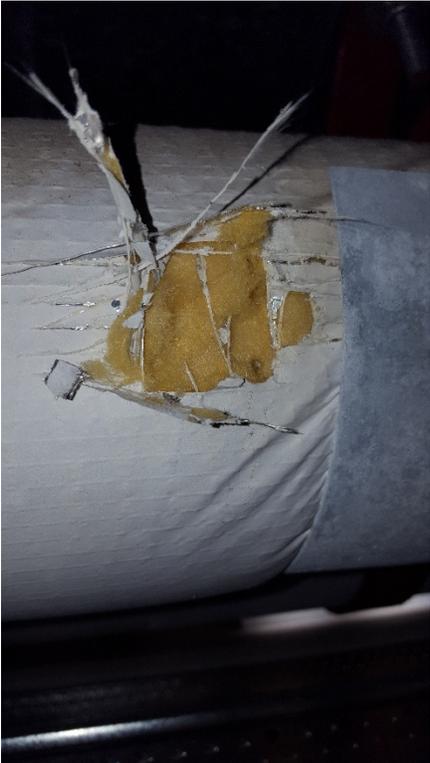
Without removing portions of insulation it was difficult to determine the thickness of the installed insulation. It was noted however that in many cases insulation has been damaged or removed in portions altogether. Due to the low ceiling height of the building it also appears that portions of insulation have been compressed in order to make the ceiling clearances. Besides reducing the insulation value it also likely compromises the integrity of the vapor barrier.

Compromised insulation:

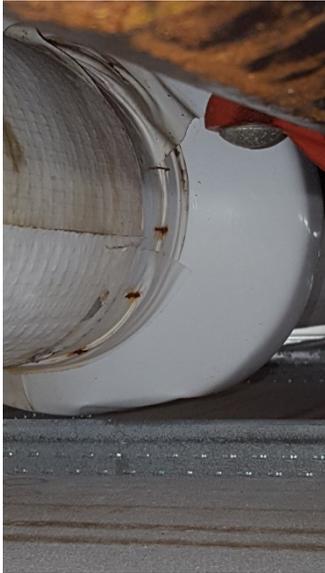
Chilled water insulation with rusted staples indicating a compromised vapor barrier:

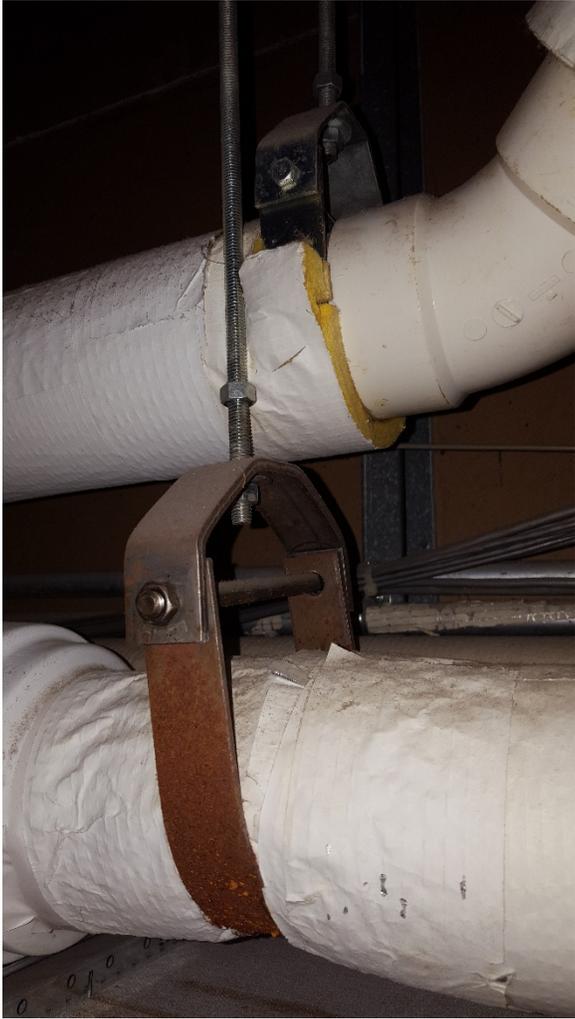
Compromised insulation. Insulation has been compressed around the hanger. The upper pipe has had the insulation wrapped around the hanger. Also note that the chilled water piping hanger is rusting and the other hanger is not:

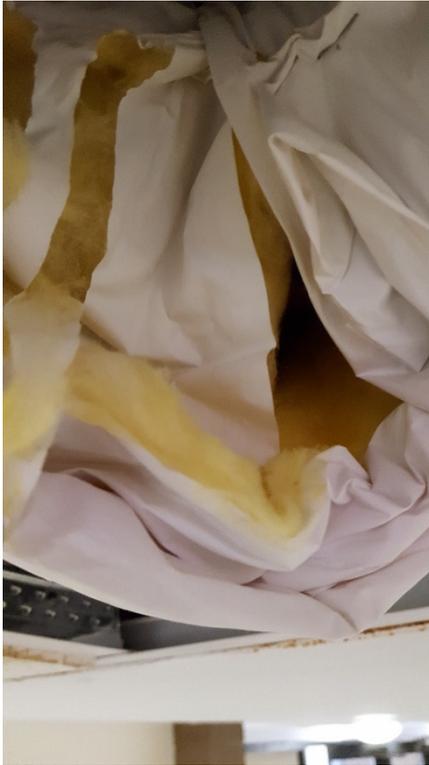
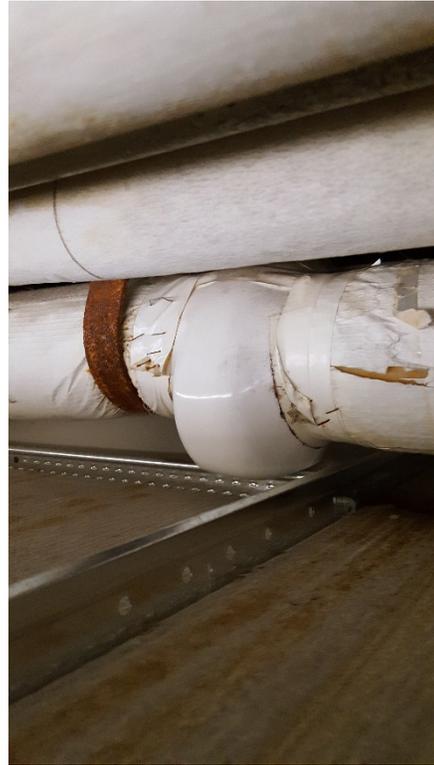
Compromised insulation:

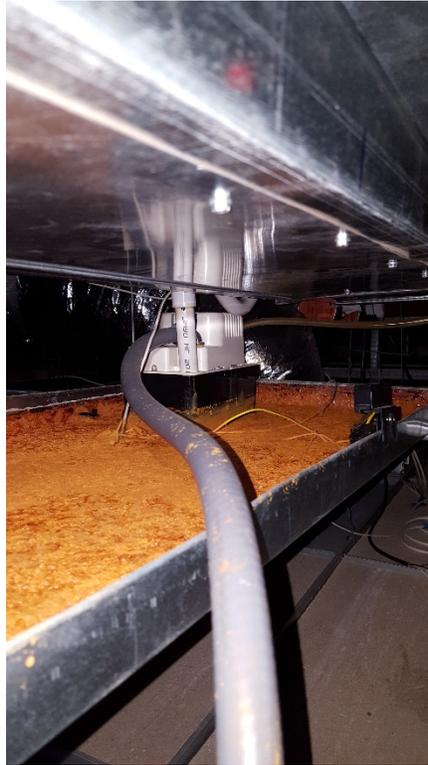
The drain pan under one of the air handling units serving a portion of the Media Center appeared to be overpitched. As can be observed in the picture below severe rusting has occurred within the pan indicating where the water resides. It appears that about half the pan fills up prior to the condensate pump activating.

Media Center AHU drain pan:

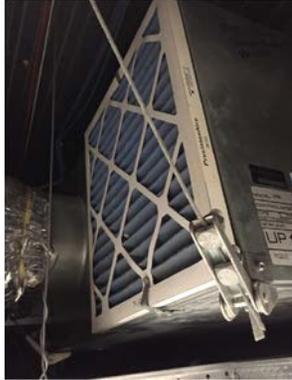
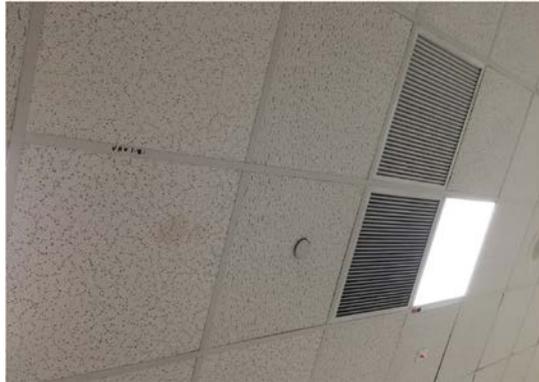
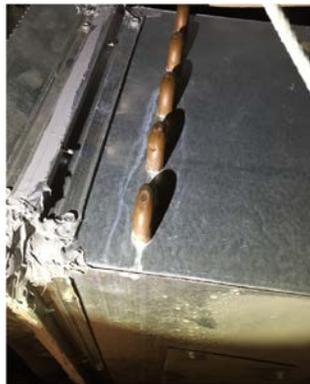
- Series fan powered VAV boxes with hot water reheat coils serve the media center. Series fan powered VAV boxes mix primary air with induced air to deliver constant volume air to the space. Primary air is from the rooftop unit and induced air is from plenum above ceiling. Where VAVs are located, staining of ceiling is present.

- The VAV reheat coil is fed from the main 2-pipe water distribution system. Signs of water staining at the reheat coil cabinet is present (photo above). While the control valve on the supply side is closed during summer operation, water temperature inside the reheat coil is likely to approach the chilled water return temperature, where condensation at the surface of the pipes/coils can occur.
- Valves and specialties are not insulated. (photo below)

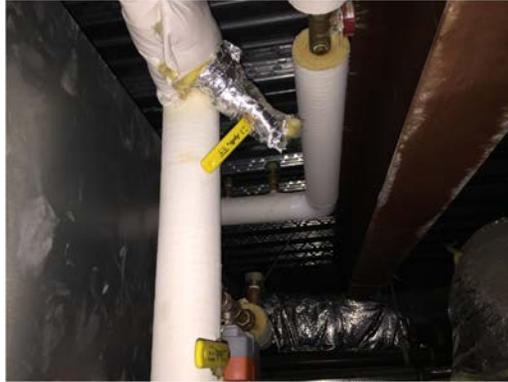
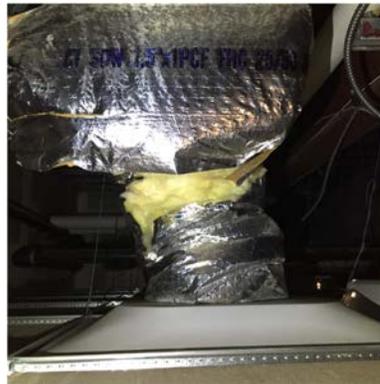
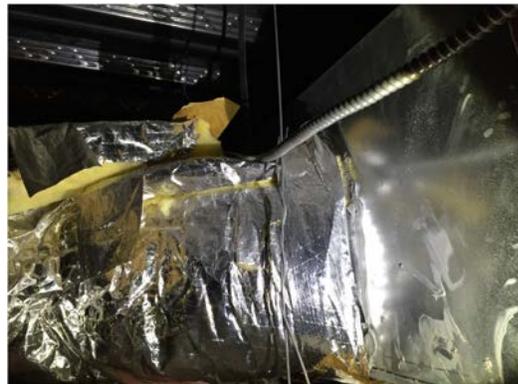
- Ductwork did not appear to be sealed. Air movement was observed above the ceiling.
- Ductwork insulation is not taped/stapled properly and no insulation at diffuser backpan. (middle and right photo above)

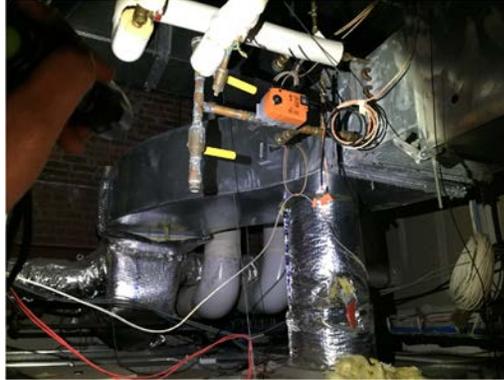
- Series fan powered VAV boxes with hot water reheat coils serve the corridor. Series fan powered VAV box mixes primary air with induced air to deliver constant volume air to the space. primary air is from the rooftop unit and induced air is from ceiling mounted return grille in corridor. Where VAVs are located, staining of ceiling is present.

- Valves and specialties are not insulated. Copper oxidation (patina) in pipe fittings from leak drips/condensation overtime. (photo above)
- Duct insulation not sealed/taped.

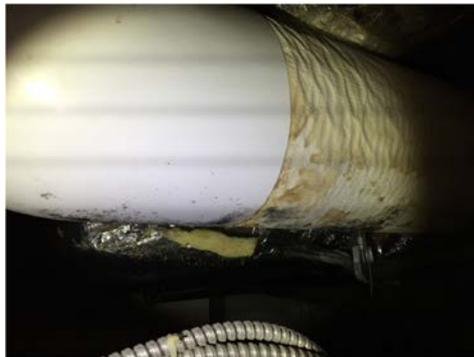
- Mold spotted at chilled water piping insulation and bottom of elbow insulation jacket from chiller on roof. Portions of insulation need to be removed to verify integrity of vapor barrier and if vapor seals are installed at butt joints.

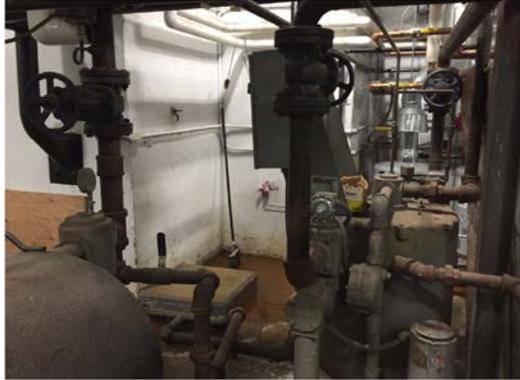
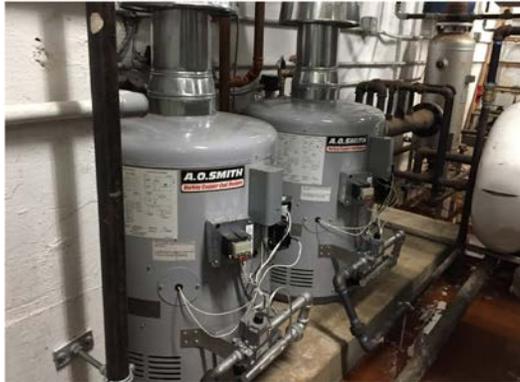
- Ventilation air to the boiler room is wide open all year round.
- Water at corner of the boiler room near domestic water heater is observed.

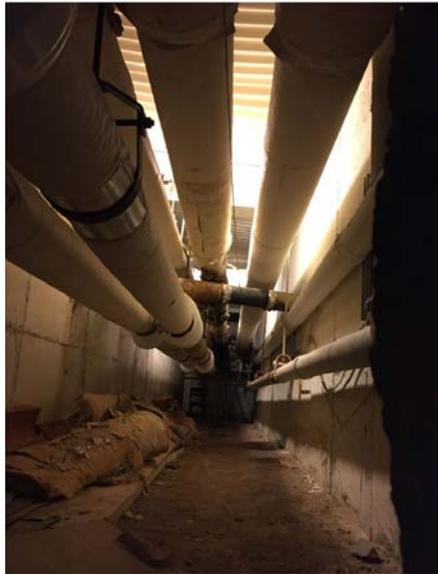
- Several gaps in the piping insulation on steam piping in the tunnel were observed. It is possible that leaks were repaired, and the piping was never reinsulated. (right photo above)

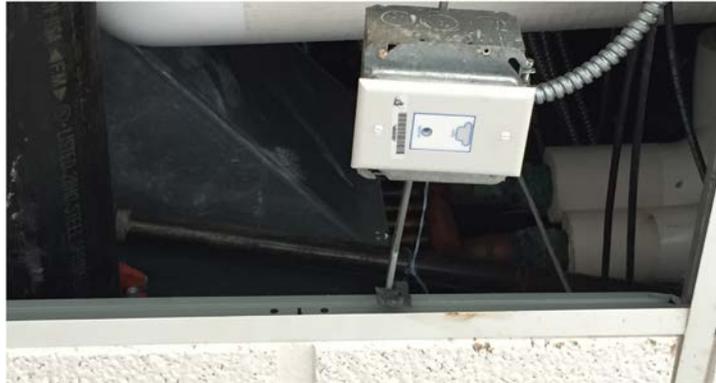
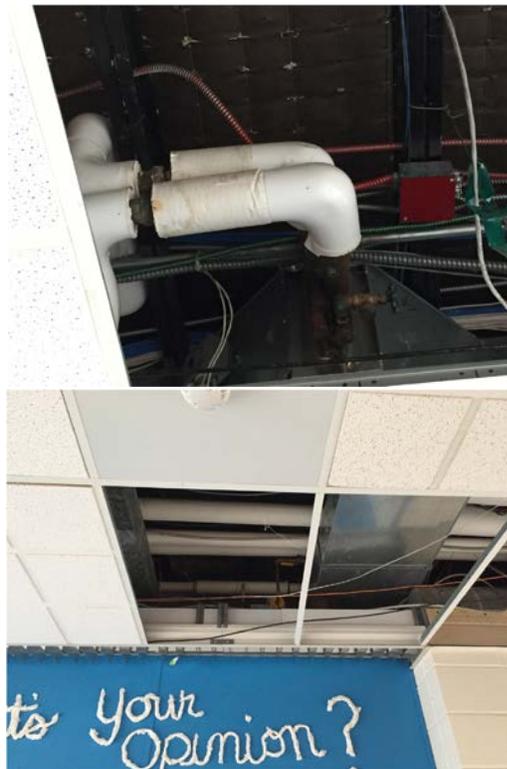
- Piping connections to the hot water coils have visible copper oxidation (patina) in pipe fittings from leak drips/condensation overtime. (photo below)

- Outside air ductwork serving the classrooms is not insulated. (photo above)
- Ductwork has no mastic sealer at joint.

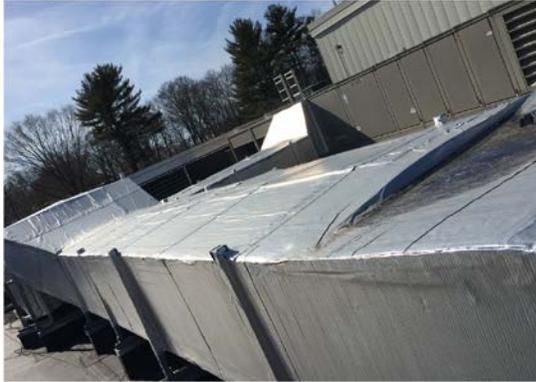
- Water on top of insulated exterior ductwork.

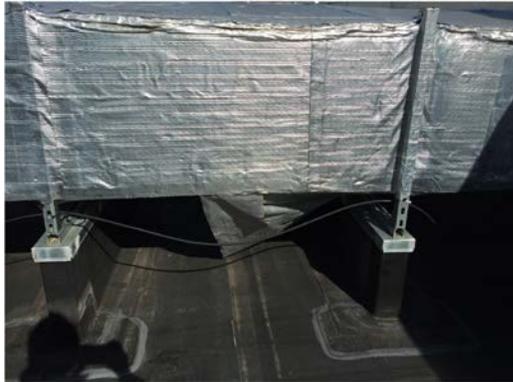
- Insulation falling off exposed ductwork on roof.
