Client: City of Stamford Mold Task Force

Site: KT Murphy—Elementary School

Job Number: S-2087-033

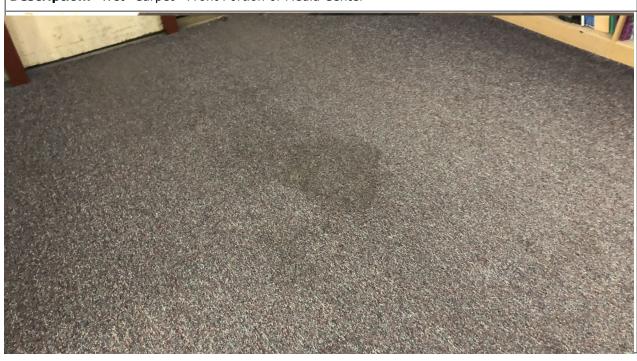
Photograph No.: 3 Date: 11/2/18 Direction Taken: —

Description: "Wet" Carpet—Front Portion of Media Center

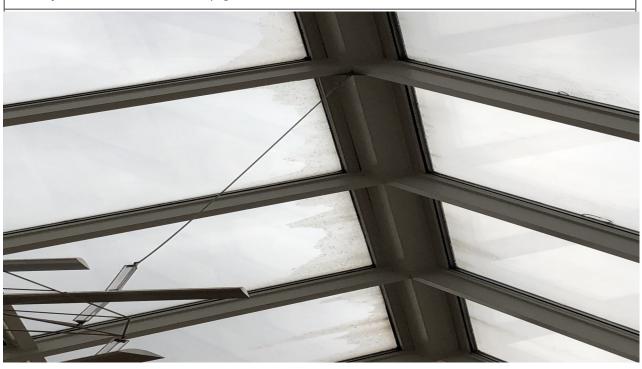
Photograph No.: 4 Date: 11/2/18 Direction Taken: —

Description: Visible Water at Skylight—Media Center

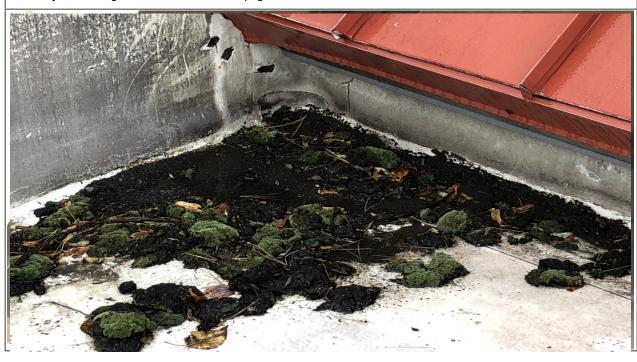
Photograph No.: 5 Date: 11/5/18 Direction Taken: —

Description: Vegetative Growth at Skylight—Exterior Roof

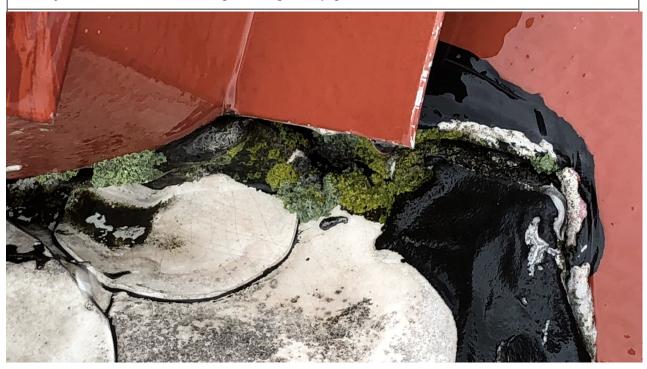
Photograph No.: 6 Date: 11/5/18 Direction Taken: —

Description: Deteriorated Caulking/Flashing at Skylight— Exterior Roof

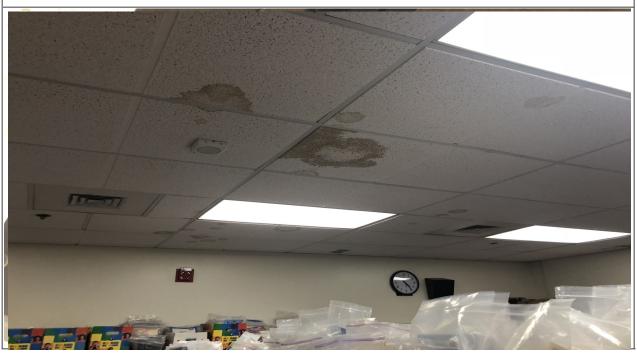
Photograph No.: 7 | Date: 11/2/18 | Direction Taken: -

Description: Water Stained Ceiling Tiles—Book Room

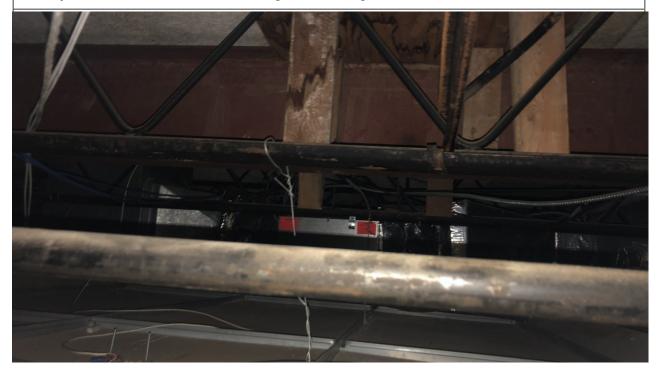
Photograph No.: 8 Date: 11/5/18 Direction Taken: —

Description: Water Stained Wood Blocking above Ceiling—Book Room

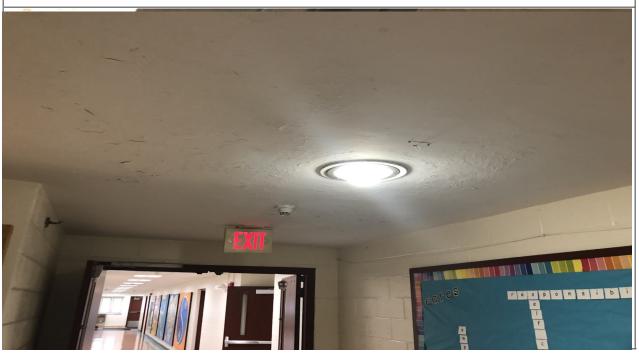
Photograph No.: 11 Date: 11/2/18 Direction Taken: —

$\textbf{Description:} \ \mathsf{Peeling} \ \mathsf{Paint} - \mathsf{Corridor} \ \mathsf{at} \ \mathsf{Room} \ \mathsf{12}$

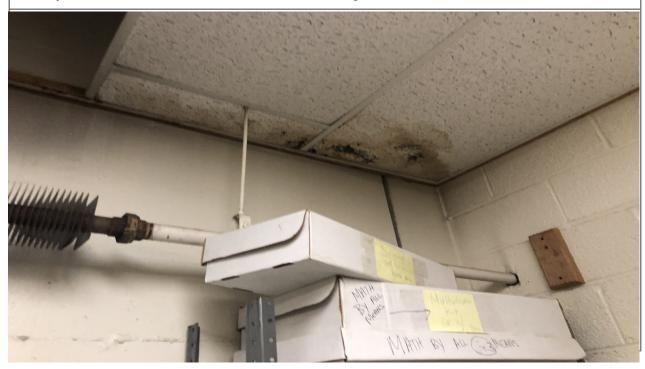
Photograph No.: 12 Date: 11/2/18 Direction Taken: —

Description: Water Stained and Black Growth on Ceiling Tiles— Basement Corridor Closet

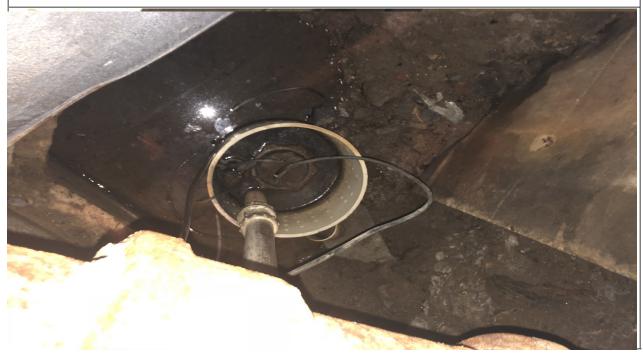
Photograph No.: 13 Date: 11/2/18 Direction Taken: —

Description: Standing Water in Sump Pump—Auditorium Sump Pump Closet

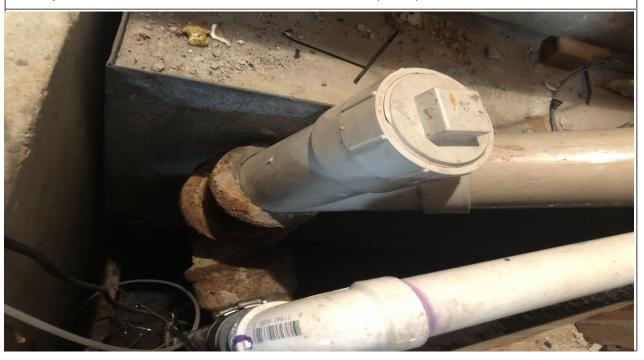
Photograph No.: 14 Date: 11/2/18 Direction Taken: —

Description: PVC to Cast Iron Connection—Auditorium Sump Pump Closet

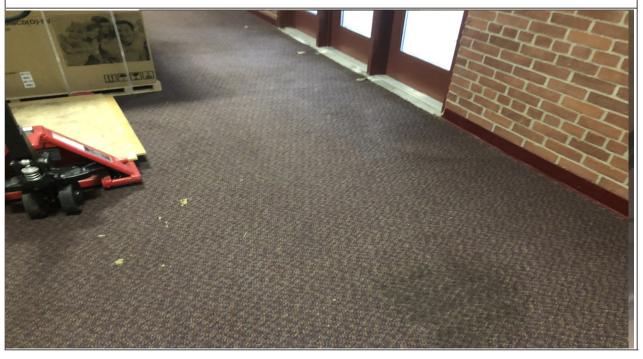
Photograph No.: 15 Date: 11/2/18 Direction Taken: —

Description: "Wet" Carpet—Auditorium Entryway

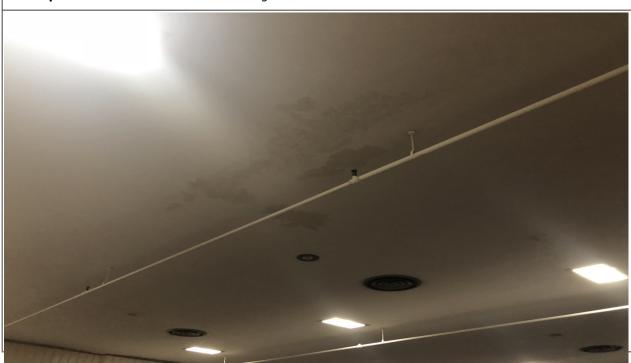
Photograph No.: 16 Date: 11/2/18 Direction Taken: —

Description: Water Stained Plaster Ceiling—Auditorium
