M. Gottfried, Inc.

RE: Roof report and repair quotation
K. T. Murphy Elementary School
19 Horton Street
Stamford, CT 06906

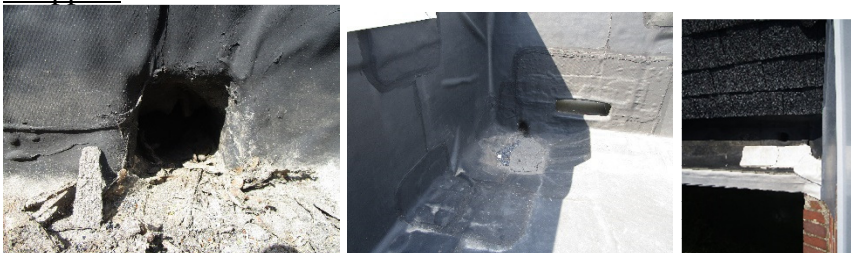
Scuppers

There is minor debris collecting at the scuppers. This should be cleaned and removed. We also found that

when you put your hand inside the scupper the rubber flashing material does not go in very far and is lifting a little. An additional piece of membrane flashing should be installed around the inside of the scupper to make sure this detail remains tight. Finally, the scuppers lead to built-in gutters under the shingle sections. It looks like patches have been made on the membrane in the gutter. We could not get out to inspect these areas, but should they become problematic, further investigation may be needed. The difficulty in inspecting and working in these gutters will be the lack of access and difficulty getting to them.

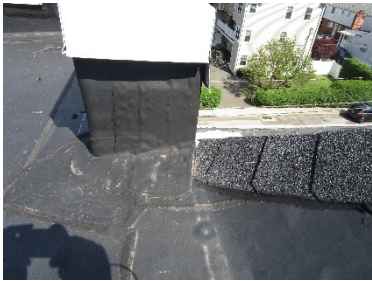
Corner flashing detail

Another interesting detail on the Carlisle roofs occurs at the junction of the hips where the shingles and EPDM meet. It looks like the flashing of the parapet wall extends out and onto the bottom shingle. This should be monitored to make sure the membrane doesn't lift up and leave a void.

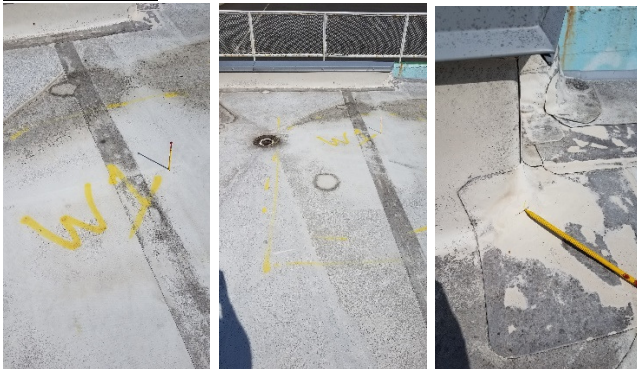
Wet area #1

Holes were found in the area marked #1.

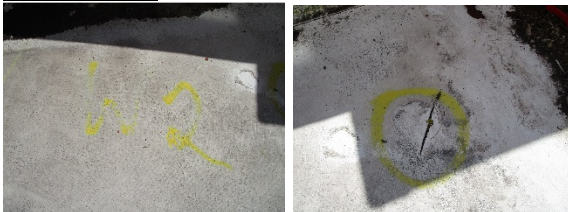
Wet area #2

A slice in the membrane was found at wet area #2

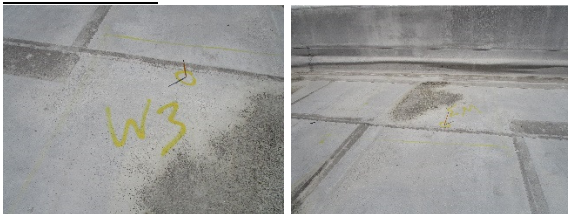
Wet area #3

A hole was found at wet area #3

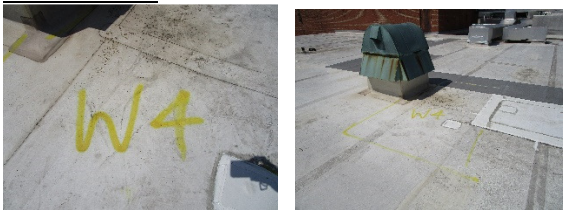
Wet area #4

Wet area number 4 may be due to an issue with a lap that was made on the roof when a rooftop item was removed. The membrane over the area where the item was removed is the cleaner white. It extends up and onto the JM roof. The lap area over the JM roof is suspect and needs to be further checked and repaired.

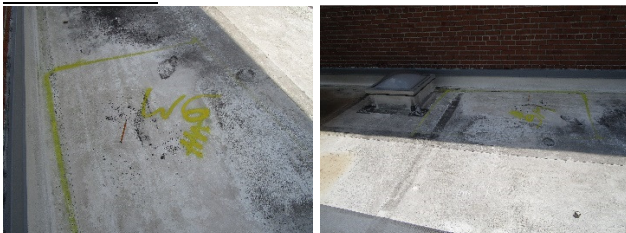
Wet area #6 is caused by a hole in the roof membrane.

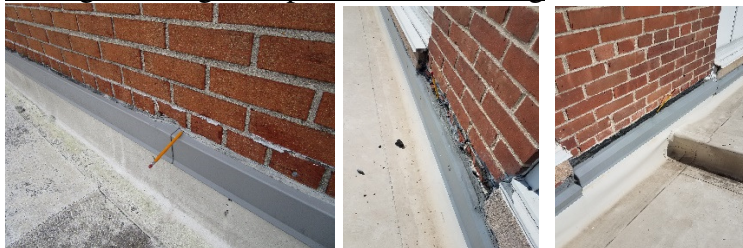
Failing caulking on top of counterflashing

The caulking at the reglet joint at the top of the metal counterflashing is shrinking and cracking. All instances of this condition should be checked and recaulked as needed.

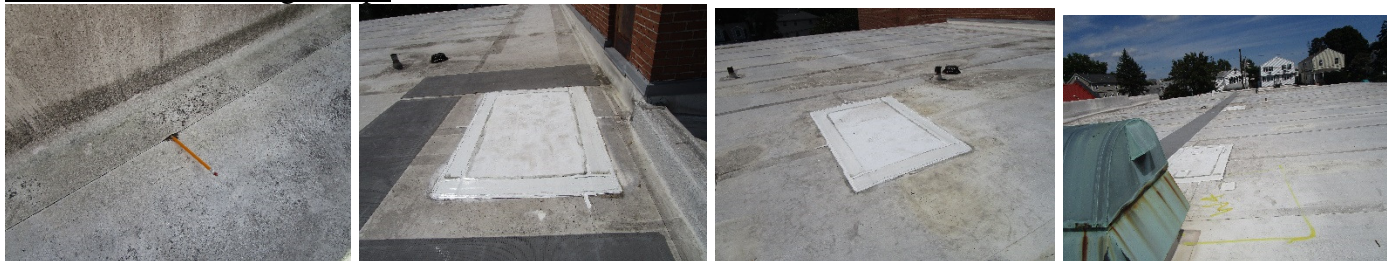
Fishmouths at flashing or laps

Some fishmouths or openings at the base flashing and field laps were noted. These need to be cleaned and properly sealed before they get larger and let water into the roofing system. In addition, as noted with leak area #4 units or curbs have been removed from the roof and patches installed. The laps on all the patches should be checked to make sure they are tight. If they are not, the laps should be overlaid.

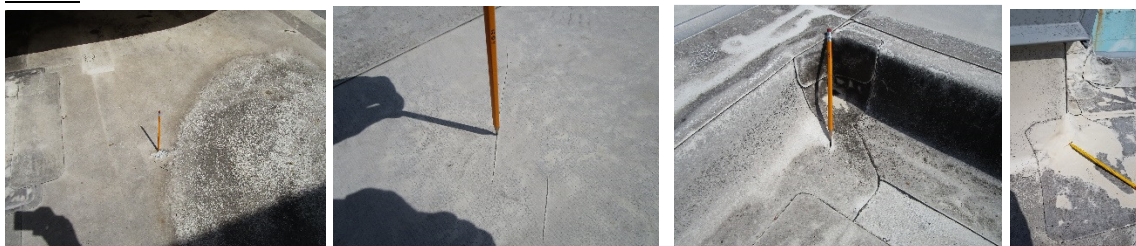
Holes and slices were seen in the membrane in area not shown as “wet”. These need to be patched before the insulation underneath gets soaked and becomes “wet”.

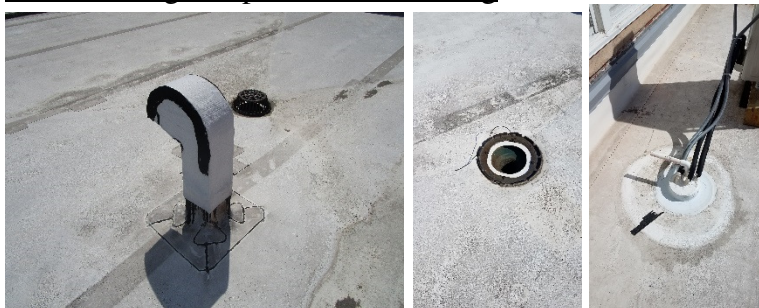
Curb flashing and penetration flashing

All curb, penetration and drain flashing should be checked and repaired as necessary. All penetration pockets should be “topped off” with additional pourable sealer if needed.

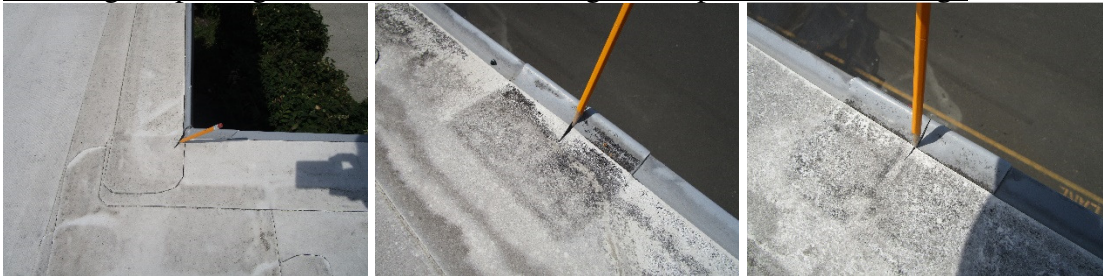
Cracking or splitting in the membrane flashing on the perimeter metal edge

The membrane that seals the flange of the perimeter edging needs to be checked where it goes over the joints in the metal. We found instances where the membrane has split or been torn. These need to be patched before the splits worsen and water can get into the roofing system.

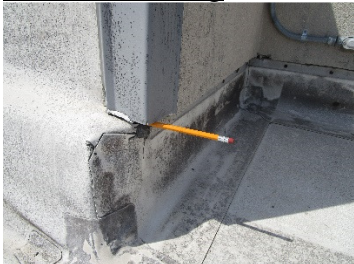
Voids in flashing

There are a few areas where voids are found where the membrane base flashing meets metal corner flashing. These should be sealed to prevent water infiltration.

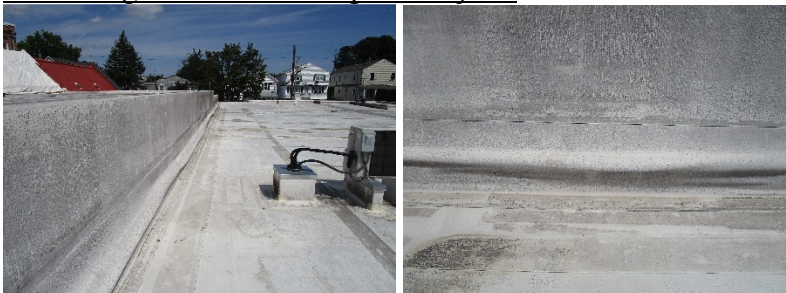
Loosening membrane at expansion joint

The membrane over the expansion joint has either loosened or the backer rod in the joint has shifted over time. This detail needs further investigation to see if a batten bar is needed to secure the membrane and put the backer rod back into place.

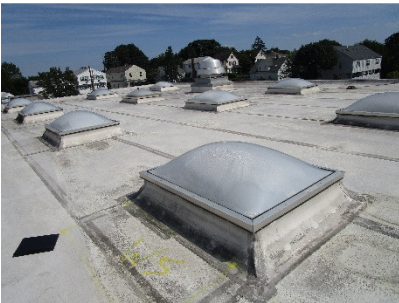
Upper non-warranted roof

The upper roof appears to be an older roof. It has many skylights. One wet area was noted on this roof level.

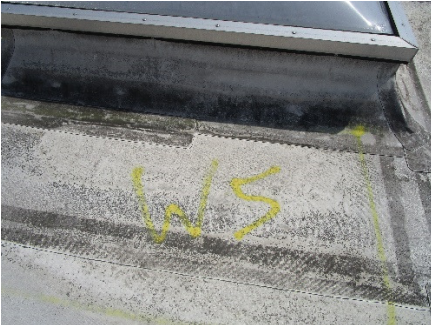
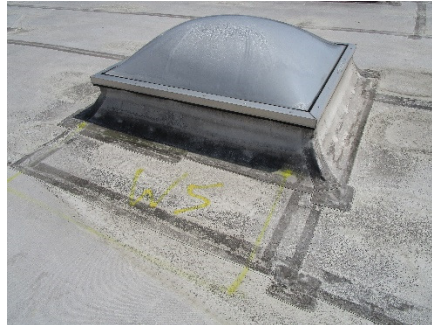
Wet area #5 is marked at the base of a skylight. We did not see any failed or open laps or corners, or, find any holes in the roof in this area. This leak may be coming from the skylight. We found a number of skylights that had water between the two domes. There is also a skylight with a broken outer dome with water held by the inner dome.

gaskets between the domes and then going behind the curb flashing at wet are #5, or if some other cause is to blame for the wetness found. More investigation needs to occur when the wet area is replaced.

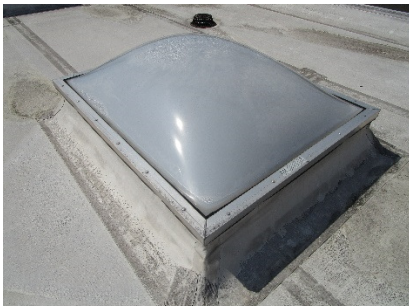
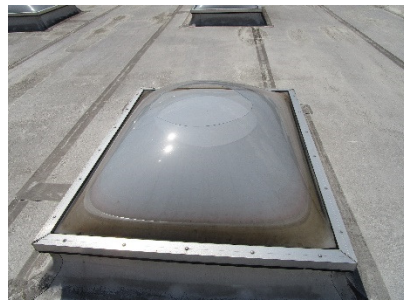
We are not sure if the moisture found in the infra-red scan was coming in between the domes, or at the

In any case, judging by the broken dome, and finding trapped water in other skylights, the school should start planning to replace the skylights on this roof.

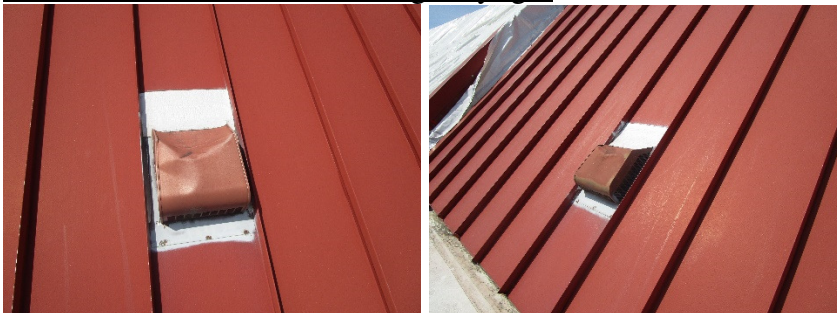
Metal roof at the front of the large skylight

The flanges of the vents on the metal roof have been coated. We are not sure if they have previously leaked or if they were added to the roof at a later date. The coating looks to be thin, and no reinforcing fleece is

seen in the overlap of the vent and roof on the bottom side of the vent. These vents should be reflashed using a PMMA membrane and reinforcing fleece as a precaution.
