# FACILITIES NEEDS ASSESSMENT

## FACILITIES NEEDS ASSESSMENT OF NEWFIELD ELEMENTARY SCHOOL

345 Pepper Ridge Road  
Stamford, Connecticut 06905

**EMG Project #:** 88166.09R-012.017  
**Date of Report:** August 29, 2009  
**On site Date:** March 17, 2009

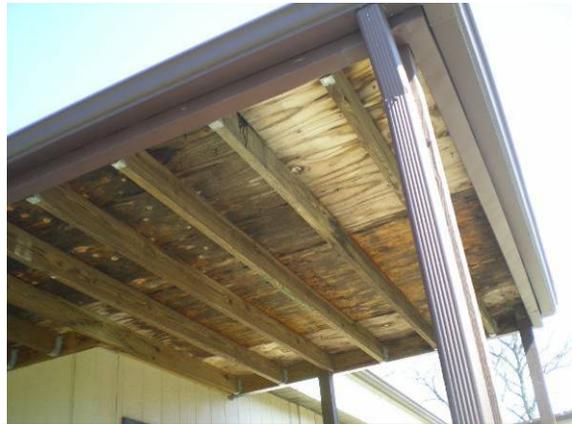
Photo #17: Damaged fascia and canopy at loading dock

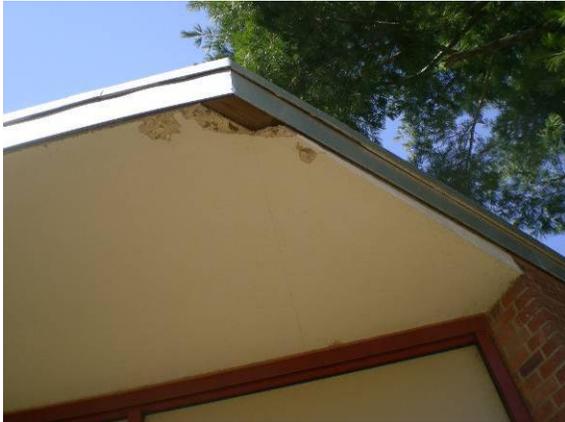
- The exposed soffit at the front elevation covered walkway is in good to poor condition. Spalling, flaking and damaged areas were observed in isolated areas throughout the canopy. Epoxy injection patching or sectional replacement will be required. The larger areas of damage will require steel reinforcing tied into the existing sections. A professional structural engineer must be retained to analyze the existing condition, provide recommendations and, if necessary, estimate the scope and cost of any required repairs. The estimated cost to retain an engineer is included in the Replacement Reserves Report. A cost allowance to repair or replace the affected sections of the canopy is included in the Replacement Reserves Report – see Section 6.3.

Photo #25: Spalling soffit near kindergarten classrooms

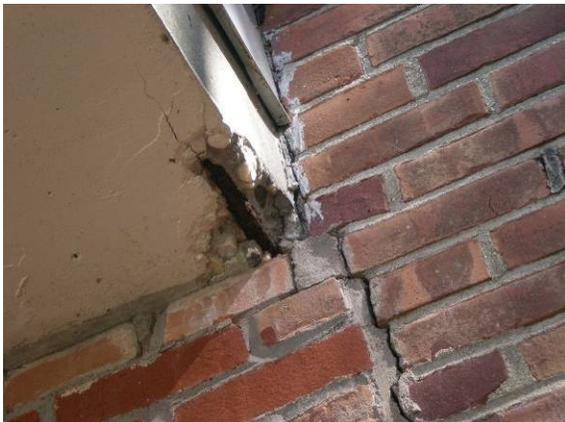
Photo #27: Cracking brick and exposed rebar at front canopy at kindergarten area

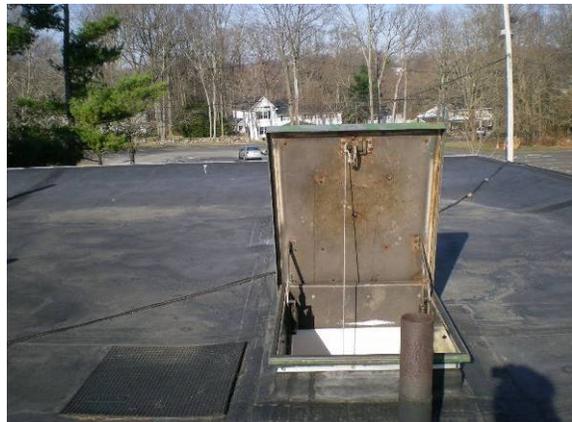
Photo #28: Roof hatch secured by rope

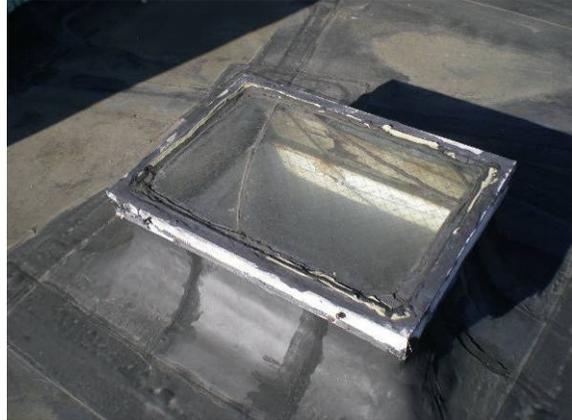
Photo #32: Broken glass at skylight near roof hatch

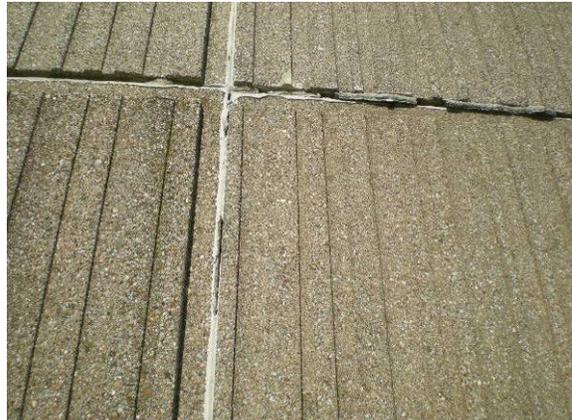
Photo #34: Damaged joints at gymnasium – typical throughout gymnasium

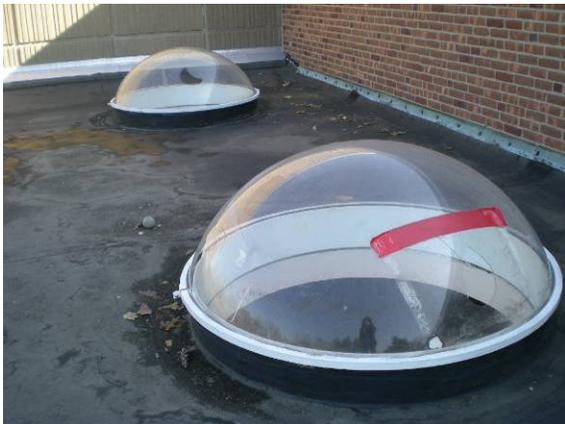
Photo #39: Broken/damaged skylights at main covered walkway

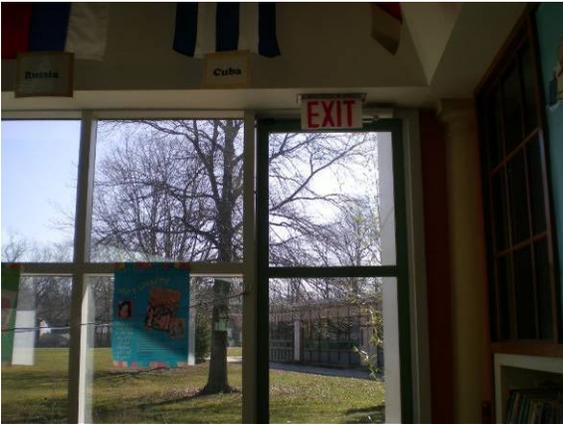
Photo #51: Storefront door not properly fit into wall – open gaps to exterior with air infiltration

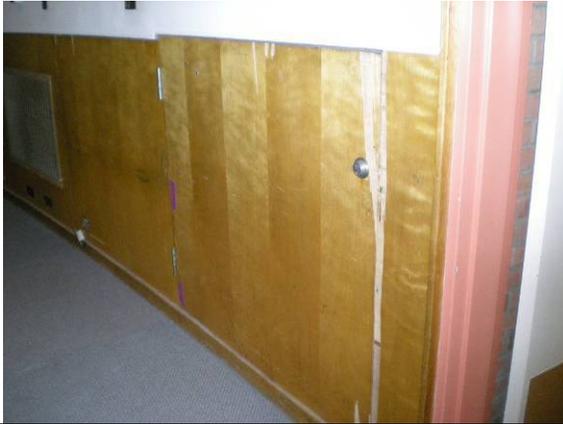
- Suspect termite damage was observed in the auditorium. Dry rotted wood studs and paneling were observed at the rear and side walls. A local, licensed exterminator must be retained to treat the property as required to eliminate the pest and associated threat. The estimated cost of this work is included in the Replacement Reserves Report. In addition to this work, an annual termite inspection program must be instituted. An engineering professional with experience in structural damage due to insects must be retained to evaluate the extent of damage in hidden conditions. The estimated cost to retain an engineering professional is included in the Replacement Reserves Report.

Photo #55: Evidence of termite damage at access panel at rear of auditorium

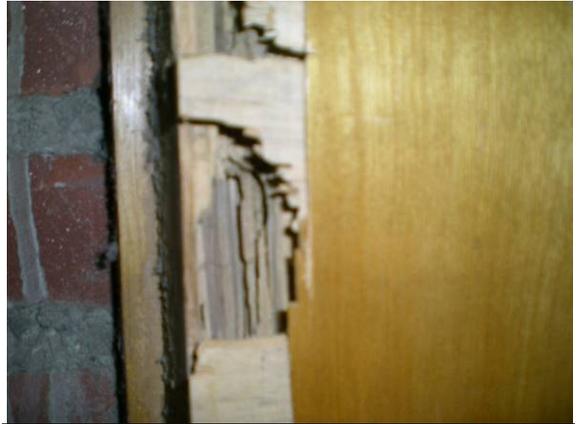
Photo #56: Evidence of termite damage in auditorium near access panel

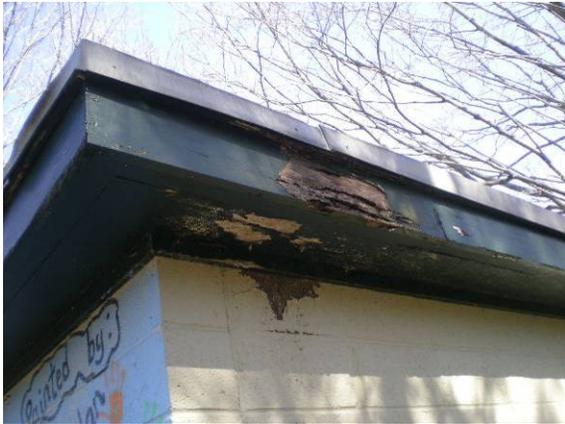
Photo #63: Damaged fascia and soffit of storage building

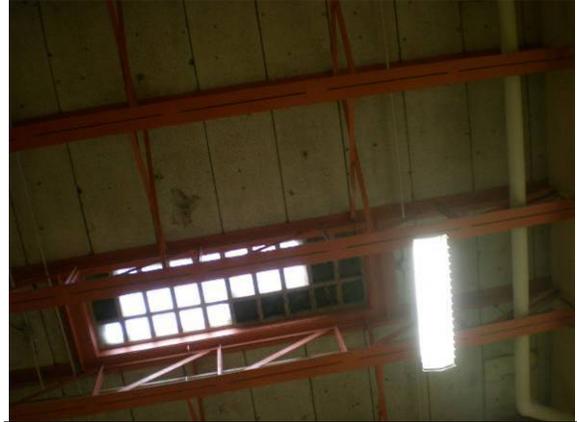
Photo #68: Covered glass block and damaged tectum panels at ceiling of gymnasium/cafeteria

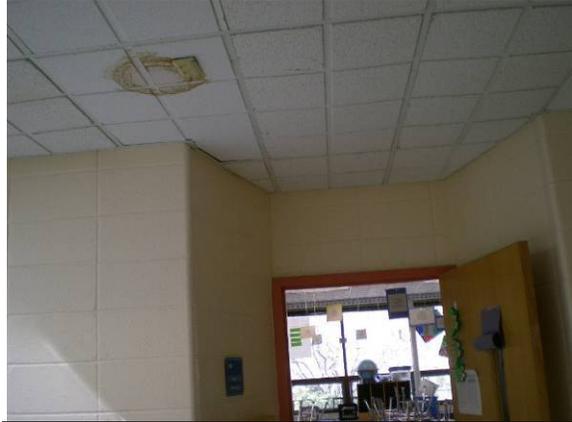
Photo #74: Evidence of roof leaks in corridor

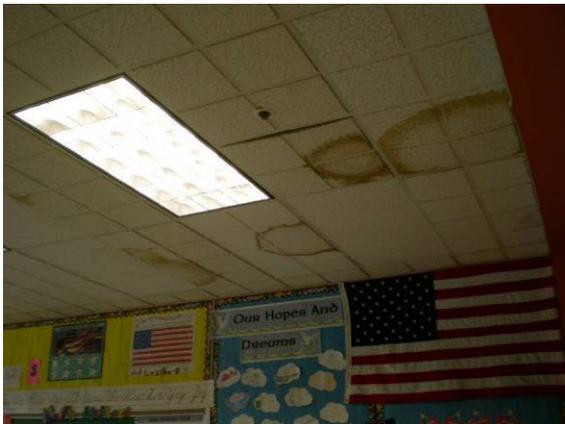
Photo #75: Ceiling staining in Classroom 316

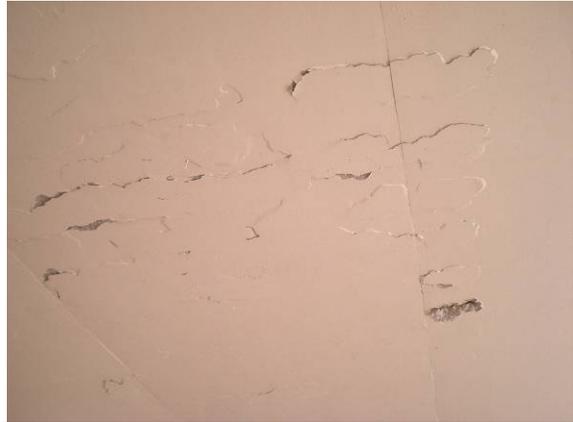
Photo #80: Spalling under main walkway canopy

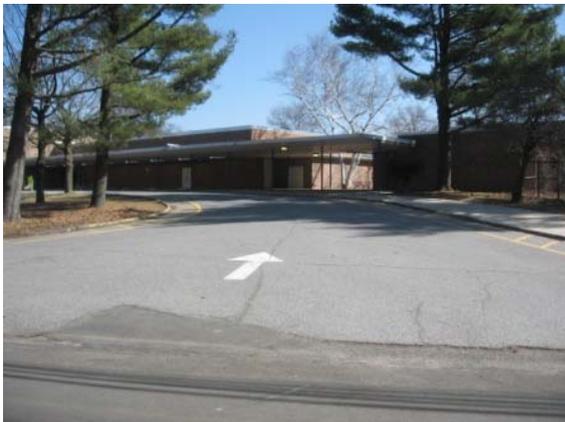
Photo #83: Main property entrance drive off Pepper Ridge Road (missing property signage)

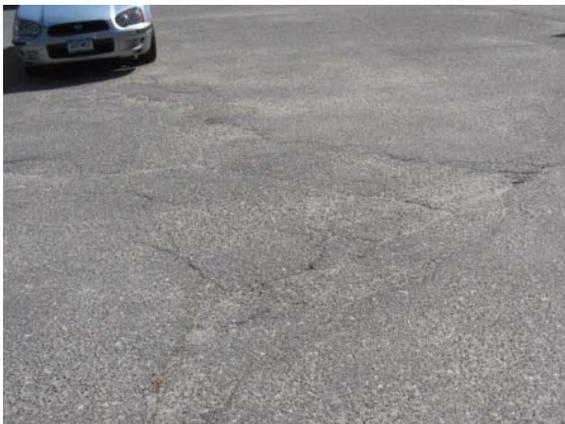
Photo #89: Cracking and worn asphalt paving at main parking lot

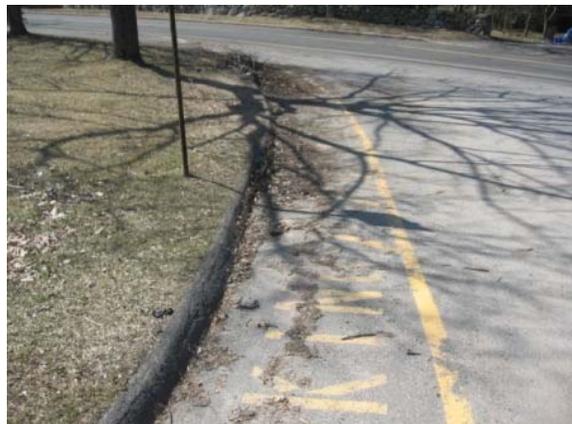
Photo #90: Caved in section at exit asphalt drive lane

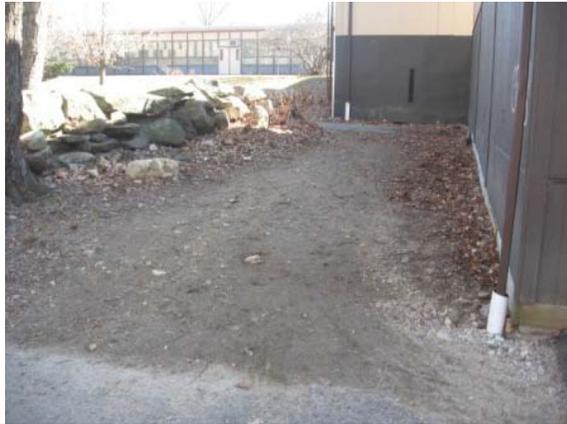
Photo #97: Worn landscaping path rear of modular building (install asphalt sidewalk)

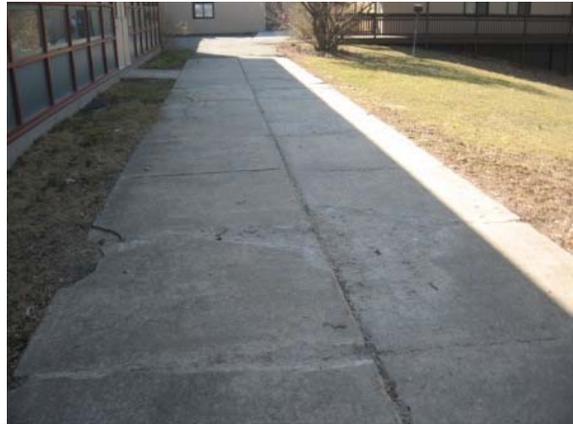
Photo #98: Deterioration and spalling of concrete sidewalk at left side of building

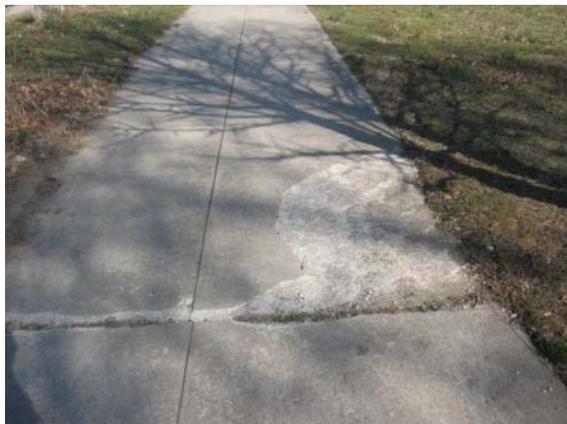
Photo #99: Deterioration and spalling of concrete sidewalk at rear of building

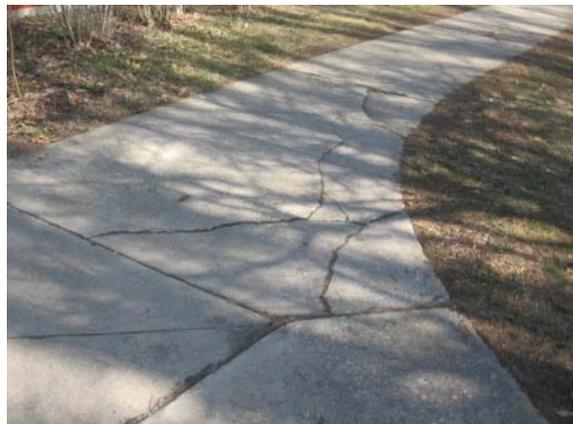
Photo #100: Settlement and cracking at concrete sidewalk at right side of building

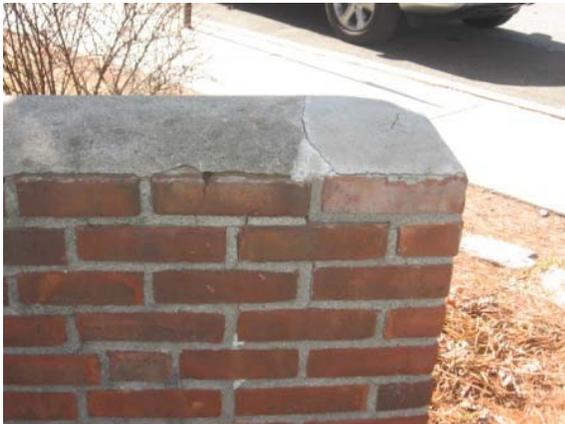
Photo #105:	Deterioration at brick retaining wall adjacent to loading dock
-------------	--

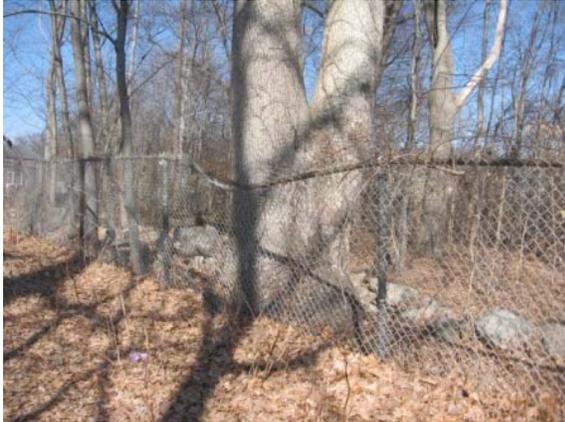
Photo #121: Failing chain link fence at rear property line

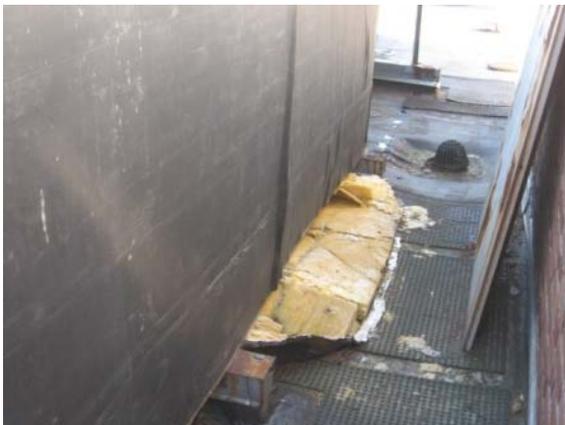
Photo #125: Deterioration at HVAC rooftop ducting

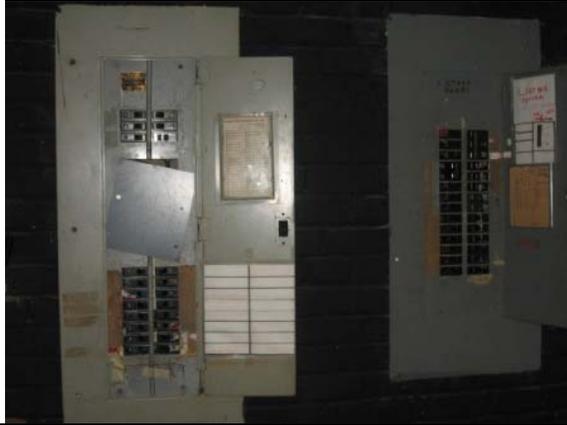
Photo #151: Original and worn circuit break panels at stage

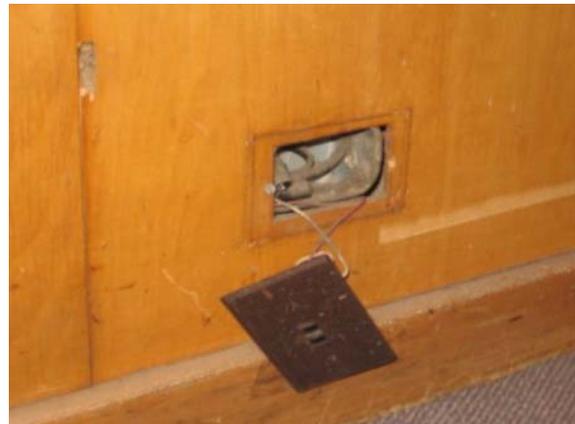
Photo #156: Loose and exposed wiring at receptacle outlet at Auditorium

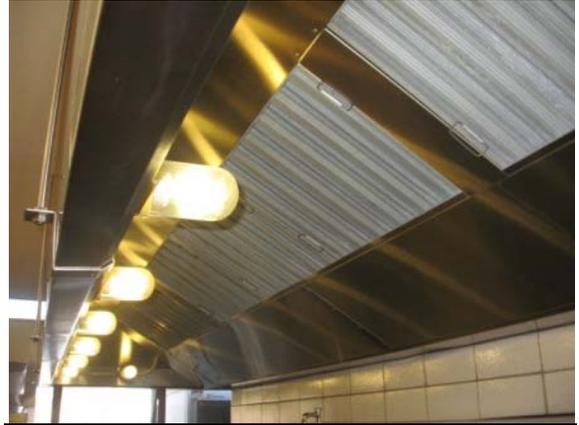
Photo #164: Kitchen exhaust hood without fire suppression system
