Initial Assessment—Photographic Log

Client: City of Stamford Mold Task Force

Job Number: S-2087-033

Site: Newfield Elementary School

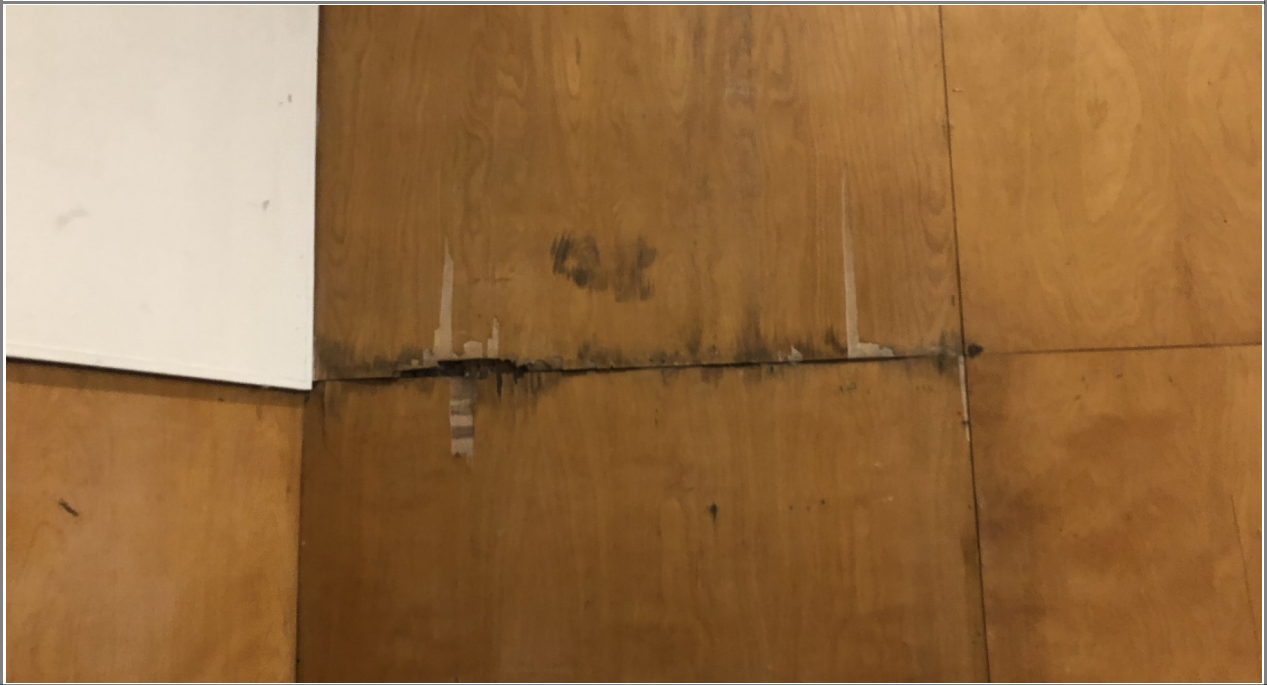
Photograph No.: 13	Date: 11/2/18	Direction Taken: —
Description: Black Growth/Insect Damage on Wood Wall Paneling — Auditorium

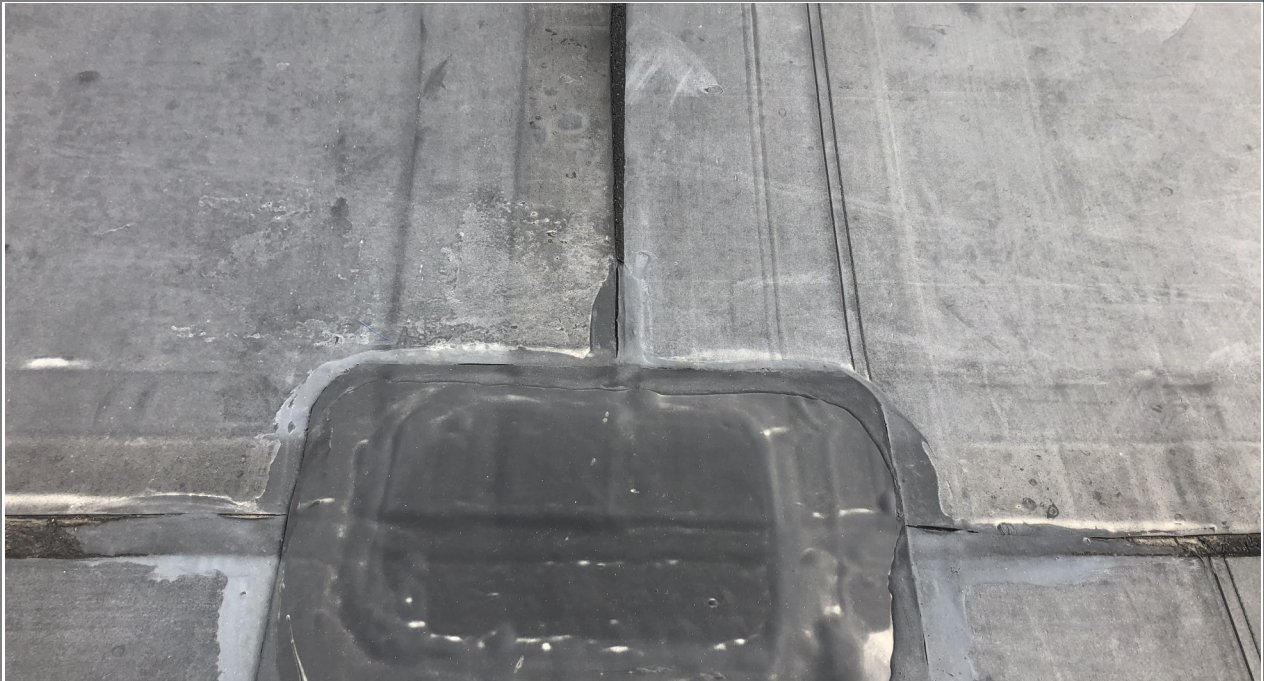
Photograph No.: 15	Date: 11/2/18	Direction Taken: —
Description: Limited Deteriorated Roof Caulking/Flashing — Roof Room 200
