# **Infrared Thermographic Roof Moisture Analysis**

**LOCATION:** Rogers International School  
Stamford, CT

**CONDUCTED ON:** June 3, 2019

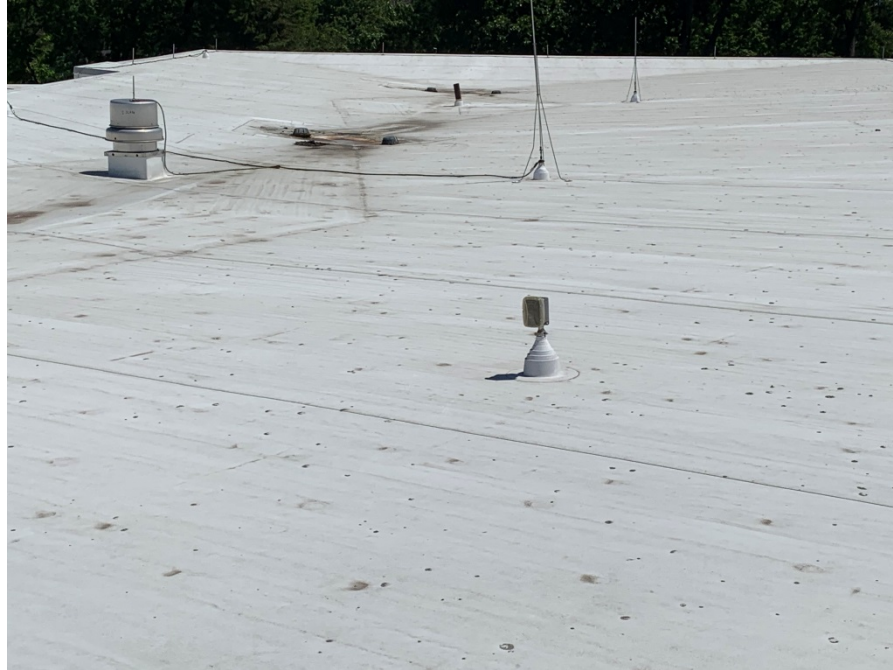
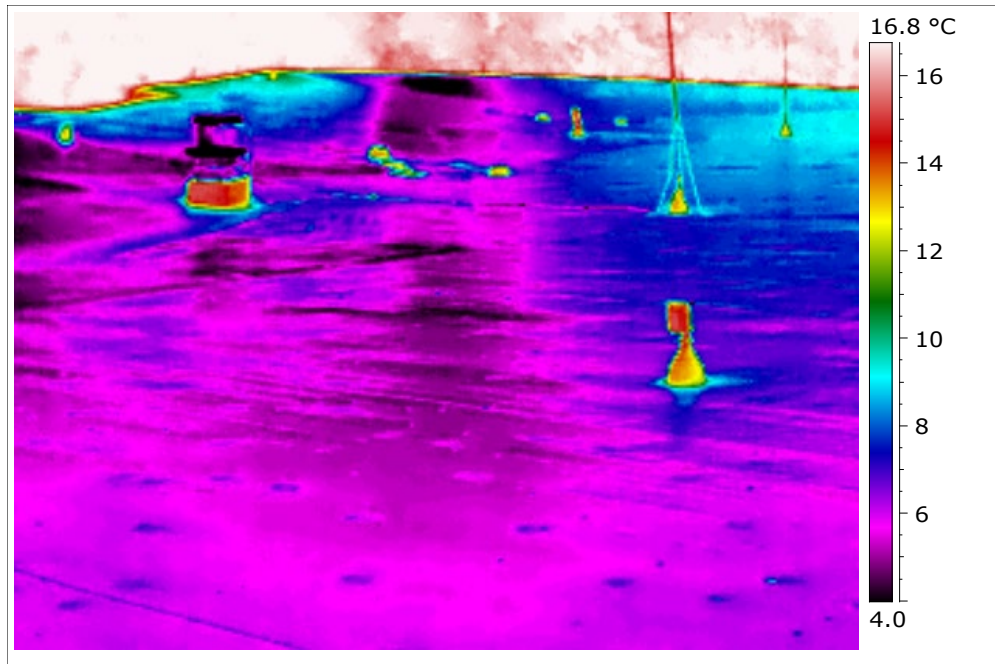
Thermogram # 1

Dry area of roofing

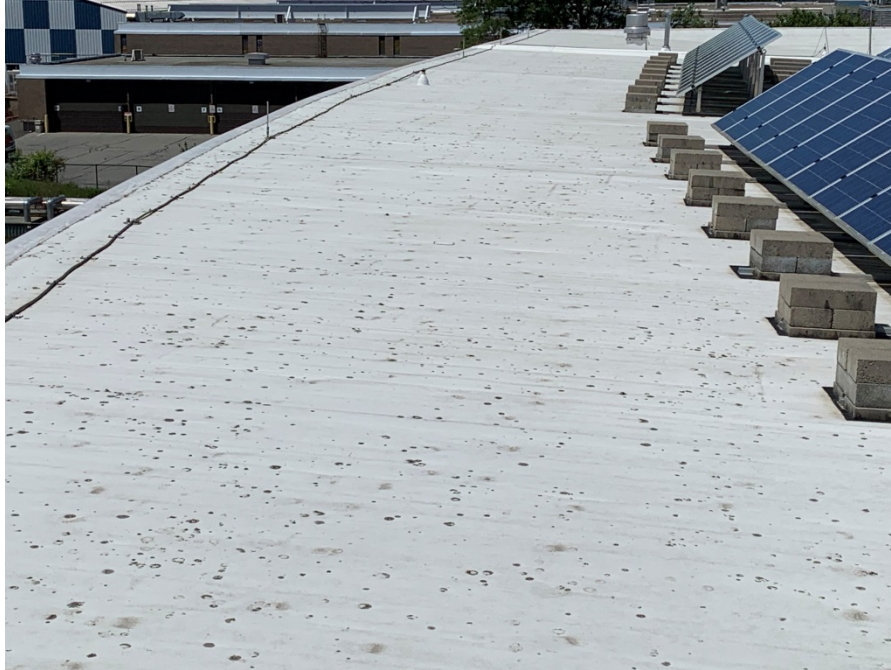
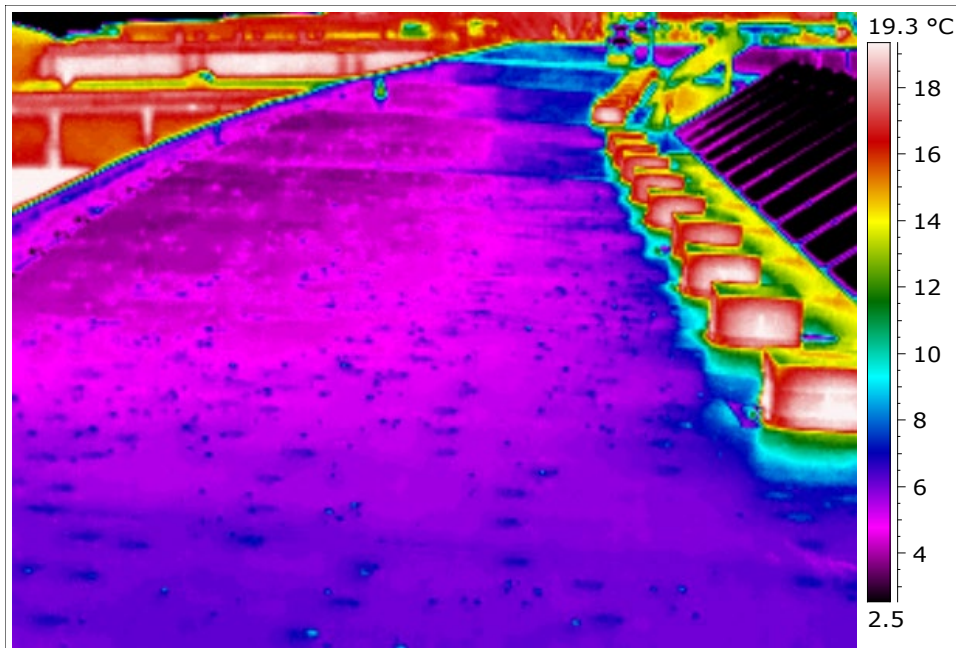
Thermogram # 2

Dry area of roofing

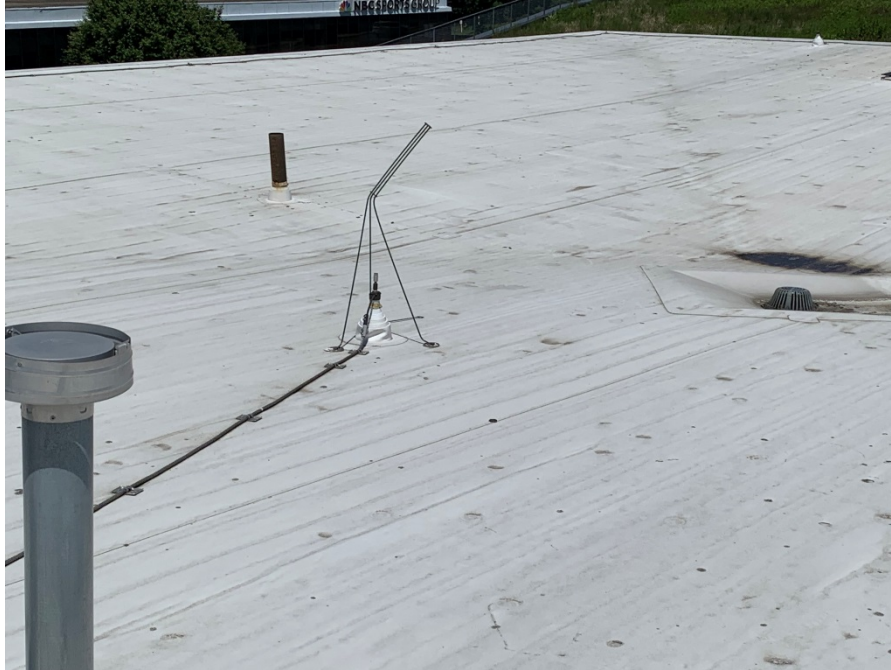
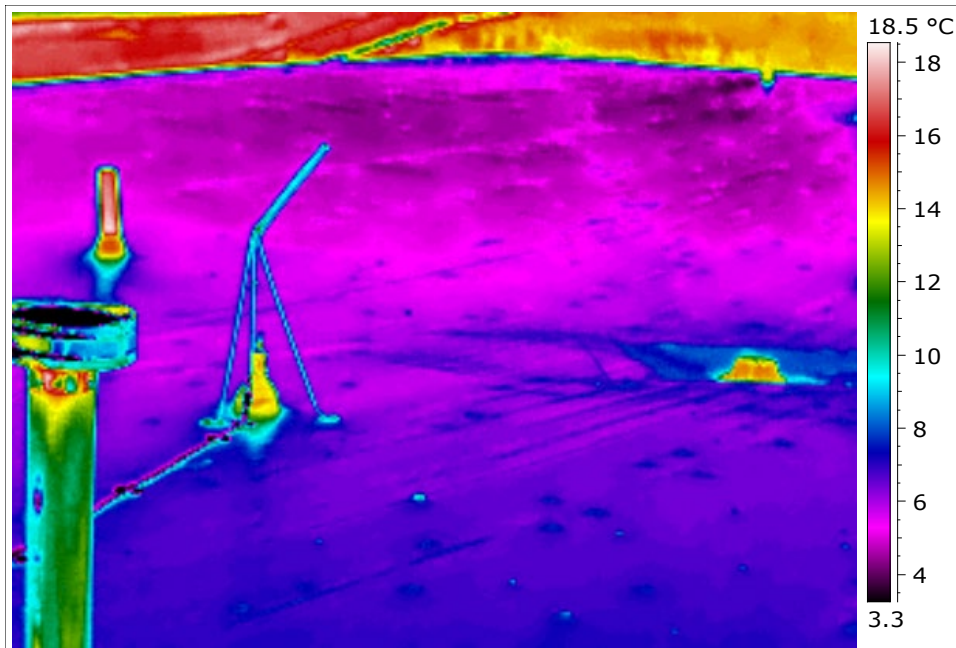
Thermogram # 3

Dry area of roofing

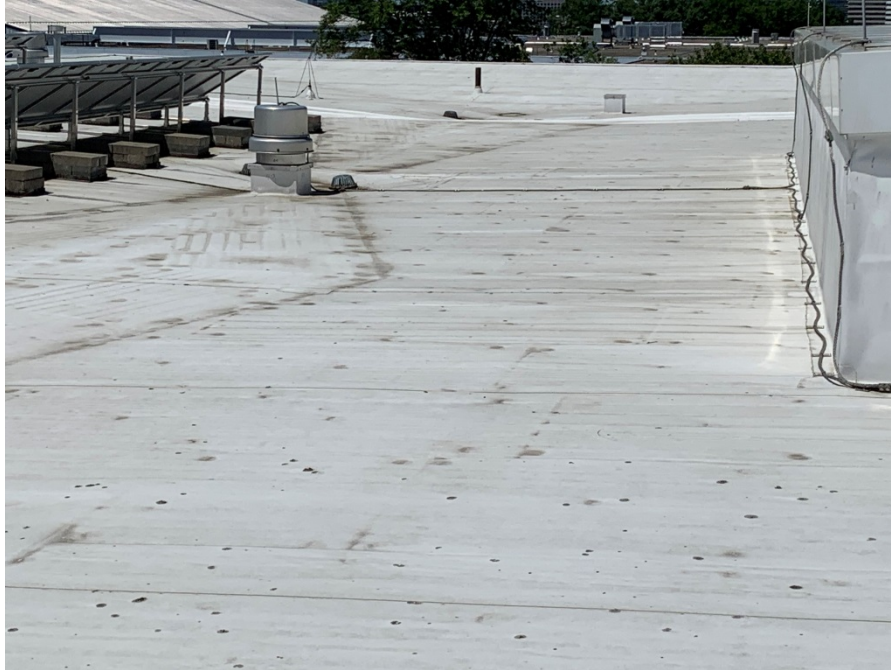
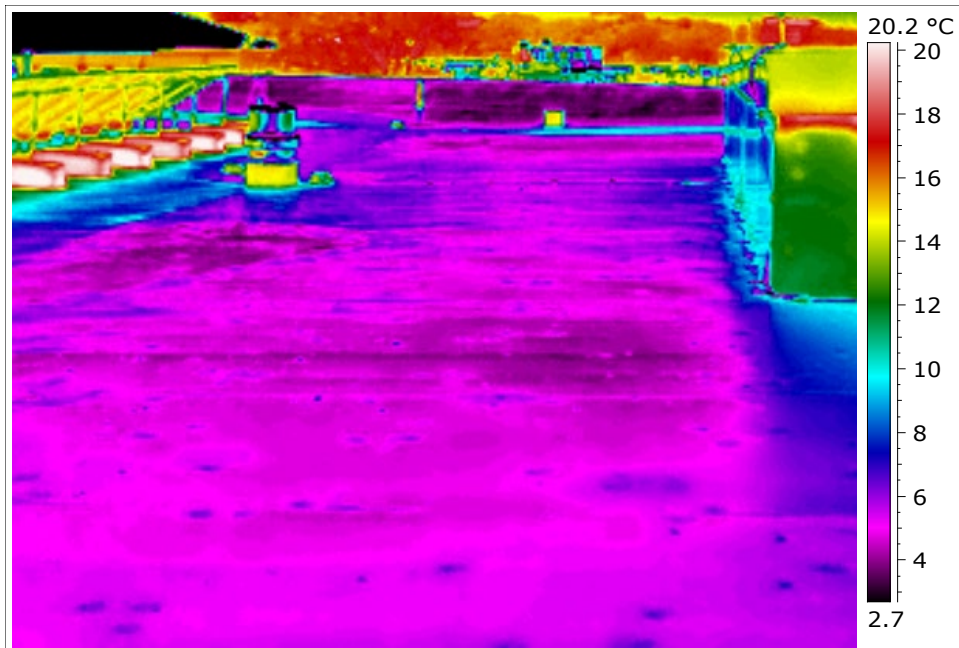
Thermogram # 4

Dry area of roofing

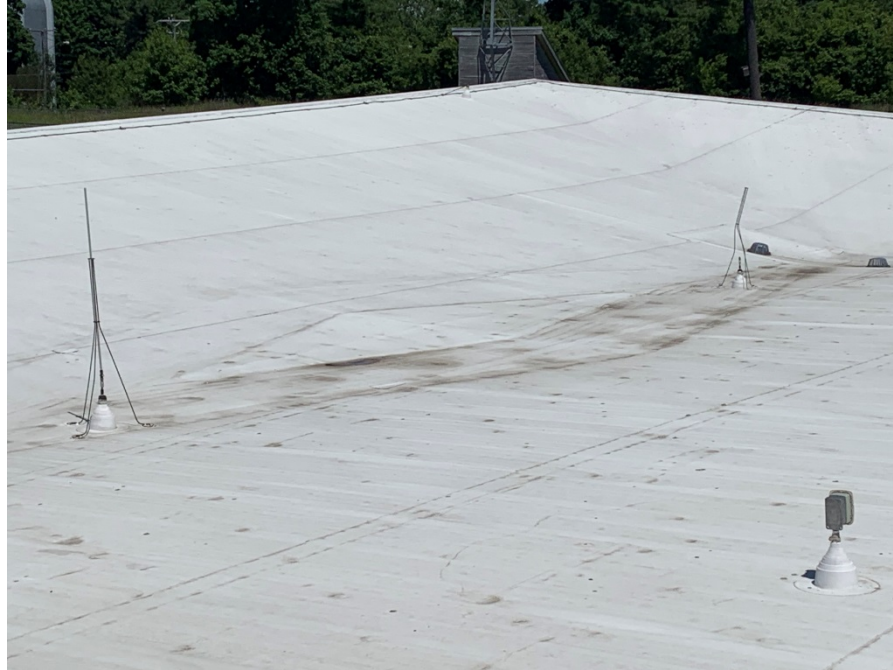
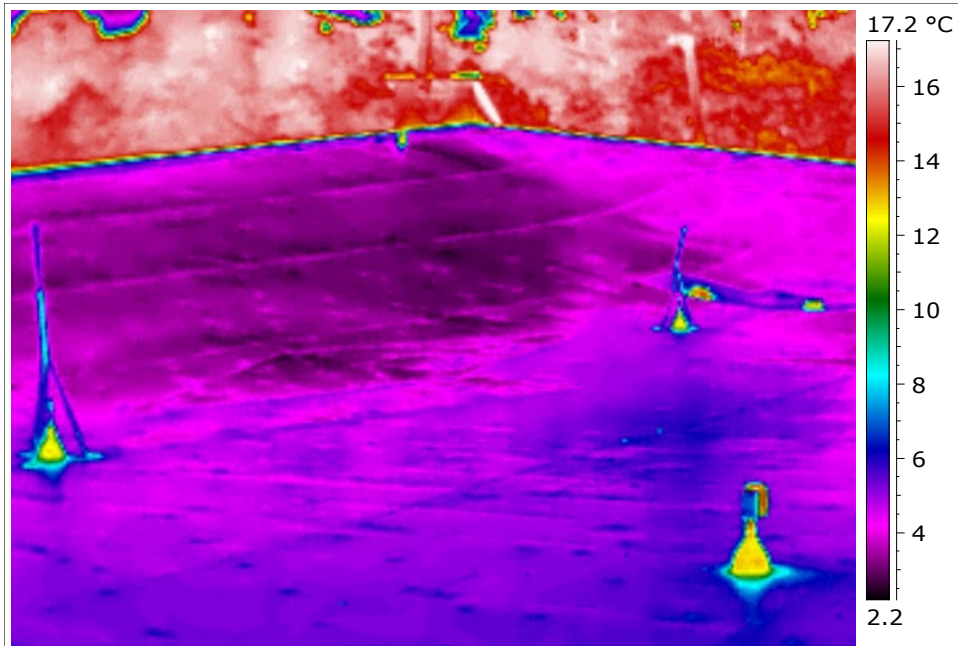
Thermogram # 5

Dry area of roofing

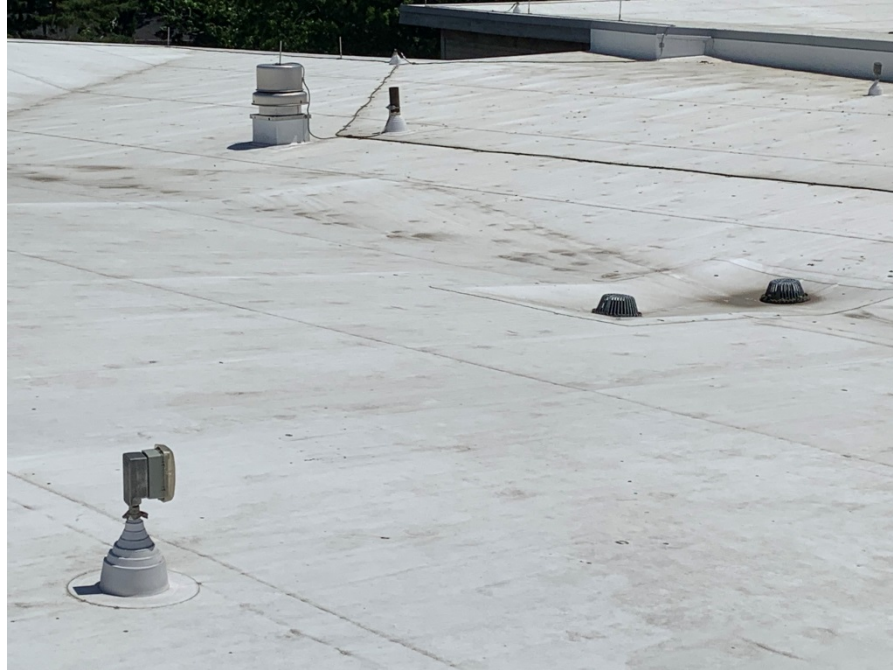
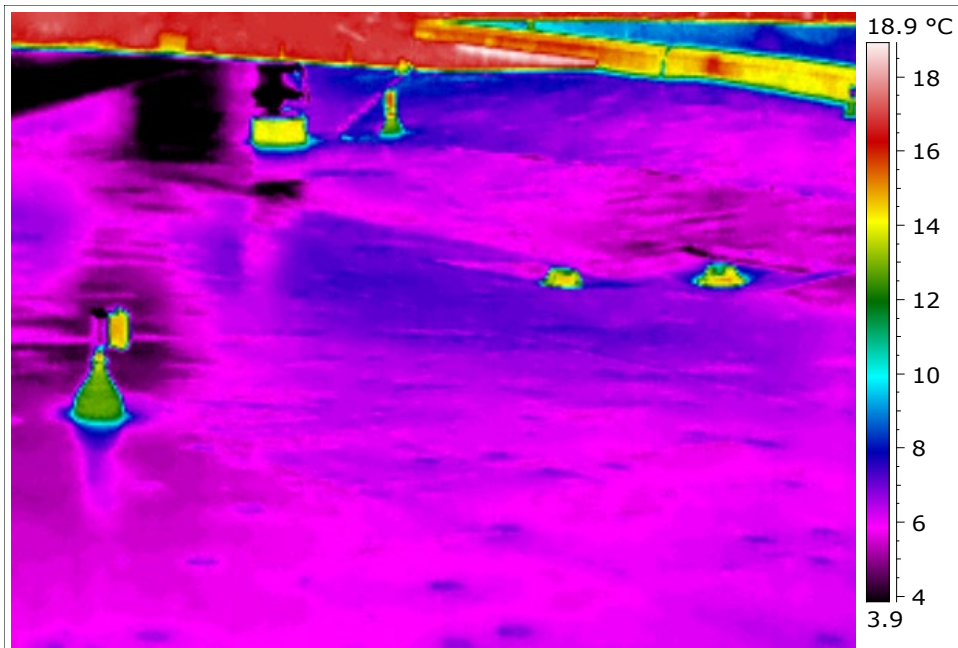
Thermogram # 6

Dry area of roofing

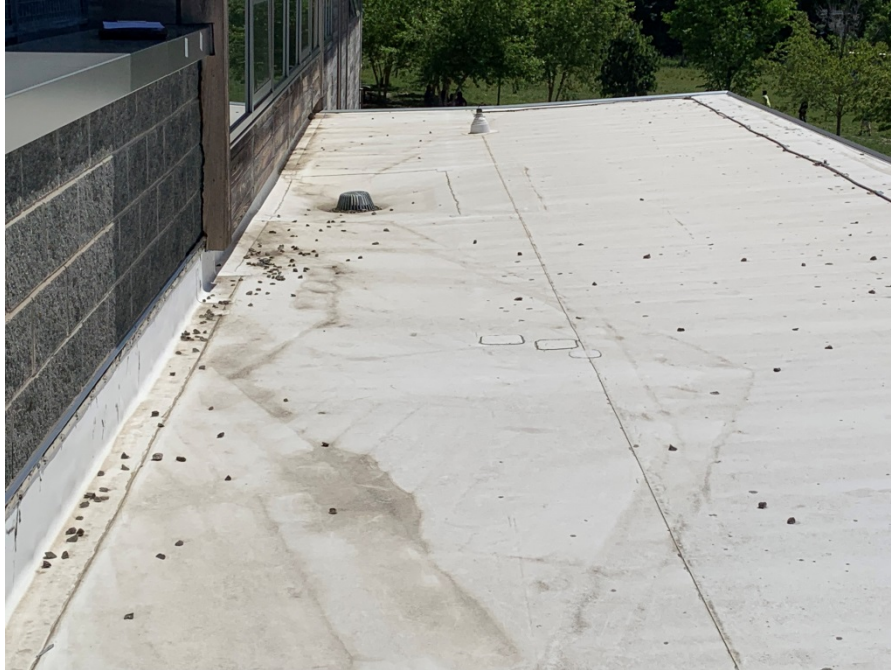
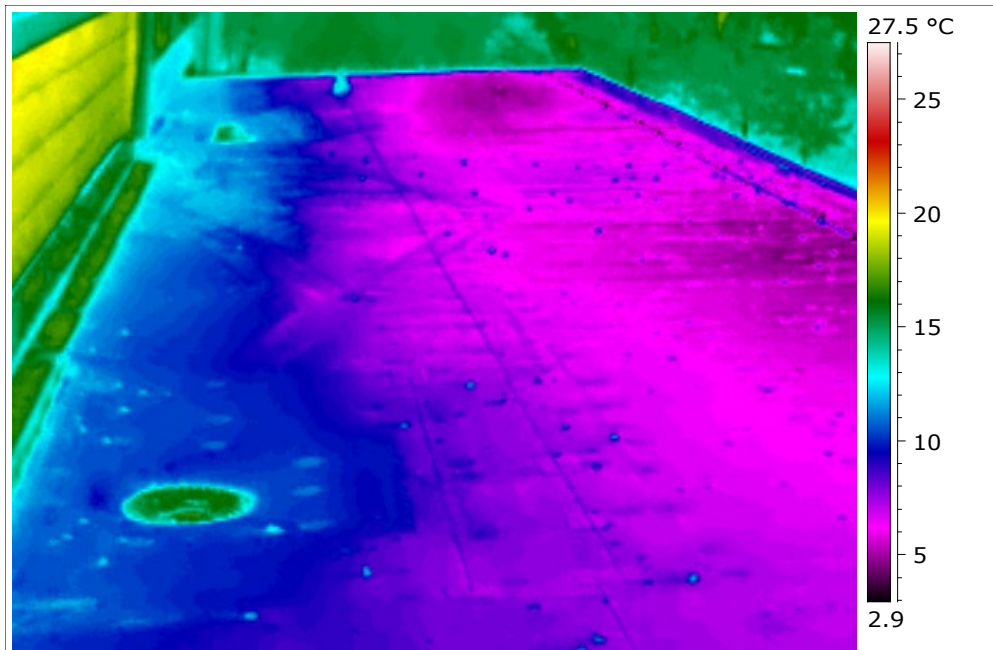
Thermogram # 7

Dry area of roofing

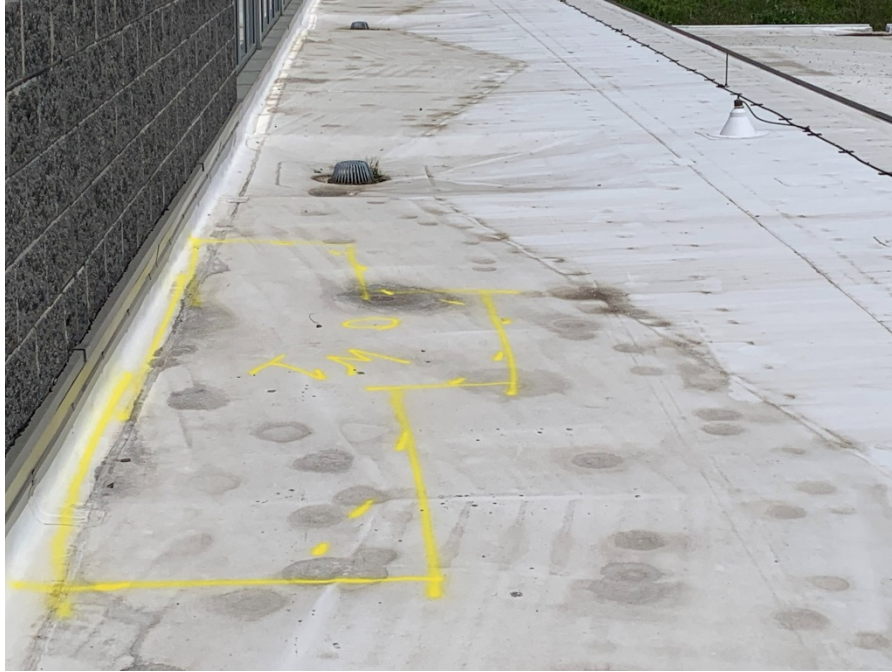
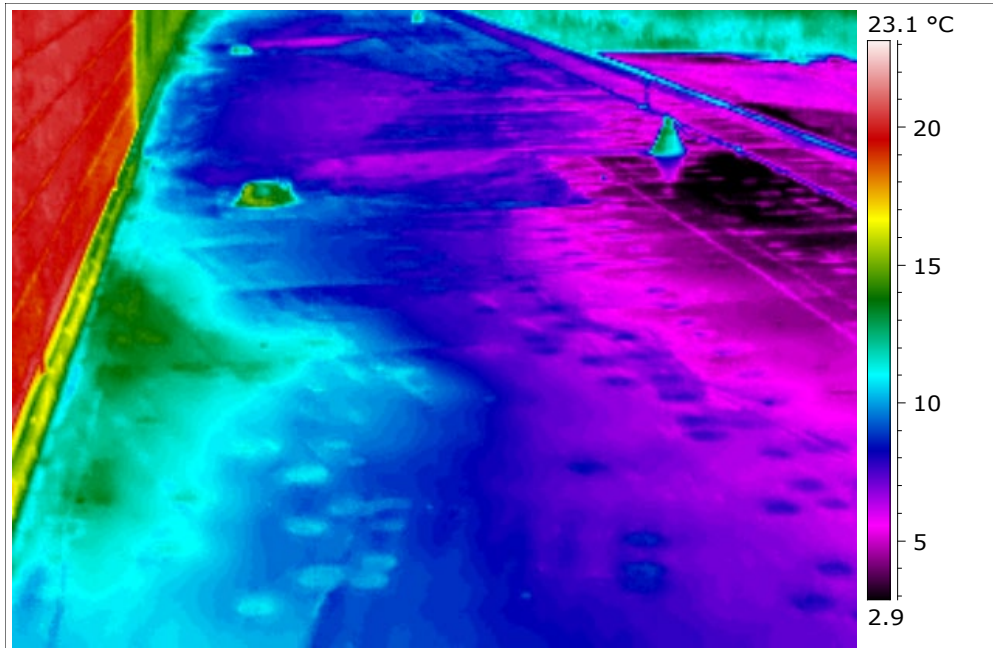
Thermogram # 8

As per our survey procedures, the entire roof area in the contract was scanned a minimum of two times. A total of 1 area of suspected wet insulation was detected in the top layer of roofing.

The total size of the roof that was inspected with the infrared camera is approximately 43,840 square feet. The total amount of suspected wet insulation equals approximately 55 square feet. The amount of suspected wet insulation is <1% of the total roof areas. This area of suspected wet insulation is marked directly on the roof surfaces and on the maps provided. Please refer to these maps when reviewing the report.

Wet Area #1
