Initial Assessment—Photographic Log

Client: City of Stamford Mold Task Force

Job Number: S-2087-033

Site: Roxbury Elementary School

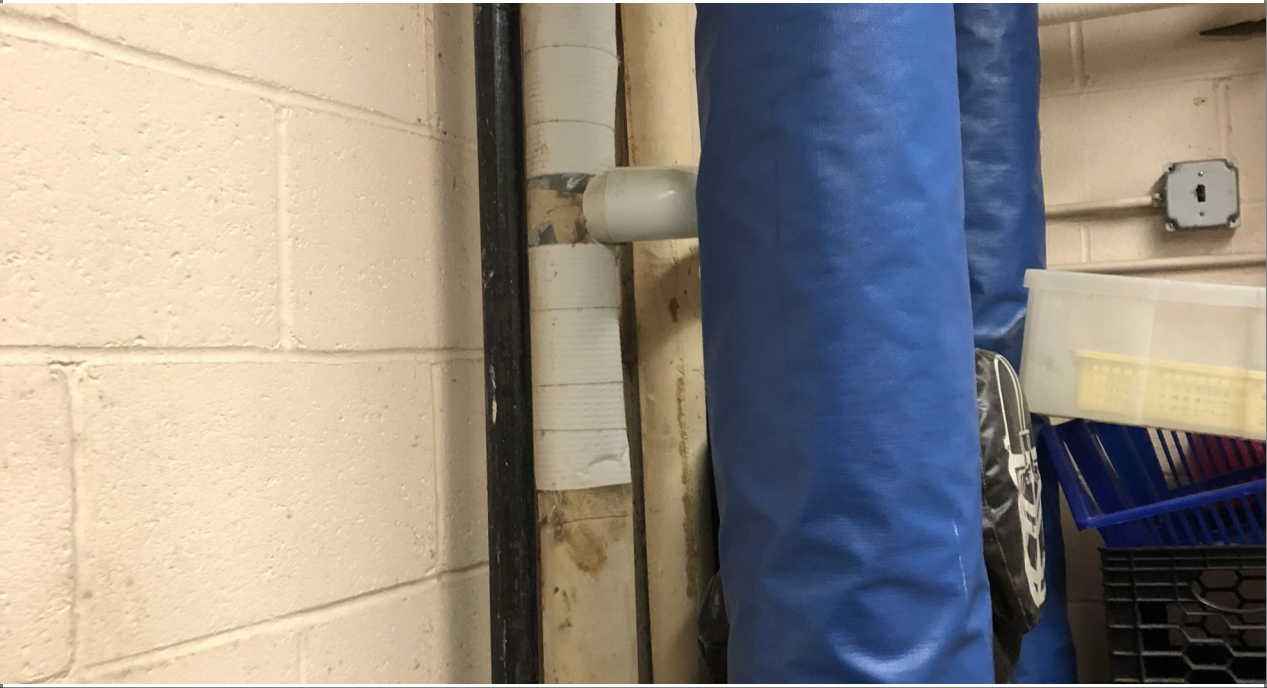
Photograph No.: 3	Date: 11/07/18	Direction Taken: —
Description: Water Stained Fiberglass Pipe Insulation—Gymnasium Storage

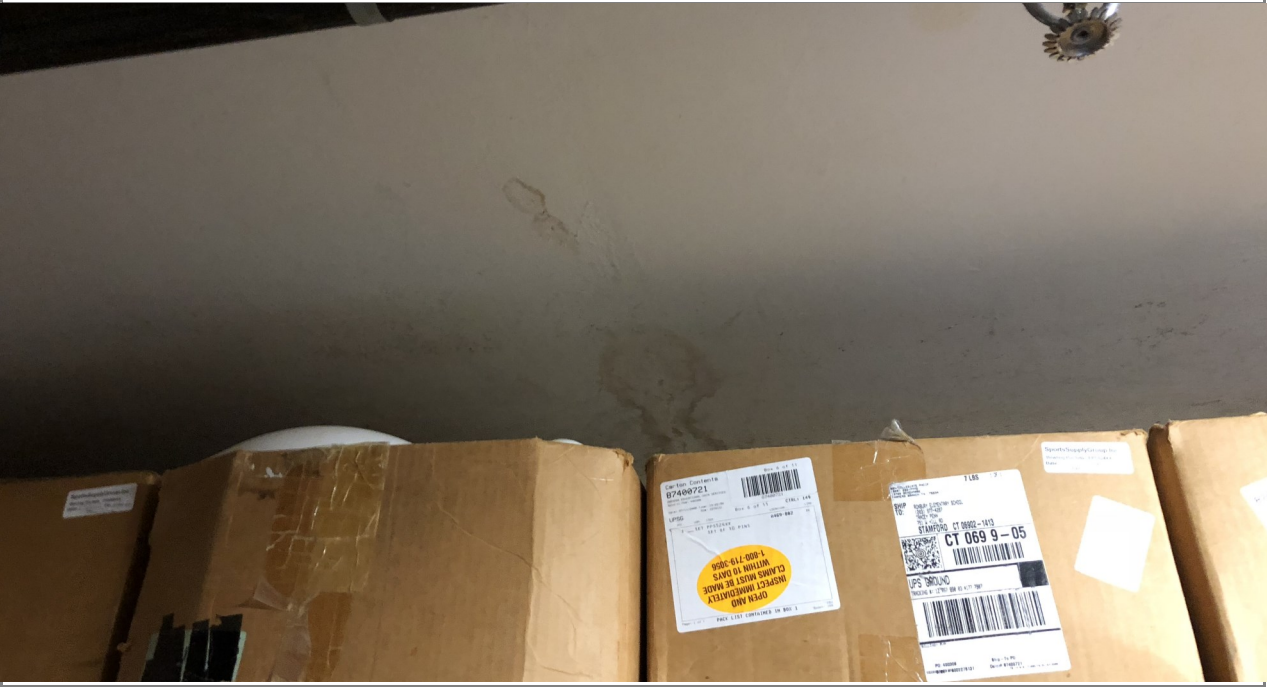
Photograph No.: 4	Date: 11/07/18	Direction Taken: —
Description: Water Stained Plaster Ceiling — Gymnasium Storage

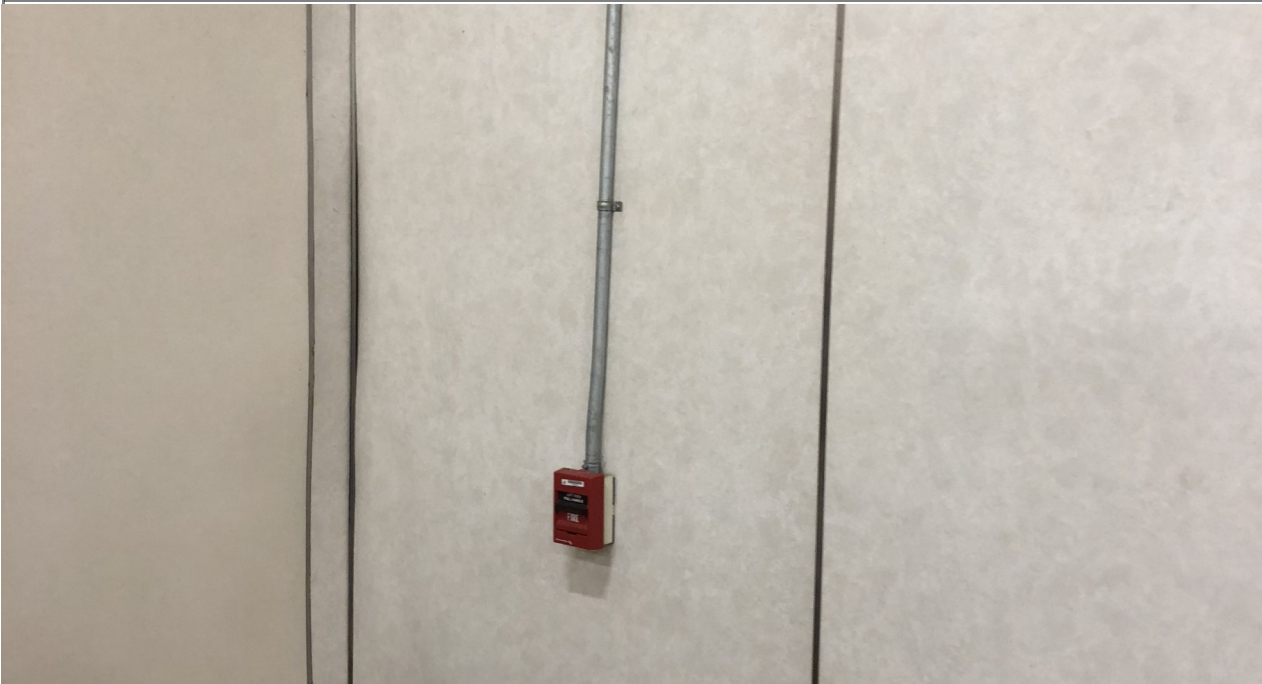
Photograph No.: 10	Date: 11/07/18	Direction Taken: —
Description: Water Damaged Paneling—Cafeteria
