Initial Assessment—Photographic Log

Client: City of Stamford Mold Task Force

Job Number: S-2087-033

Site: Springdale Elementary School

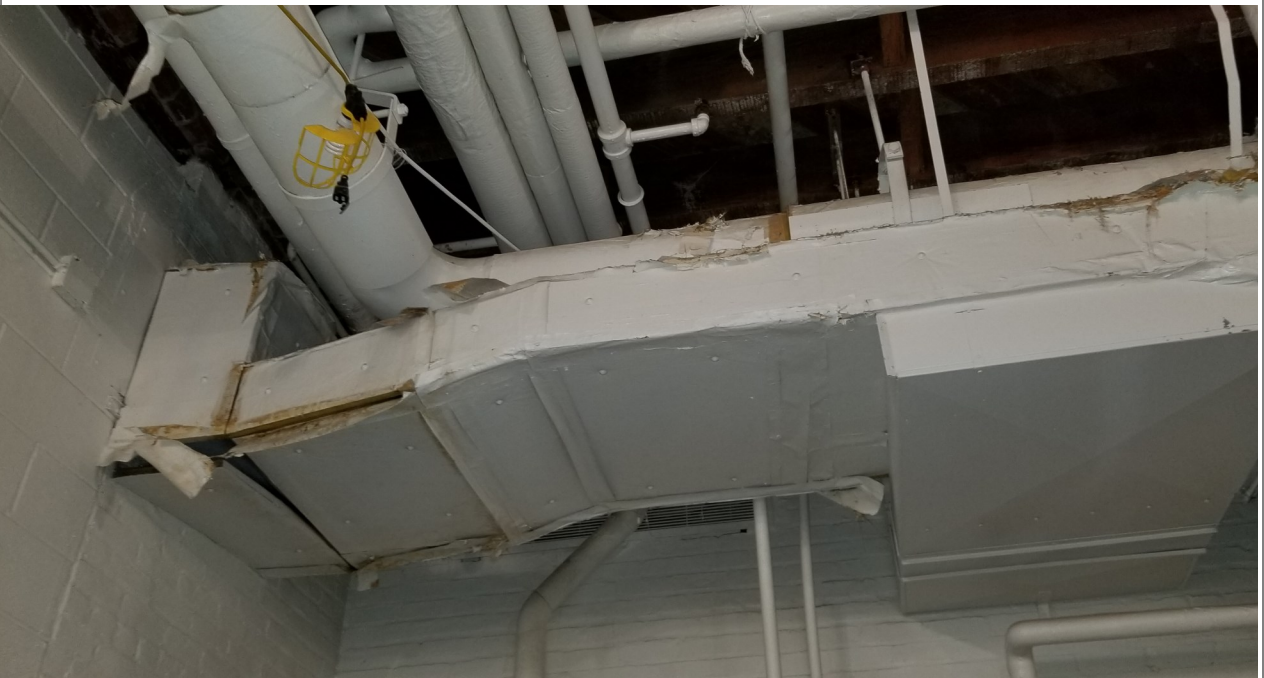
Photograph No.: 16	Date: 11/13/18	Direction Taken: —
Description: Art Storage Room—Gaps in Insulation

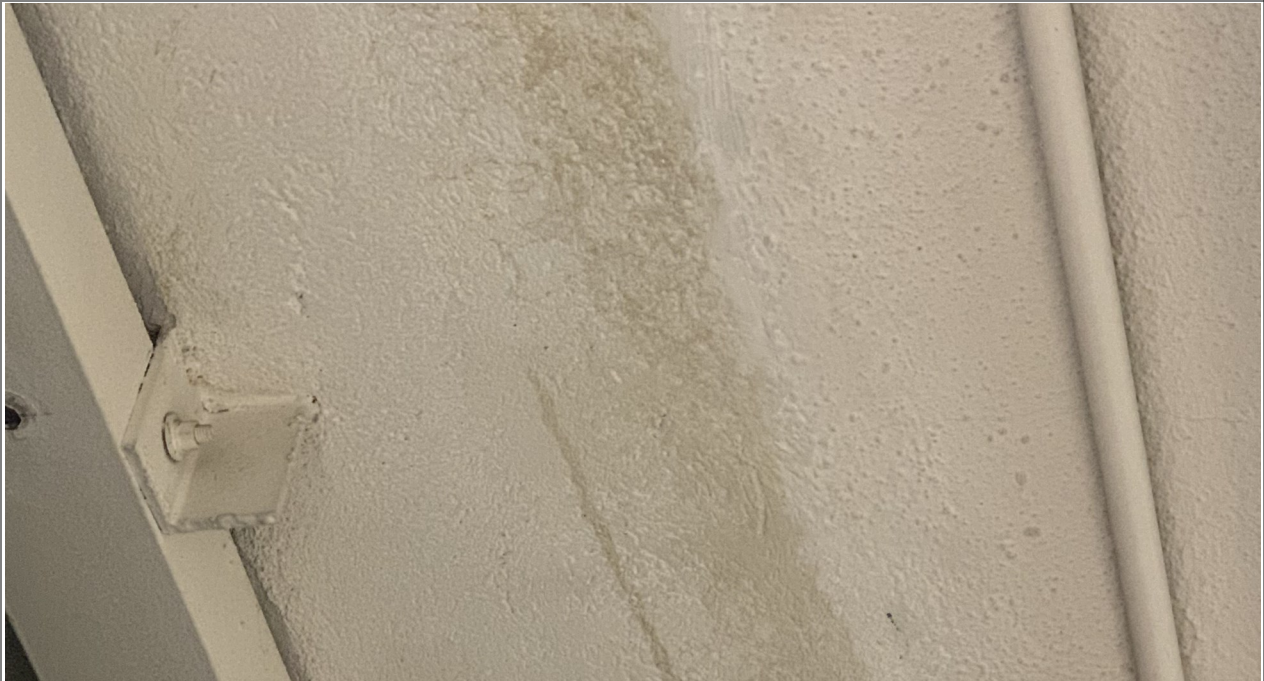
Photograph No.: 25	Date: 03/14/19	Direction Taken: —
Description: Lower Level Art Room — Water Stain on Ceiling

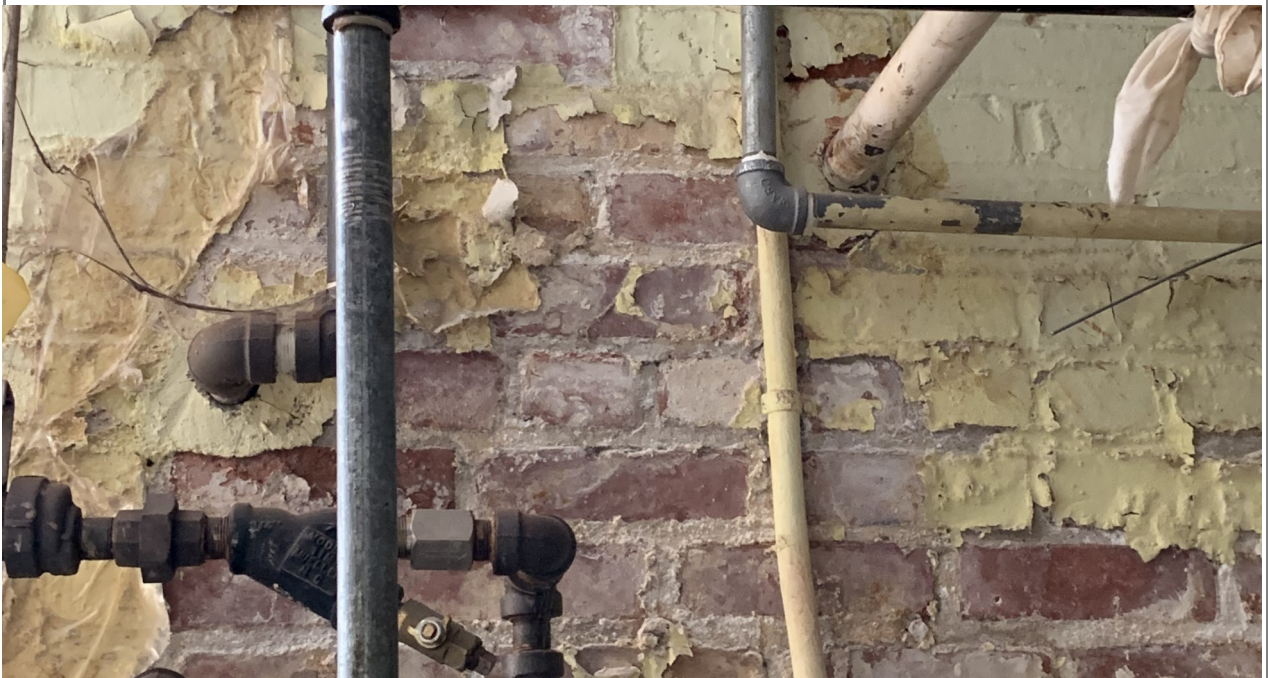
Photograph No.: 26	Date: 03/14/18	Direction Taken: —
Description: Lower Level Storage 2 — Peeling Paint on Brick Wall

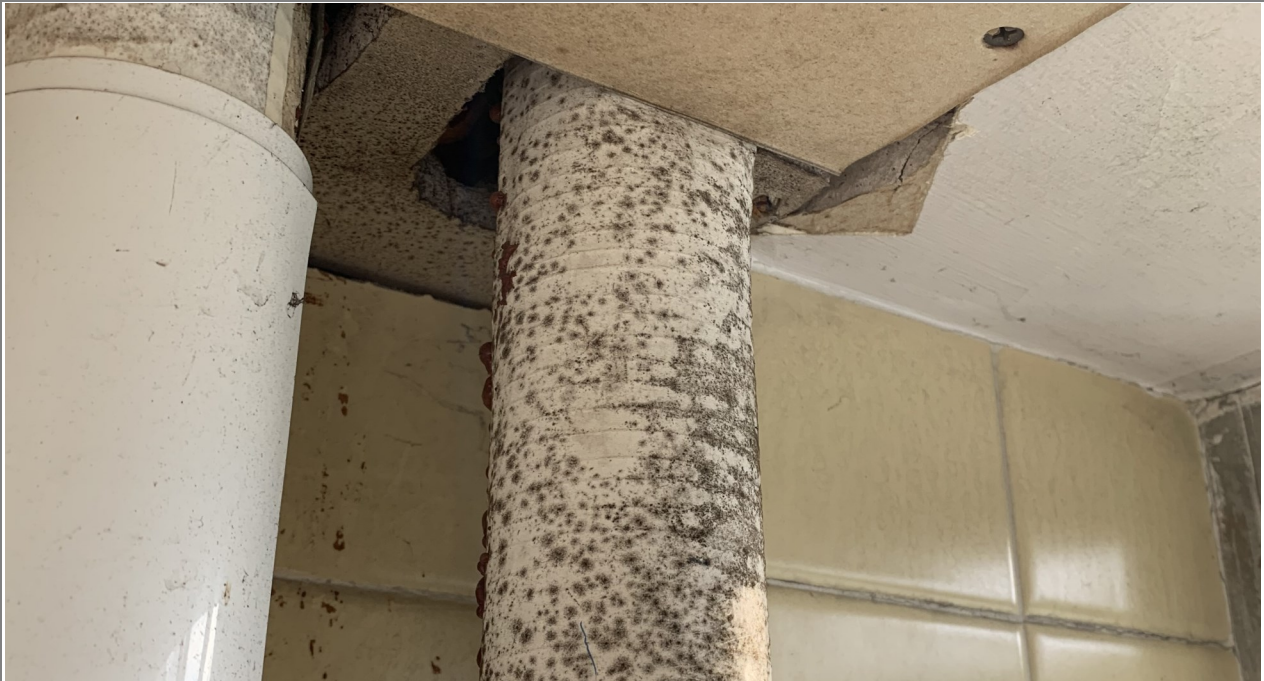
Photograph No.: 31	Date: 03/14/19	Direction Taken: —
Description: 2nd Floor Boy's Bathroom — Visible Mold Growth on Fiberglass Pipe Insulation
