# Initial Assessment—Photographic Log

**Client:** City of Stamford Mold Task Force

**Job Number:** S-2087-033

**Site:** Springdale Elementary School

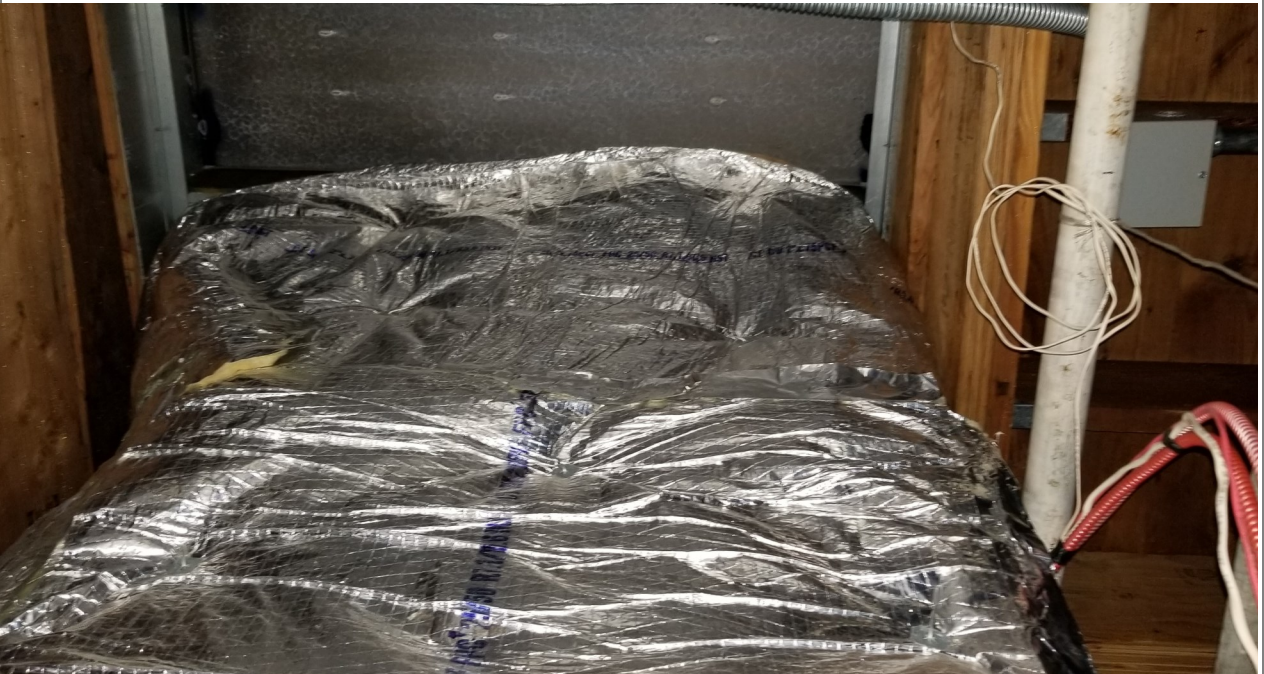
<b>Photograph No.:</b> 13	<b>Date:</b> 11/13/18	<b>Direction Taken:</b> —
<b>Description:</b> Hall by Room 203—Mold Growth on Ceiling Tile

<b>Photograph No.:</b> 14	<b>Date:</b> 11/13/18	<b>Direction Taken:</b> —
<b>Description:</b> Hall by Room 203—Gaps in Duct Insulation
