FACILITIES NEEDS

ASSESSMENT

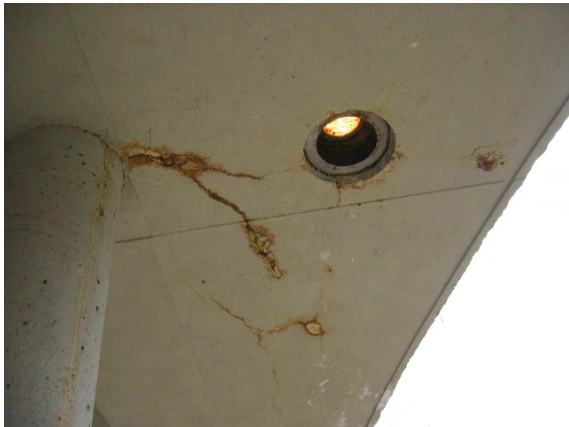
Photo #3: The carport canopy roof leaks frequently down through this light

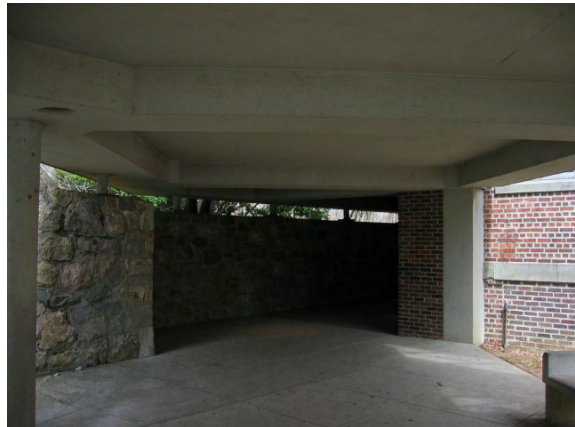
Photo #4: View of the main entrance tunnel

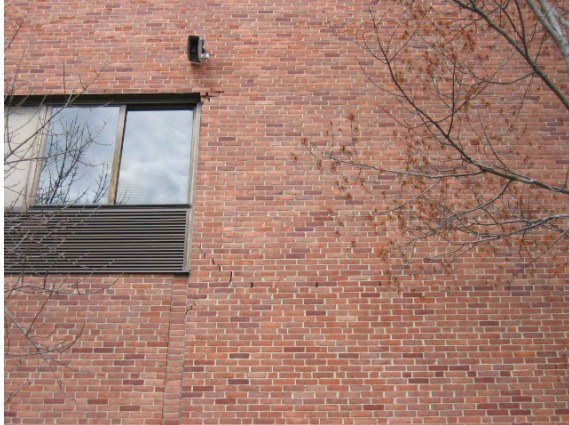
Photo #13: Portions of the brick facades have step cracking

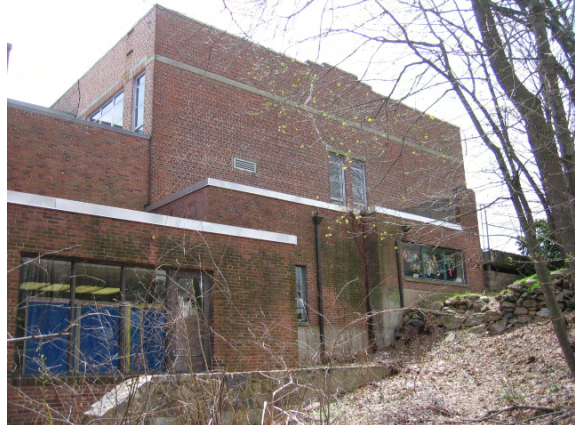
Photo #14: View of the north façade towards the front entrance

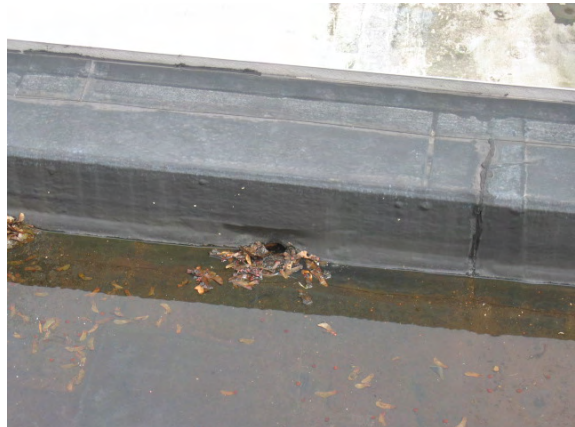
Photo #28: Several of the roof drain strainers are missing or clogged

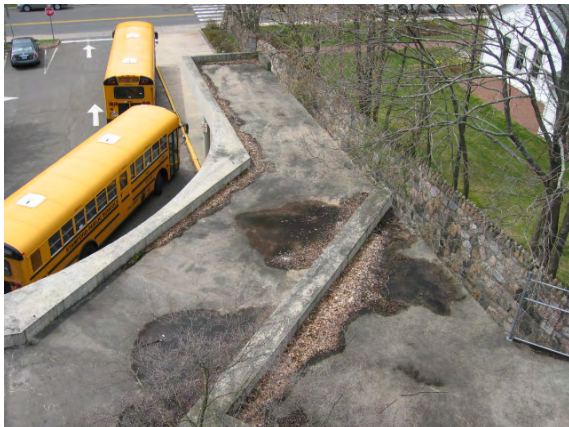
Photo #29: Carport canopy roof with fallen organic matter and ponding

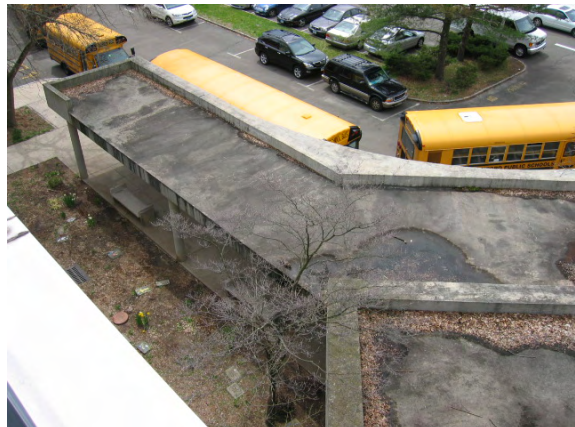
Photo #30: Carport repairs are required due to leaks

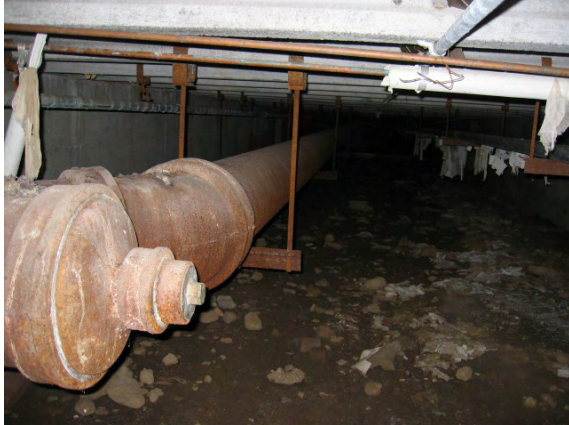
Photo #31: Chronic leaks were reported at the main roof drain main located in the crawl space

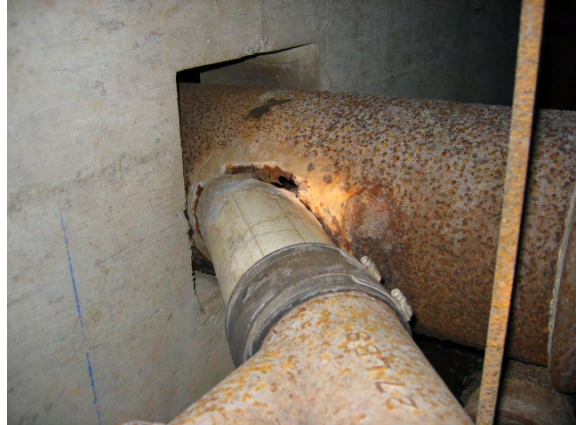
Photo #32: Detail view of a large crack and poorly executed repair at this multi-Y joint

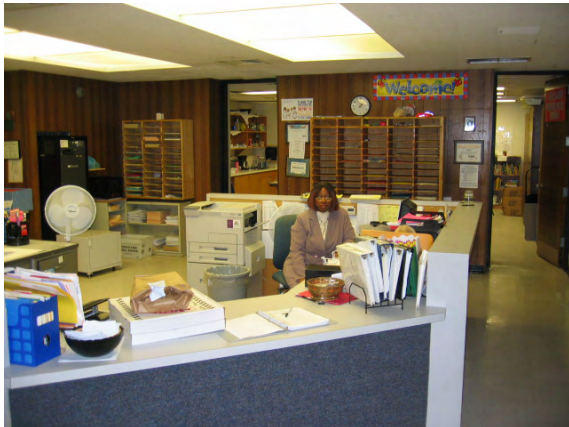
Photo #33: Main office interior

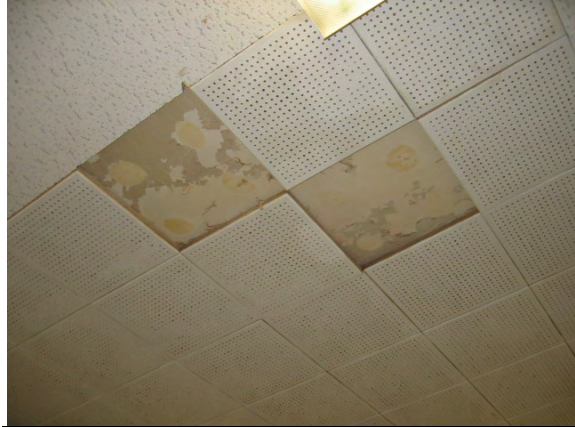
Photo #38: Poor conditions were observed at the adhered kitchen ceiling

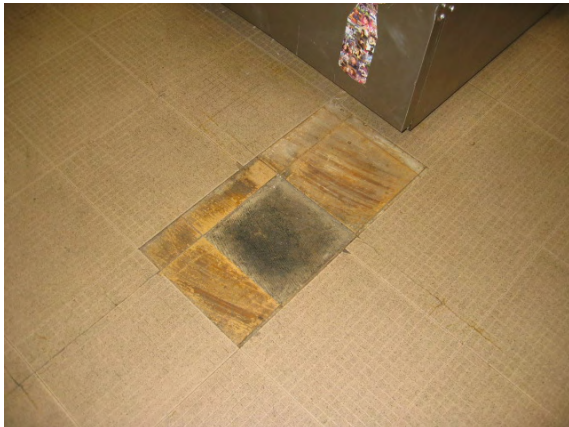
Photo #39: Poor conditions were observed at the kitchen VCT flooring

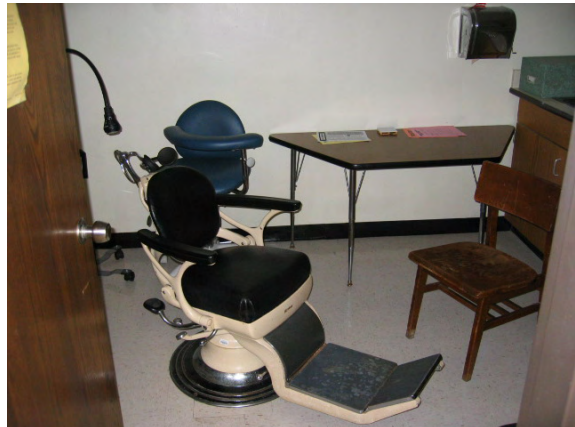
Photo #40: Nurse's office and dental chair

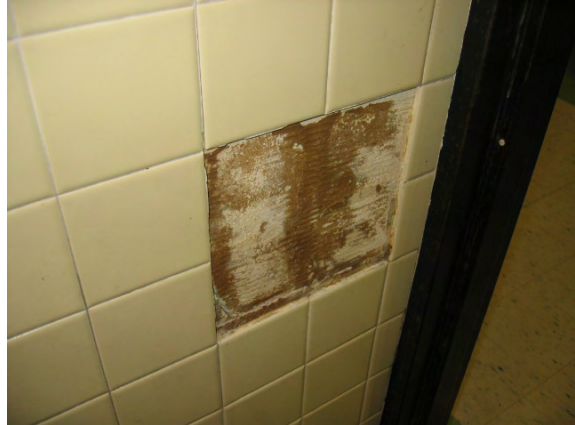
Photo #50: Several sections of the toilet room wall tiles in the primary section are damaged

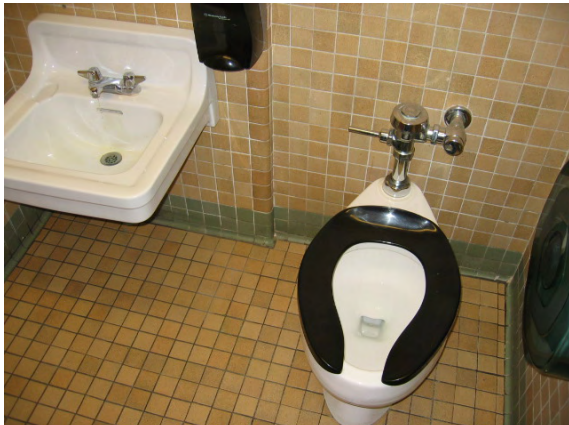
Photo #51: The kindergarten and 1st grade classrooms have private toilet rooms

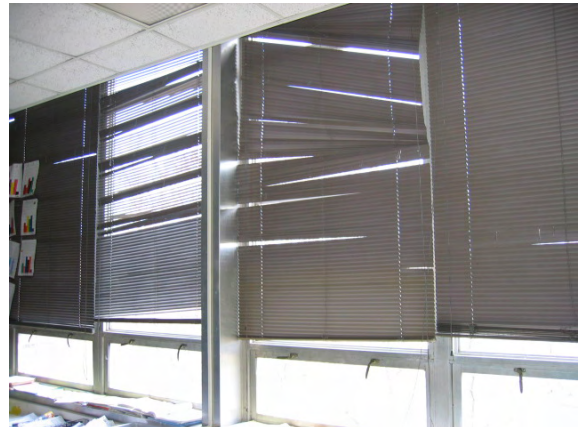
Photo #58: Many of the classroom window blinds are damaged and inoperable

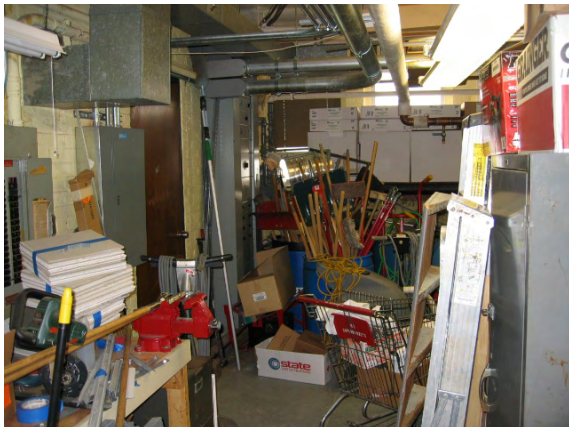
Photo #59: Maintenance type storage room

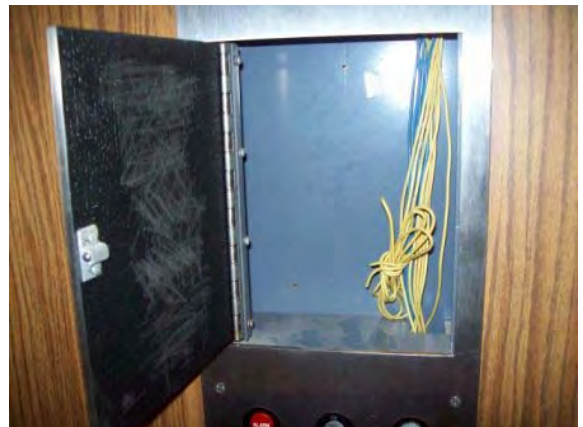
Photo #100: Missing emergency communication equipment

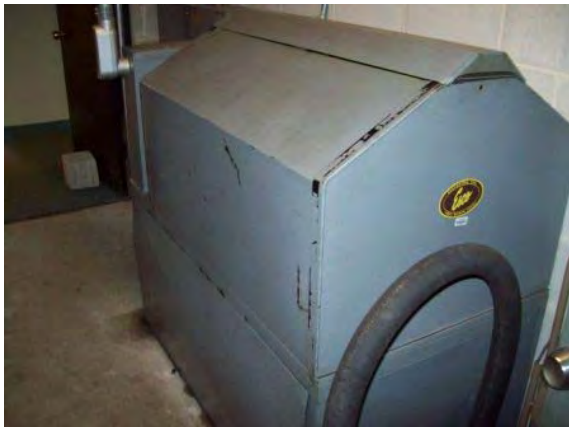
Photo #101: Hydraulic elevator equipment

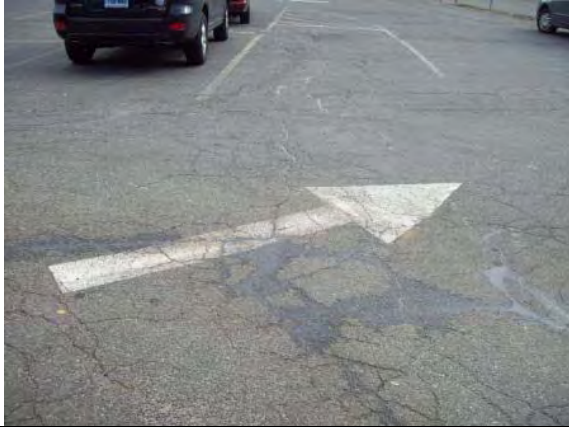
Photo #121: Asphalt damage in rear parking lot

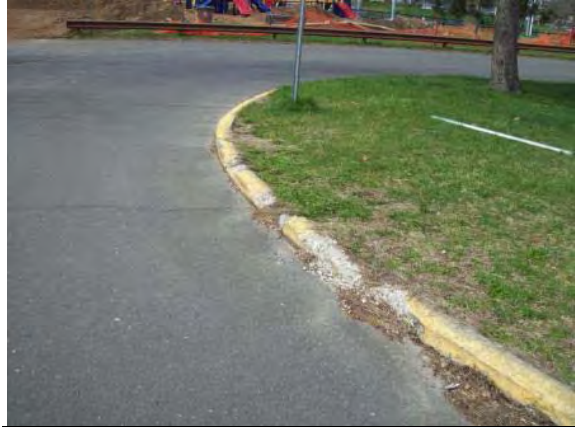
Photo #122: Curb damage in rear parking lot

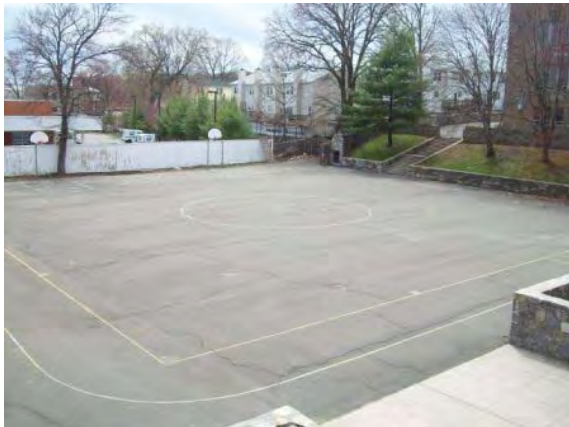
Photo #123: Asphalt paved play area

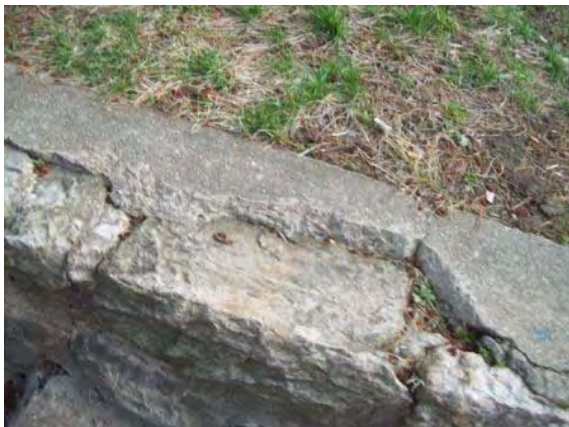
Photo #129: Damage at concrete steps

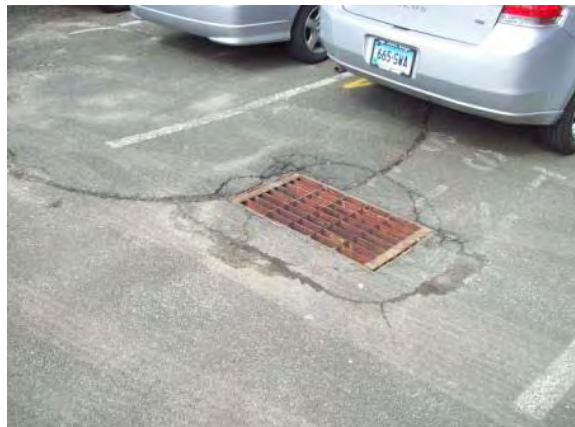
Photo #130: Sinking catch basin

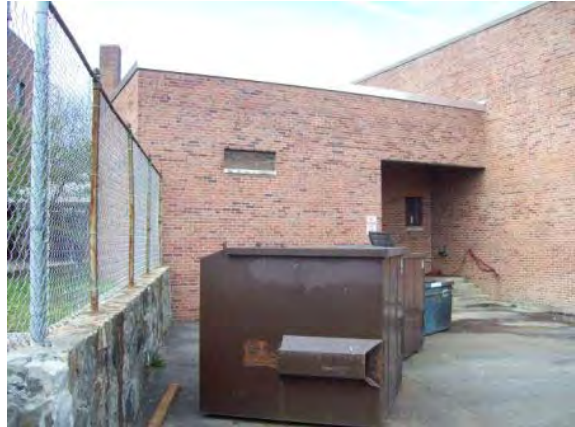
Photo #136: Corrosion at fencing near loading dock

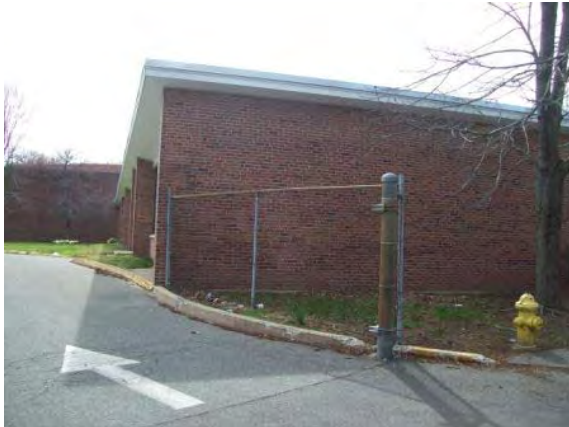
Photo #137: Corrosion at fencing near southeast corner of building

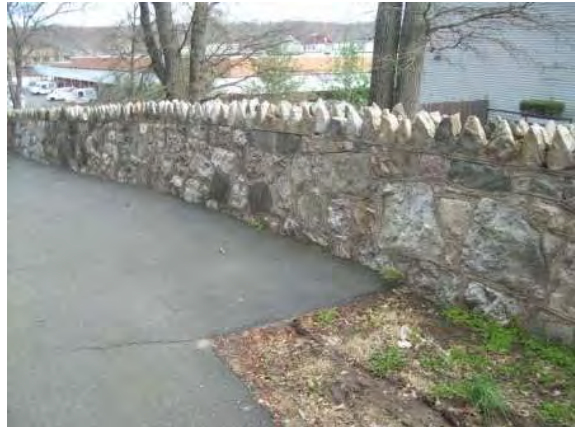
Photo #138: Stone wall at south property line
