M. Gottfried, Inc.

RE: Roof report and repair quotation
Springdale Elementary School
1127 Hope Street
Stamford, CT 06907

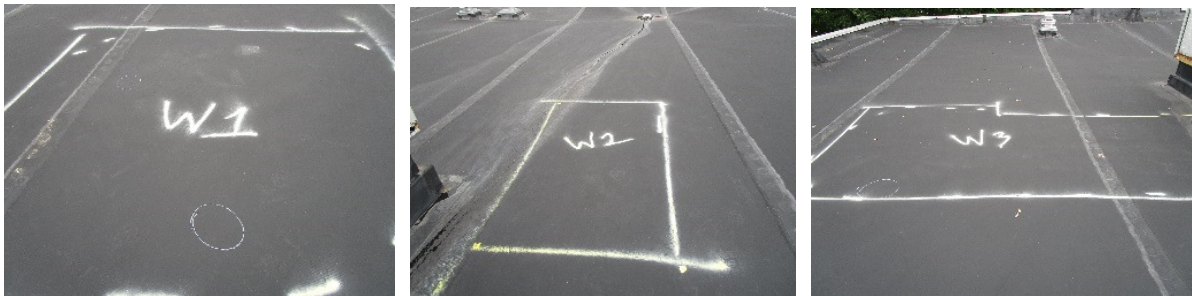
The roof construction on **Roof Area A** is a mechanically fastened reinforced EPDM roof over ½” insulation over a Built-up-roof on a wood deck. There is no active warranty on this roof. Three wet areas were noted on the roof: W-1, W-2 and W-3. Test cuts confirmed that the areas are wet. Inspecting the marked areas revealed that the water infiltration was from holes in the membrane. Instead of only patching the holes, it would be possible to remove the wet areas and leave the underlying BUR then install new ½” insulation and membrane. This would remove the trapped moisture from the roof system as well as stop more water from getting in.

Wet areas in Roof A with holes marked

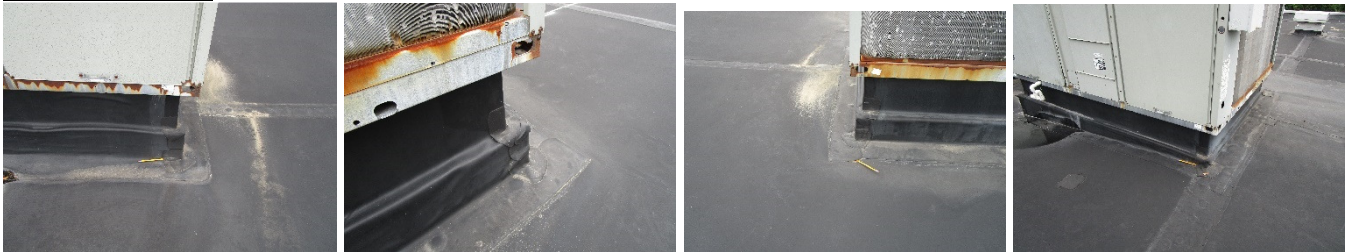
Corners at curbs

Bridging or the pulling away of the membrane flashing is found at many of the corners on the various curbs. As these corners continue to open, water can get into the roofing system.

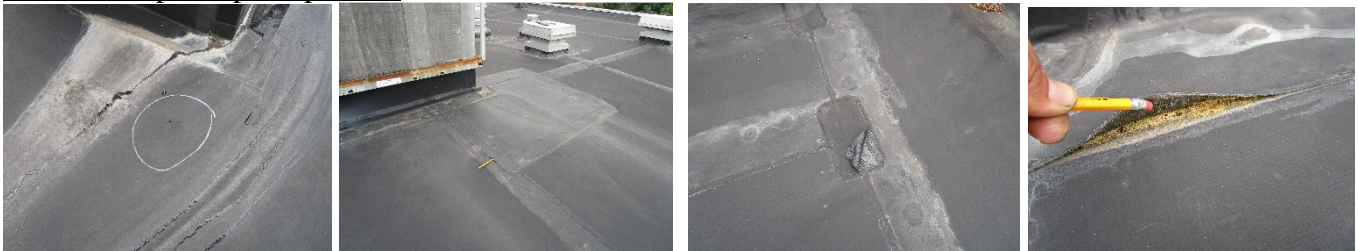
Holes and open laps or patches

Holes in the membrane and holes or bridging on laps and patches need to be properly repaired to prevent water infiltration.

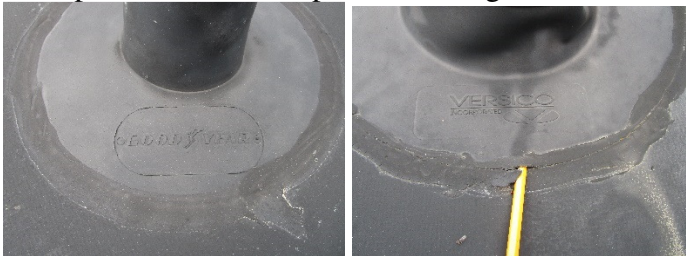
Multiple manufacturers products being used

Products from multiple manufacturers are found on this roof. To maintain warranties, if present, only the products of the manufacturer of the roofing system warranting the roof should be used. We can also see that some of these flashings are bridging and need to be repaired.

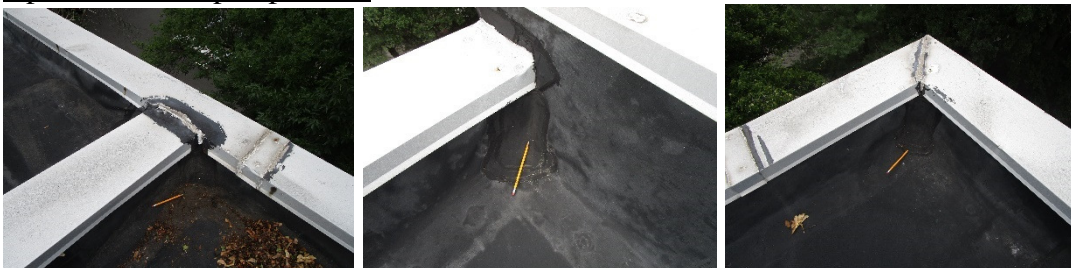
Open corners at parapet wall

Similar to the corner conditions at the curbs and penetrations, we found open and bridging corners at the parapet wall. These also need to be repaired.

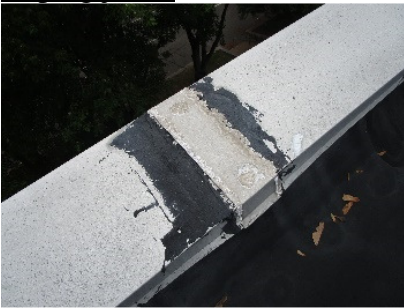
Coping joints

As seen here and in the above pictures, it looks like the school has been experiencing problems with the joints in the parapet coping. Many joints have been caulked or coated with roofing cement. If repairing the corners, holes and bridging in the parapet flashing does not stop leaks, overlaying the coping joints with a pressure sensitive EDPM flashing should be considered.

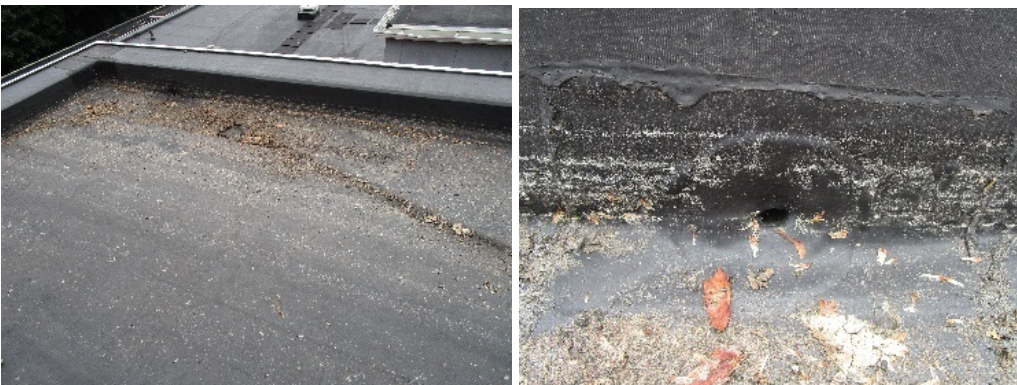
The roof is in good shape, but it only has one small scupper drain. Debris and staining from a build up of water is evident on the roof. Cutting an overflow scupper or enlarging the scupper will involve masonry work. If the ponding or slow draining water becomes a problem, the Construction manager will need to obtain pricing from a mason contractor in addition to roofing pricing.

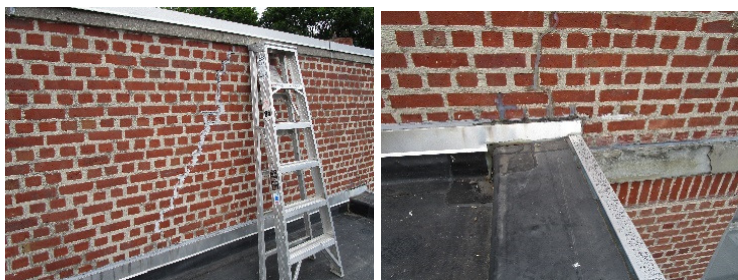
A mason Contractor may also need to be engaged to repair the large crack that is in the wall between Roof B and C. No repair or maintenance work is included for this roof area

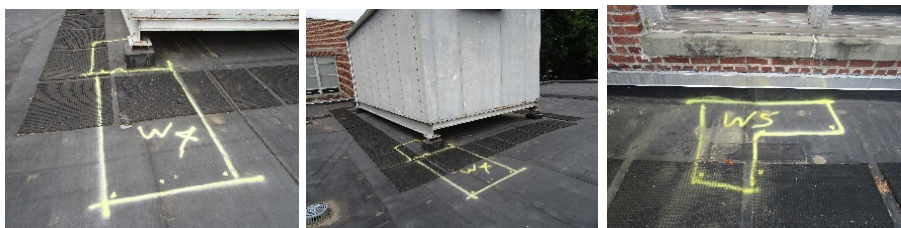
It appears that the leak at W-4 is from the penetration pocket. We found separation between the pocket sealer and the pocket perimeter as well as possible bridging of the corners on the pocket.

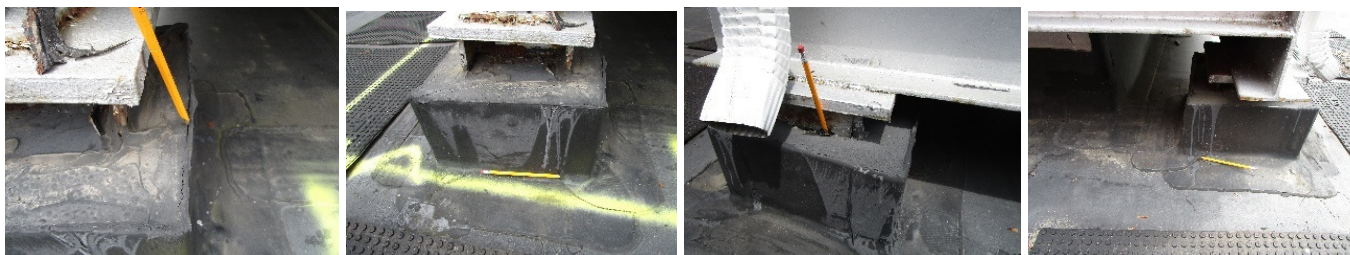
All the pockets need to be checked, corners repaired, and filler repaired to ensure no more water gets into the roofing system. If any wet insulation is found, it should also be replaced.

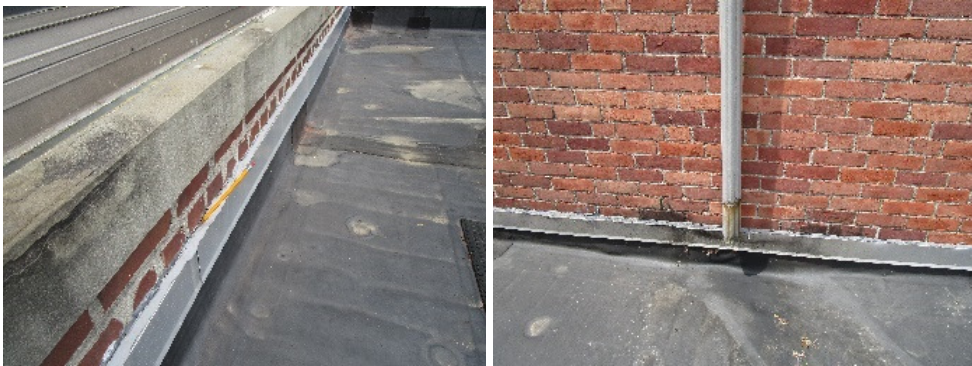
Caulking work

We found a number of areas where the caulking above the metal cap flashing had shrunk and has left possible infiltration points for water. These should be rechecked.

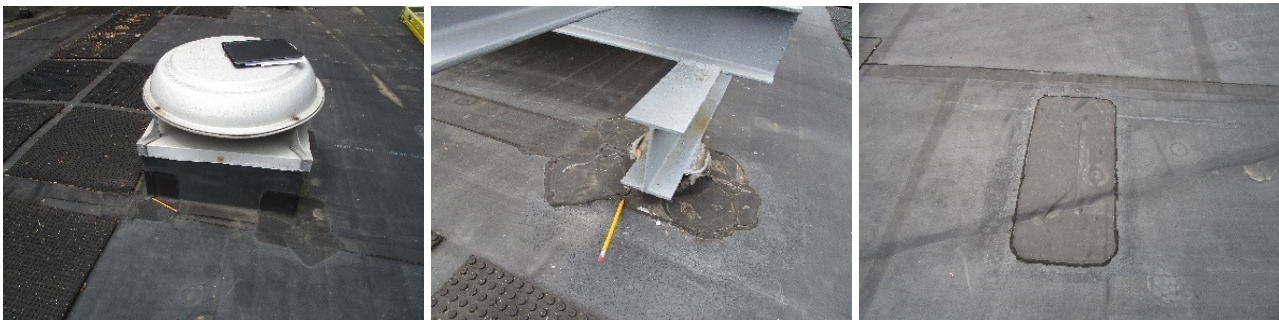
Miscellaneous roof maintenance

The roof also needs basic maintenance. In addition to maintaining/repairing the penetration pockets, we also found other corners that are starting to bridge. All corners and flashing should be inspected and repaired as needed.

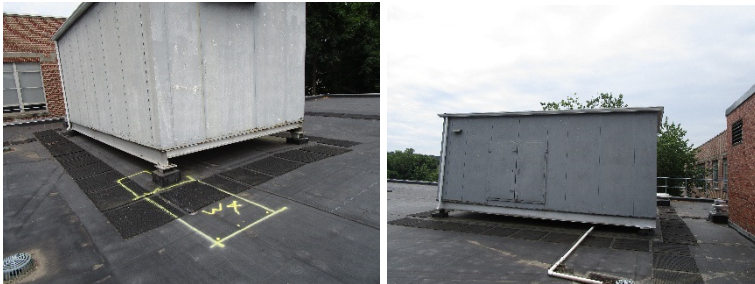
Because it is raised above Roof C, we do not think it is contributing to the leak at W-4. Because it is an independent structure above the main roof, we did not go on top of the roof. The scan showed that most of this roof is wet. If the contents inside are sensitive or getting wet, or if the top or deck is starting to rust or wear, reroofing should be considered. A price can be provided once the structure is investigated and its construction and purpose are provided.

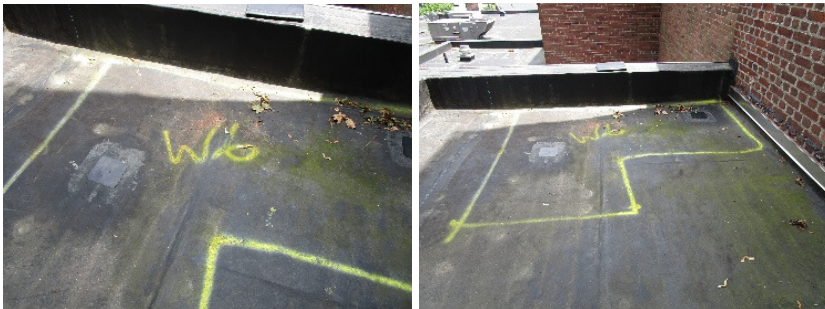
We found patched holes within the marked areas. The balance of the roof should be inspected for additional holes. Wet insulation should be removed, and new insulation and membrane installed in the marked area.

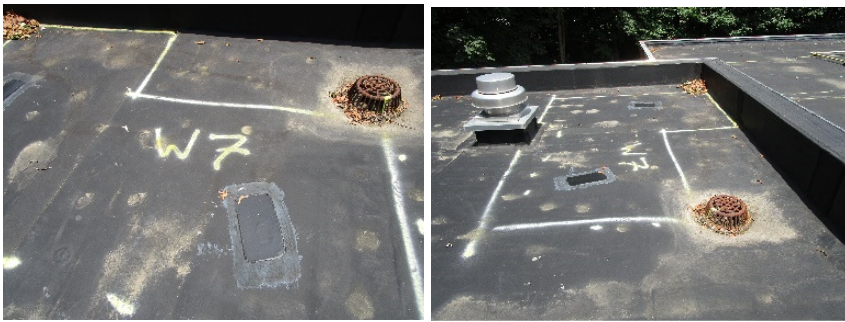
Holes are also assumed to be the cause of the leaks on this roof and patches can be found in the wet area.

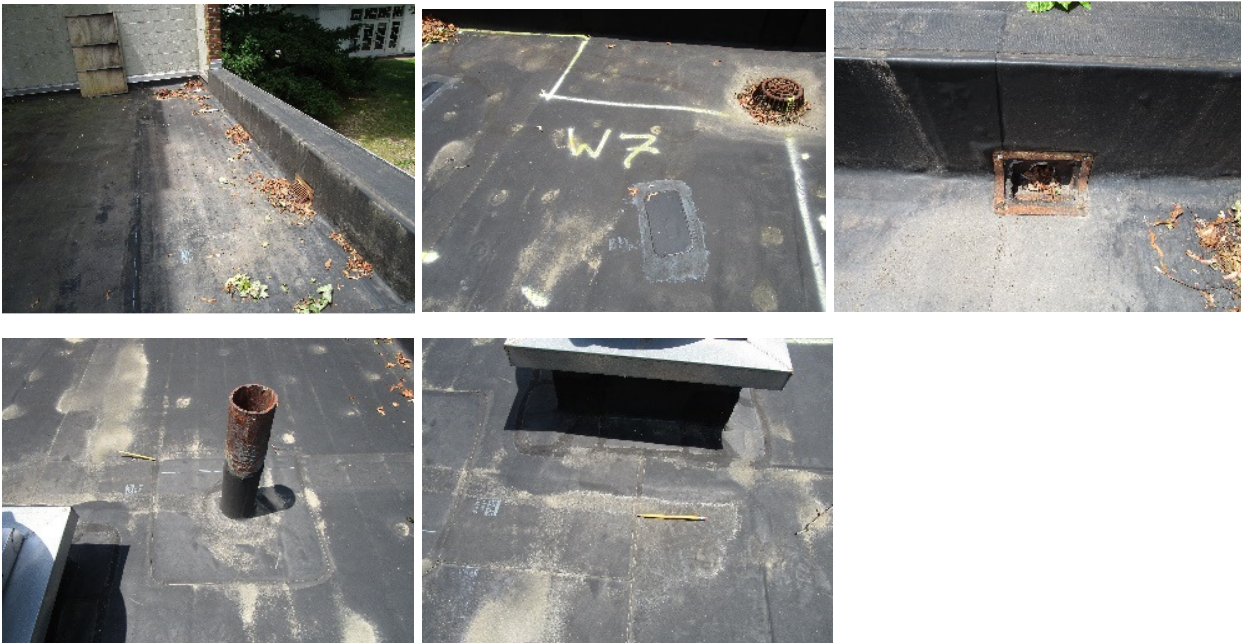
This roof needs maintenance. Debris that can clog the drains is on the roof. In addition, a few laps and patches are starting to lift.

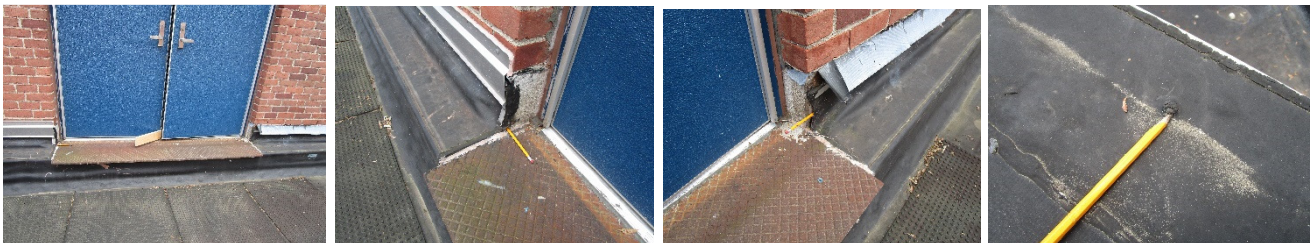
This roof appears to be a main access point to the roofs and gets roof traffic. As such it should regularly be inspected for holes and other signs of wear. In addition to patching some holes we found, the vertical membrane flashing at the doors needs to be touched up and terminated.

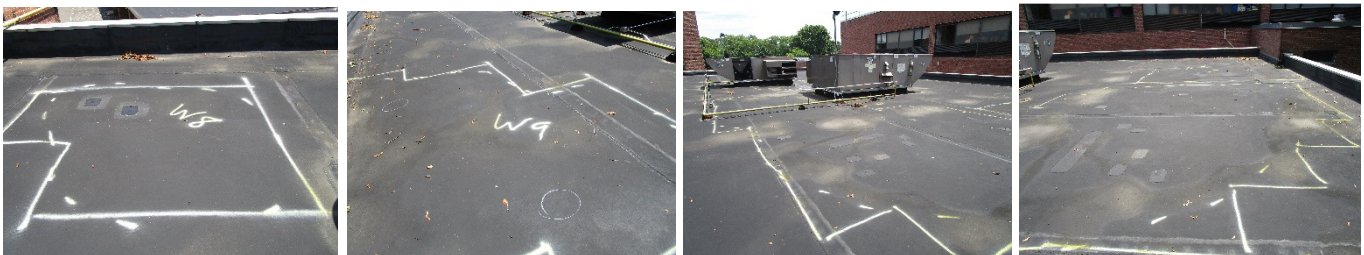
Roof Area H consists of an EPDM roof over 1/2" insulation over a built-up-roof over insulation on a metal deck. The roof is in very poor condition. Wet areas W-8, W-9, W-10 and W-11 are located on this roof. The wet areas marked take up a good portion of the roof. This roof is not under warranty.

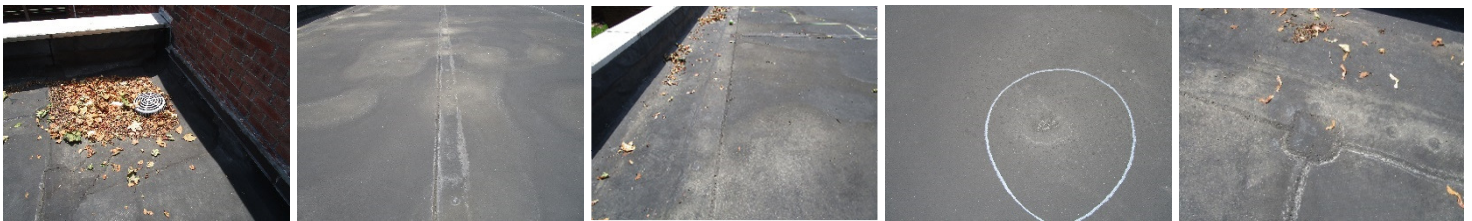
We saw that some of the water infiltration was from holes, some of which were patched, others were not. In addition, we saw laps that were cracked, worn areas of membrane, debris, etc.,

Debris clogging drains Worn and cracking lap Cracking lap Scrim visible thru membrane Cracking laps

This roof area should be replaced. Between the wet areas taking up a good percentage of the roof area, and the maintenance work needed at laps and flashings and the general worn condition of the membrane, it would be better and more cost effective to replace this roof then to try to change the wet areas and repair the rest. No repair and maintenance costs or replacement of the wet areas are included the pricing section of this report. A quote for replacement can be provided upon request.

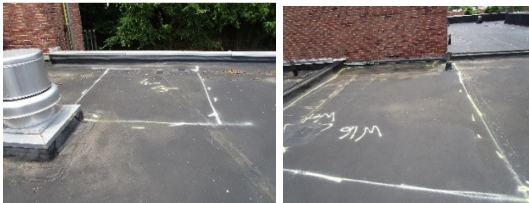
Holes were noted within the marked areas, but problems exist throughout the rest of this roof area.

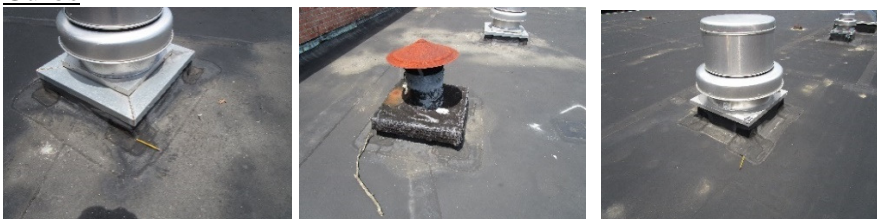
Curbs

Corners on the curbs are starting to bridge and open. These need to be repaired. Some of the vent curbs are made out of wood and covered with roofing cement. Some of these have rotted and are falling apart.

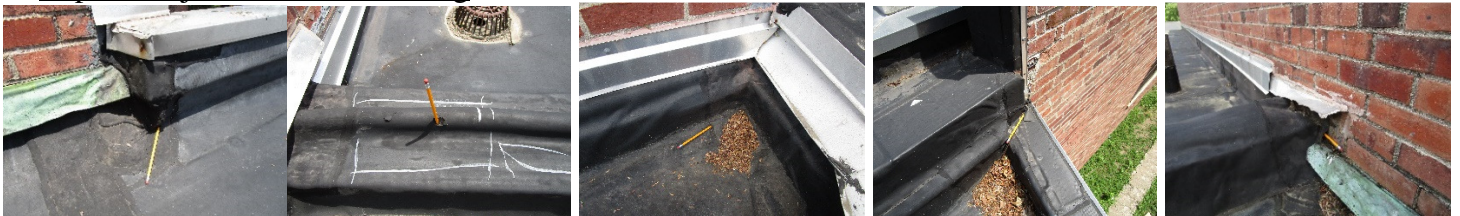
Expansion joint and wall flashing

Holes, open laps, open corners, loose termination, etc., were found in all the perimeter conditions of this roof area.

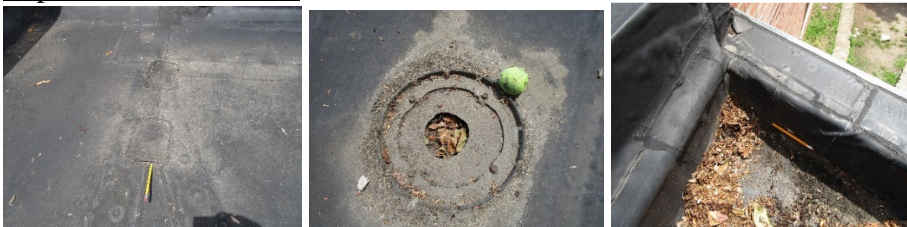
Laps, drains and debris

The laps and patches on this roof are in poor shape and are starting to crack and open. Drain flashings are in poor shape and some are clogged. Debris needs to be cleared from the roof.

Roof area I should be replaced. It would be possible to just change the wet areas, but when the needed maintenance and repairs are added to scope, the School would be better off replacing the roof. No costs for replacing the wet areas or performing maintenance to this section is included in the pricing section of this report. If requested, we can provide pricing for reroofing Roof Area I.

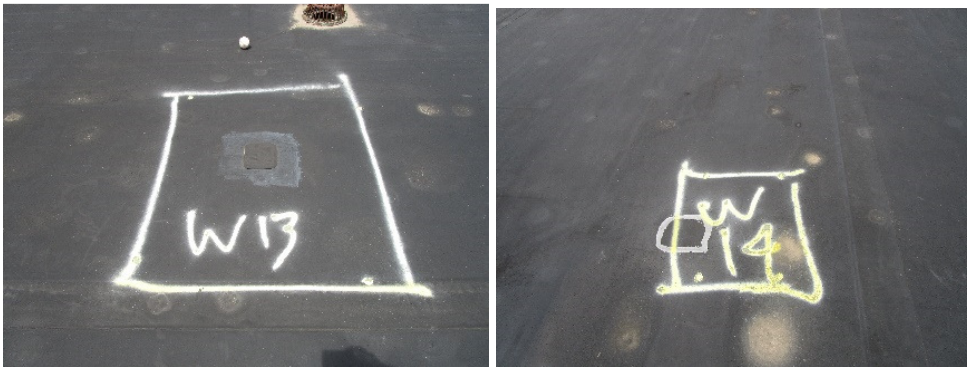
Both of these wet areas appear to have come from holes that have subsequently been patched.

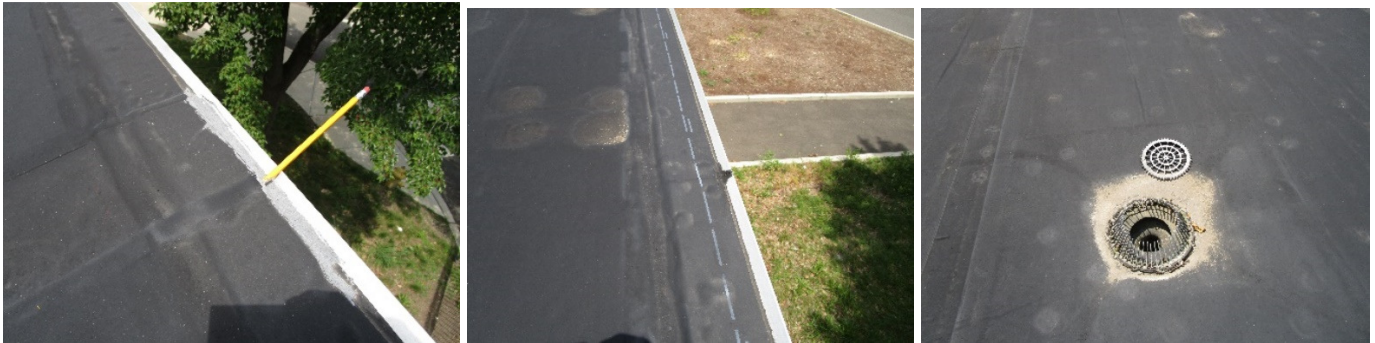
General maintenance is needed to check and repair corners, replace broken drain baskets, etc., in addition, EPDM patches should be installed over the backside of the perimeter edging joints. It looks like some of these have opened and possibly leaked because they have been caulked. A patch will provide a longer lasting repair.

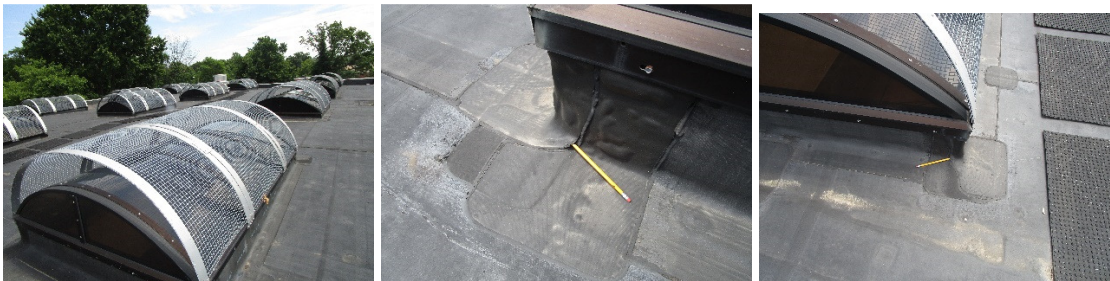
General maintenance is needed on this roof to keep it leak free. There are many skylights on this roof. We found some of the corners on the skylight curb flashing are starting to open. All corners should be checked and repaired as needed to prevent water infiltration.

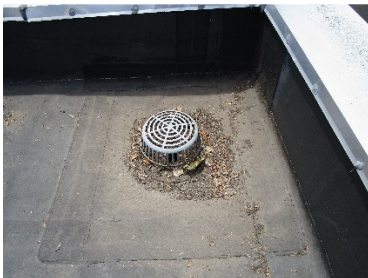
Drains should be cleaned, and all debris removed from the roof.

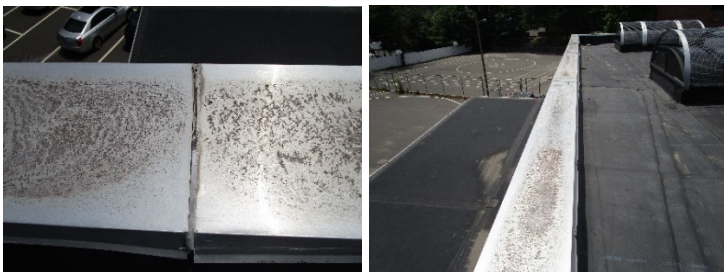
The coping on this roof area looks like it has been previously caulked. If any leaks develop in the future at the perimeter walls caulking or other work may be needed on this coping. No work on the coping is included in the maintenance portion of this proposal.
