M. Gottfried, Inc.

DATE: July 2, 2019

RE: Roof report and repair quotation
Stillmeadow Elementary School
800 Stillwater Road
Stamford, CT 06902

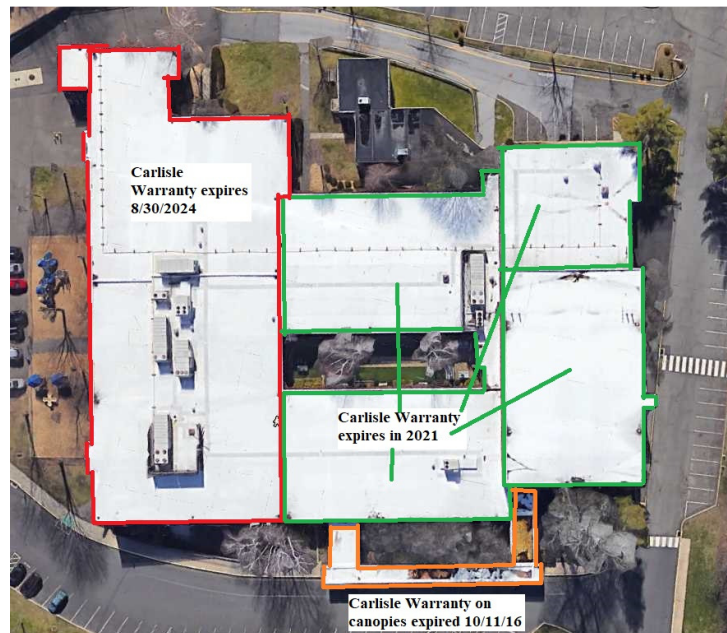
Carlisle roof warranties were issued for all areas of the building except the portable classrooms. The canopies had a 15-year warranty that expired in 2016 and the left side (shown outlined in red above) has a 20-year warranty **in effect** that runs until 8/30/2024 and the center and right sides (shown outlined in green above) has a 20-year warranty in effect that runs until 2021 (actual warranty not forwarded from Viking but came up in discussions with Carlisle while obtaining the drawings for the other areas).

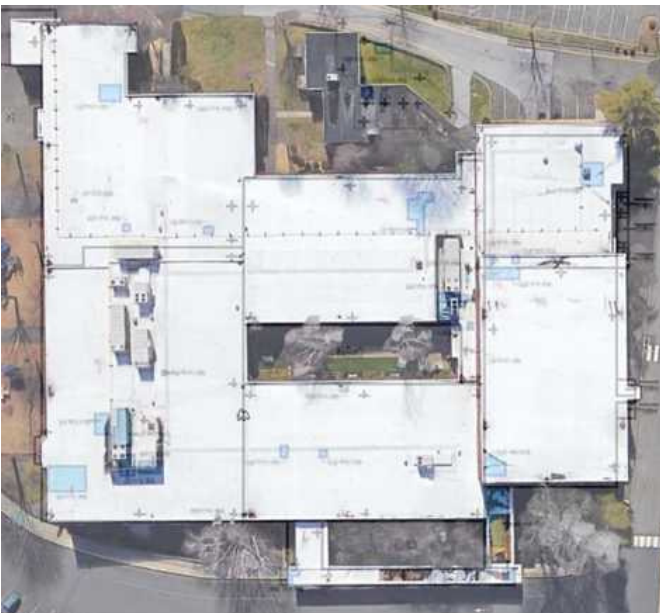
The infrared tests revealed **30 areas** of suspected wet areas of roof. The below picture shows the wet areas marked out in the infrared report on an aerial view of the school.

Wet areas superimposed on roof map

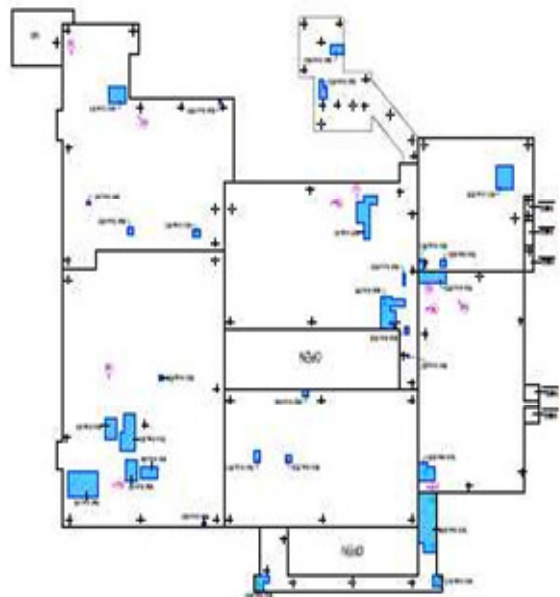
Clearer view of wet areas

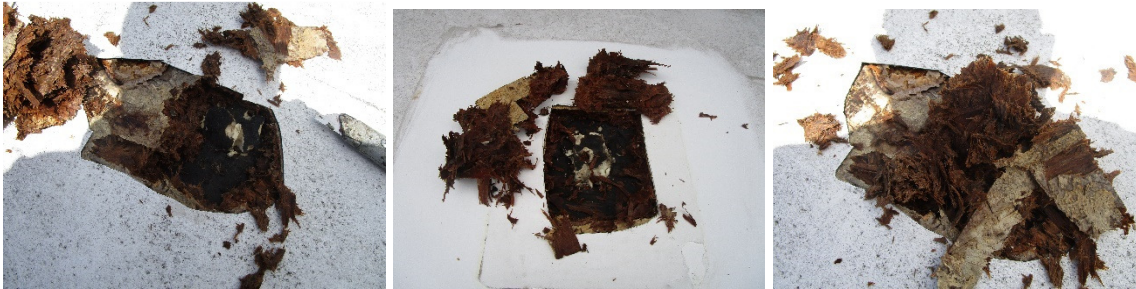
We performed test cuts at a few of the noted wet areas. The roof construction found is: steel deck, 2" polyisocyanurate insulation, tapered polyisocyanurate insulation, followed by 5/8" OSB board followed by the adhered white TPO roofing system. When we cut open the roofs to obtain this information, we found that the OSB board was soaked and delaminating. The polyisocyanurate insulation and facers were also wet.

Test cuts at the areas marked "wet" revealed a soaked and delaminating OSB board over polyisocyanurate insulation.

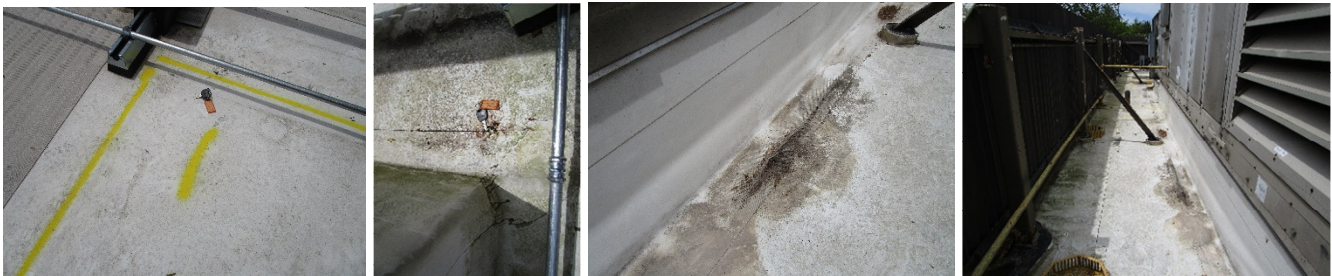
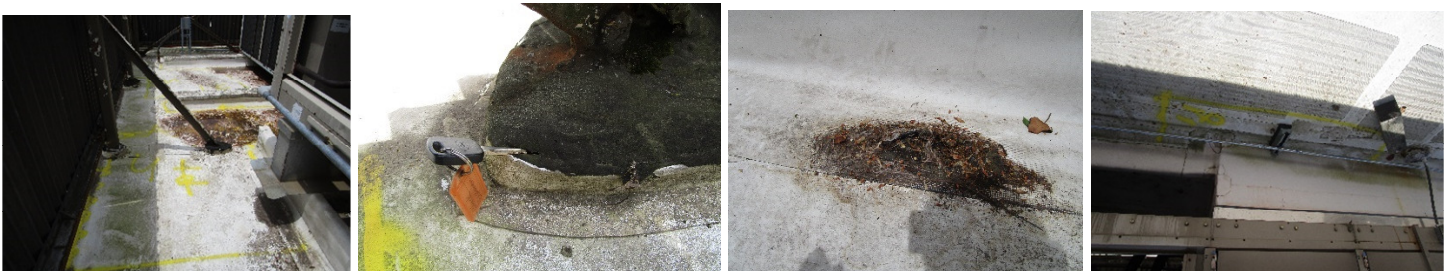
Wet areas 1, 2 and 20

Wet areas 1 and 2 stretch from the courtyard edge, along the unit and screen wall down toward the outside edge facing the portable classrooms. Area 20 lies on the opposite side of the large HVAC unit.

This area has penetration pockets at the screen wall, equipment rails below the end of the large unit and the large curb that the unit sits on. We found holes, cuts, possible opening fishmouths in the laps, penetration pockets where the sealer has shrunk and left voids, and areas with the top of the membrane has been scuffed or worn off exposing the scrim reinforcing. All these items have let water into the roofing system. The membrane in this whole area should be removed, wet OSB any wet insulation removed, and new Carlisle materials installed in its place. When installing new materials, the Carlisle representative recommended install Carlisle ½" SecurShield HD in lieu of the OSB board. The SecurShield is a high density (100 PSI) coverboard that will withstand traffic but will not turn to mush or come apart if it gets wet. In addition, the facers are fiberglass and are not conducive to mold growth. In addition, since this area appears to get a lot of activity, he recommended to use an .080 reinforced membrane rather than the standard .060. We have made these material changes for all of the replacements noted below as well. Sleepers, the HVAC curb, pail posts and supports, vents, etc., that fall within this area would also receive new flashings.

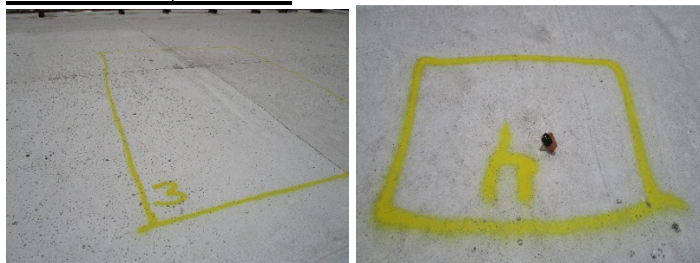
Wet areas 3,4 and 30

Areas 3, 4 and 30 are relatively small areas. We found some holes and punctures in these areas. These areas should be opened, and any wet material removed, then new materials installed.

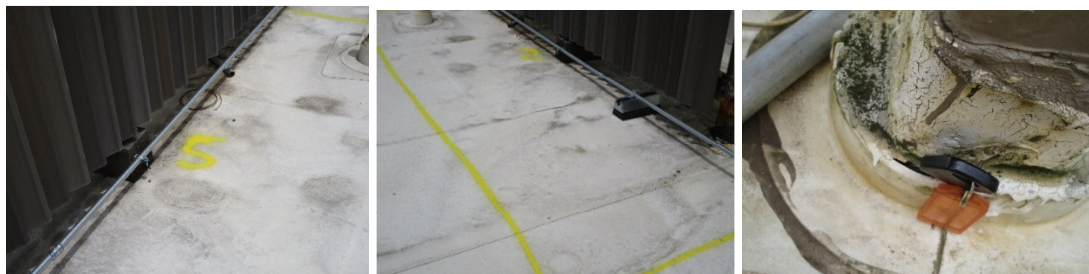
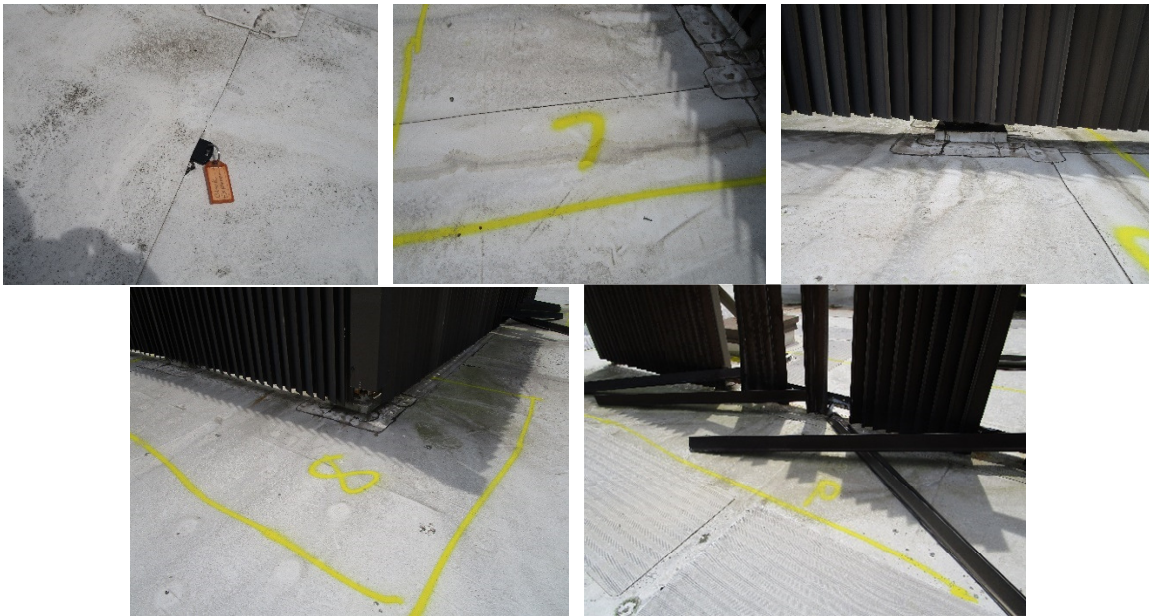
Wet areas 5,6, 7,8 and 9

Wet areas 5 through 9 surround the other area with a screen wall. This area contains rail posts, a hatch, vent, etc.,

In this area we found holes, opening laps, shrinking filler in penetration pockets, parts of the screen wall that have fallen and made holes, etc., The membrane and any wet materials underneath need to be removed, new insulation, HD coverboard and .080 membrane installed. New penetration flashings need to be installed as well.

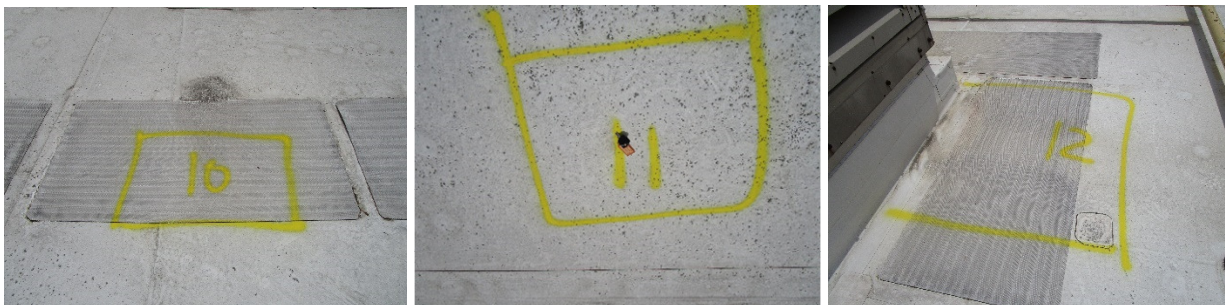
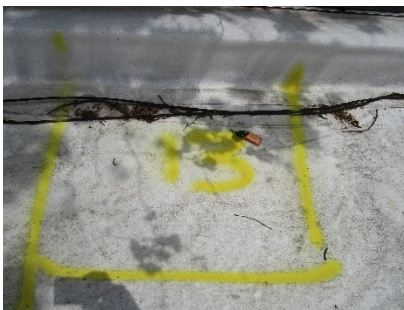
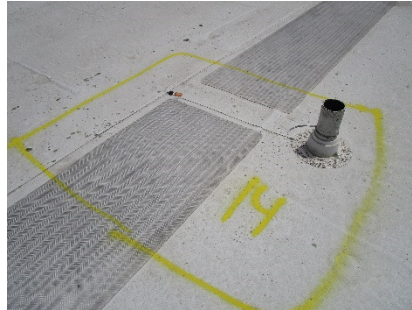
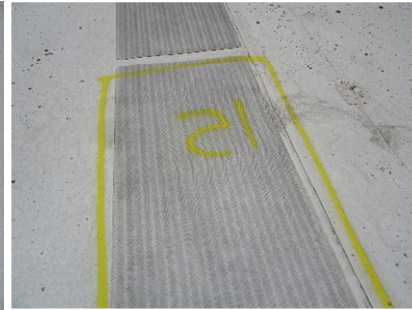
Wet areas 10, 11, 12, 13, 14, 15 and 30

Wet areas 10, 11, 12, 14, 15 and 30 are all small areas in the field or along an edge.

In these areas we were able to find some holes, and some laps and flashing that may need attention. Some of the marked areas fall around walkway pads. We cannot tell if the water is only under the pad and above the roof, or if there is a hole under the pad. For these areas we need to lift the pads and inspect/do a test to see if the OSB board is wet. If the areas under the membrane is dry the test cut will be patched, the area checked. A new pad will be installed if the existing is not salvageable. All other areas will be probed in the same fashion, if wet material is found it will be replaced and removed.

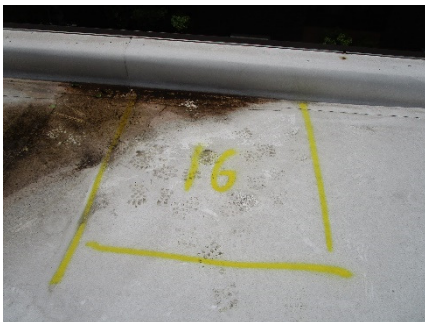
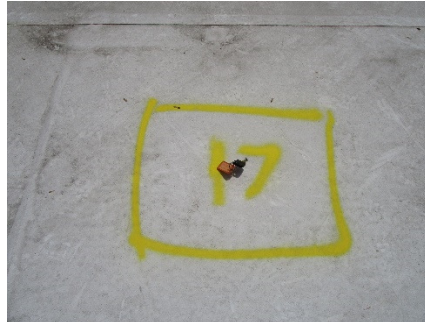
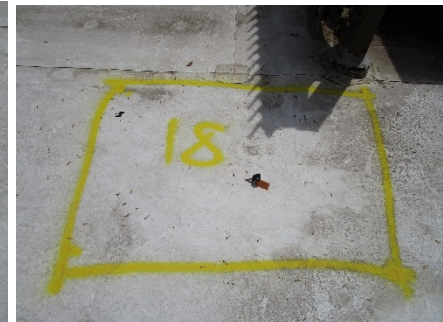
Wet areas 16, 17 and 18 are small areas. 16 is by a drain, 17 and 18 are along the narrow section of roof along the higher gym wall going to the large unit and area 20.

Holes were found at each of these areas. They will be opened, wet material changed, and new membrane installed.

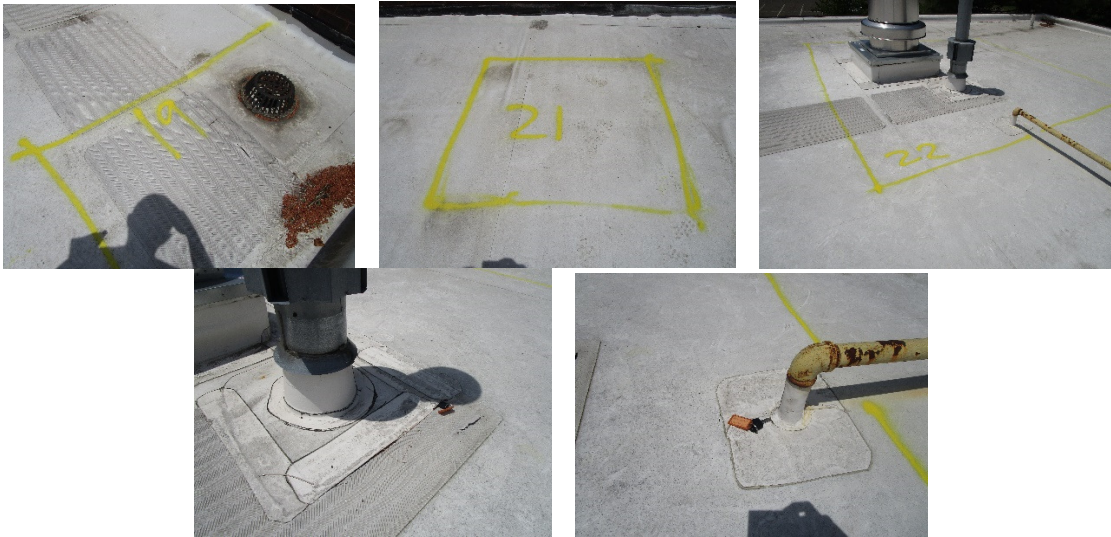
Wet areas 19,21 and 22

Wet areas 19, 21 and 22 are on the raised roof below the gym.

At area 19, we found a few cuts around the drain. The area should be cut out and the drain reflashed. We did not find anything obvious at area 21. This area spot requires further investigation. Area 22 is a larger area that the other areas marked on this level. It Contains a fan curb, vent and gas line. We did a test cut and the OSB board is wet. The area needs to be replaced and new materials installed. The curbs and penetrations will all need to be reflashed.

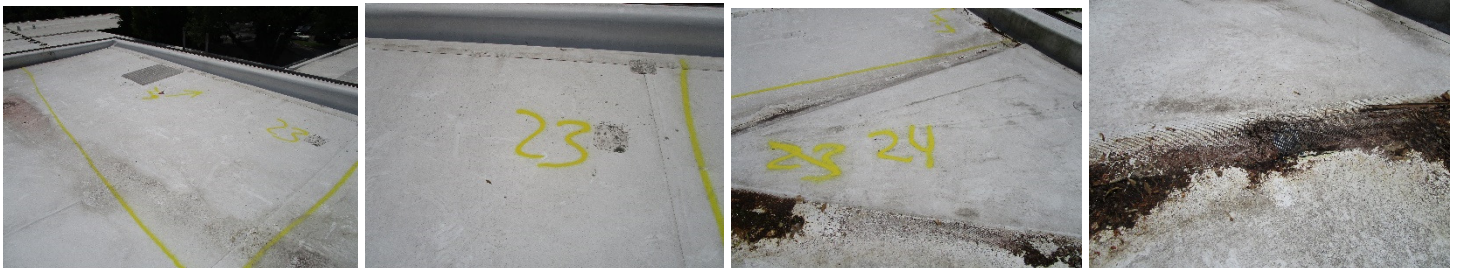
Wet area 23 and 24

Wet areas 23 and 24 lit on opposite corners of the gym roof. Both are occurring at crickets on the roof.

Holes were found in area 23 and 24 in addition the membrane on the edge of the cricket of 24 is worn.

Both these areas need to be removed and replaced.

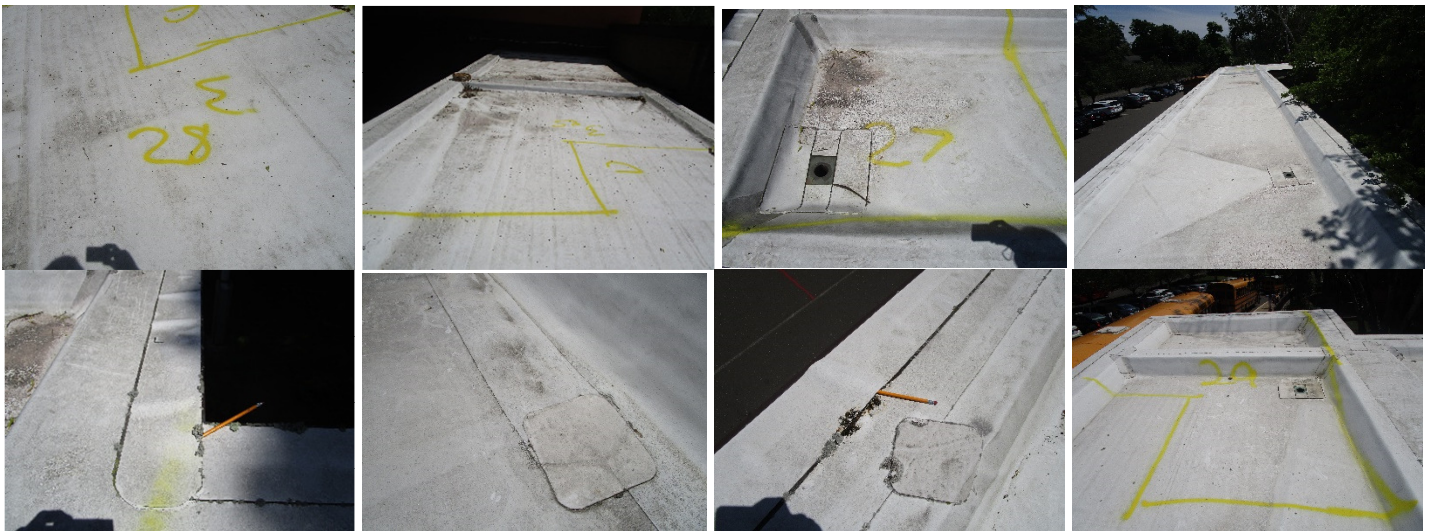
Wet areas 27, 28 and 29

Areas 27, 28 and 29 are on the canopy roof. The canopy roof is divided into distinct sections with raised dividers. The three roof sections containing the wet areas are in poor shape and should be replaced. In addition, maintenance is needed on the other sections.

We think a lot of the problems on the canopy roofs is due to the drains. The drains are just tubes that extend into the drainpipe. We do not think there is any gasket ring or means to prevent backup of water if the drain line is clogged or if rains exceed the capacity of the pipes. This would lead to water coming up and getting under the membrane. In addition, to the marked areas, we found open laps and patches and edge striping on the other canopy roof segments. We feel the wet areas should be replaced, and new proper roof drains installed. If new drains are not feasible proper roofing retrofit drains (if they fit) should be installed in all the sections of the canopy roof. The sections not reroofed should be properly patched and repaired.
