FACILITIES NEEDS ASSESSMENT

STILLMEADOW ELEMENTARY SCHOOL

EMG

Date of Report: August 27, 2009

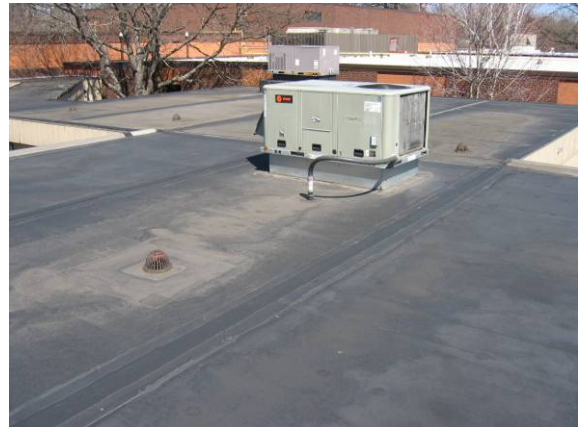
Photo #21: Several of the flat roof drain strainers were missing or damaged.

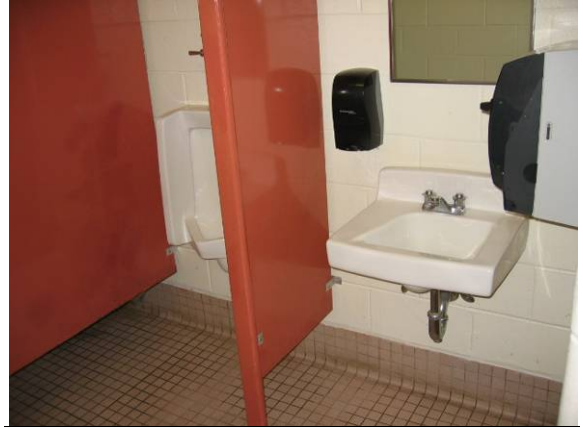
Photo #55: The only grab bars are provided within a single user toilet room in the nurse's office.

3.1	2903	Add ADA Grab Bar and blocking									20	20	0	10	EA	\$1,575.00	\$15,750	\$15,750											\$15,750	
3.1	2902	ADA, Renovate restroom for full compliance									20	20	0	4	EA	\$15,120.00	\$60,480	\$60,480											\$60,480

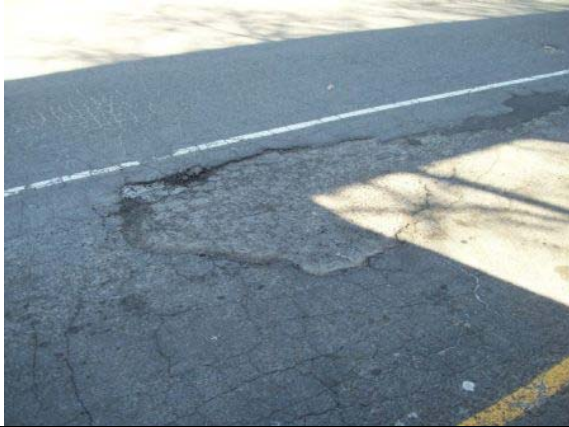
Photo #115: Asphalt damage in east parking lot

5.2	2608	Seal Coat and stripe asphalt, no repairs									5	1	4	9,045	10000 SF	\$4,315.53	\$39,034					\$39,034							\$39,034	
5.2	2605	Cut & Patch asphalt									10	9	1	4000	SF	\$3.01	\$12,046		\$12,046										\$12,046

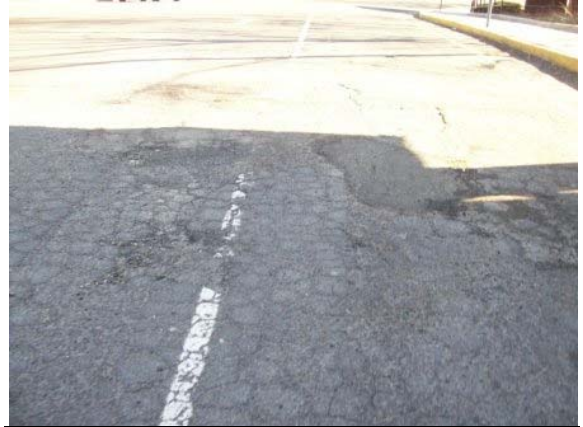
Photo #116: Asphalt damage in east parking lot

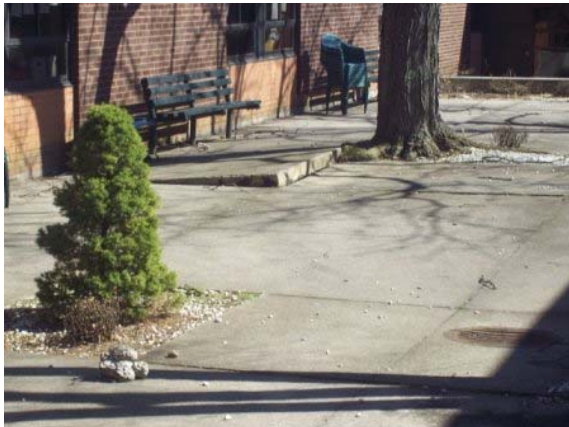
Photo #117: Concrete damage in courtyard

3.1	2923	ADA, Wrap drain pipes below accessible lavatory									0	0	0	25	EA	\$81.90	\$2,048	\$2,048											\$2,048	
5.2	2609	Replace damaged concrete									30	29	1	90	SY	\$450.99	\$40,589		\$40,589										\$40,589

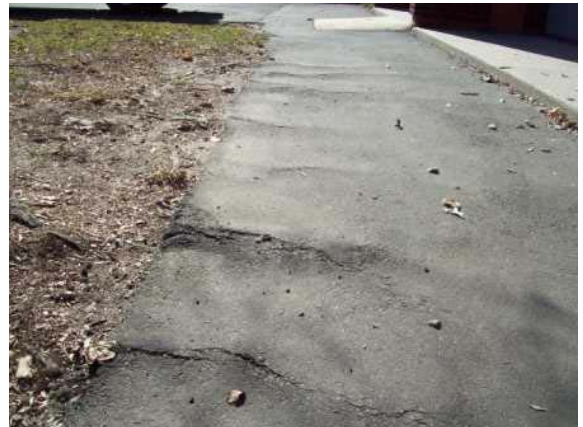
Photo #118: Heaving pavement in south parking lot

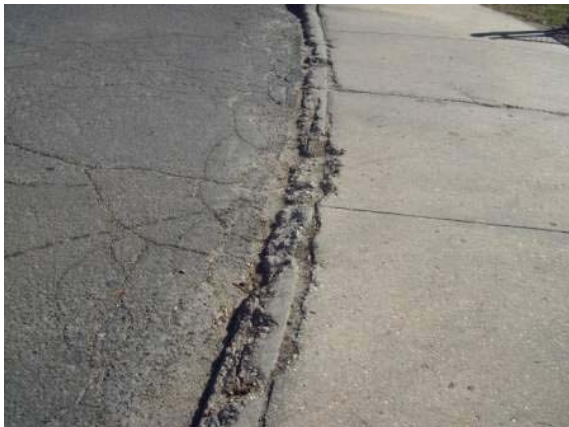
Photo #119: Curb damage at entrance to south lot

5.2	2610	Replace concrete curbs									25	24	1	60	LF	\$38.12	\$2,287		\$2,287										\$2,287	
5.3	3042	Replace Corrugated metal pipe 36" dia, 25 ft length.									30	30	0	5	EA	\$4,460.72	\$22,304	\$22,304											\$22,304

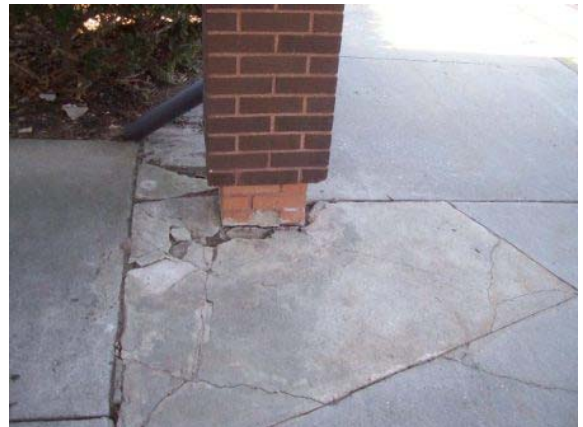
Photo #120: Concrete damage near column

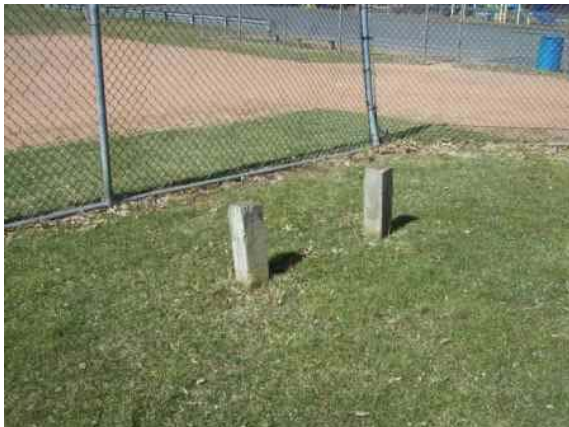
Photo #131: Missing wood bench

5.5	2618	Add wood chips, 3" deep, hand spread	10	5	5	300	SY			\$7.23	\$2,170							\$2,170					\$2,170
5.5	2619	Replace exterior wood bench, 8' long	15	15	0	2	EA			\$1,399.08	\$2,798	\$2,798											\$2,798
