Initial Assessment—Photographic Log

Client: City of Stamford Mold Task Force

Job Number: S-2087-033

Site: Toquam Magnet School

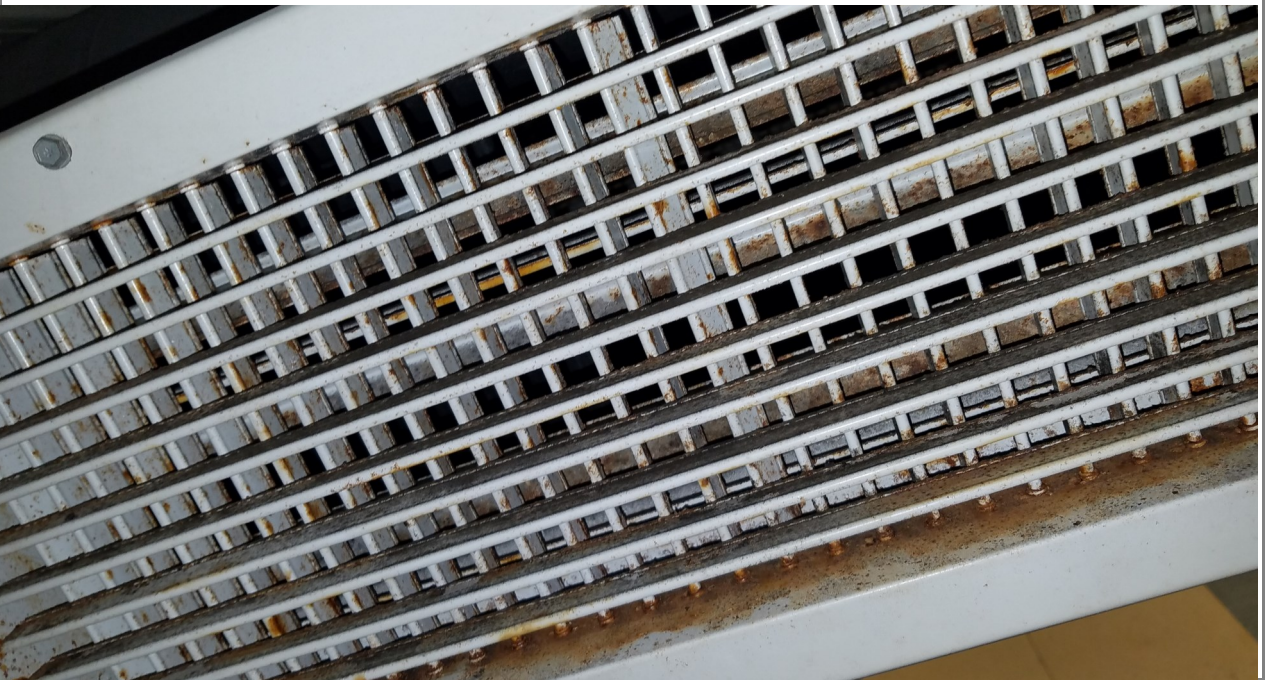
Photograph No.: 13	Date: 11/8/18	Direction Taken: —
Description: Room 23—Mold Growth and Rust on Supply Air Diffuser

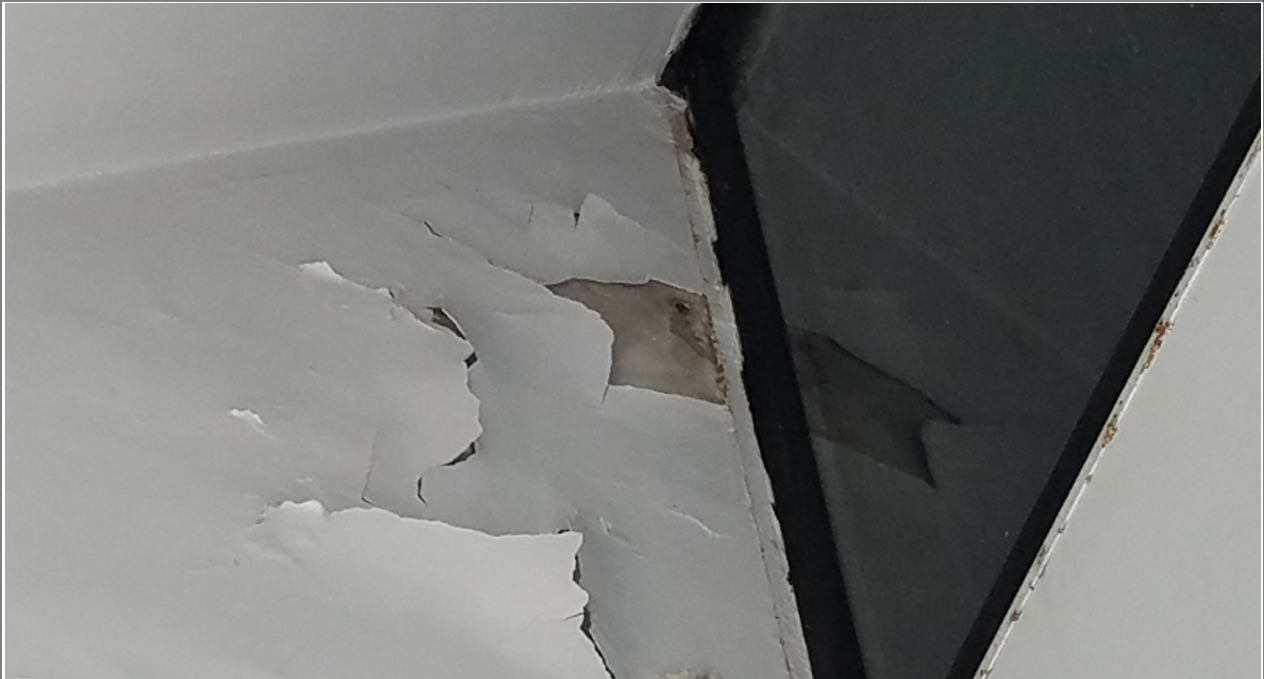
Photograph No.: 15	Date: 11/8/18	Direction Taken: —
Description: Hall Skylight by Room 24—Mold Growth on Gypsum Board Wall

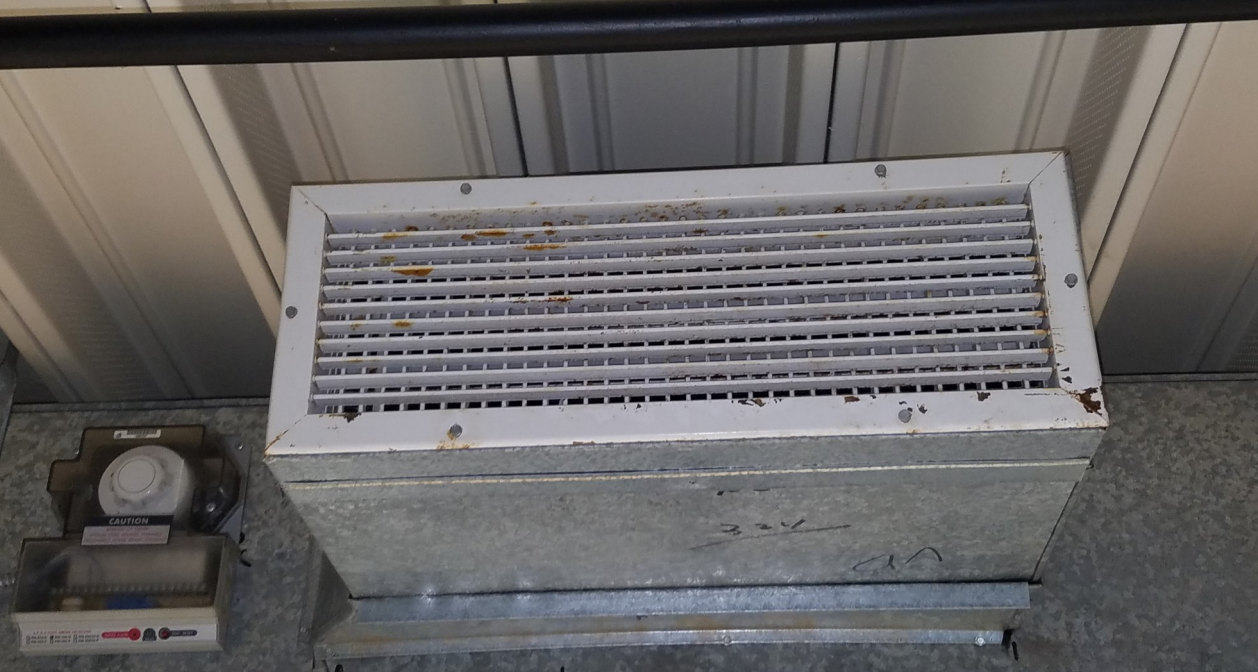
Photograph No.: 28	Date: 11/8/18	Direction Taken: —
Description: Room 37—Rust on Supply Air Diffuser

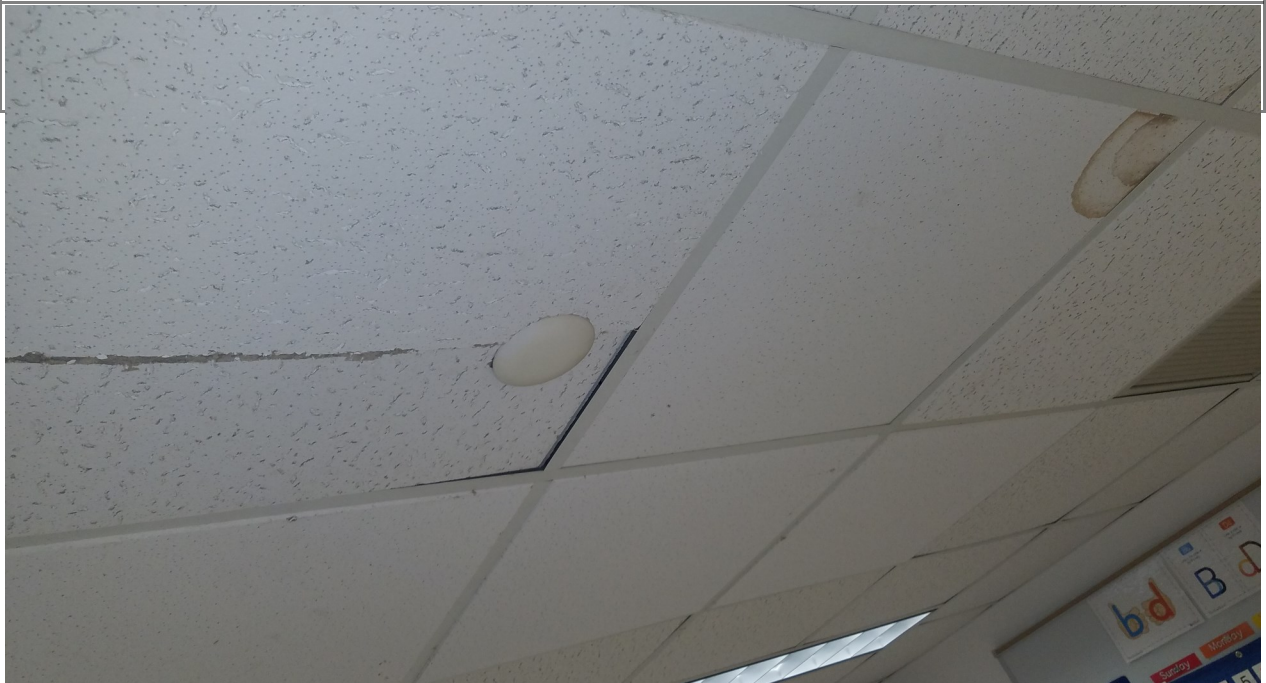
Photograph No.: 29	Date: 11/8/18	Direction Taken: —
Description: Room 43—Water Staining on Ceiling Tiles

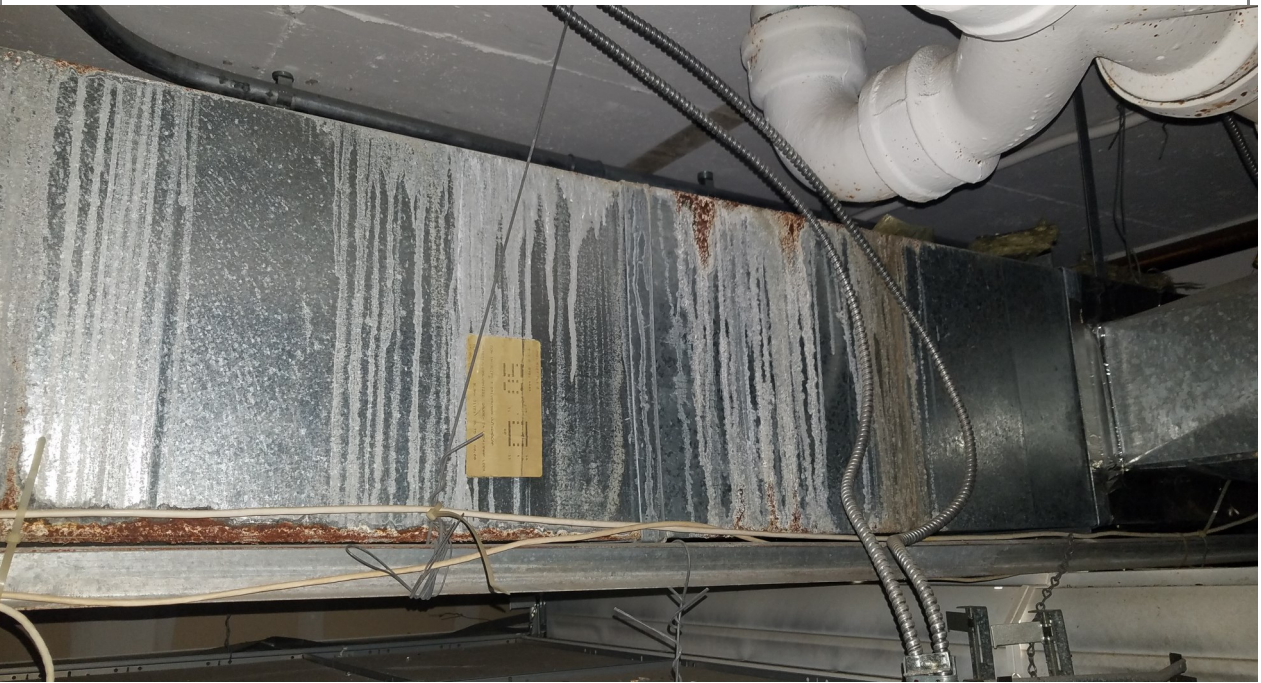
Photograph No.: 30	Date: 11/8/18	Direction Taken: —
Description: Room 43—Signs of Water Intrusion on Duct (Rust and Staining)
