# **Infrared Thermographic Roof Moisture Analysis**

**PERFORMED FOR:** Viking Construction  
1387 Seaview Ave.  
Bridgeport, CT 06607

**LOCATION:** Toquam Elementary  
Stamford, CT

**CONDUCTED ON:** May 22 & 24, 2019

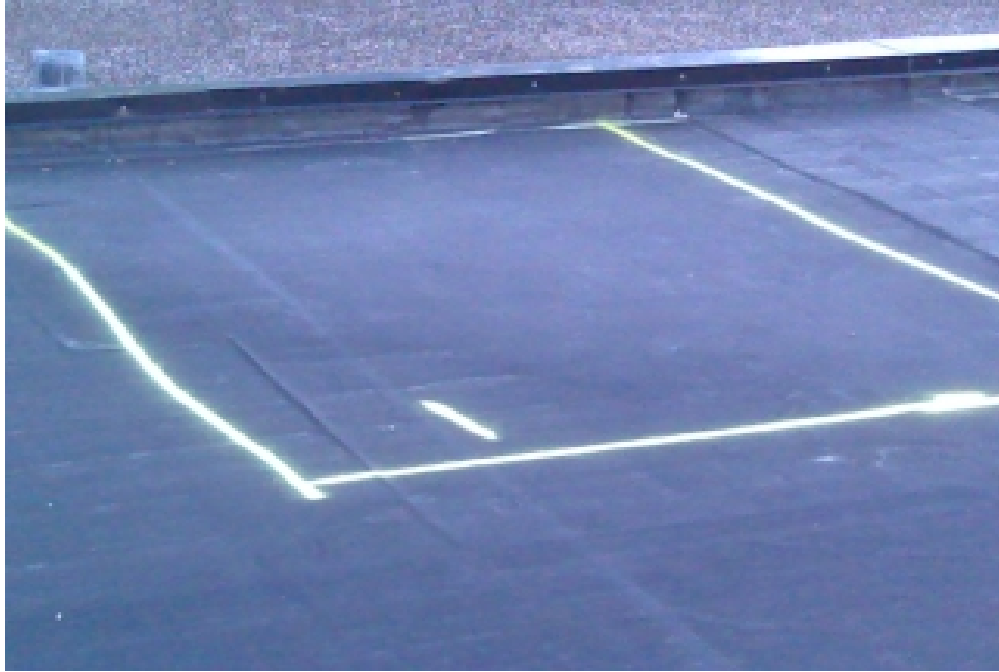
Wet Area #1

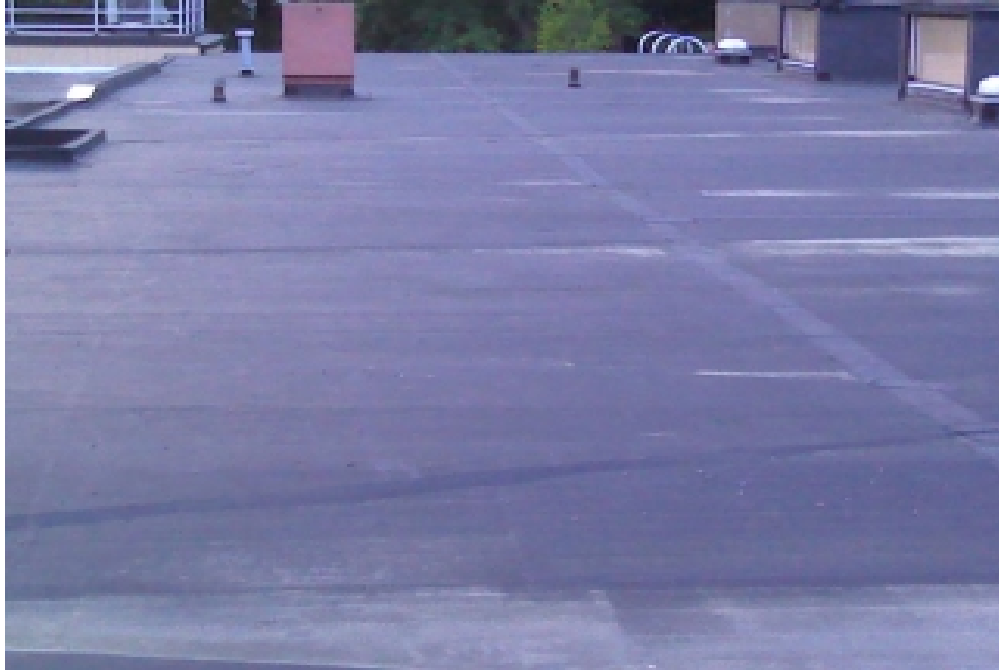
Dry area of roofing

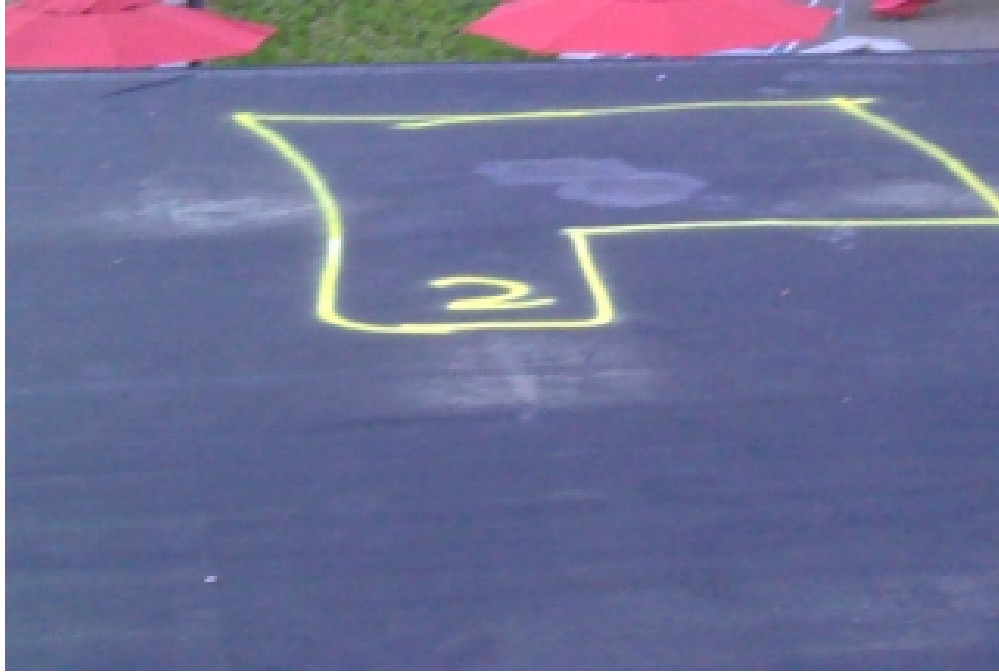
Wet Arera #2

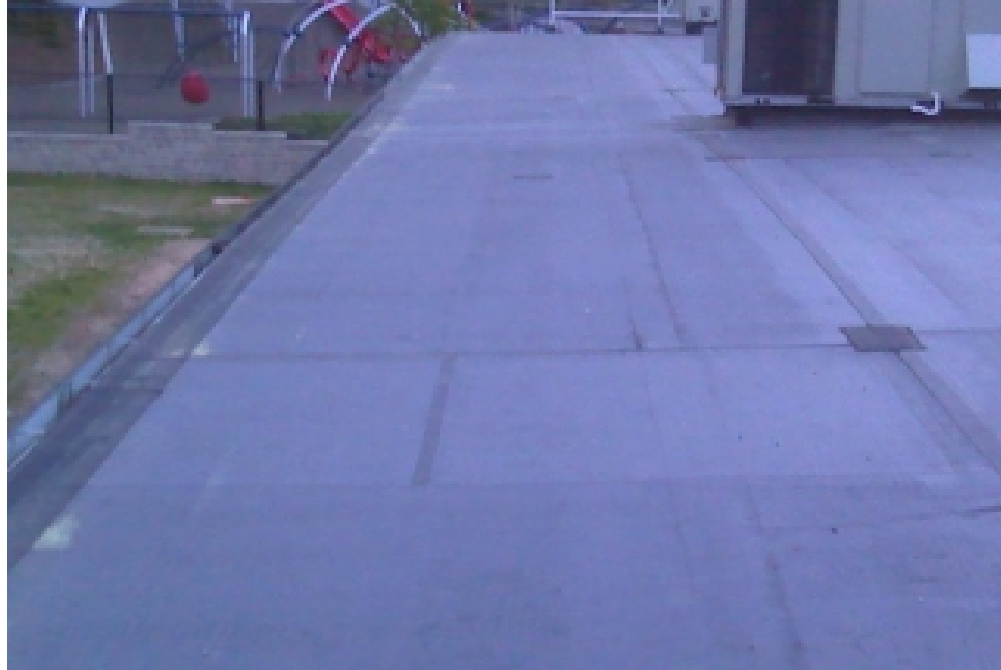
Dry area of roofing

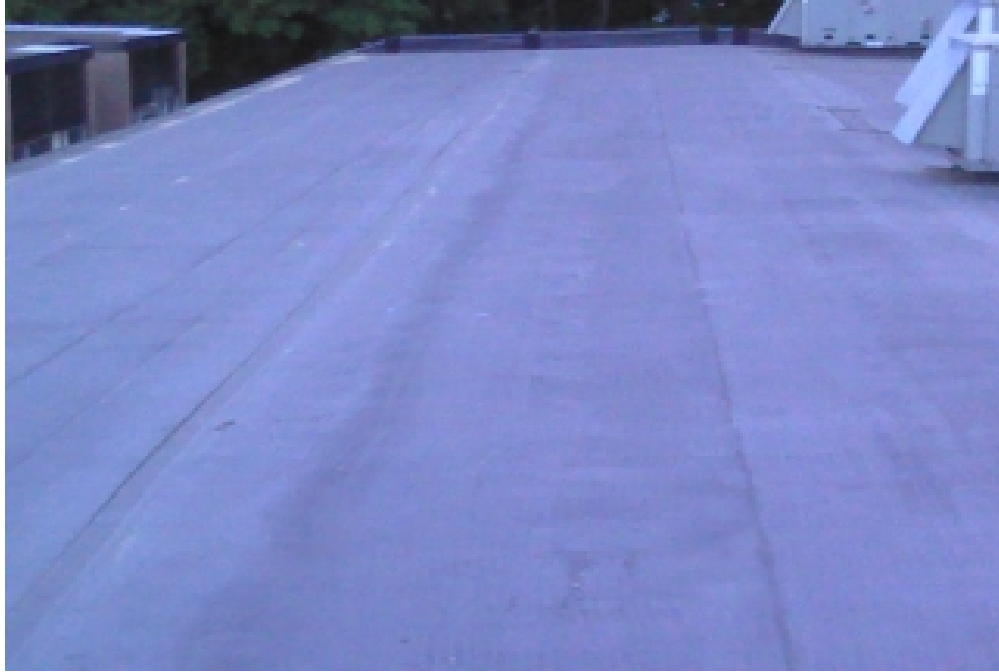
Dry area of roofing
