Roofing and Sheet Metal Contractors

RE: Roof report and repair quotation

Cloonan Middle School 11 West North Street Stamford, CT 06902

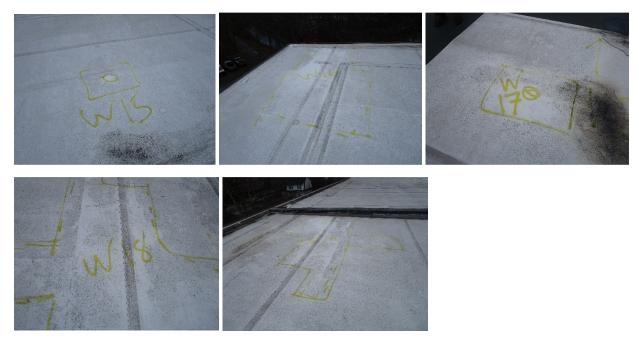
Wet areas #15, #16, #17 and #18

Holes are evident in each of these marked wet areas.

- Removing and replacing the marked wet areas. Any penetration, curb or vent withing the marked wet area would be reflashed.
- Inspect the entire roof. Clean, prime and patch any hole, puncture or cut in the roofing membrane.
- Inspect all curb flashings. Clean prime and patch any open joint or lap.
- Inspect field laps. Clean prime and patch any open area of lap.
- Inspect all penetration pockets. Dig out (if necessary), prime and top off as needed.
- Check all roof drains and clear any debris from roof.
- Replacement of broken skylight sections or individual skylights is not included but can be quoted upon request.
