# Mold Assessment — Photographic Log

**Client:** City of Stamford Mold Task Force

**Job Number:** 28-2087-033K

**Site:** Cloonan Middle School

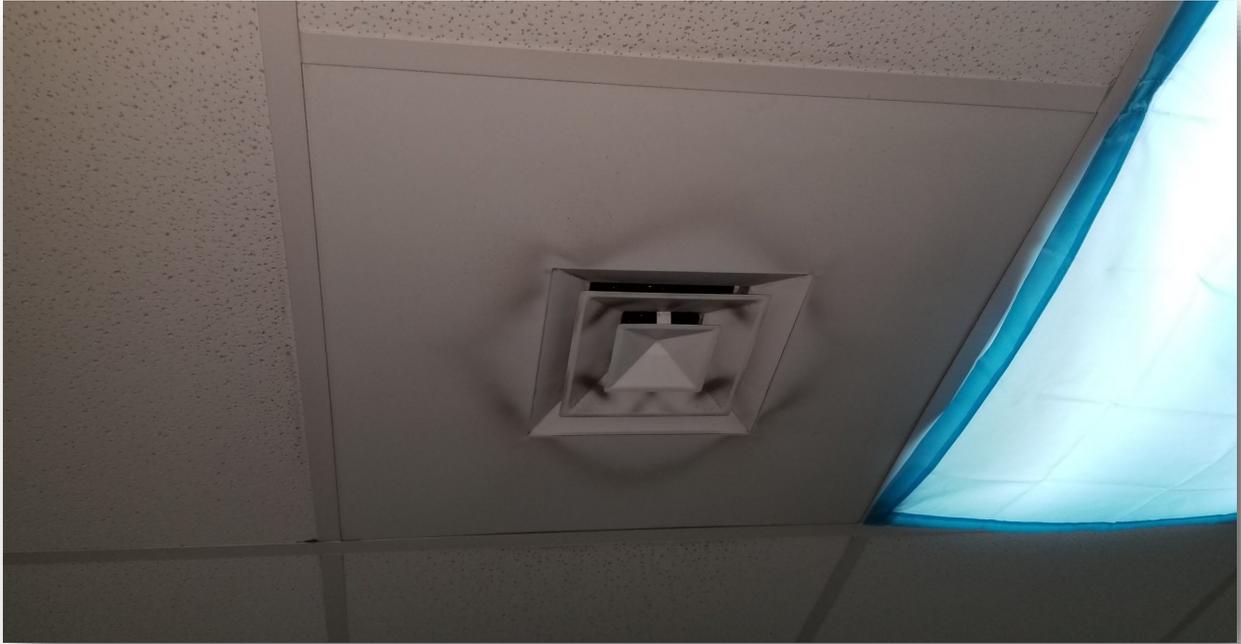
<b>Photograph No.:</b> 29	<b>Date:</b> 3-11-19	<b>Direction Taken:</b> NA
<b>Description:</b> Ground Floor—Room 111C—Heavy Dust Loading on Supply Air Diffuser

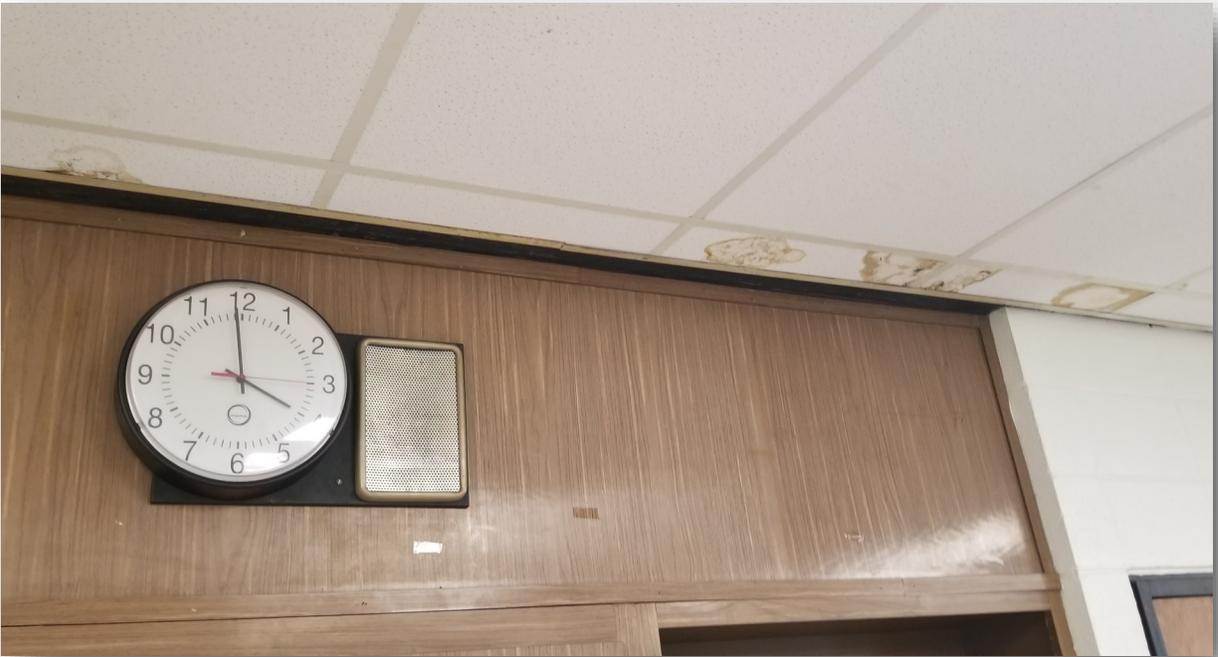
<b>Photograph No.:</b> 30	<b>Date:</b> 3-11-19	<b>Direction Taken:</b> NA
<b>Description:</b> Second Floor—Room 321—Mold and Water Staining on Ceiling Tile; Roof Leak

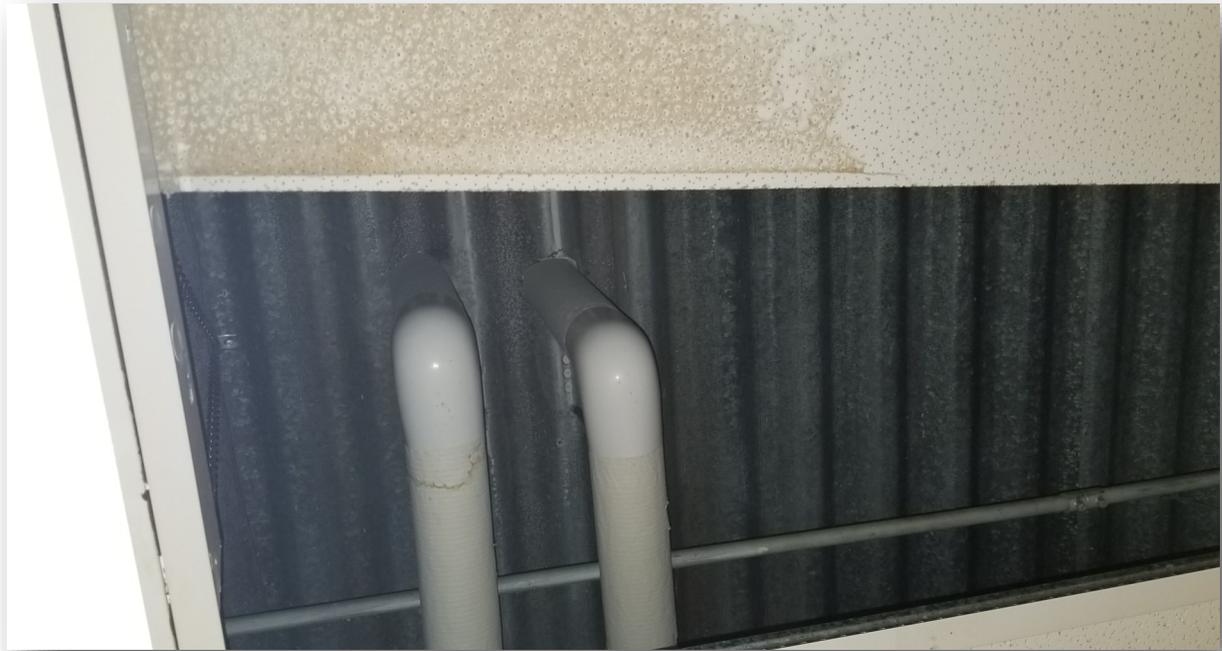
<b>Photograph No.:</b> 35	<b>Date:</b> 3-11-19	<b>Direction Taken:</b> NA
<b>Description:</b> Main Floor—Room 220—Water Stained Ceiling Tiles below Pipe Penetration of Roof Deck

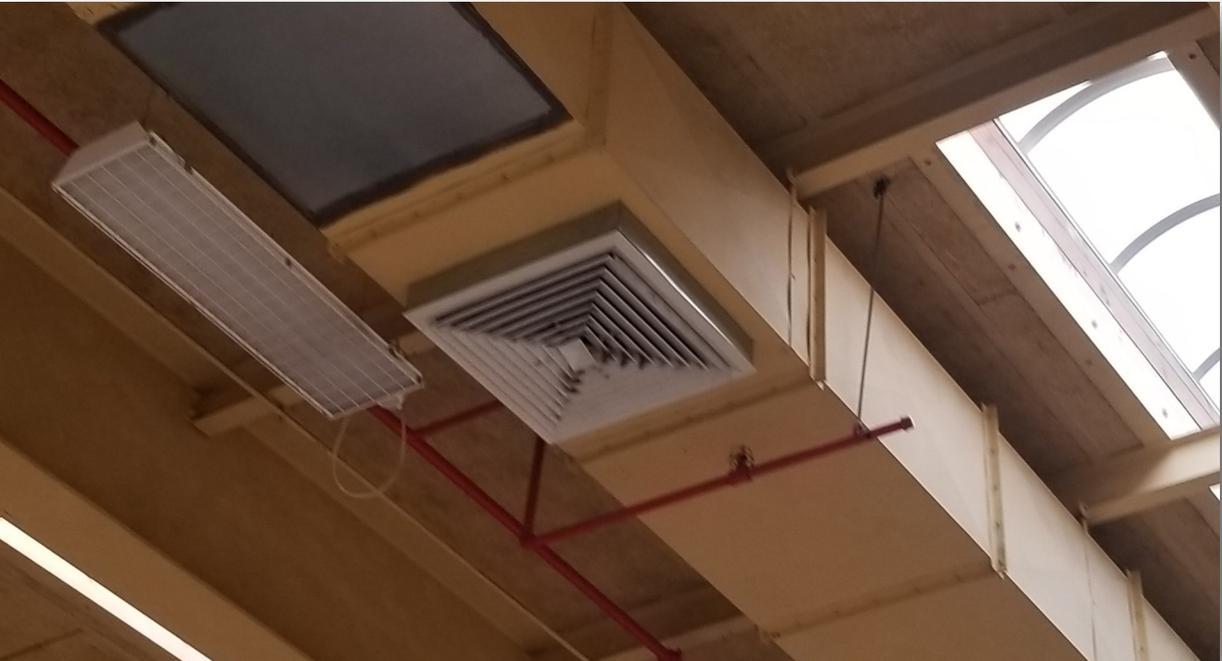
<b>Photograph No.:</b> 36	<b>Date:</b> 3-11-19	<b>Direction Taken:</b> NA
<b>Description:</b> Main Floor—Gymnasium—Moderate to Heavy Dust Loading on Supply Air Diffusers

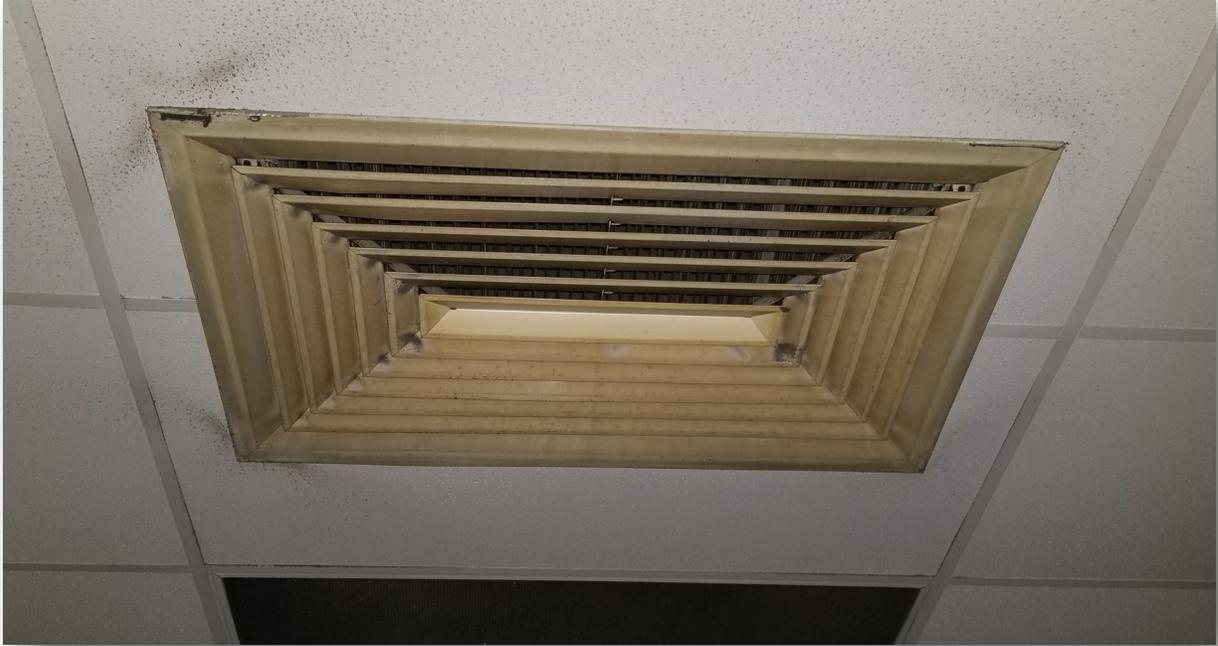
<b>Photograph No.:</b> 37	<b>Date:</b> 3-11-19	<b>Direction Taken:</b> NA
<b>Description:</b> Ground Floor—Room 106—Moderate to Heavy Dust Loading on Supply Air Diffusers

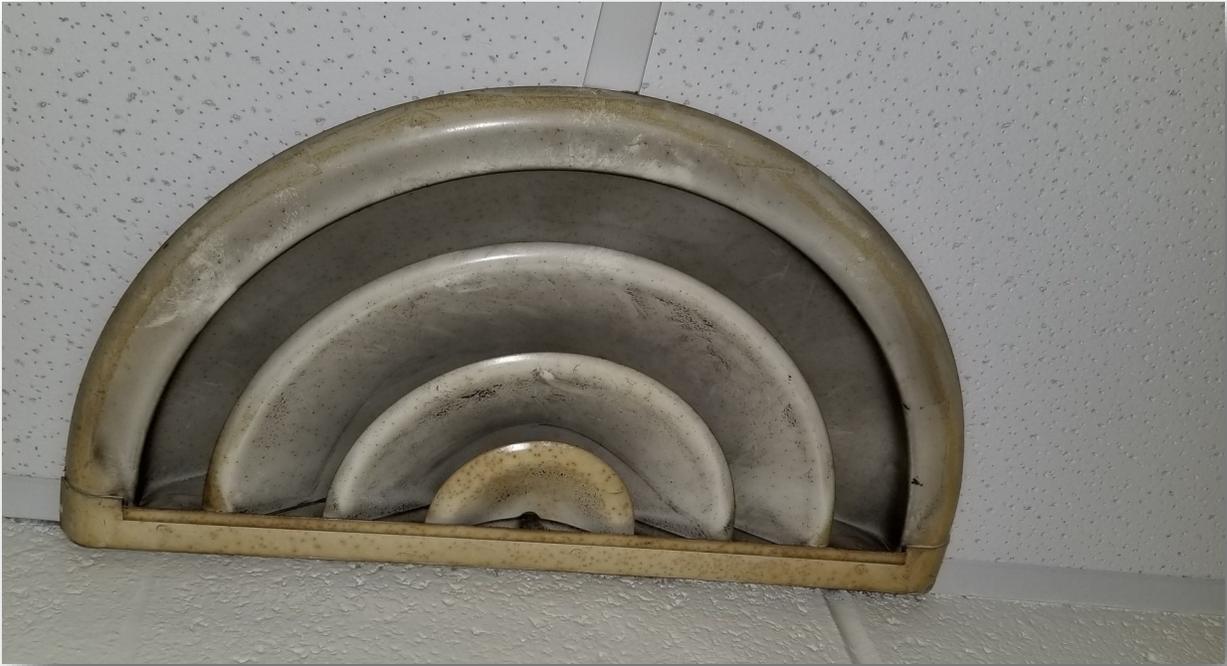
<b>Photograph No.:</b> 38	<b>Date:</b> 3-11-19	<b>Direction Taken:</b> NA
<b>Description:</b> Ground Floor—Music Office—Heavy Discoloration on Supply Air Diffusers
