Infrared Thermographic Roof Moisture Analysis

PERFORMED FOR: Viking Construction
1387 Seaview Ave.
Bridgeport, CT 06607

LOCATION: Turn of River Middle School
Stamford, CT

CONDUCTED ON: May 22 & 24, 2019

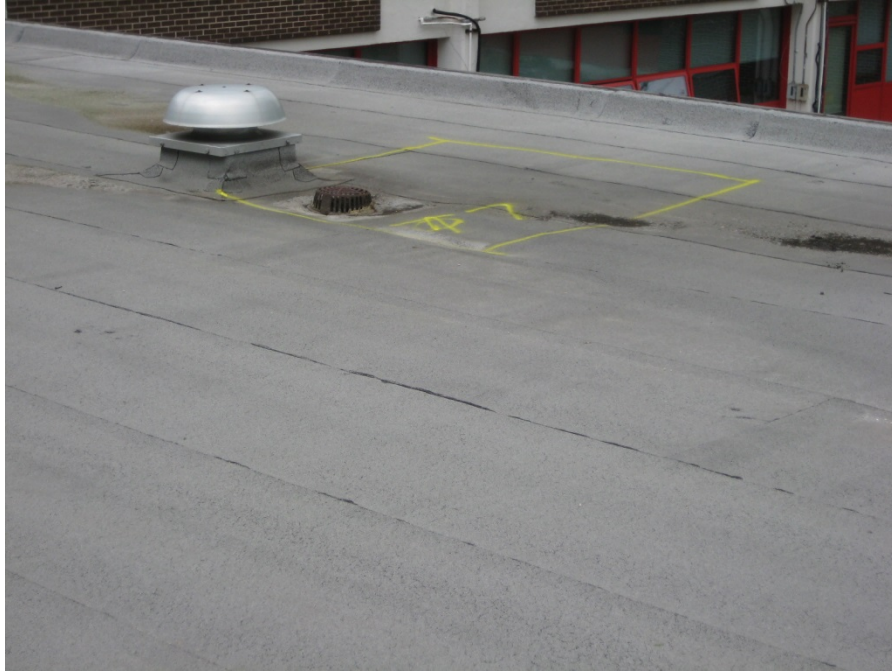
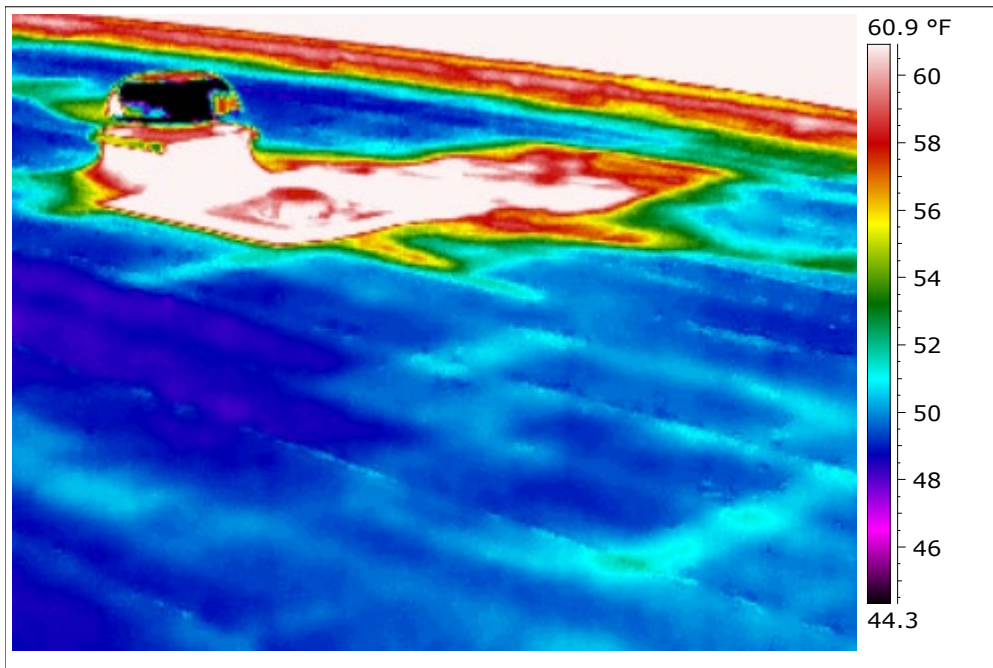
Thermogram # 1

Wet Area #7

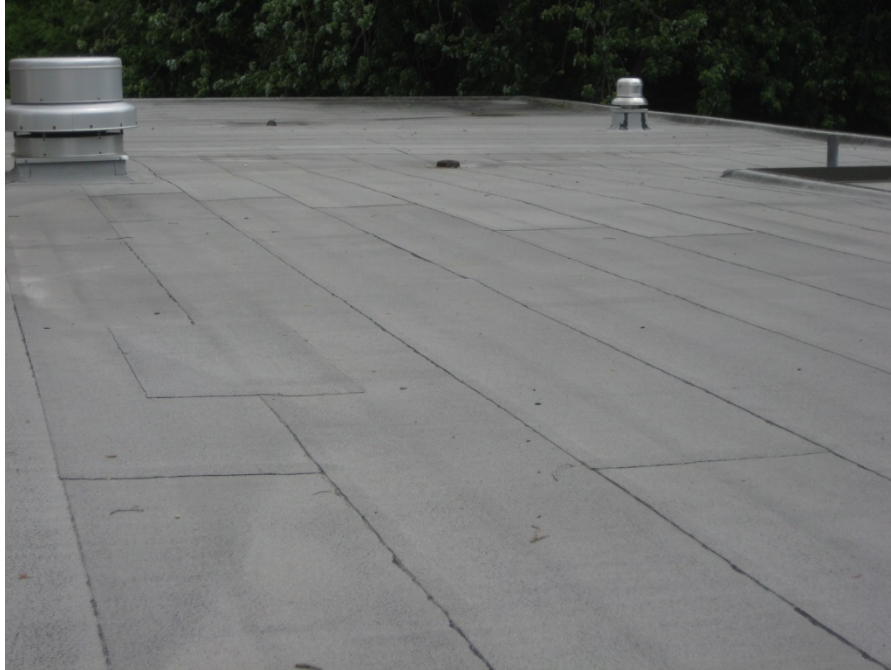
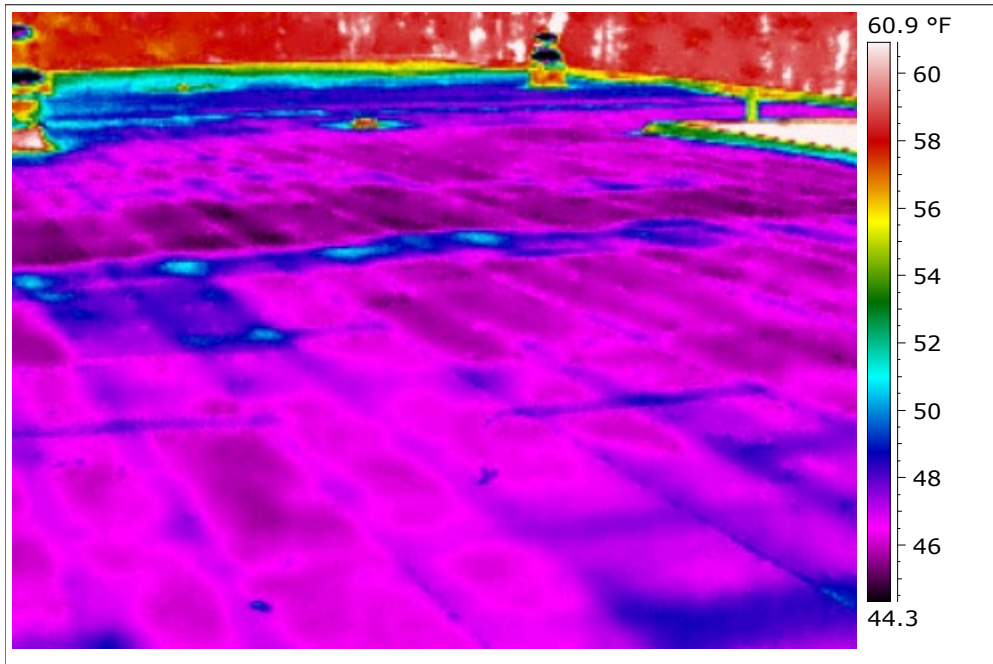
Thermogram # 2

Dry area of roofing

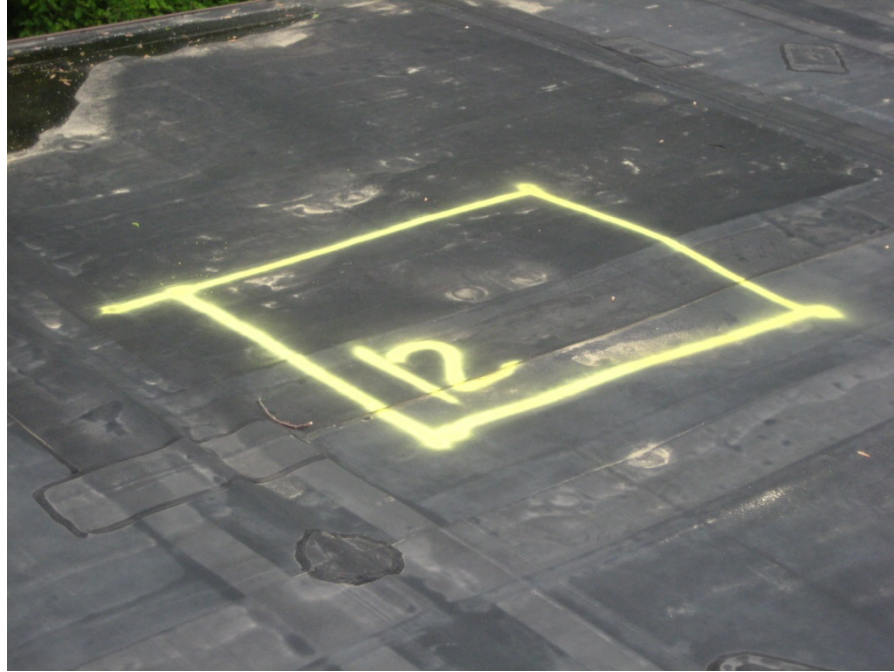
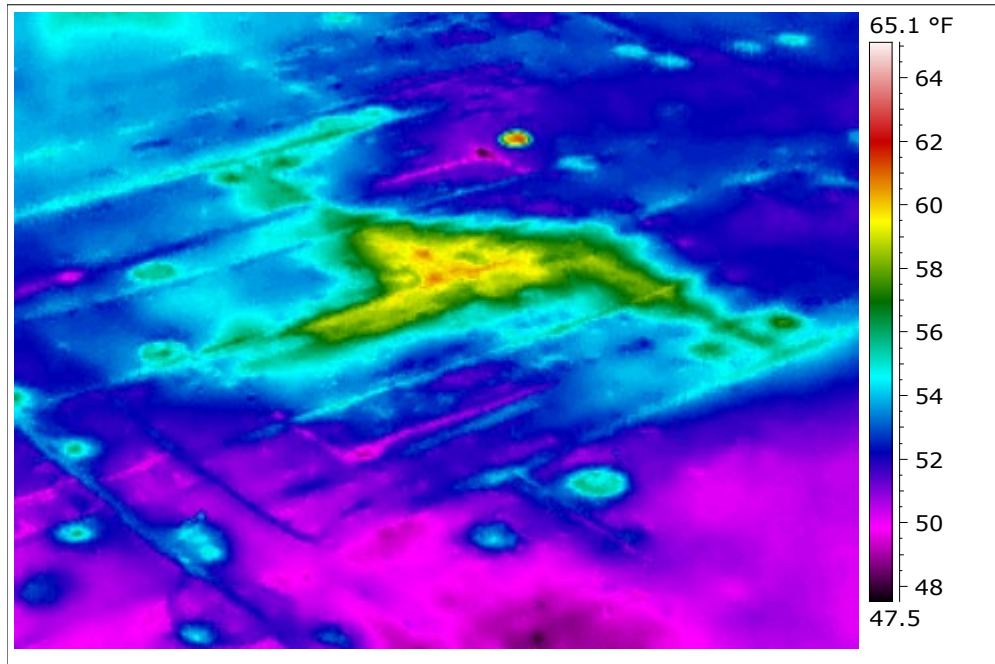
Thermogram # 3

Wet Area #12

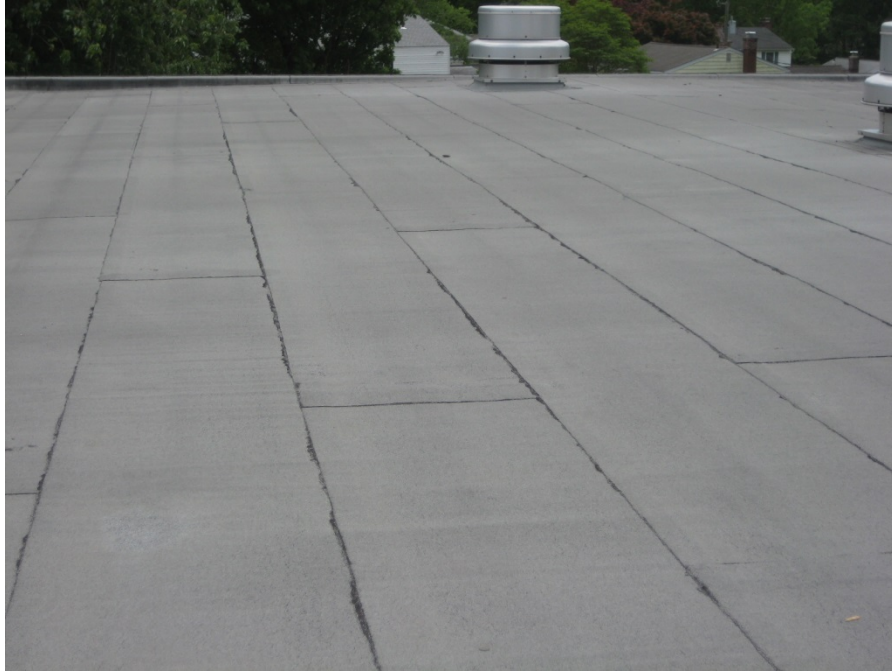
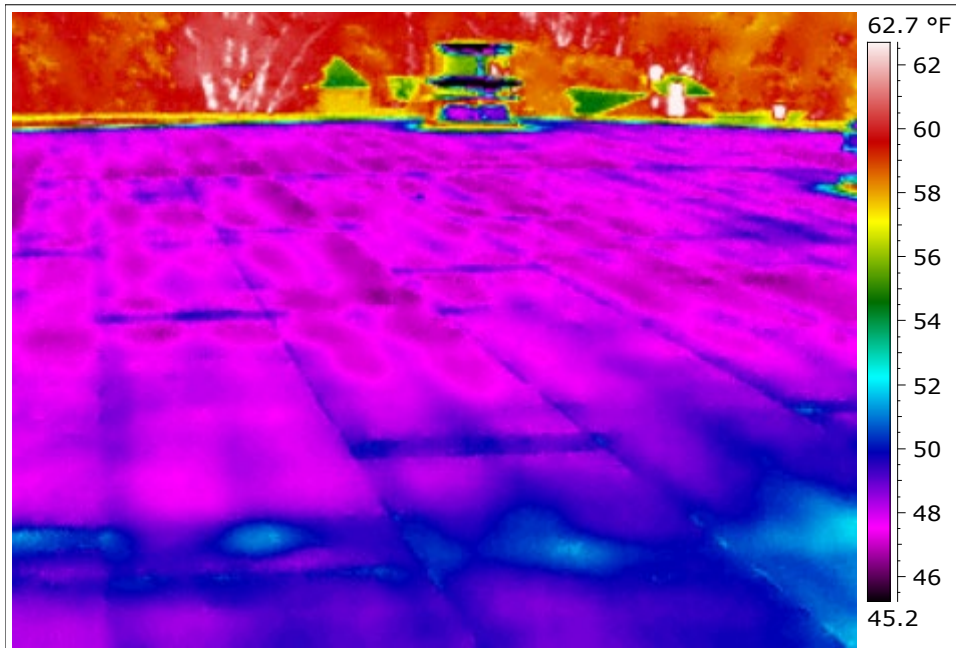
Thermogram # 4

Dry area of roofing

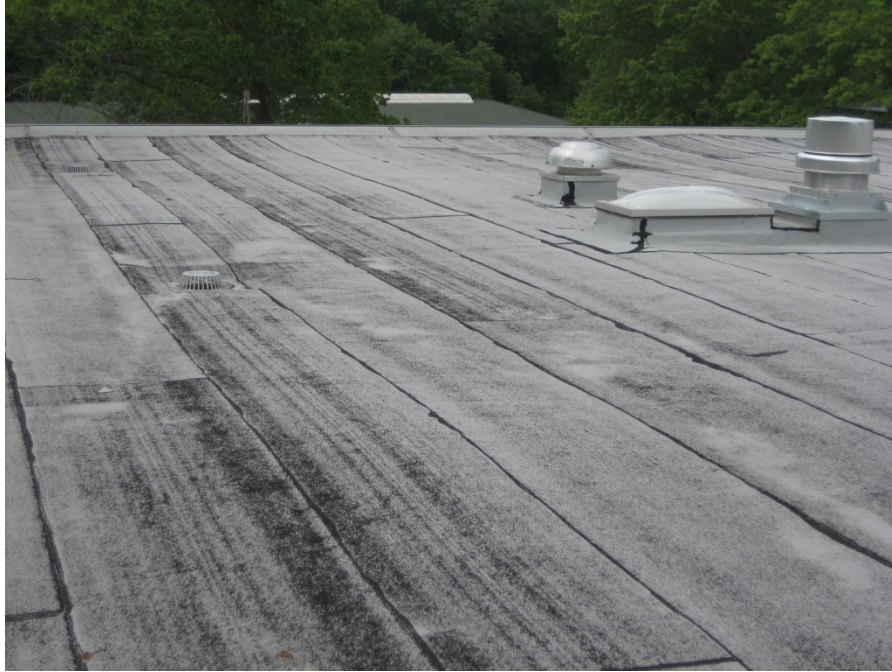
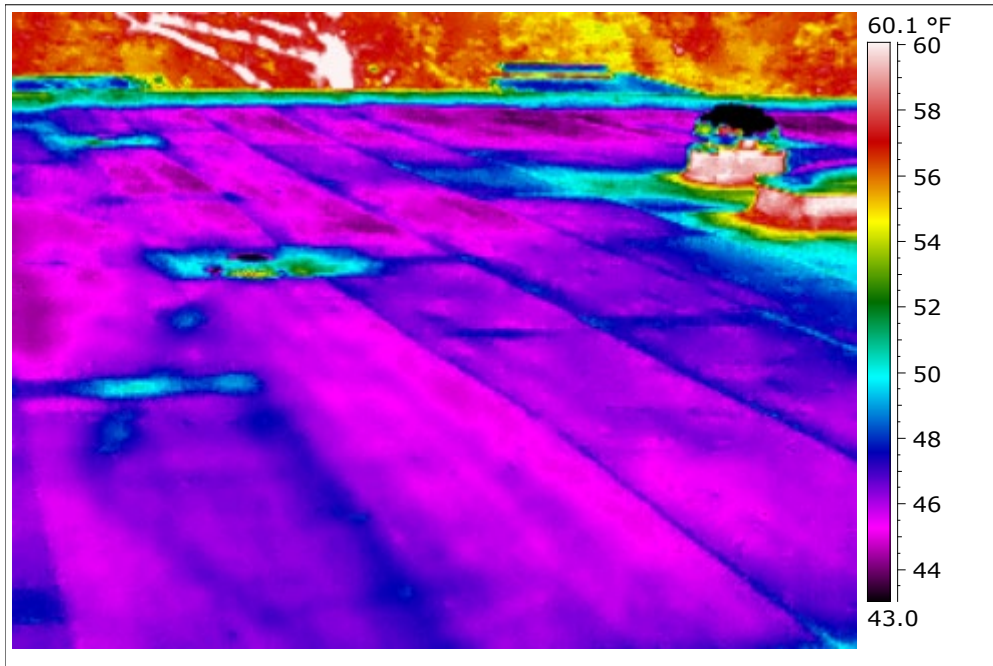
Thermogram # 5

Dry area of roofing

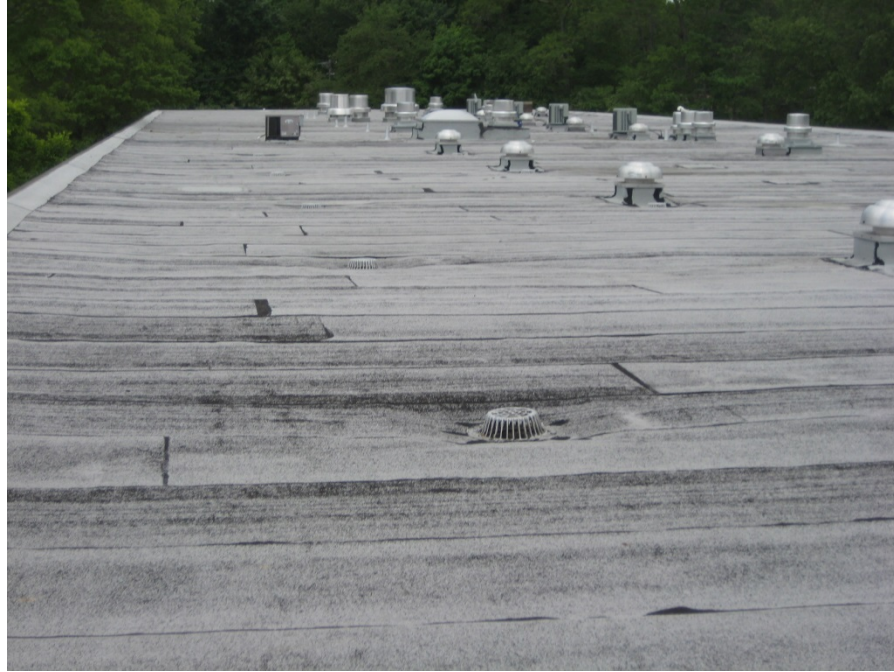
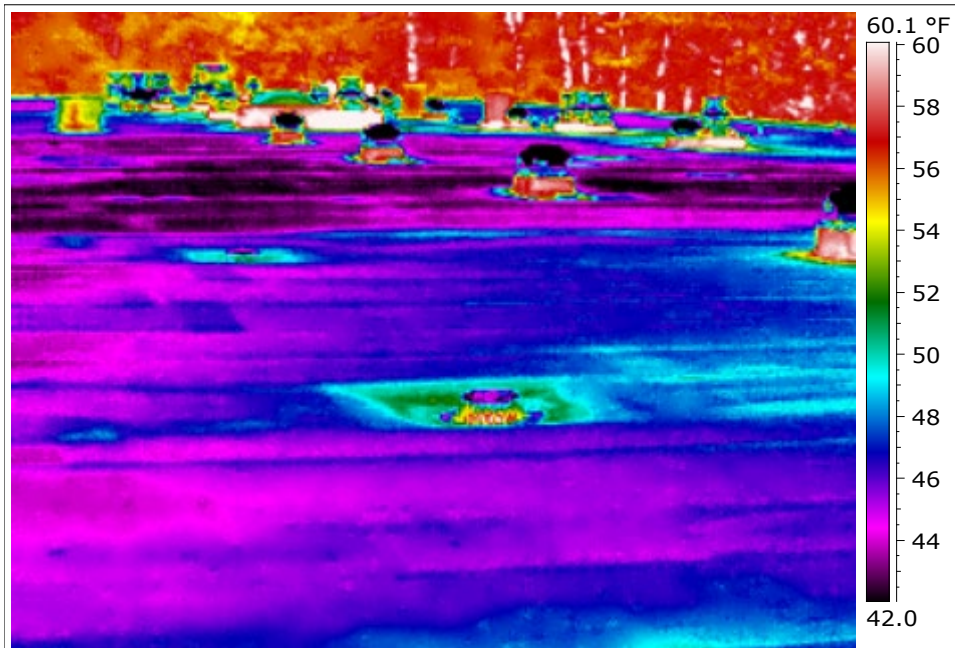
Thermogram # 6

Dry area of roofing

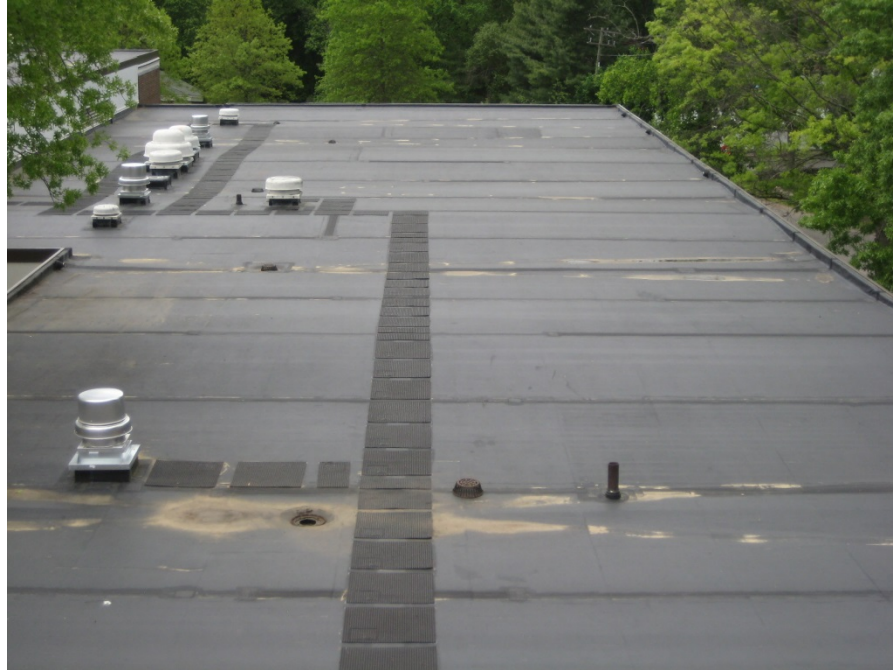
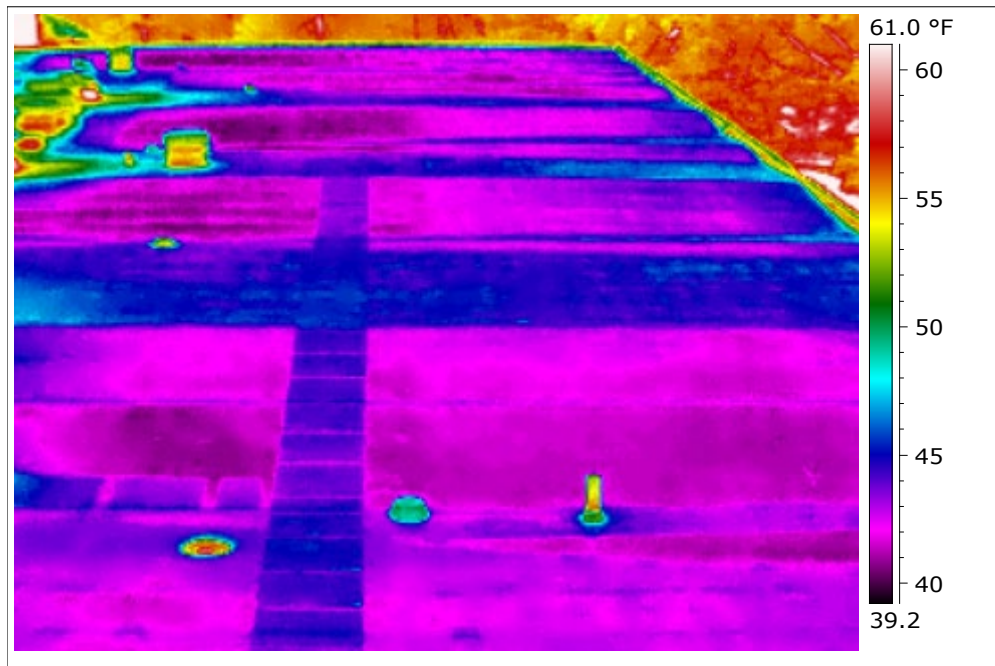
Thermogram # 7

Dry area of roofing

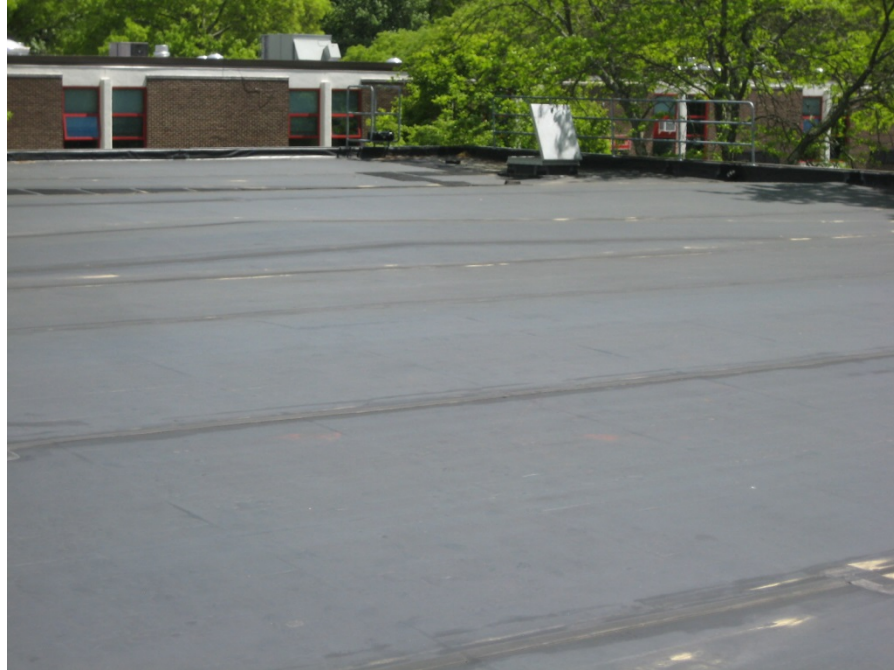
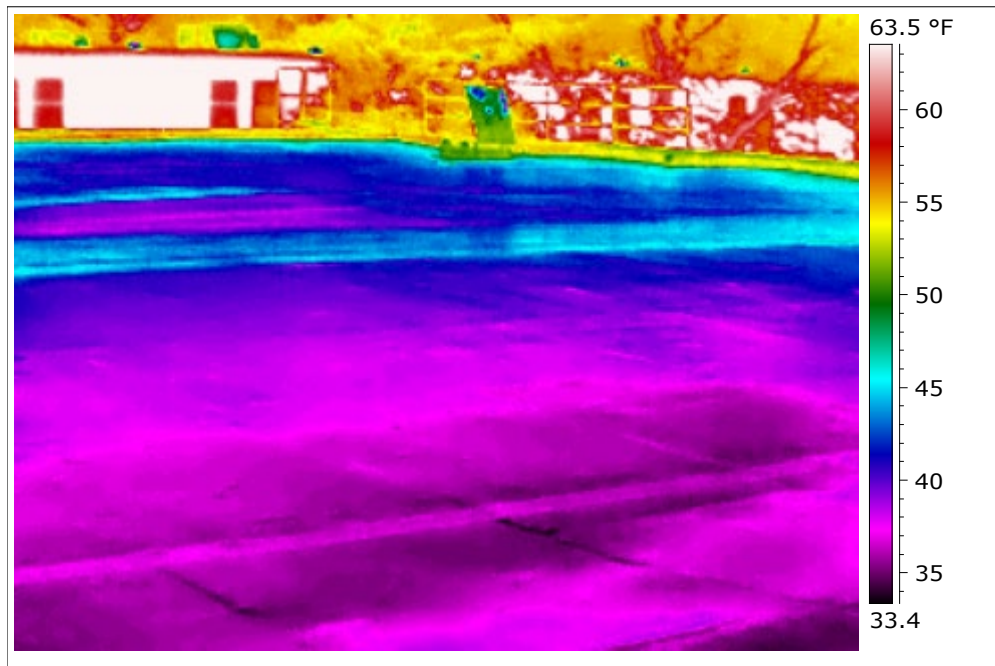
Thermogram # 8

Dry area of roofing

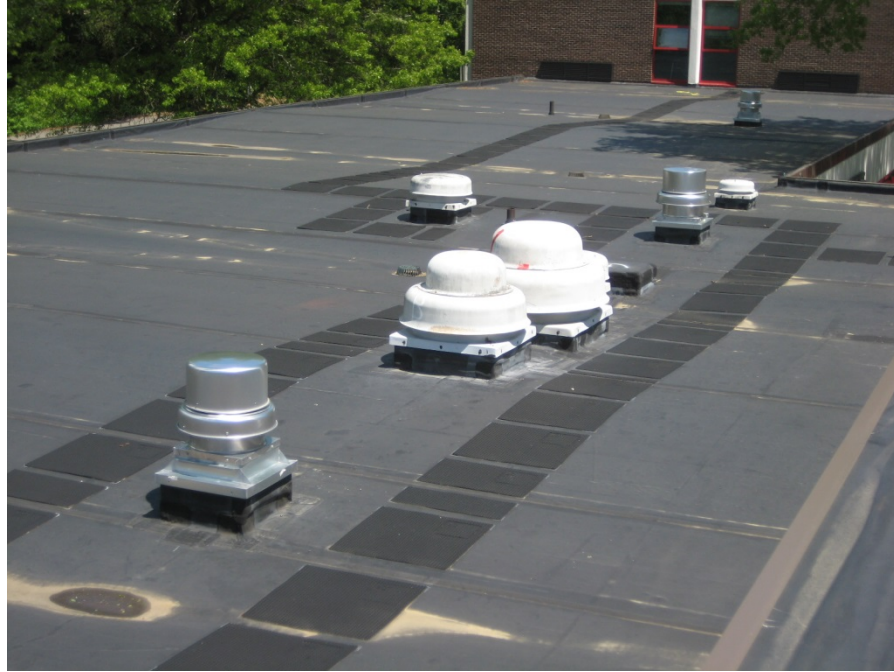
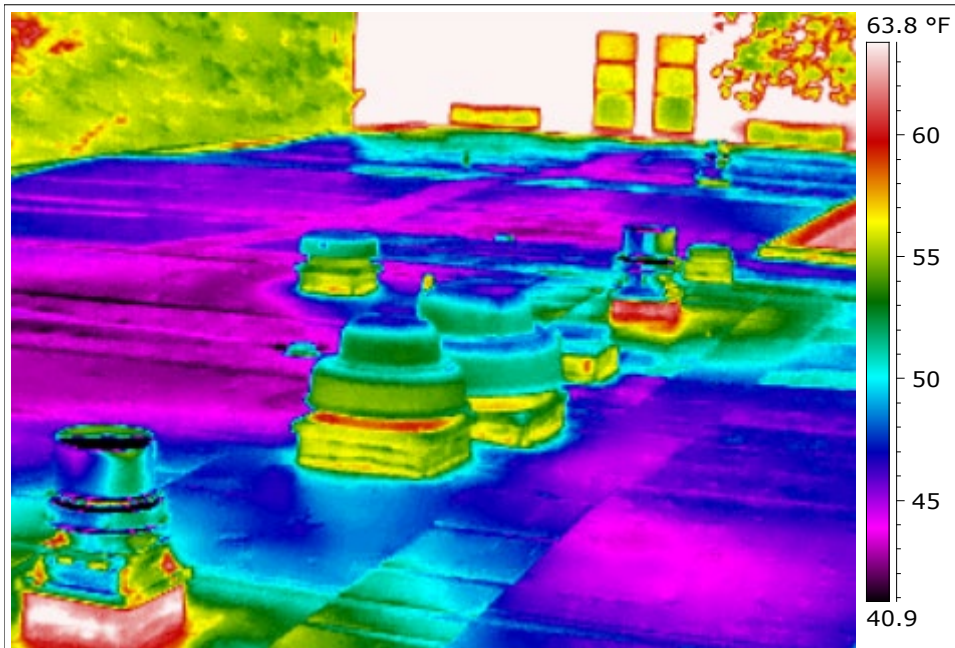
Thermogram # 9

Dry area of roofing

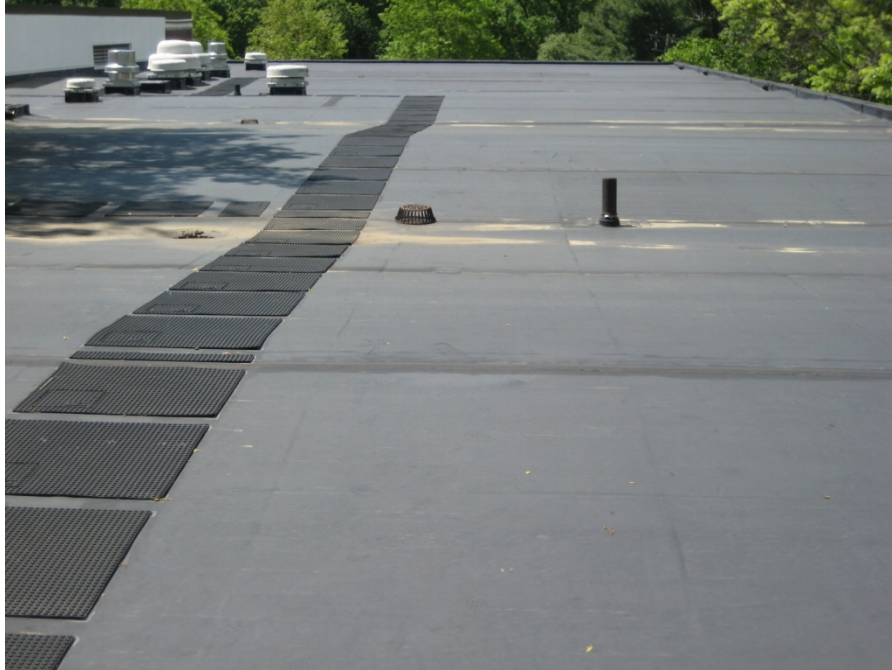
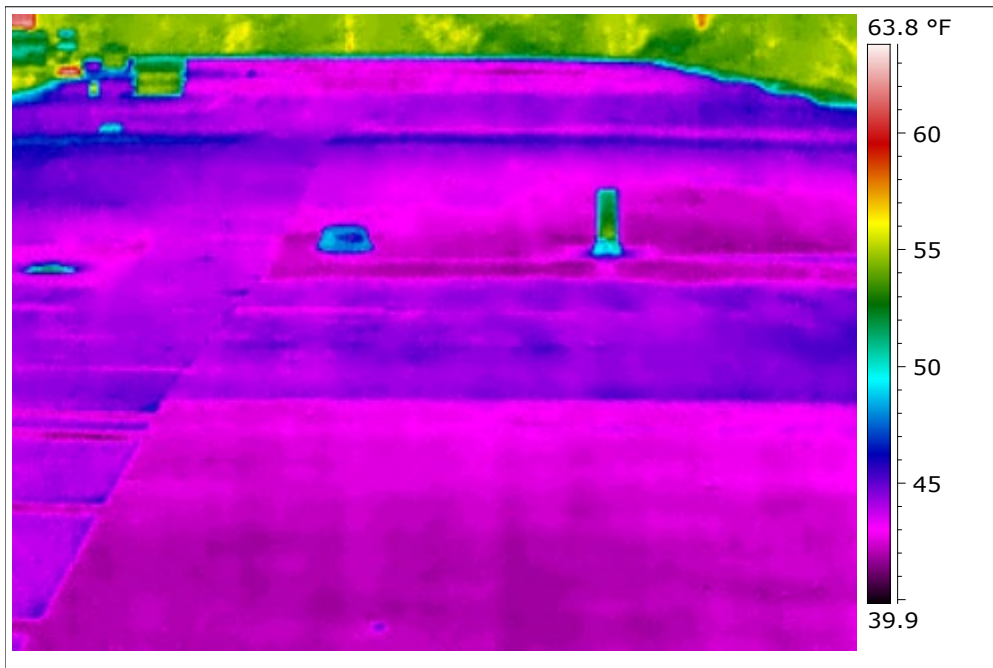
Thermogram # 10

Dry area of roofing
