# **Infrared Thermographic Roof Moisture Analysis**

**PERFORMED FOR:** Viking Construction  
1387 Seaview Ave.  
Bridgeport, CT 06607

**LOCATION:** Academy of Info. Technology & Engineering  
411 High St.  
Stamford, CT

**CONDUCTED ON:** May 15 & 17, 2019

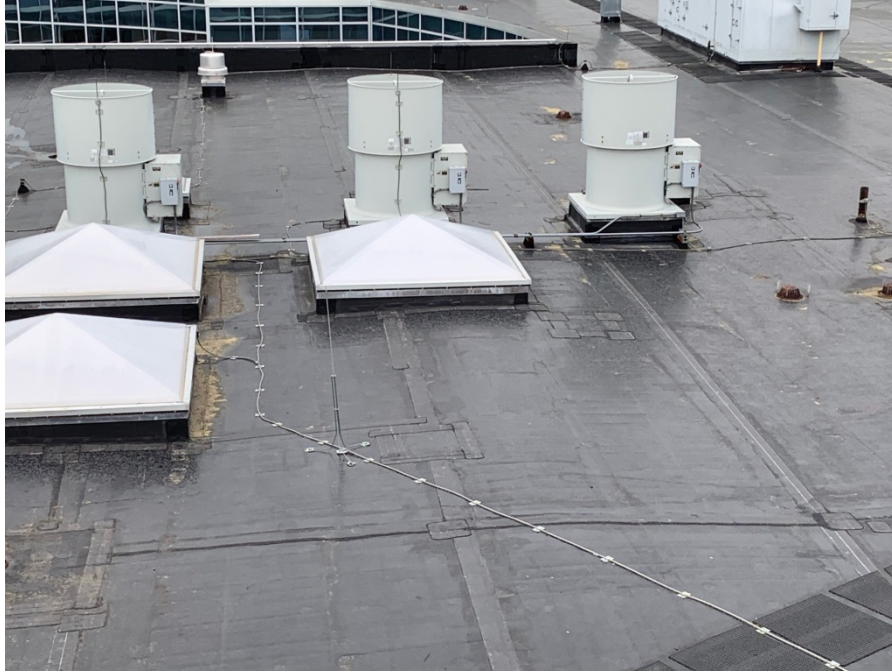
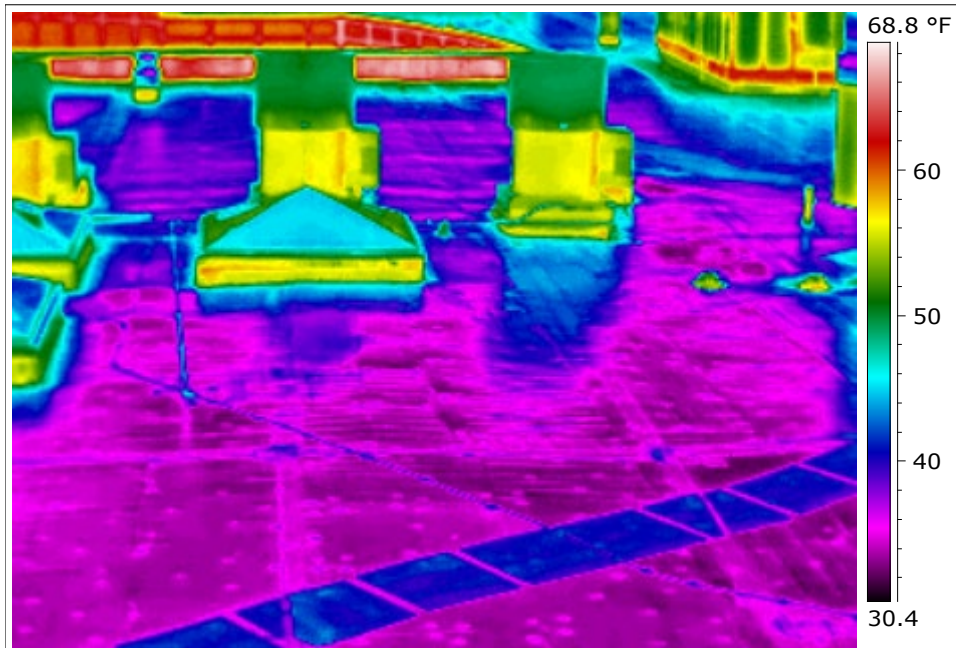
Thermogram # 1

Dry area of roofing

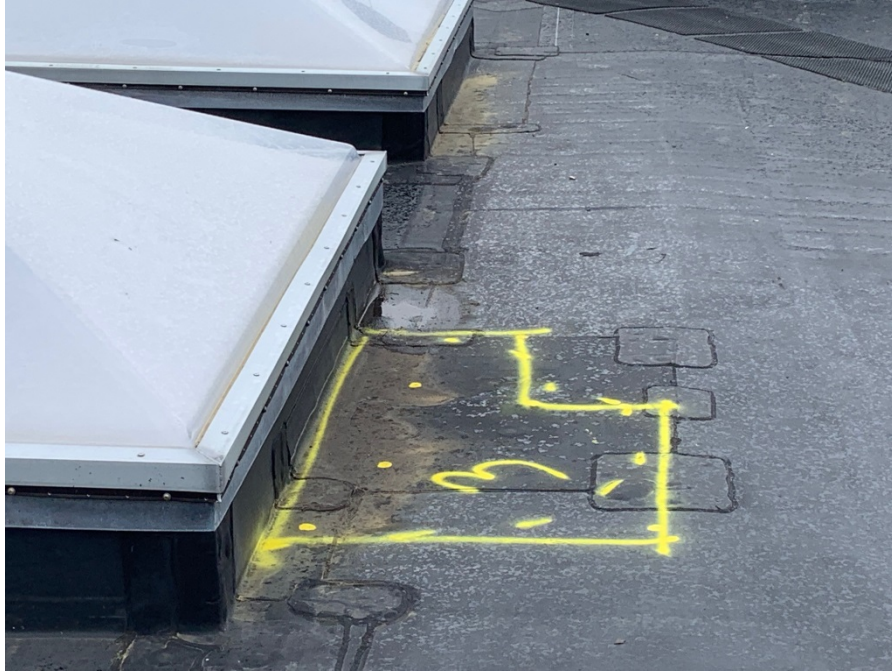
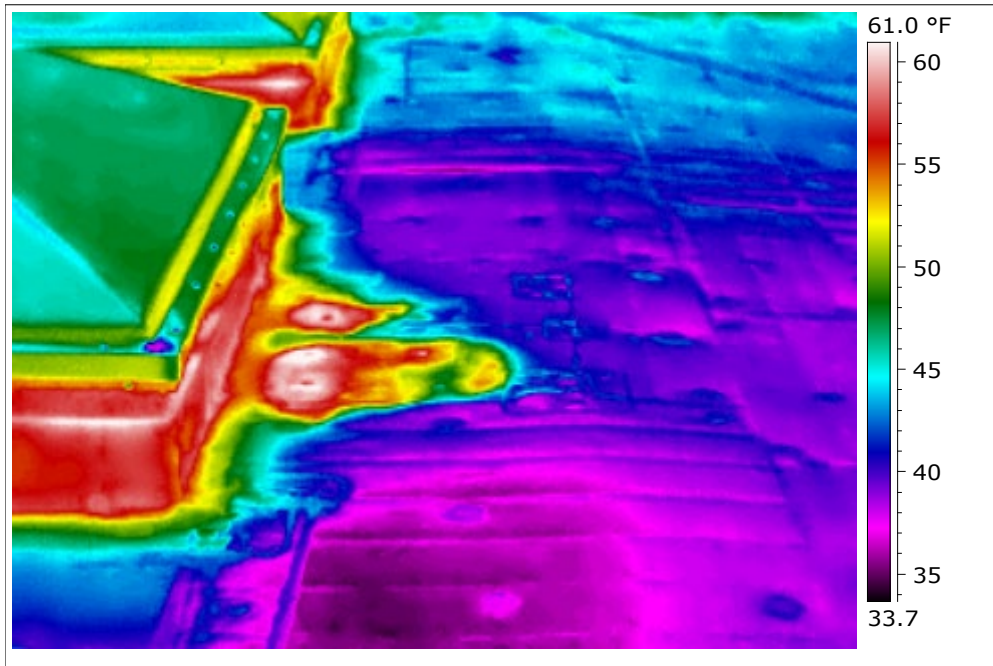
Thermogram # 2

Wet Area #3

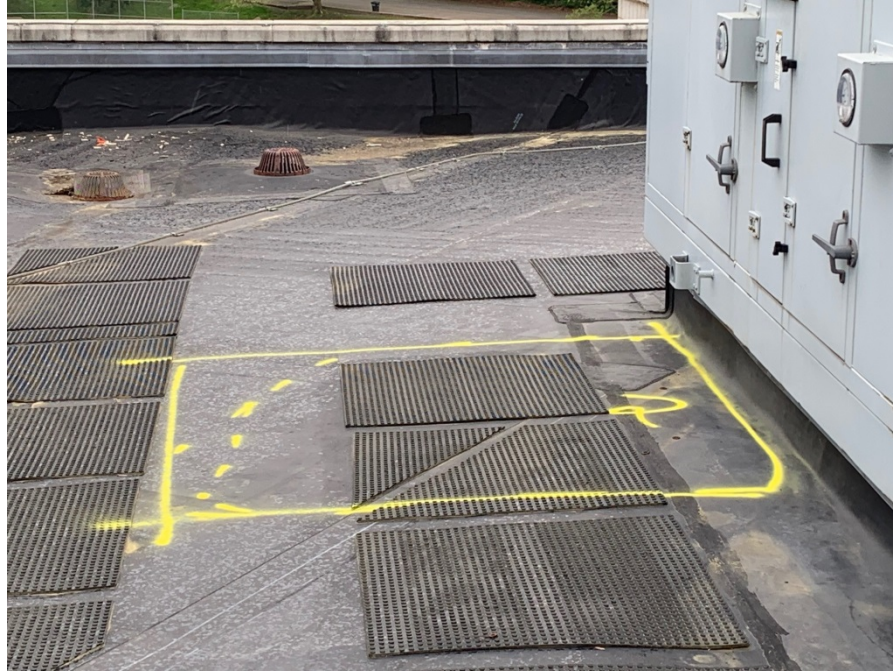
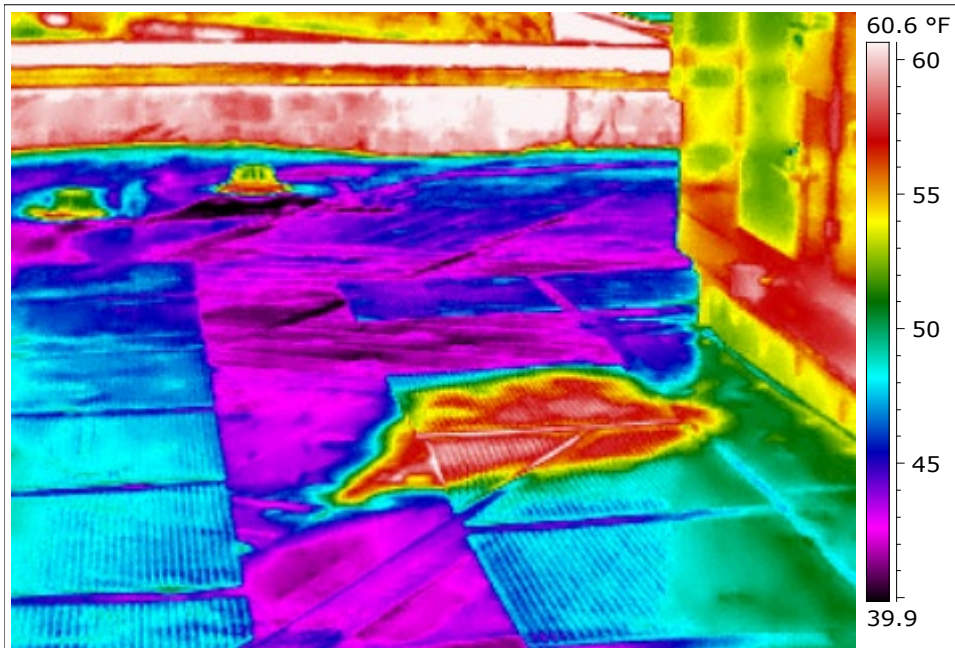
Thermogram # 3

Wet Area #2

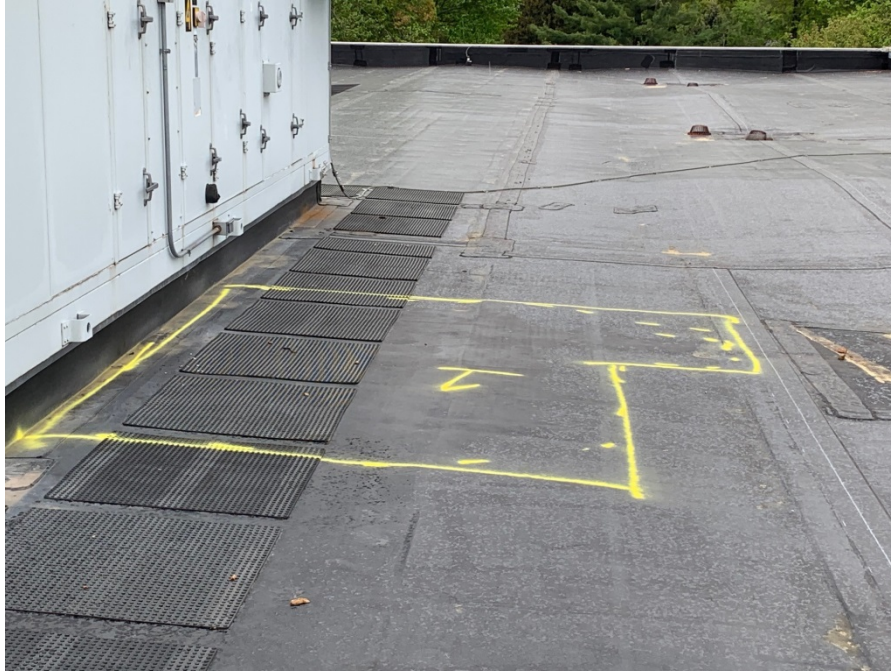
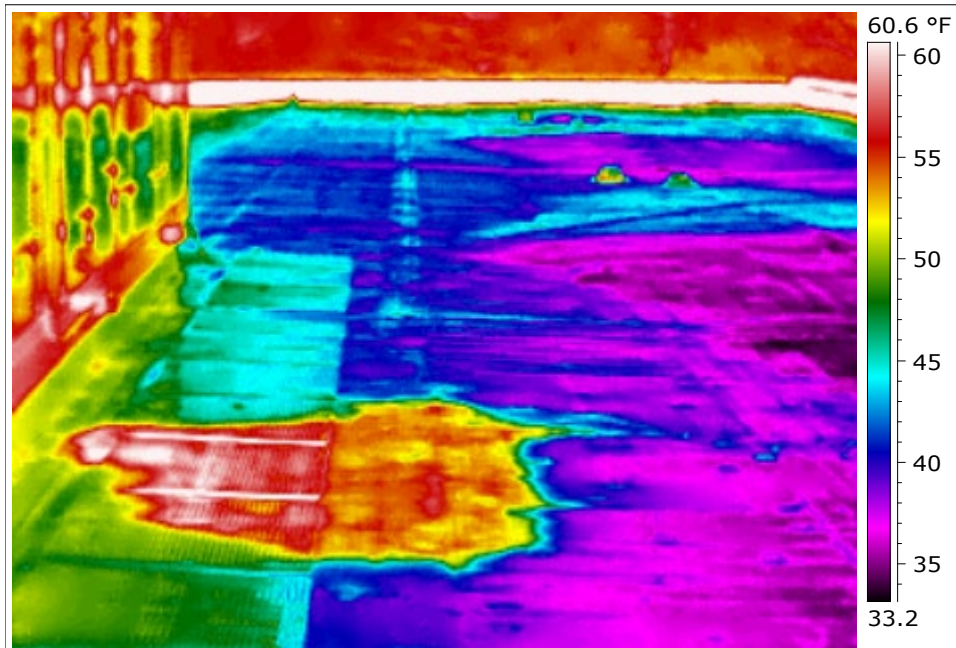
Thermogram # 4

Wet Area #1

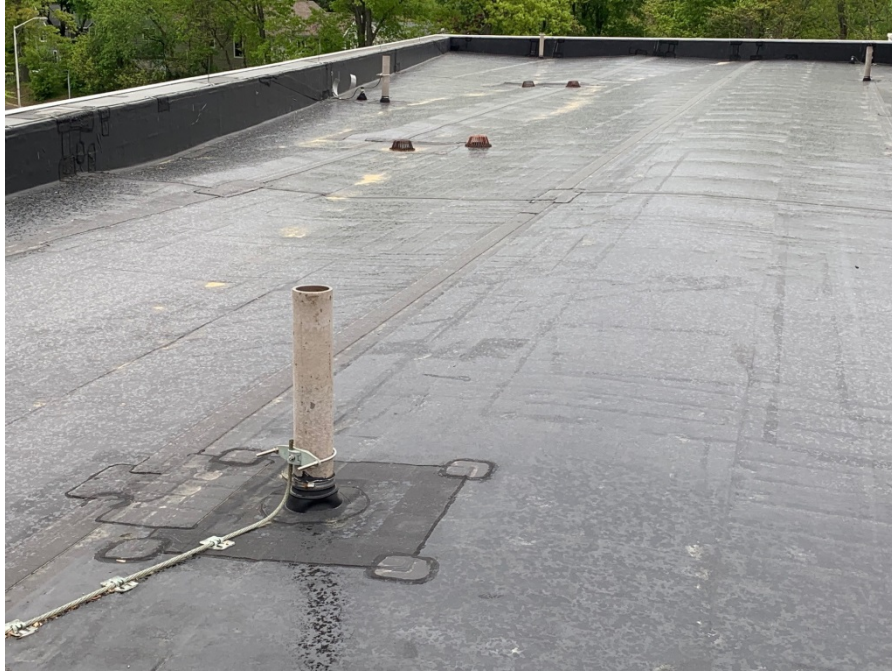
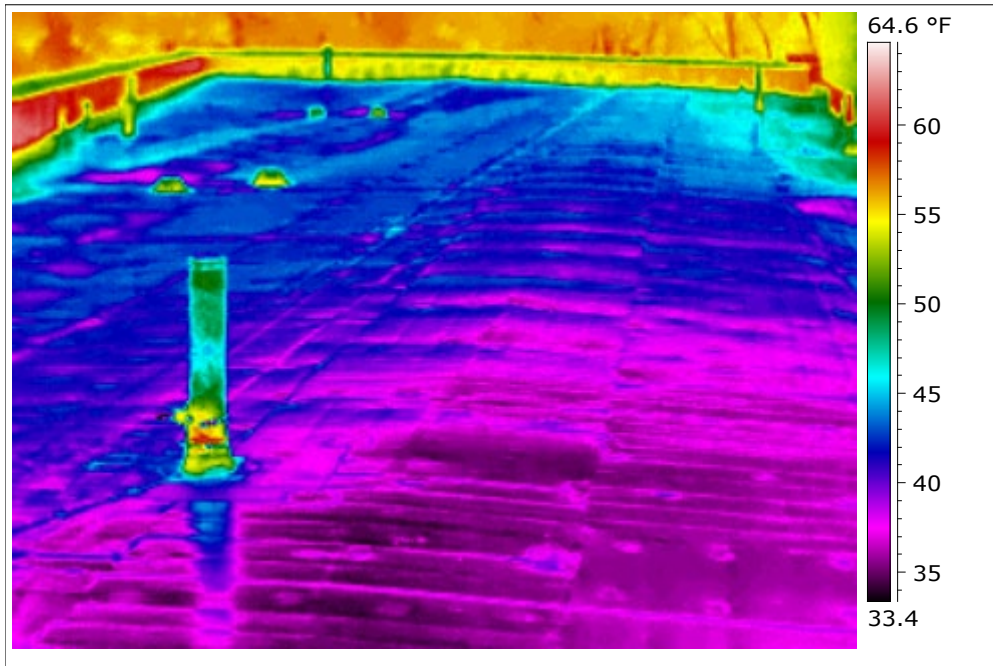
Thermogram # 5

Dry area of roofing

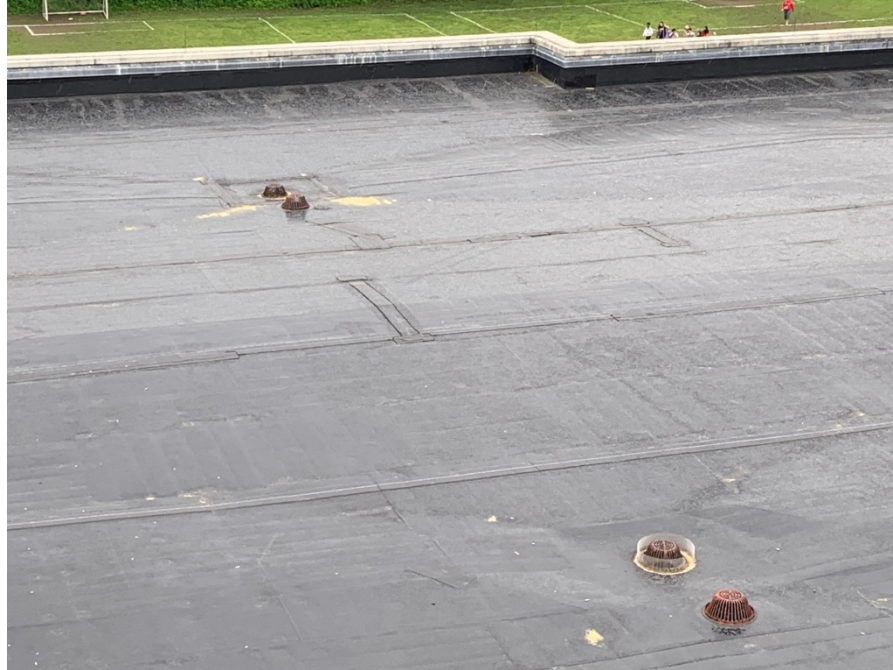
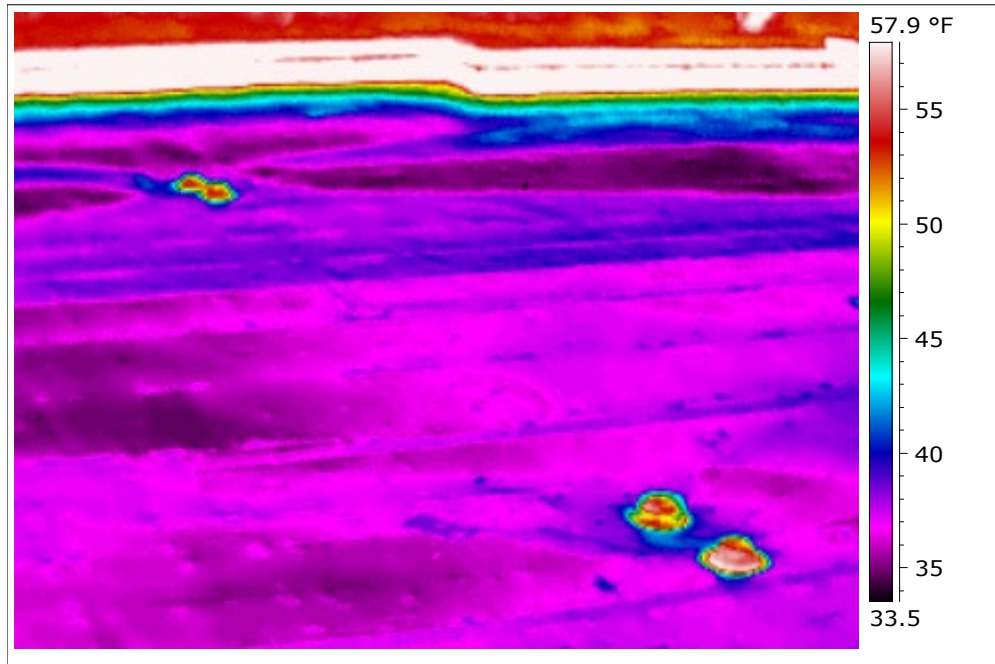
Thermogram # 6

Dry area of roofing
