# **Infrared Thermographic Roof Moisture Analysis**

**LOCATION:** Westhill High School -  
Outbuildings  
Stamford, CT

**CONDUCTED ON:** July 30, 2019

**PERFORMED BY:** Joshua Wilson, Certified Thermographer

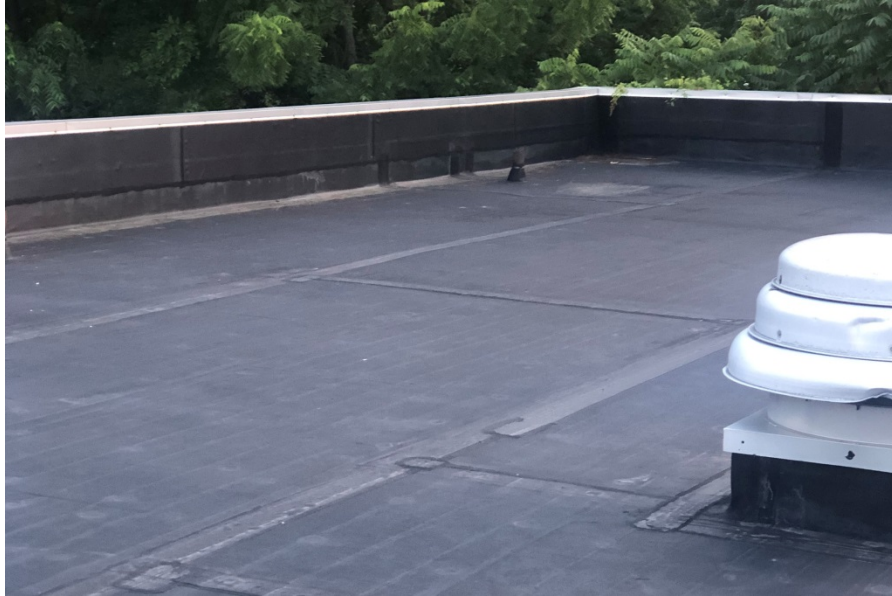
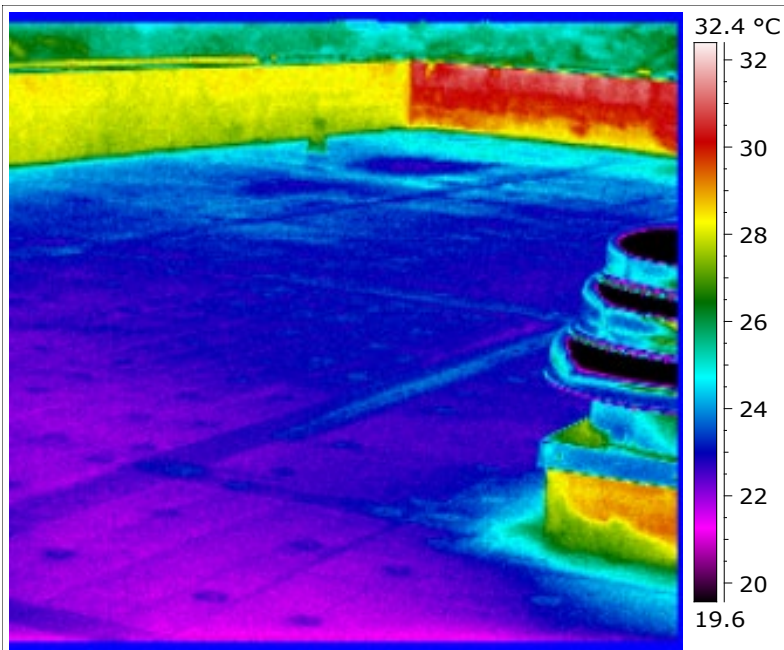
Thermogram # 1

Dry Area of Roofing –Building 1

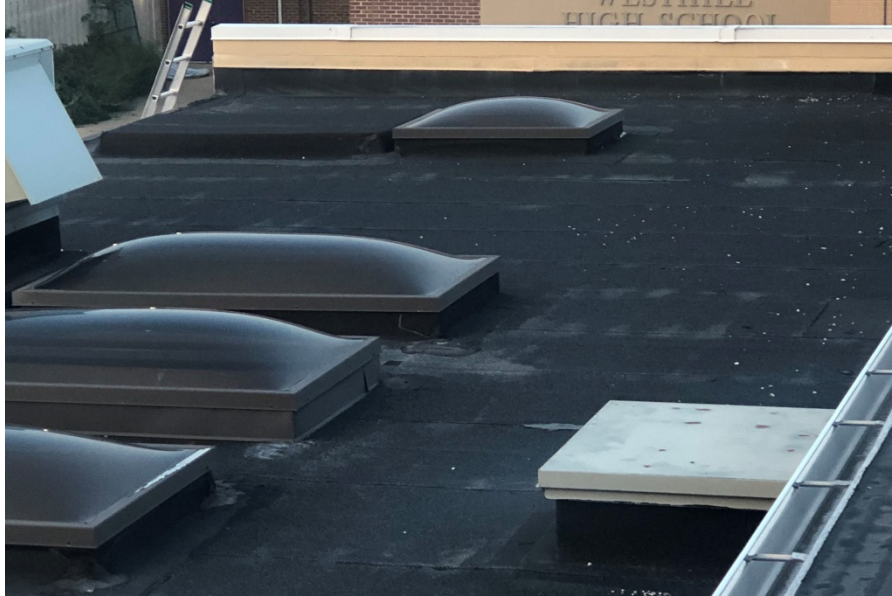
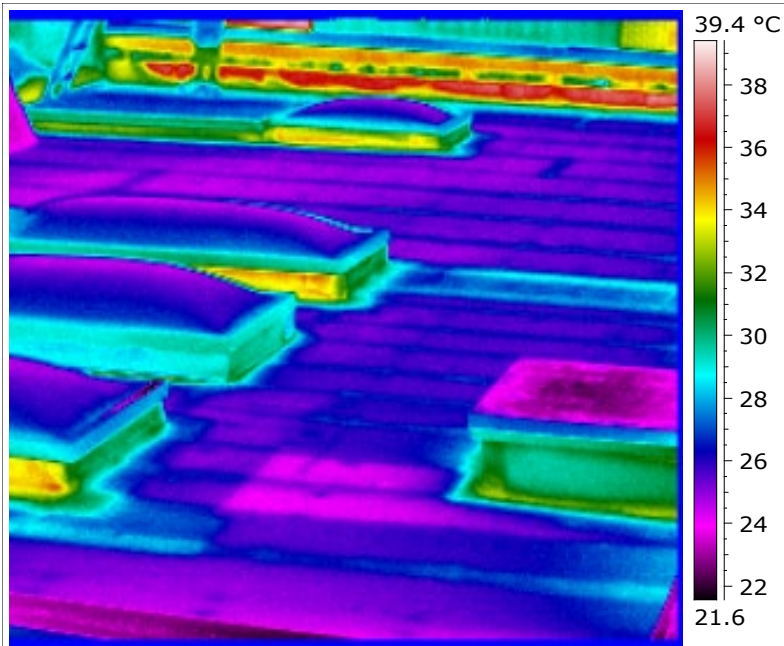
Thermogram # 2

Dry Area of Roofing – Buliding 1

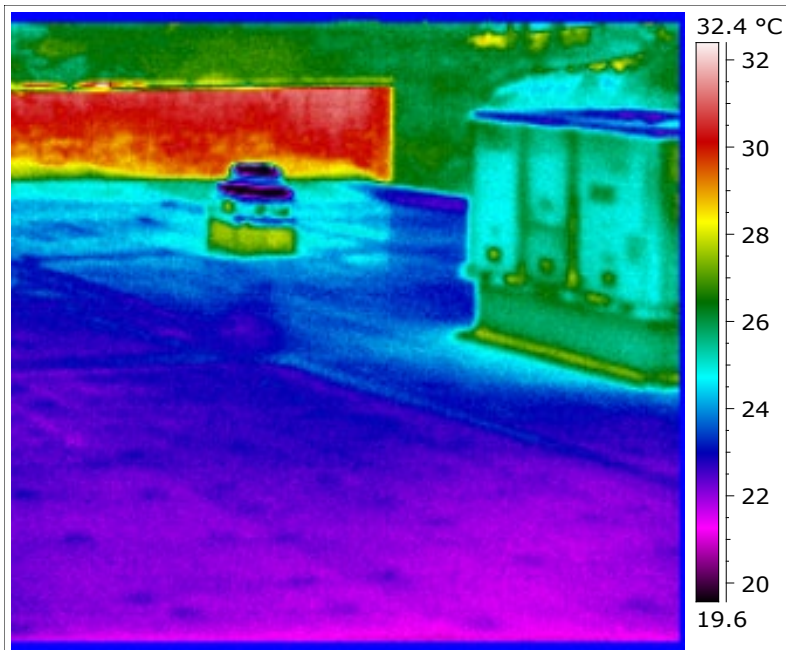
Thermogram # 3

Dry Area of Roofing – Building 1  
Control Photo not Available

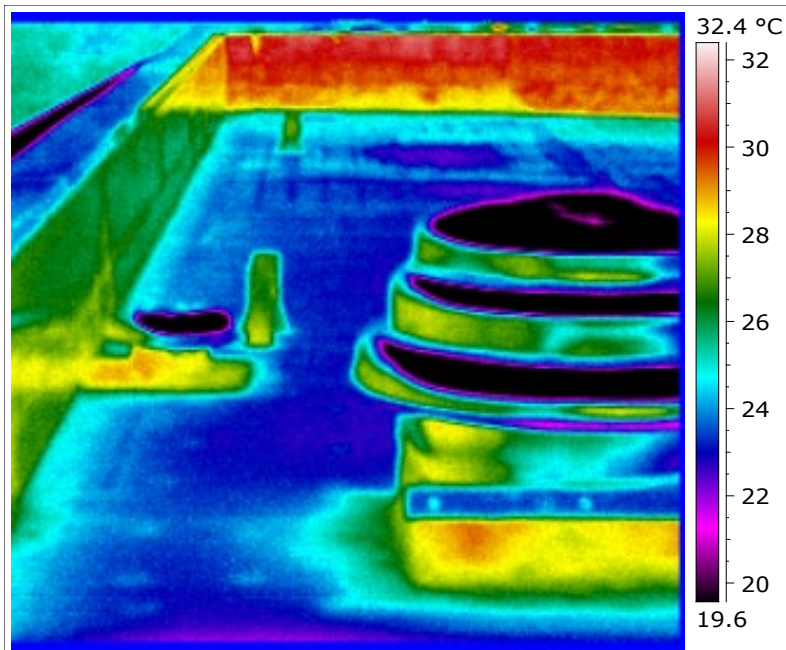
Thermogram # 4

Dry Area of Roofing – Building 1  
Control Photo not Available

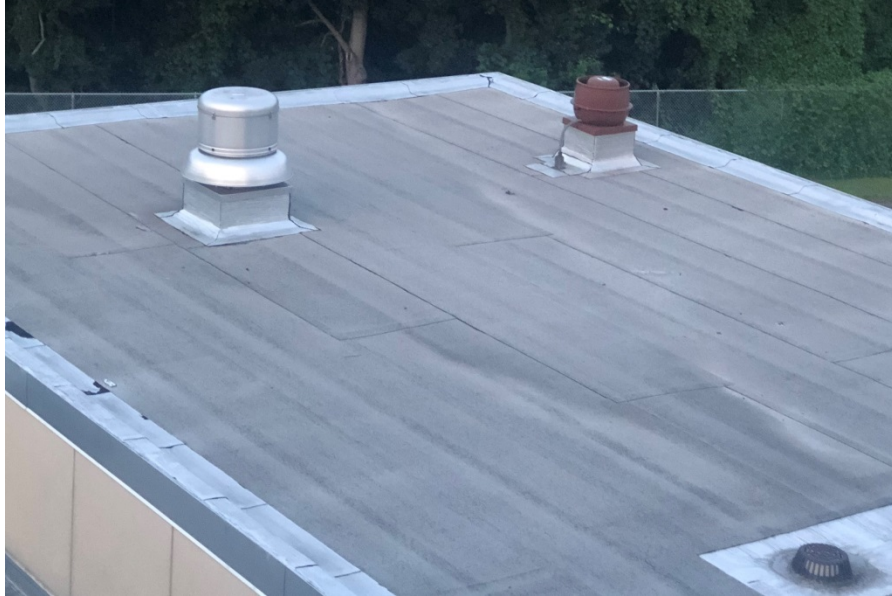
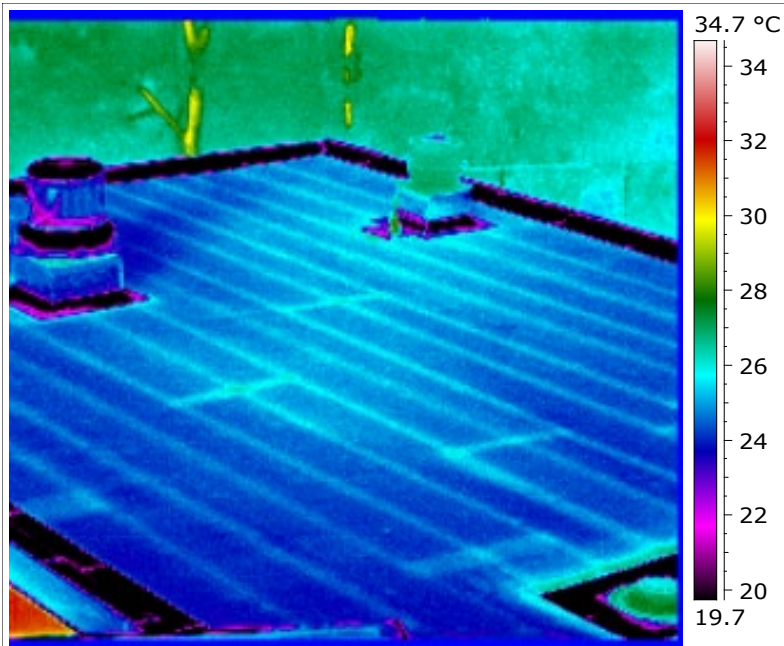
Thermogram # 5

Dry Area of Roofing – Building 2

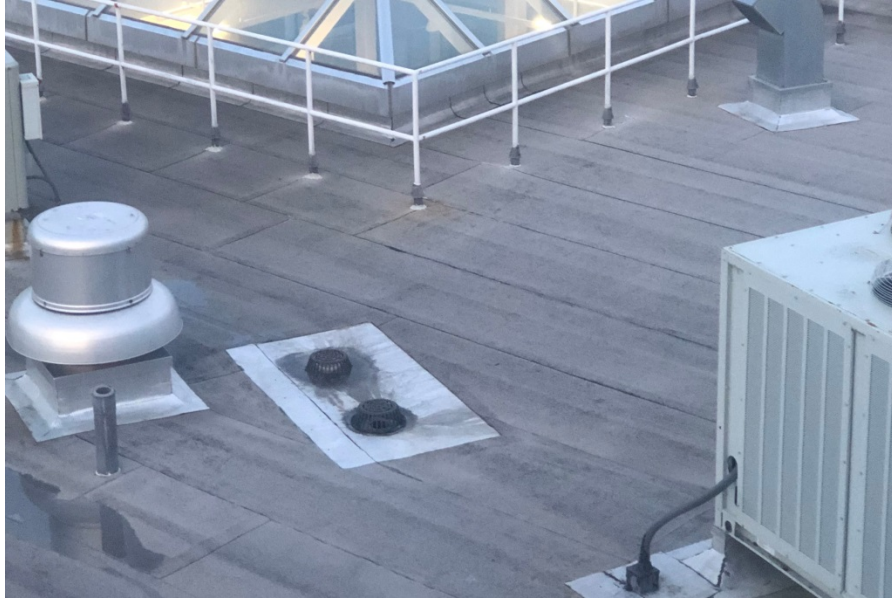
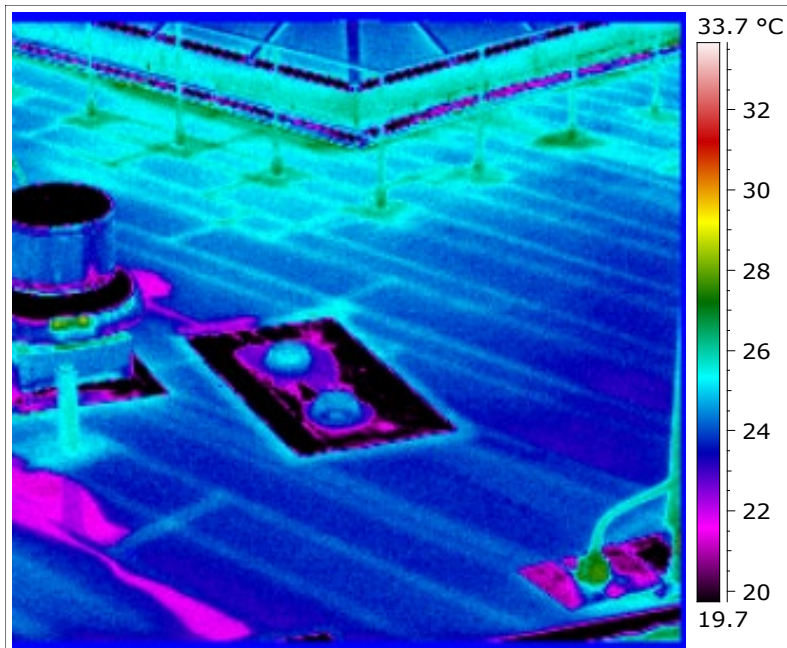
Thermogram # 6

Dry Area of Roofing – Building 2

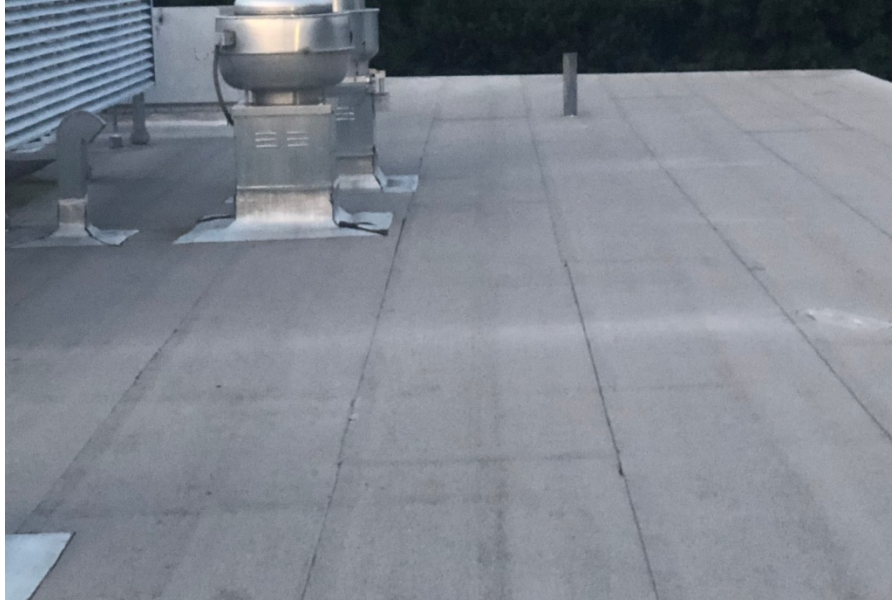
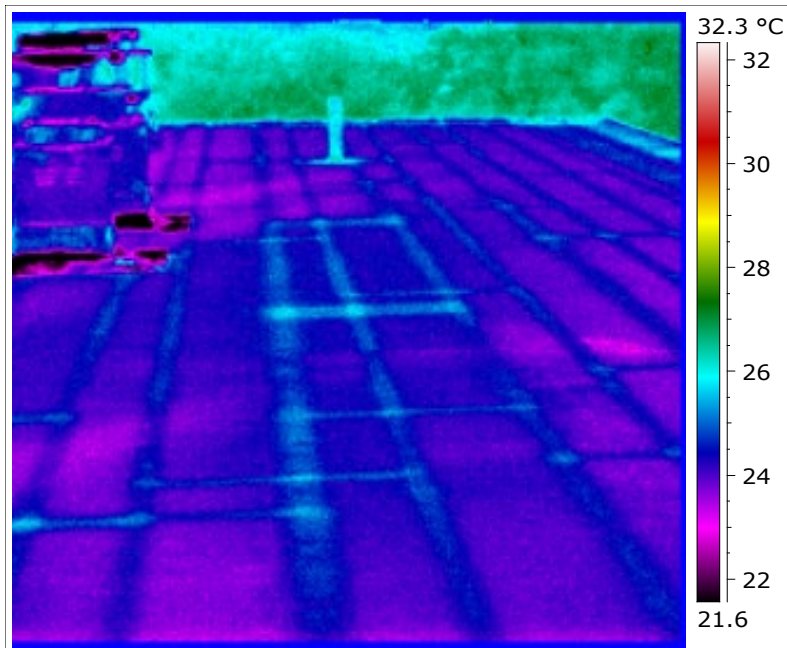
Thermogram # 7

Dry Area of Roofing – Building 2

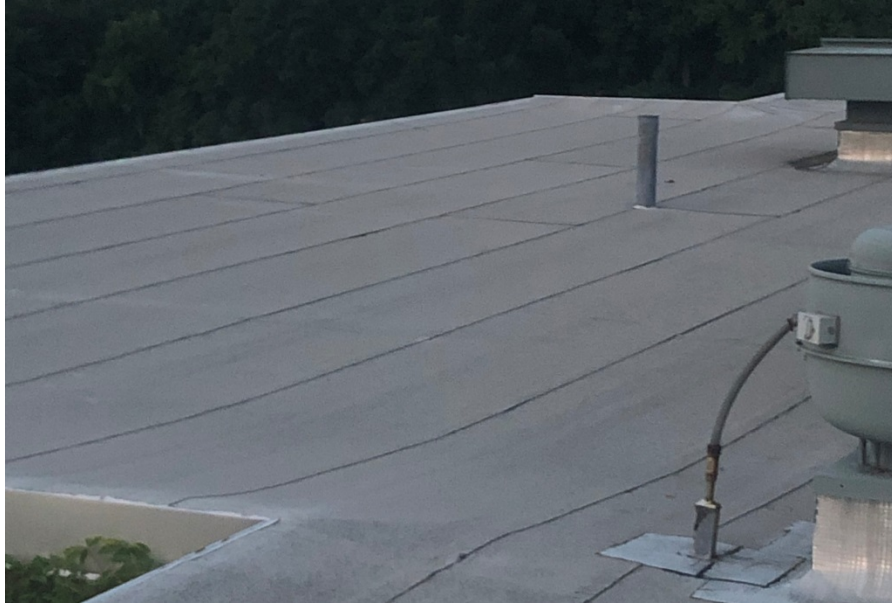
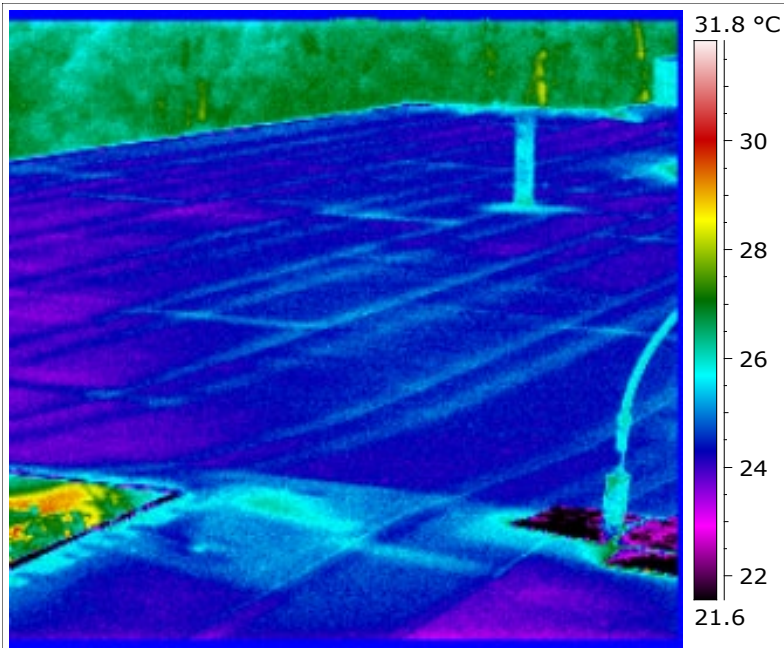
Thermogram # 8

Dry Area of Roofing – Building 2

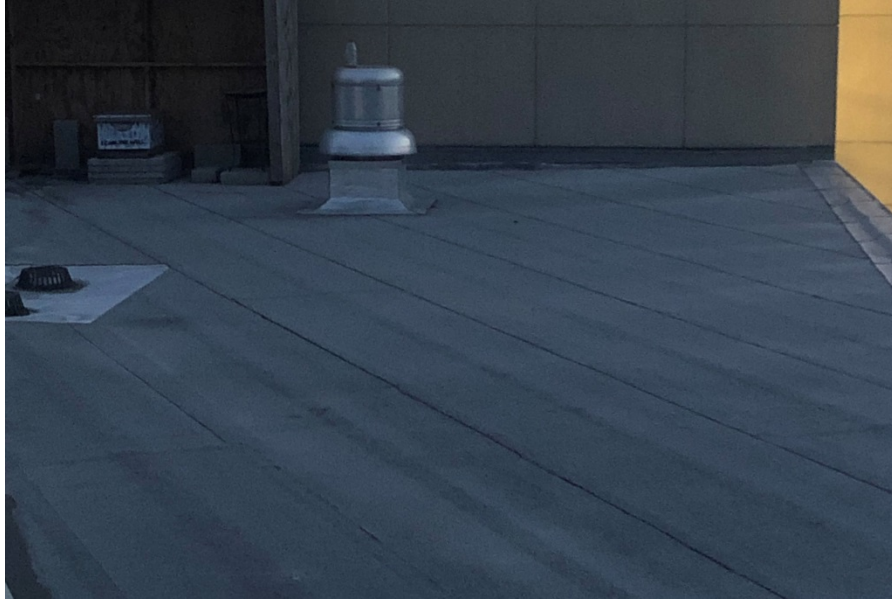
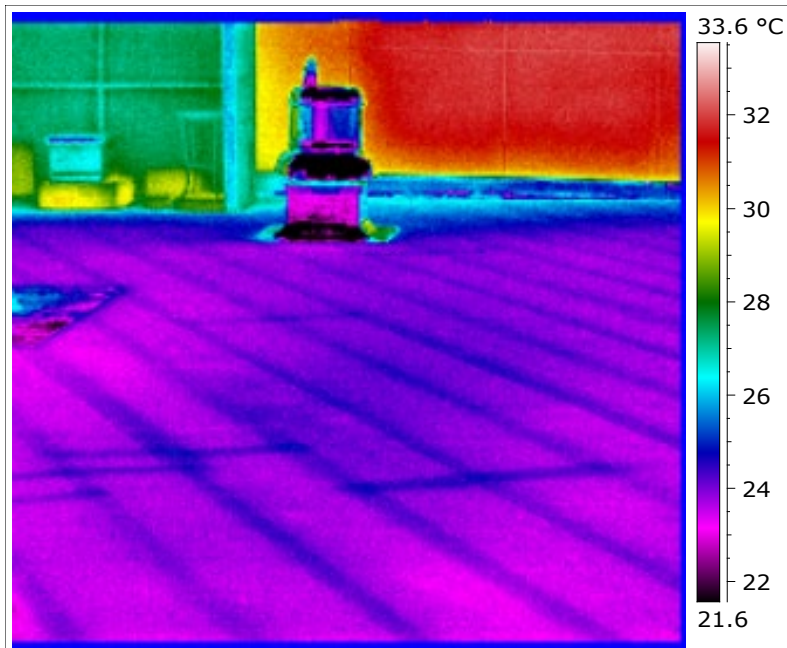
Thermogram # 9

Dry Area of Roofing – Building 2

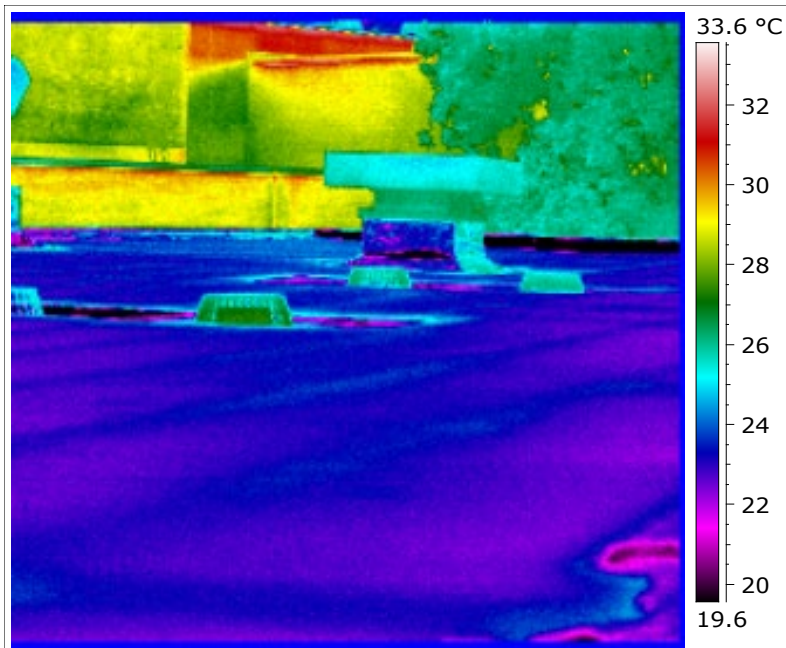
Thermogram # 10

Dry Area of Roofing – Building 2  
Control Photo not Available
