Wiss, Janney, Elstner Associates, Inc.  
2 Trap Falls Road, Suite 502  
Shelton, Connecticut 06484  
203.944.9424 tel  
www.wje.com

August 18, 2022

## Harbor Point- The Allure: P4 & P5- Local Slab Failure Final Report

WJE No. 2022.0759

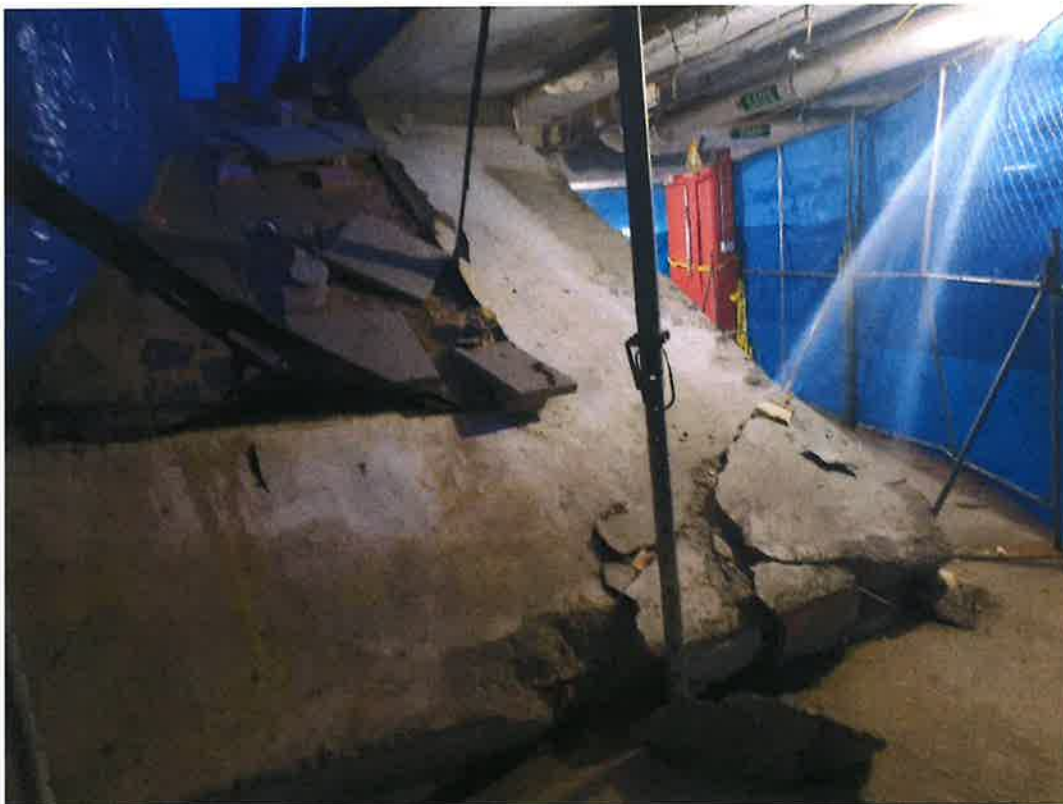
Figure 4- Partially Collapsed 5<sup>th</sup> Level Slab. Looking East to West

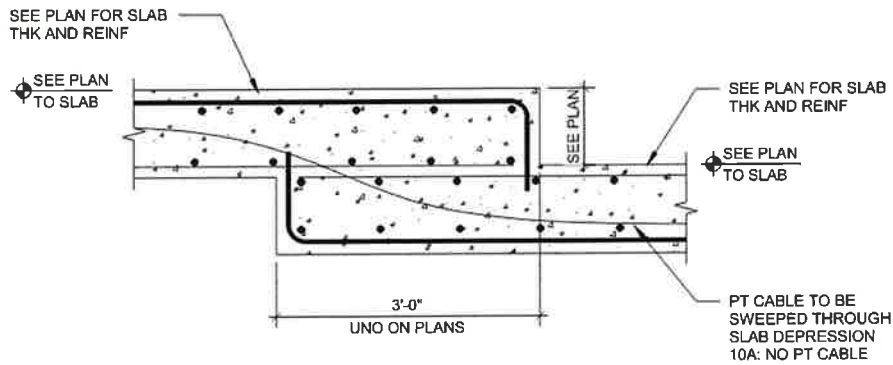
- The cause of the collapse is a result of the discontinuity of the PT across the slab step and that a horizontal construction joint was placed within the step transition with no shear transfer mechanism resulting in inadequate slab support. The report also indicates that the PT shop drawings show the tendons as continuous.

Figure 6- PT Step Detail from Original Drawings and HRSE Report

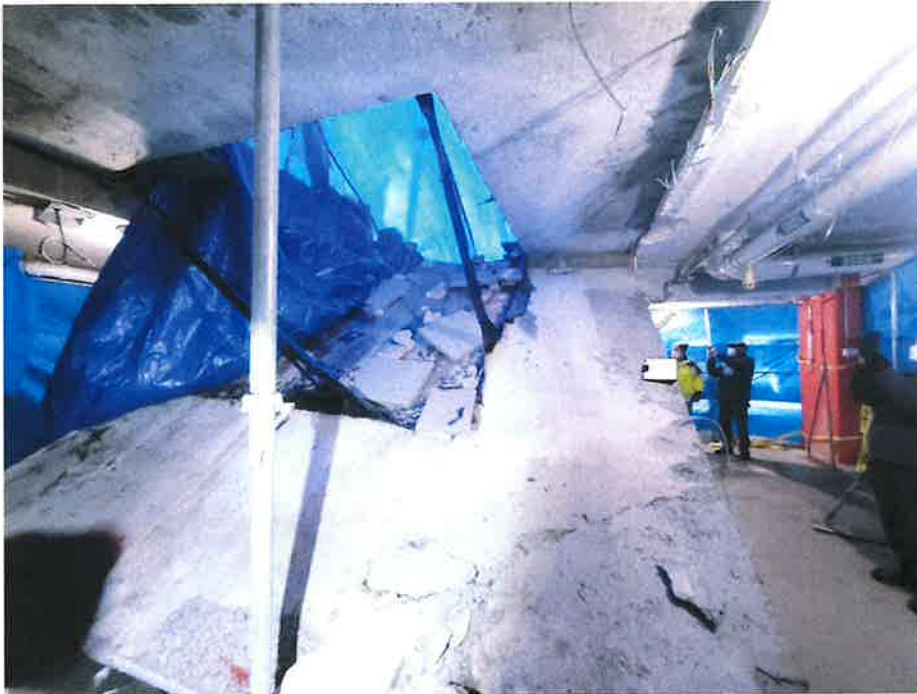
Figure 7- Partially Collapsed Slab looking West

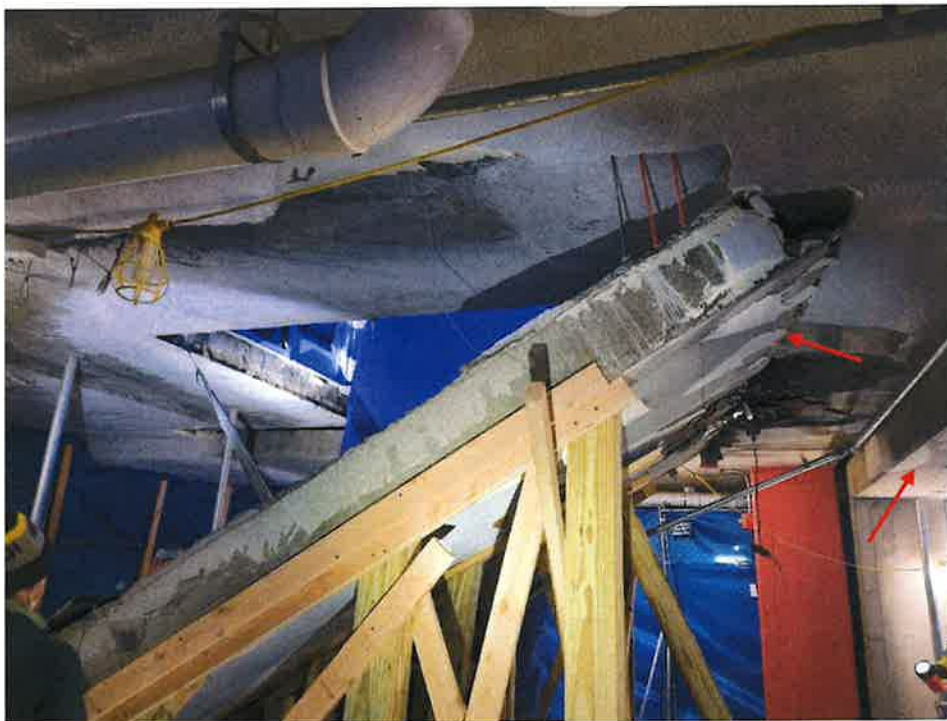
Figure 8- Shear Failure at West End of collapsed slab (left arrow). Note B21 Beam (right arrow). Collapsed Area looking South

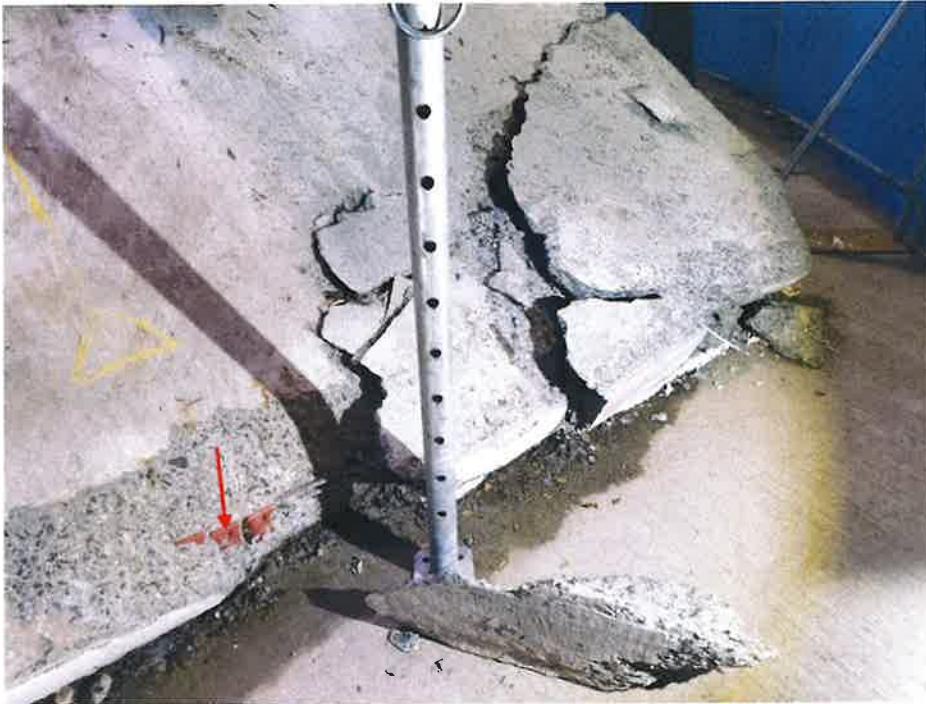
*Figure 9- Live End Anchorages at East End of Lower Collapsed Slab (Red Arrow)*

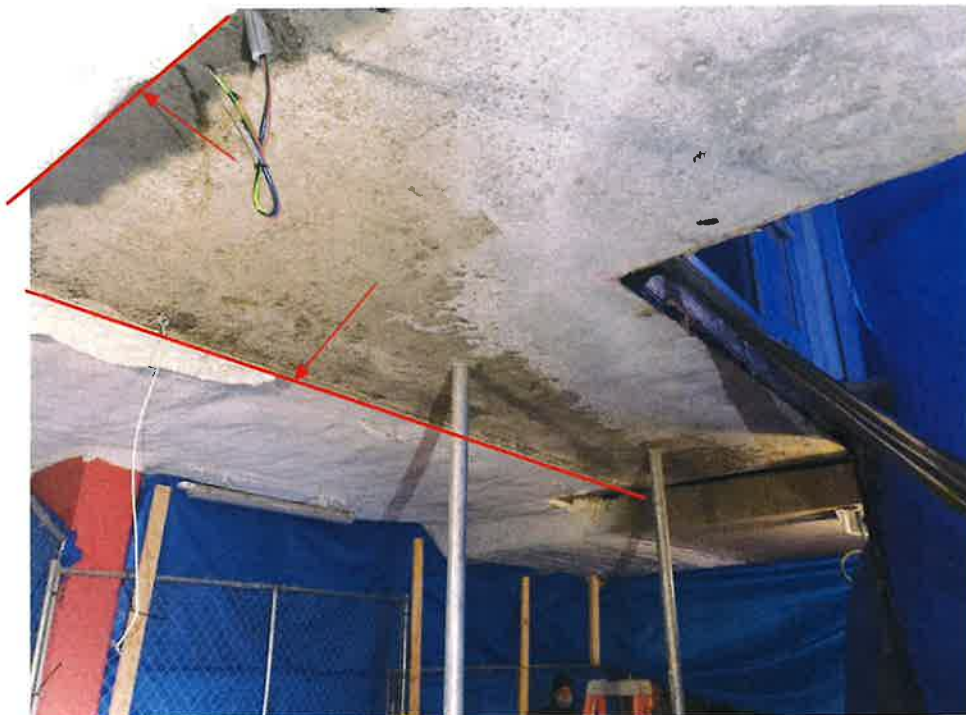
*Figure 10- Formed cold joint within transition band of stepped slab, East End of Collapsed Slab*

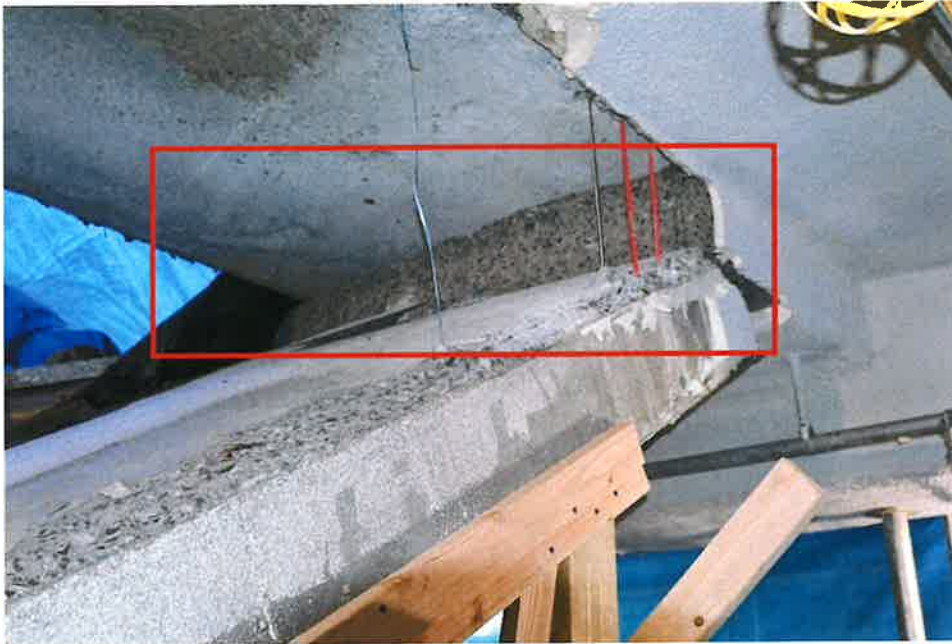
- The partially collapsed Level 5 slab measures 20 ft by 15 ft. It is a portion of the lower slab within the bay bordered by column lines G9/G10 and TE/GA. There is a crack in the west end of the slab and the east end of the collapsed portion of the slab is resting on the 4<sup>th</sup> floor level (Figures 7 and 8).
- The PT is not continuous as shown in the design and shop drawings at the slab step transition. The live (stressing) end anchorages were observed at the east end of the collapsed slab (Figure 9)
- There is a cold joint at the step in the slab at this location there is no reinforcement crossing the joint and the concrete is not roughened (Figure 10).
- Review of the failure plane indicates that there doesn't appear to be any reinforcing steel in the lower slab located higher than approximately 1-3 in. above the bottom of the slab (Figure 11 through 12).

*Figure 11- No top reinforcement at failure plane Northwest Portion of Collapsed Slab. Note smooth formed surface at underside of upper slab at transition.*

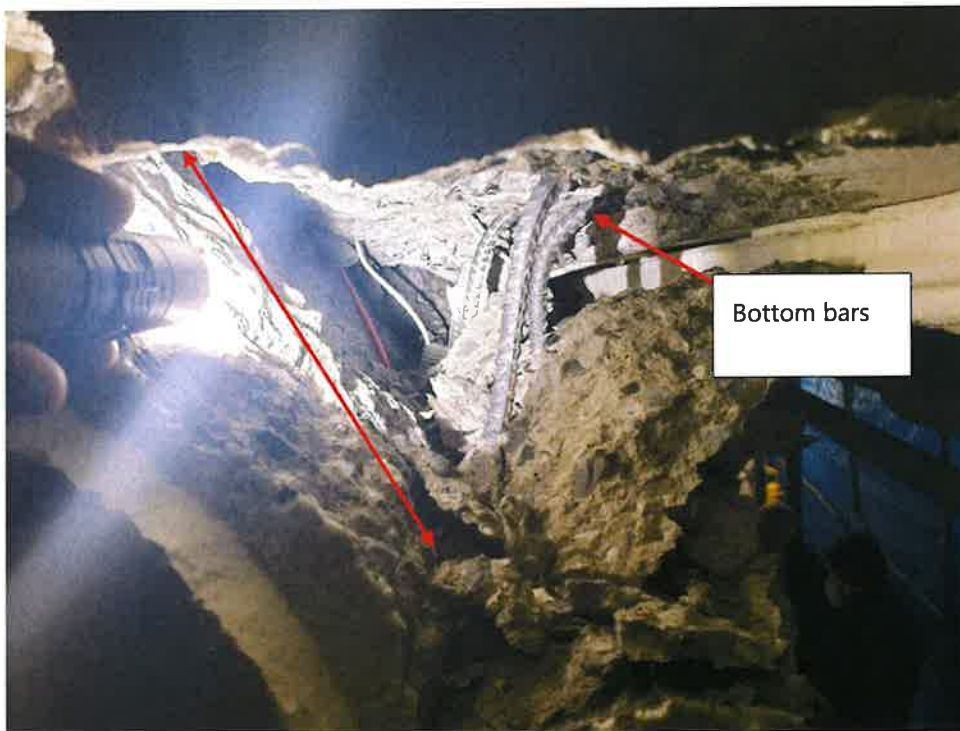
*Figure 12- No Top reinforcing Steel Crossing Failure Plane. View Looking North to South at West Failure Plane. Exposed bars exposed are bottom bars.*

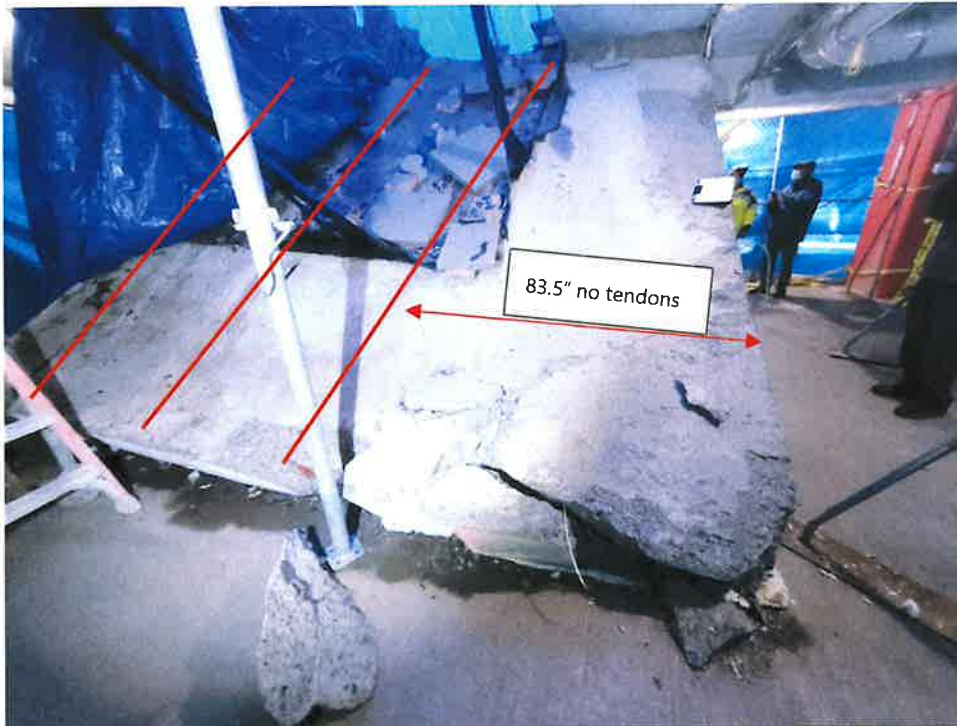
Figure 13- PT Layout at Slab Looking East to West. Red lines indicate positions of PT strands

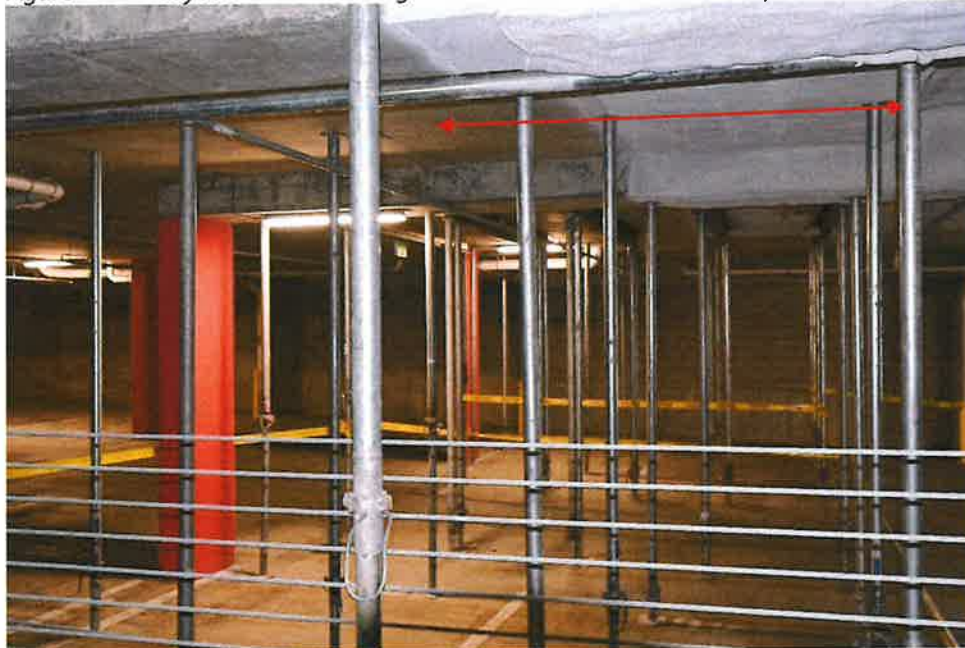
Figure 14- Underside of lower slab to west of partial collapse. Arrow indicates 83.5 in. wide region where tendons were missing in collapsed slab. WJE could not scan because of Insulation.

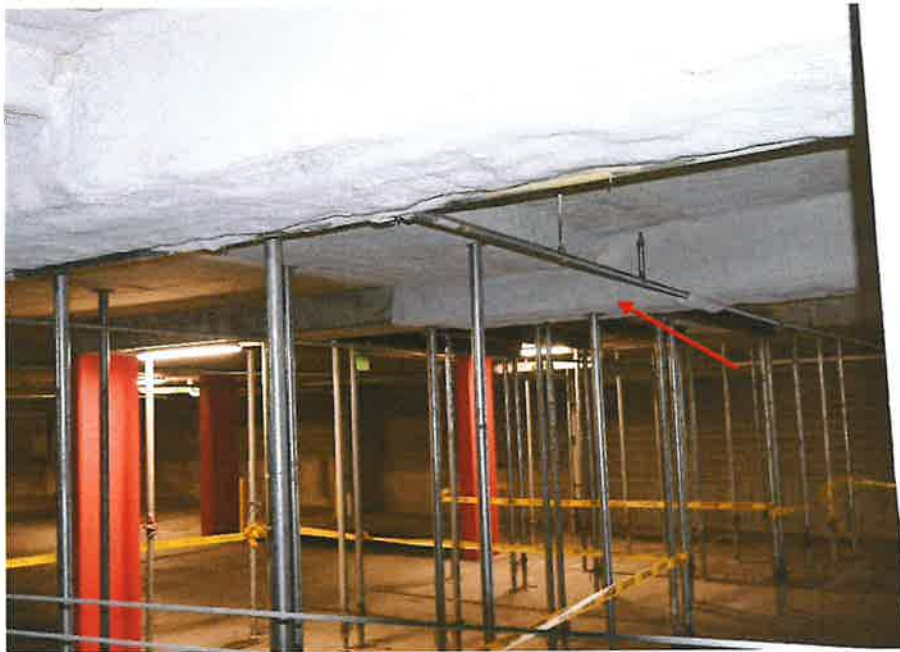
- It is also noted that an additional north-south spanning beam exists between column line T12/T13 along GD that is not shown in the design or shop drawings provided to WJE (Figure 16).

Figure 16- Added Beam Not Shown in any Drawings at Line GD (arrow)

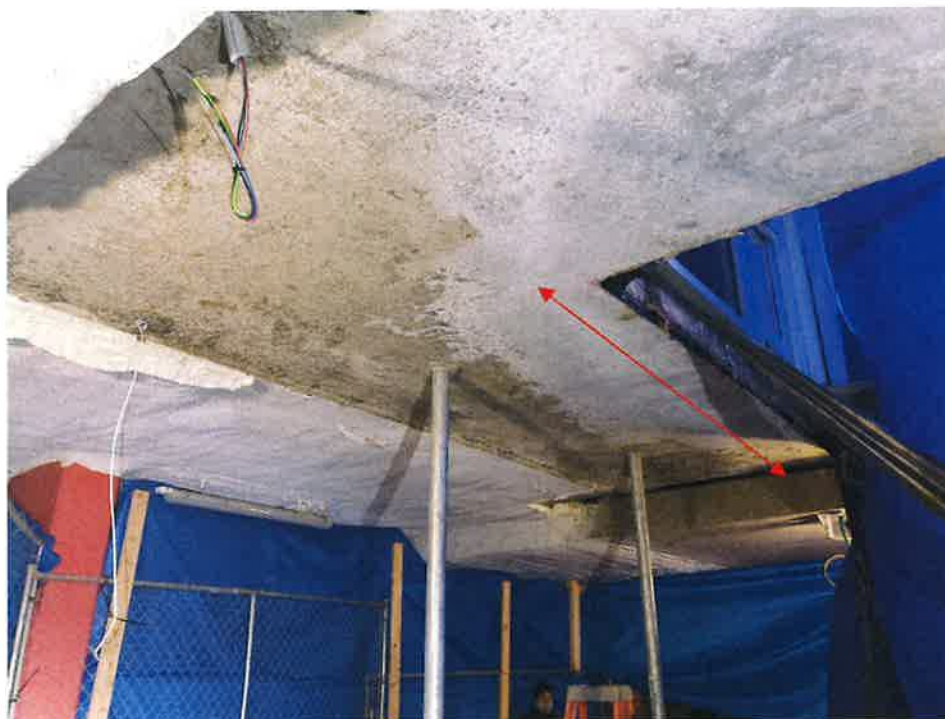
- Since the tendons were observed to be anchored in the lower slab and not continuous across the step, it is unclear to WJE how the upper slab is reinforced or supported (Figure 17).

Figure 17- Upper Slab Reinforcement in the step transition Area adjacent to the Collapsed Slab is not evident (arrow band).

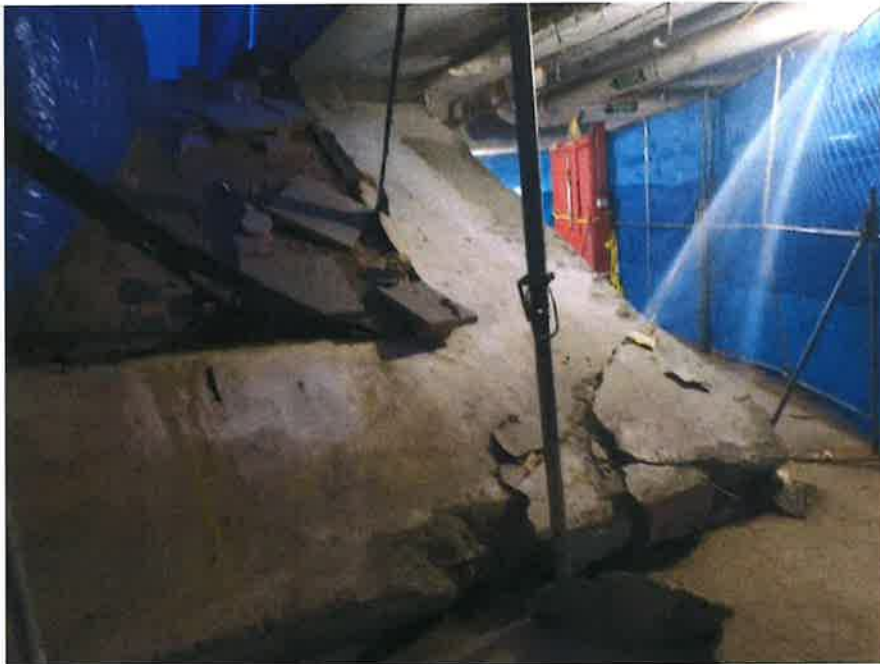
Figure 1- Partially Collapsed 5<sup>th</sup> Level Slab. Looking East to West

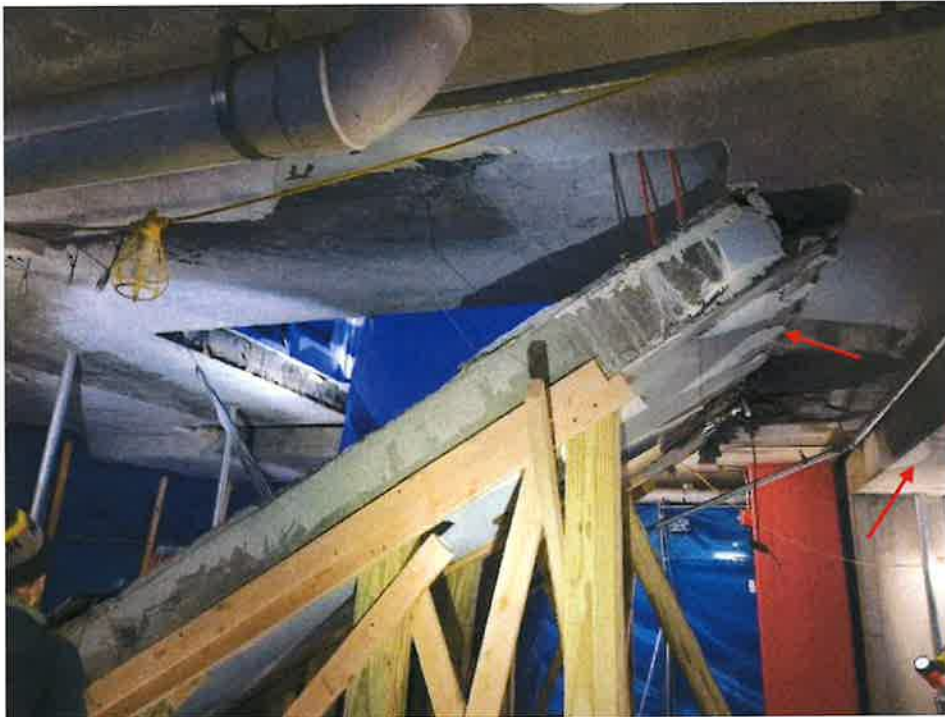
*Figure 5- Shear Failure at West End. Note B21 Beam. Collapsed Area looking South*

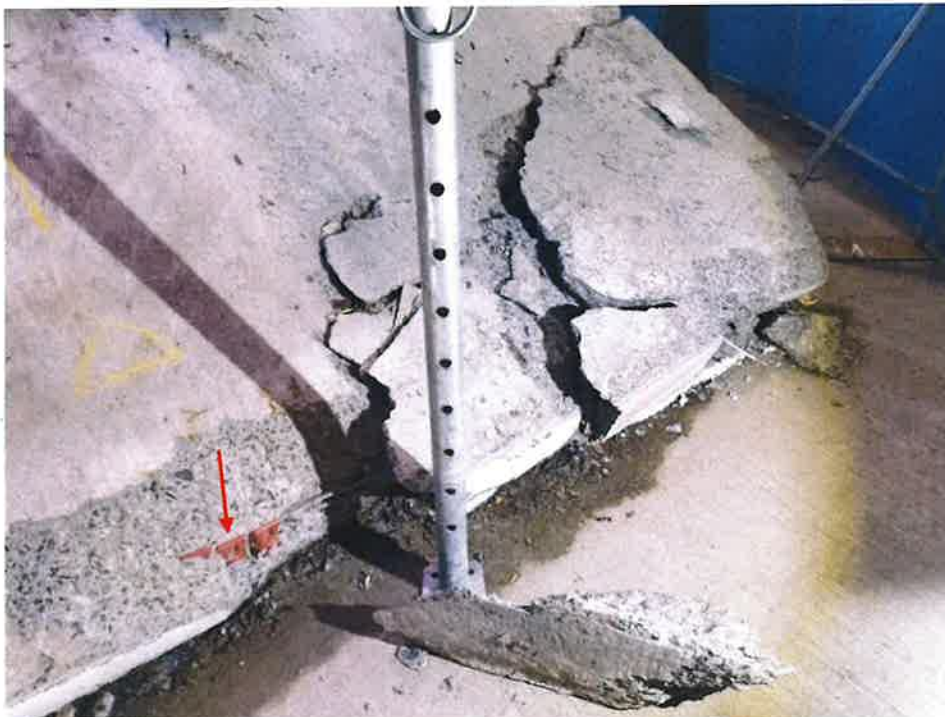
*Figure 6- Live End Anchorages at East End of Lower Collapsed Slab*

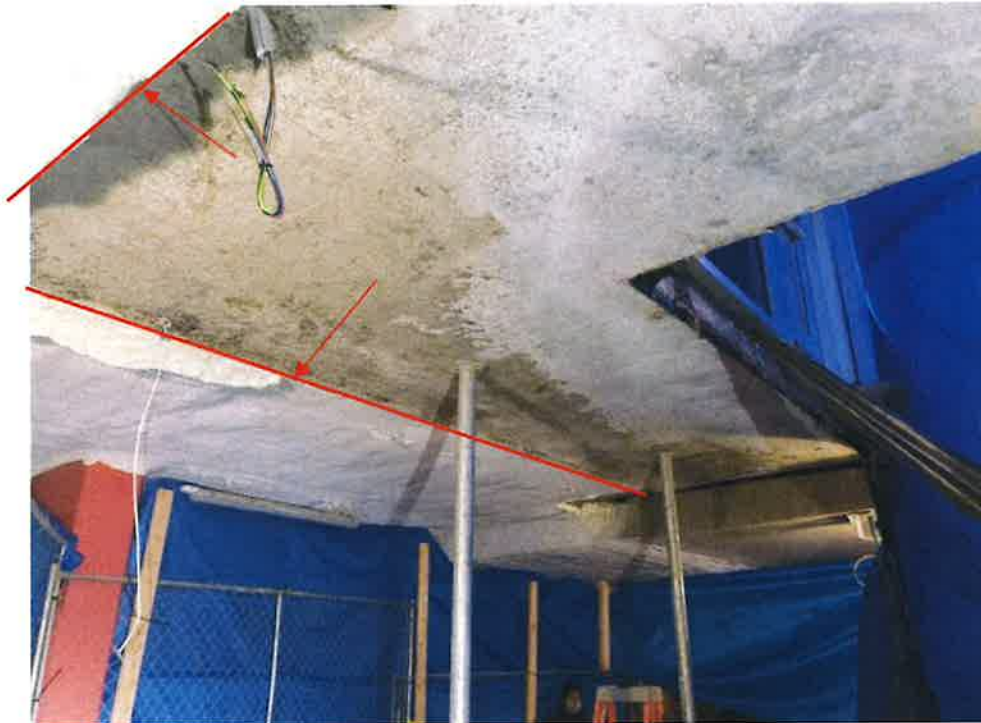
Figure 7- Construction Joint Between Upper and Lower Slab. East End of Collapsed Slab

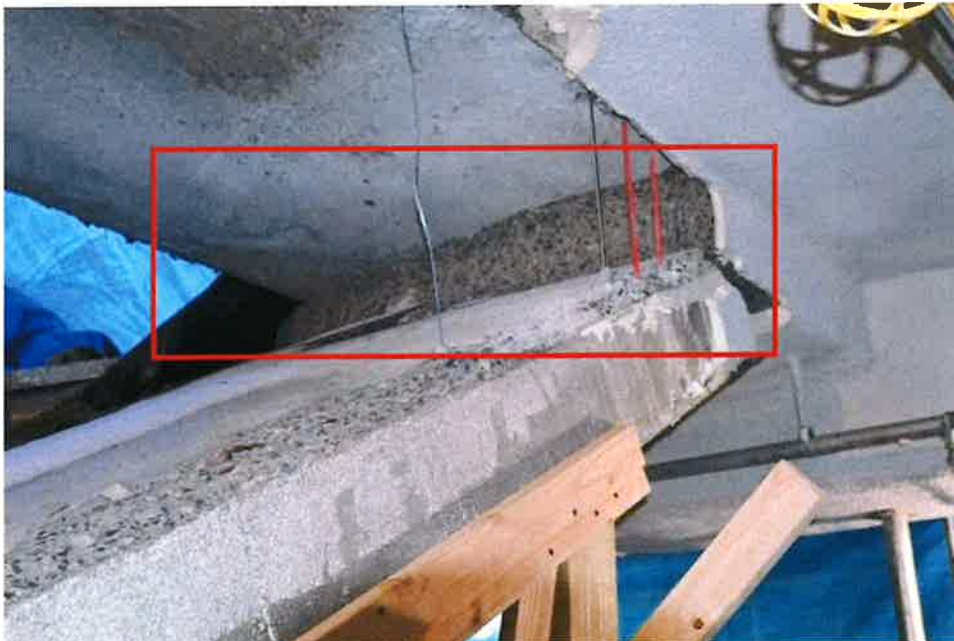
Figure 8- No top reinforcement at failure plane Northwest Portion of Collapsed Slab

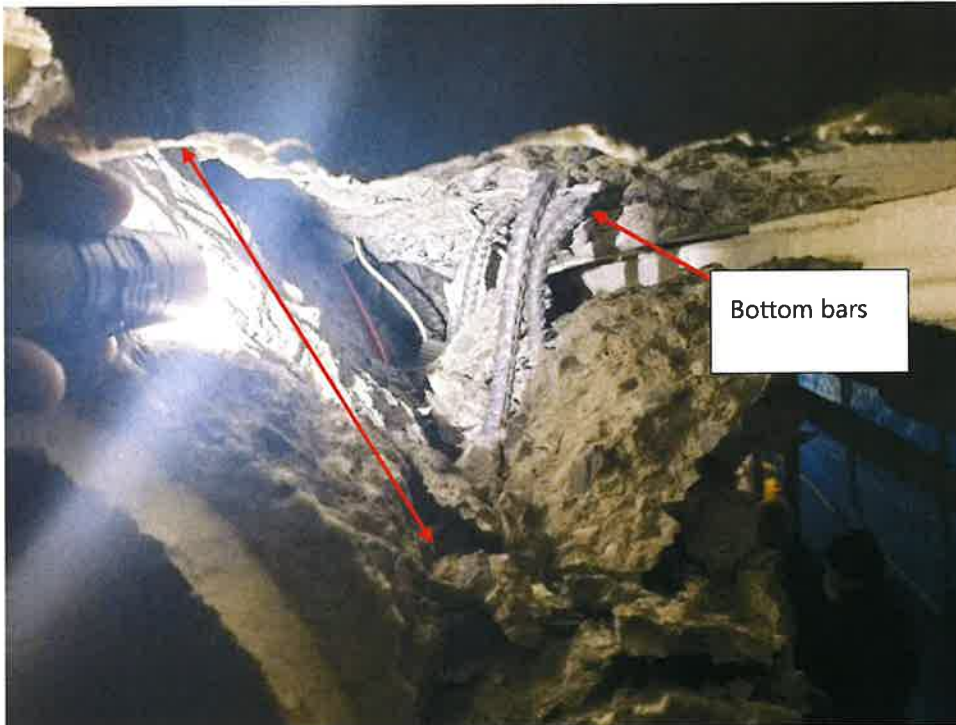
Figure 9- No Top Steel Crossing Failure Plane Looking North to South at West Failure Plane

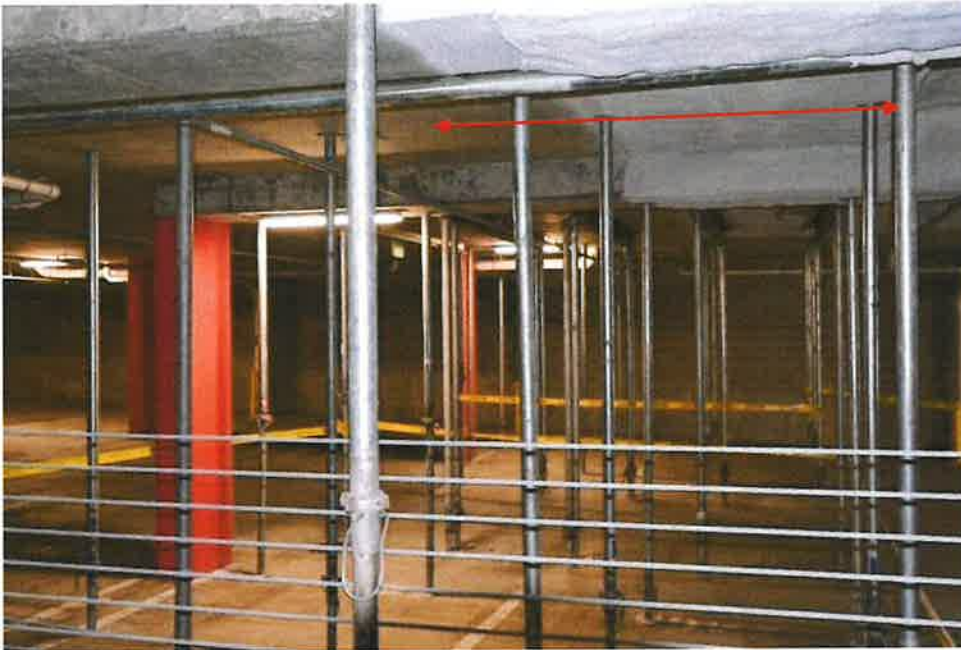
*Figure 11- Lower Slab to West of Collapsed Portion. 83.5 in. area with No Tendons in Collapsed Area. Cannot Scan Cause of Insulation.*

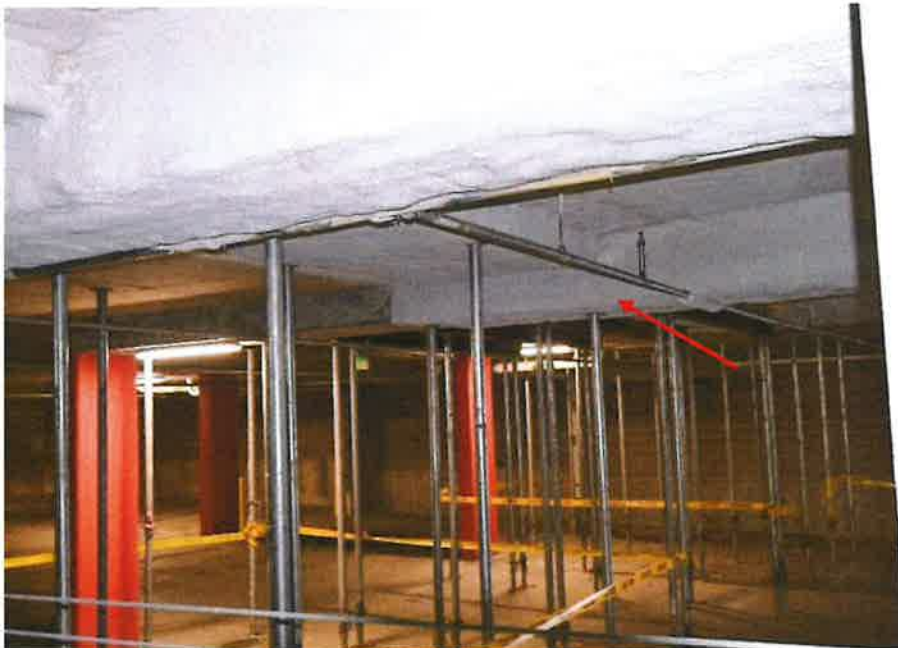
*Figure 12- Added Beam Not Shown in Drawings at Line GD*

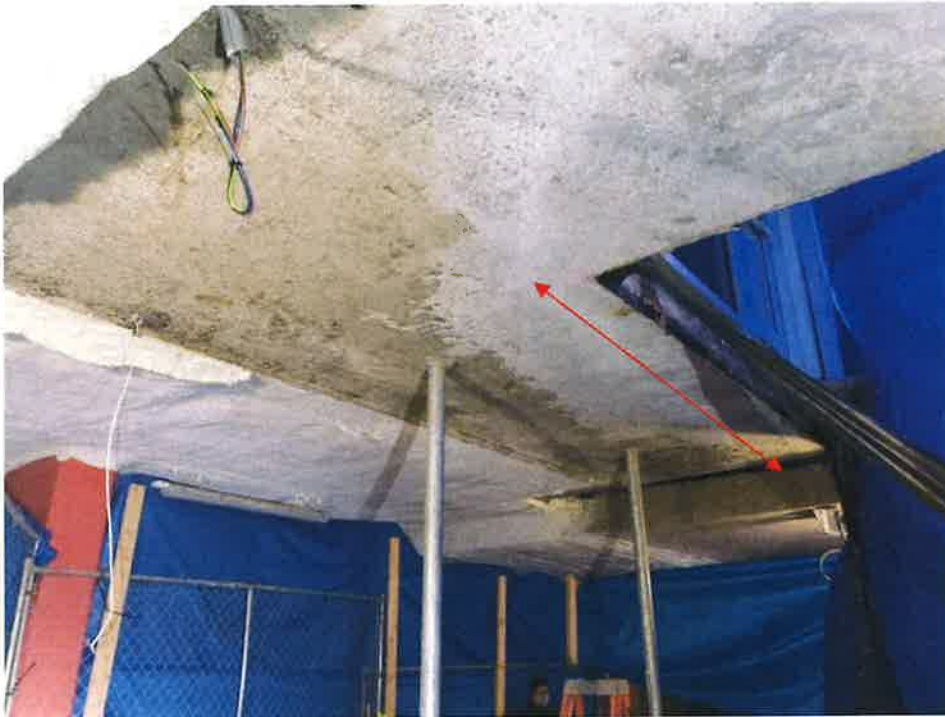
*Figure 13- Upper Slab Reinforcement in the Area of the Collapsed Slab is Unknown.*

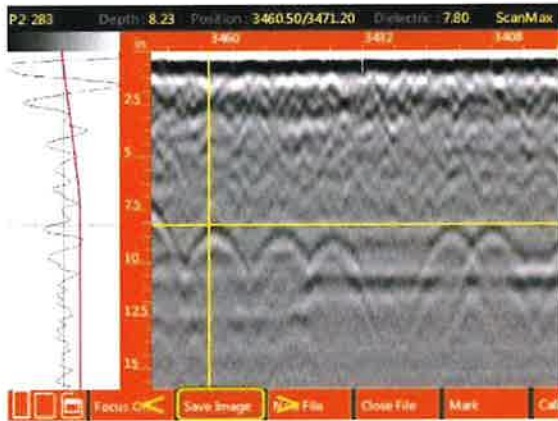
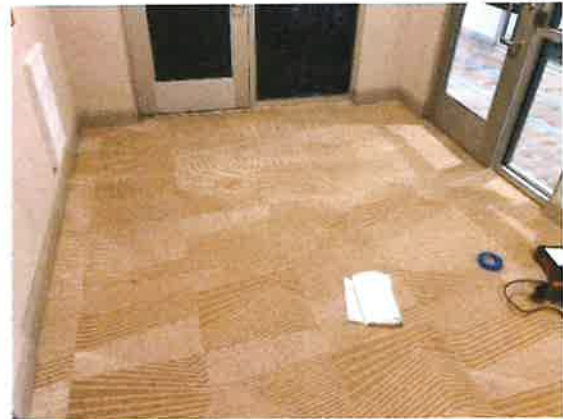
**Photo 5**

GPR data screenshot of the carpeted hallway area near the expansion joint. No PT cables were found in this area. The reactions in this data screenshot above are rebar only.

Pictured above is the area near the expansion joint where no PT cables were found.
