Wiss, Janney, Elstner Associates, Inc.

August 4, 2022

NV @ Harbor Point, 100 Commons Park North, Stamford, CT: Visual Survey

WJE No. 2022.0759

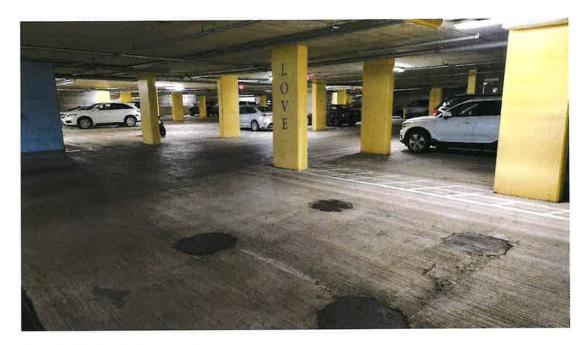
- The lower level of the parking garage was observed to be in good condition at isolated locations, shrinkage cracks were noted in the slab-on-grade as well as at the underside of the 1st floor slab level. In some instances, efflorescence was observed emanating from the shrinkage cracks (Figures 5-7).
- Levels 1 through 3 of garage appear in good condition a few shrinkage cracks noted at isolated locations (Figures 8-11).
- WJE noted corrosion staining emanating from the expansion joints at multiple levels (Figure 12).

Figure 5- Typical Lower Level of Garage

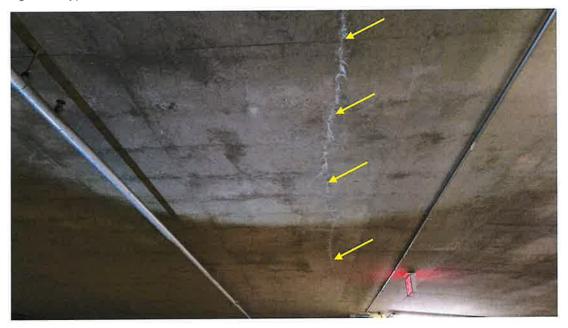
Figure 6- Typical Shrinkage Cracks at Underside of 1st Level. Note Efflorescence Emanating from Cracks

- WJE would recommend routing and sealing the shrinkage cracks to prevent the ingress of air and water which could result in corrosion of the underlying steel and/or post tensioning.
- The owner should consider applying a penetrating sealer to the parking levels top surfaces or installing a traffic coating on the parking levels top surfaces to protect the mild reinforcement from chloride laden water that is tracked into the garage from vehicles in the winter.
- Please note that expansion joints and surface treatments in parking garages are high maintenance items, requiring repair of replacement typically every 5 years.

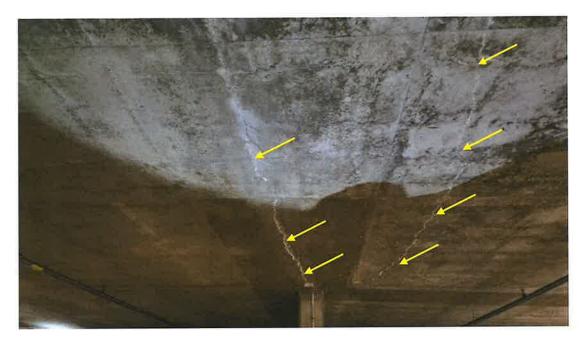
Figure 7- Typical Shrinkage Cracks at Underside of 1st Level. Note Efflorescence Emanating from Cracks

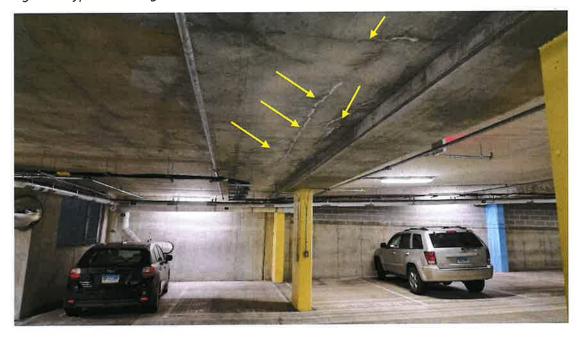
Figure 8- First Level of Garage. Note Shrinkage Cracks with Efflorescence at underside of 2nd Floor

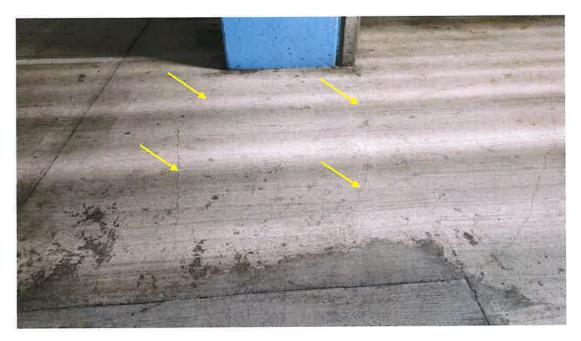
Figure 9 -Shrinkage Cracks at Floor of Second Floor Level

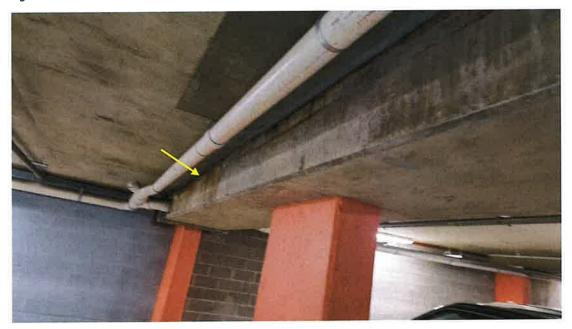
Figure 12- Corrosion at Expansion Joint

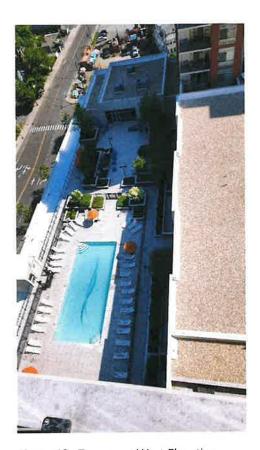
■ WJE visually reviewed the amenity terrace at the 5th Floor. WJE did not observe any cracking in finishes or excessive deflections that could be an indication of an underlying structural issue (Figures 13-14).

Figure 13- Terrace at West Elevation

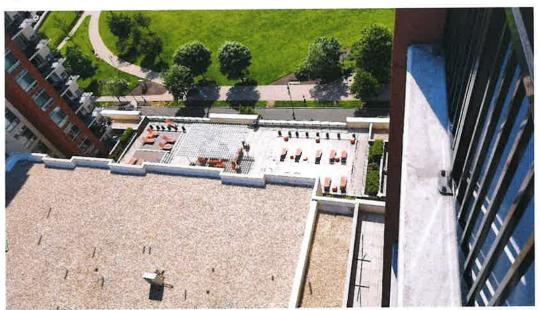
Figure 14- Terrace at East Elevation

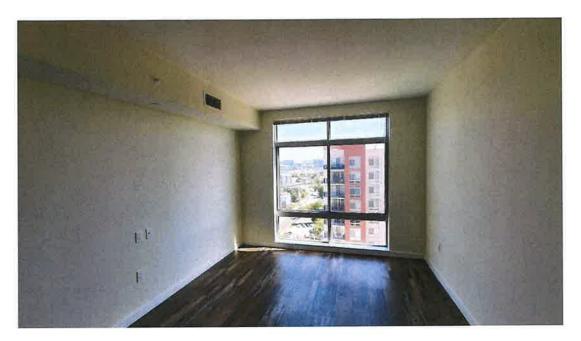
- At the time of our visit, WJE was provided access to 12 units within the two towers. WJE visually reviewed the 12 apartments and all accessible public and amenities spaces. As part of our review, WJE looked for cracks in the drywall finishes especially at doorways and floor to ceiling transitions that may be an indication of differential movement. Additionally, WJE also looked for separations in the trim or gaps in the trim that may indicate the presence of slab deflections. No distressed conditions were noted at the reviewed areas (Figures 15-18).

Figure 15- Typical Apartment

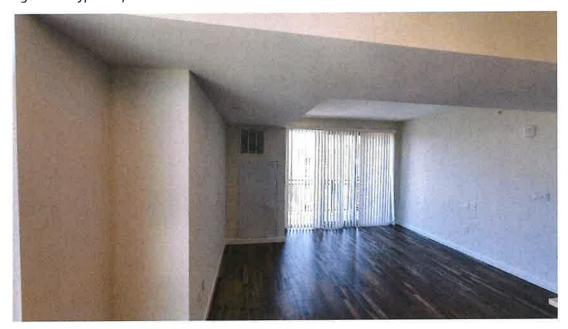
Figure 16- Typical Apartment

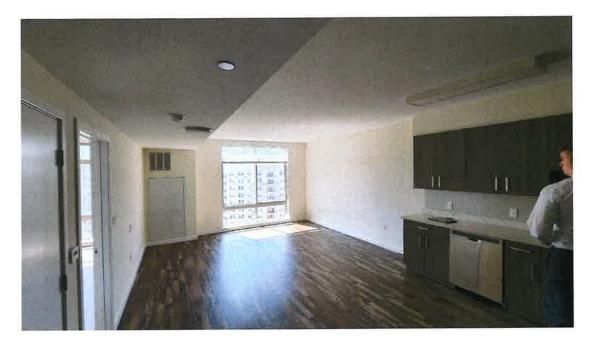
Figure 17- Typical Apartment

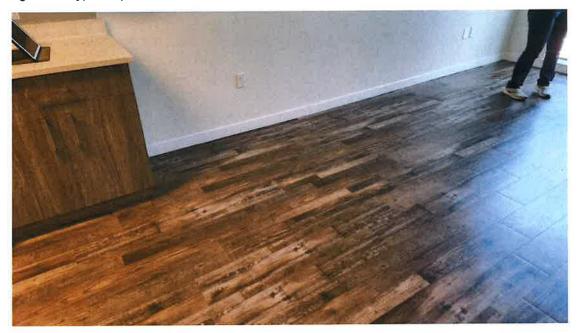
Figure 18- Typical Apartment
