Wiss, Janney, Elstner Associates, Inc.

August 4, 2022

Opus Harbor Point: 900 Pacific St, Stamford, CT Visual Survey

WJE No. 2022.0759

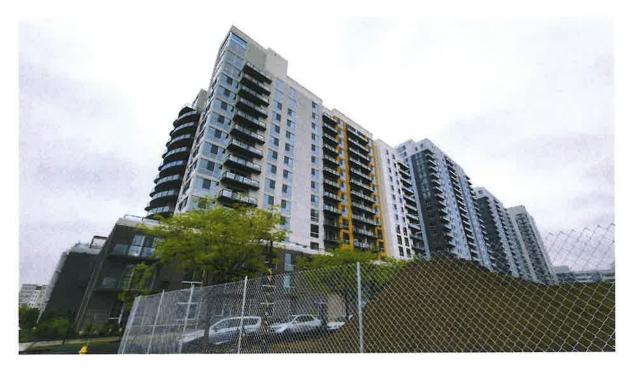
Figure 1- Opus P3: East Elevation

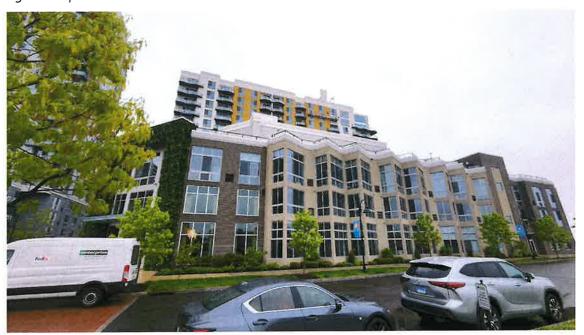
Figure 2 - Opus P3: West Elevation

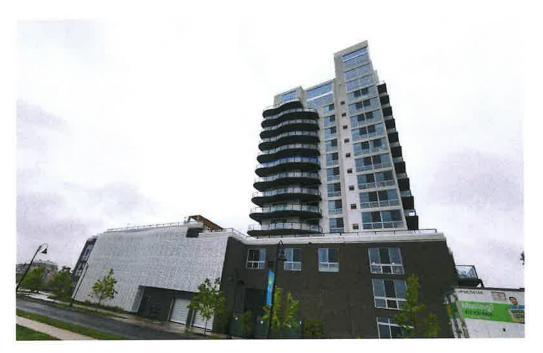
Figure 3- Opus P3: South Elevation

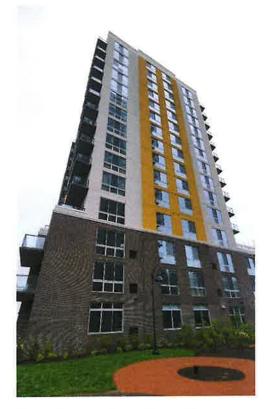
Figure 4- Opus P3: North Elevation

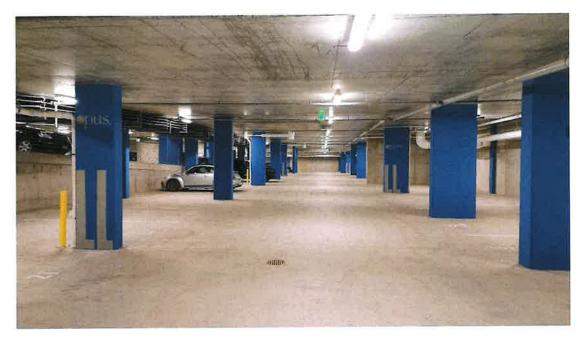
- Basement Level of garage appears in good condition no deleterious conditions were noted (Figure 5). A few hairline shrinkage cracks were noted at the underside of the 1st and 2nd floor slabs with efflorescence emanating from the cracks. Some of the cracks appear on either side of a construction joint. (Figures 6).

Figure 5- Basement Level of Garage in Good Condition

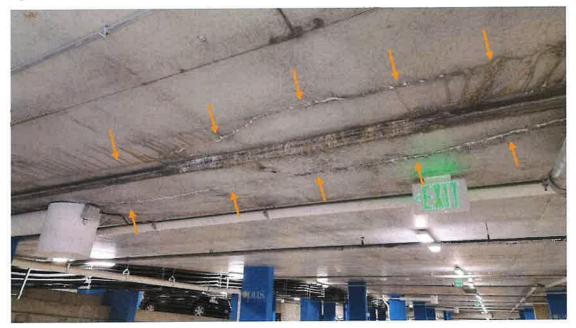
Figure 6- Level 1 - Parking Garage – Shrinkage cracks

- WJE would recommend routing and sealing the shrinkage cracks to prevent the ingress of air and water which could result in corrosion of the underlying steel and/or post tensioning.
- WJE would recommend repairing leaks emanating from the 4th level terrace to prevent premature deterioration of the concrete slab and underlying reinforcement.

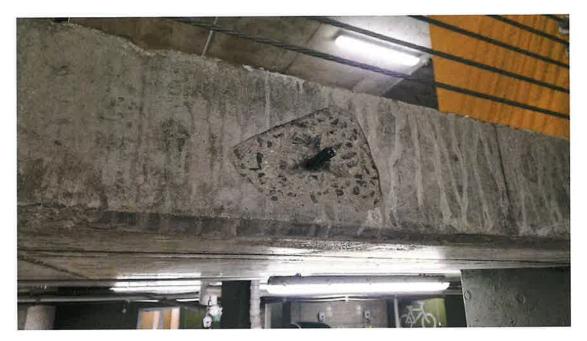
- The second Level of garage appears in good condition. WJE identified 3 broken tendons at the ramp in which the dead-end anchorage appears to have spalled the concrete after becoming de-tensioned (Figure 7). WJE notified Baker Concrete Construction (BCC) immediately. The condition was reviewed by HRSE and they issued a report on June 8, 2022 titled "Level 2 Pour 1 P1-22 and P1-24 Broken Tendons." The report indicated that analysis was performed by HRSE and CCL, the post-tensioning engineer, and both conclude that there is enough residual strength in the system that no repairs need to be performed at the 3 broken tendons. BCC patched the spalled areas of concrete.

Figure 7- Level 2 - Parking Garage – Broken PT strand

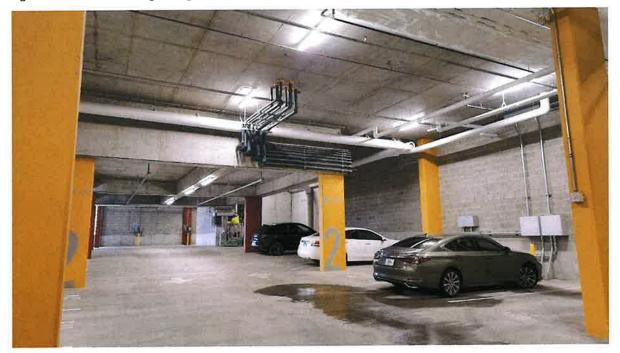
- The third Level of garage appears in good condition. A leak near the pool was identified near a pipe penetration in the slab at the ramp from the second level to the third level (Figure 8).

Figure 8- Level 3 – Parking Garage – Leaks at pipe penetrations near pool

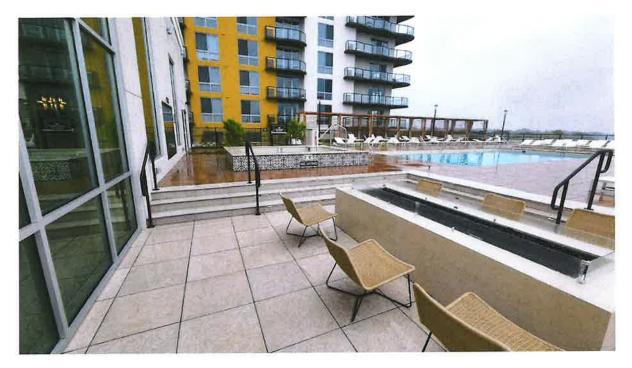
• WJE visually reviewed the amenity terrace at the 4th floor level and did not observe any cracking in finishes or excessive deflections that could be an indication of an underlying structural issue (Figures 9-11).

Figure 9- Amenity Terrace

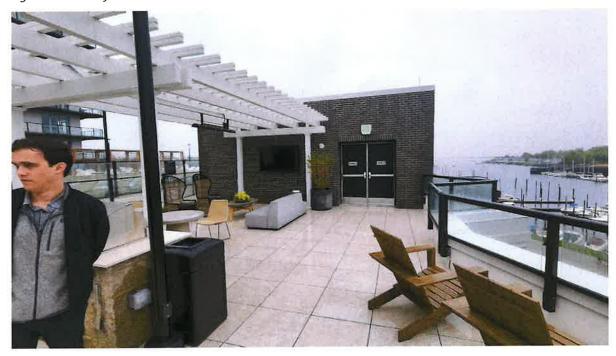
Figure 10- Amenity Terrace

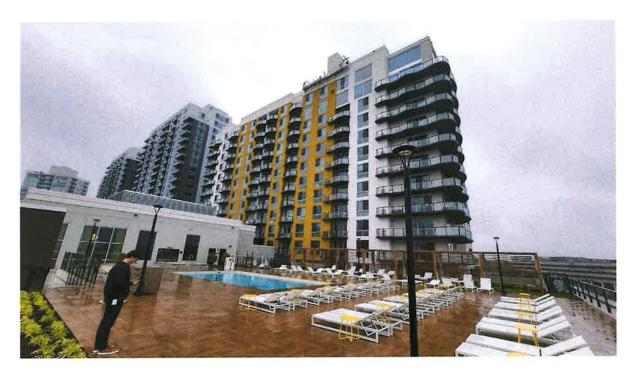
Figure 11- Amenity Terrace

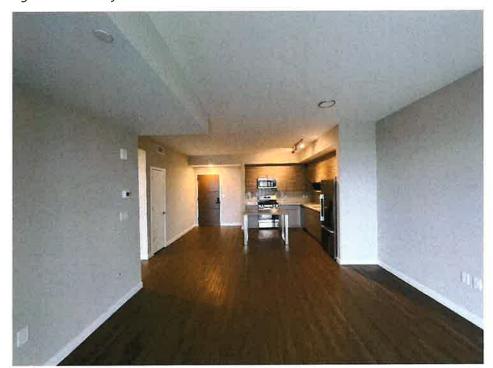
- WJE visually reviewed 26 apartments and all accessible public and amenities spaces. As part of our review, WJE was looking for cracks in the drywall finishes especially at doorways and floor to ceiling transitions that may be an indication of recent movement. Additionally, WJE was looking for separations in the trim or gaps in the trim that may indicate the presence of slab deflections. No deleterious conditions were noted at the reviewed areas (Figures 12-15).

Figure 12- Unit 1307

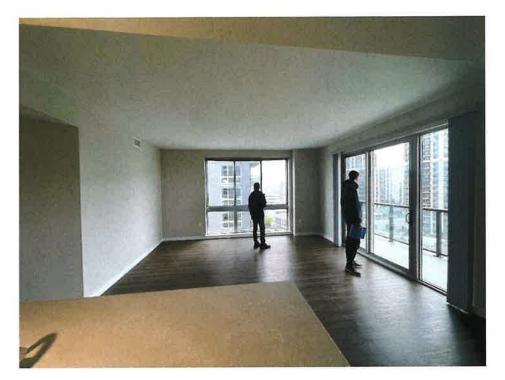
Figure 13- Unit 1201

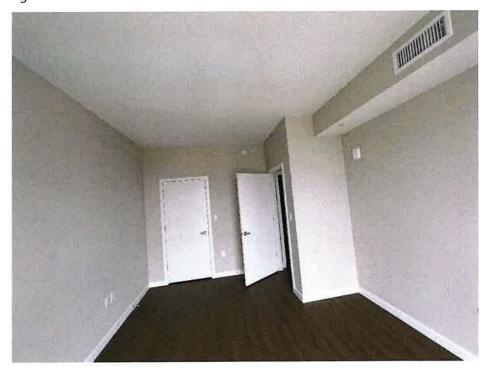
Figure 14- Unit 1112

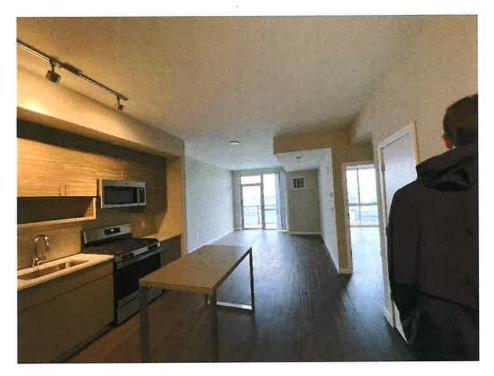
Figure 15- Unit 806

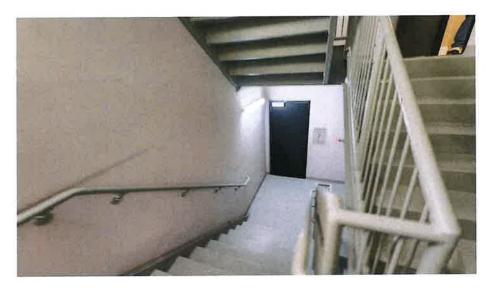
- The north and south stair towers were also partially reviewed. At these locations, painted concrete shear wall are exposed. No cracking or deleterious conditions were noted at the reviewed areas (Figures 17).

Figure 17- Stairway
