CONDITION ASSESSMENT REPORT

WATER POLLUTION CONTROL AUTHORITY BULKHEAD City of Stamford Stamford, Connecticut

May 2019

RTG Project No. 19106.00

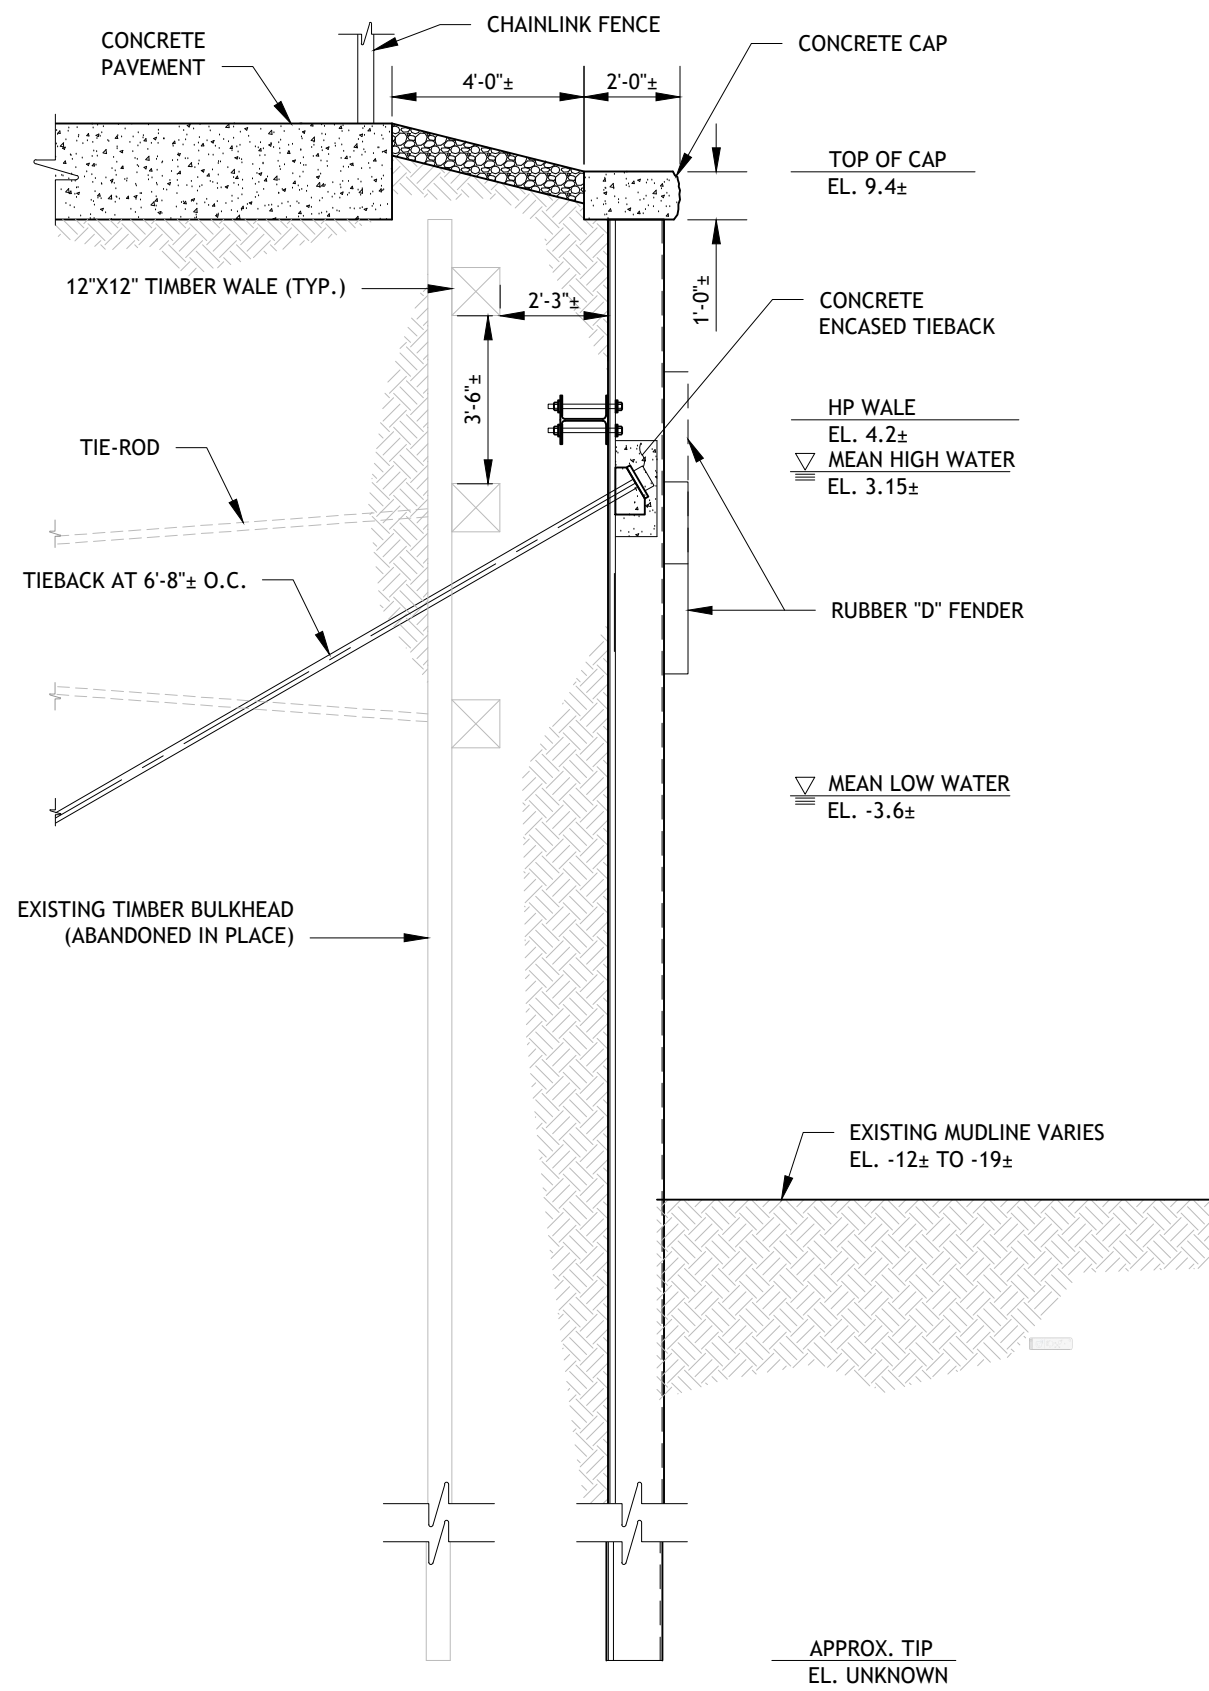
TYPE "A" BULKHEAD
STA 0+00 TO 5+55
SCALE: 1/4" = 1'-0"

Cap: The concrete cap is approximately 24-inches-wide by 12-inches-high with a top elevation of about El. 9.4 (Figure 2). From about Station 0+00 to 3+70, a 4-foot-wide gravel surface treatment slopes upward from the back of the cap to the existing concrete pavement within the WPCA facility, which is about 1-foot higher than the top of the cap (Photo No. 9). A chainlink fence is located at the edge of the concrete pavement along this section.

Wale: The steel HP-section wale is mounted to the inboard face of the existing bulkhead, and could not be observed except at about Station 1+47 (Photo No. 20). The wale is bolted to the sheeting with four (4) bolts, which are located in every other sheet pile belly, and is located approximately 5'-2" from the top of the cap to its web (Figure 2).

Sheet Piles: The steel sheet piles are approximately 20-inches-wide (i.e., 40-inches per pair) by 14-inches-deep (Figure 2). Three pipe outfalls were observed at Stations 1+10, 3+87, and 4+88. The outfalls were about 72-inches, 12-inches, and 12-inches in diameter and were located about 9'-9", 7'-0", and 10'-6" from the top of the concrete cap, respectively (Photo Nos. 21, 22, and 23).

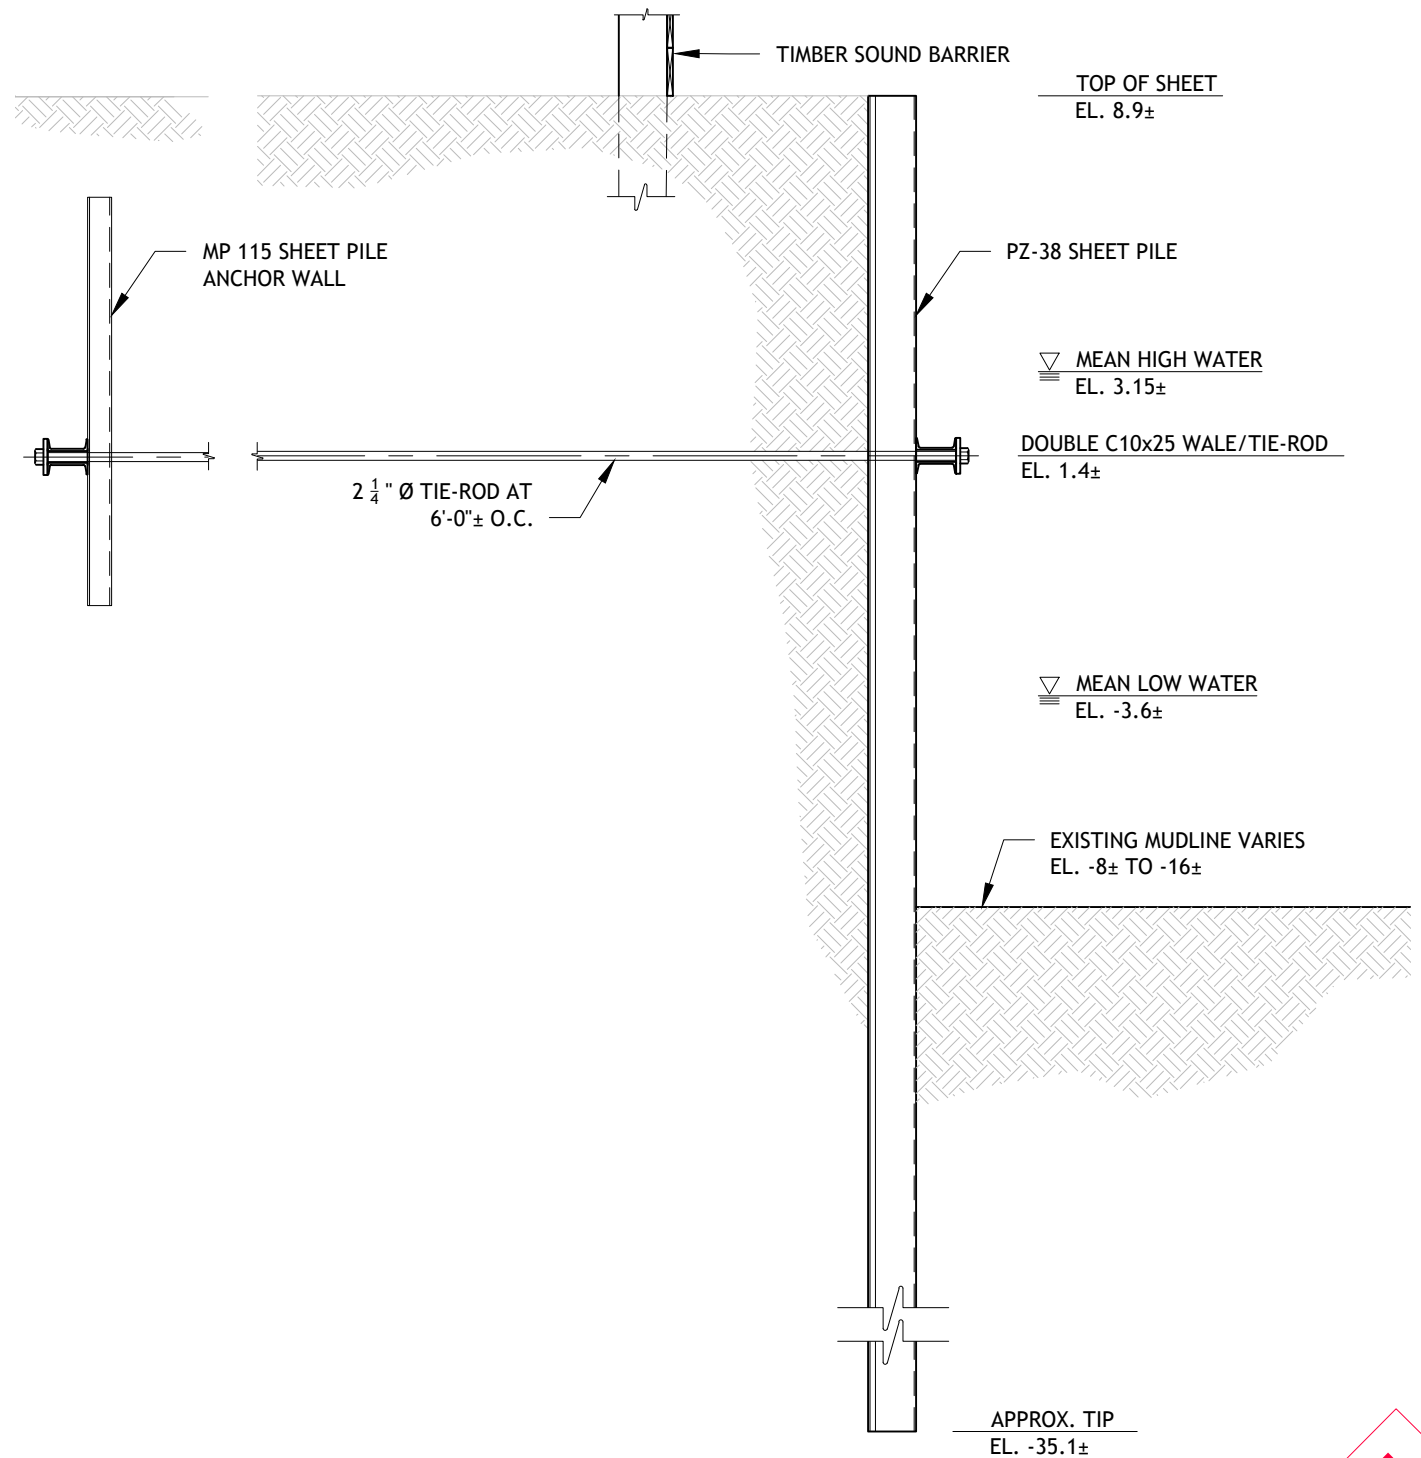
TYPE "B" BULKHEAD
STA 5+55 TO 7+40
SCALE: 1/4" = 1'-0"

Sheet Piles: The PZ-38 steel sheet piles are approximately 18-inches-wide (i.e., 36-inches per pair) by 12-inches-deep (Figure 2). The facility's main effluent line outfall was observed at Station 5+90, but was located below MLW and identified by active flow coming to the water surface (Photo No. 29). The outfall diameter could not be determined, but the record documents indicate that it is a 60-inch diameter Class IV RCP pipe.

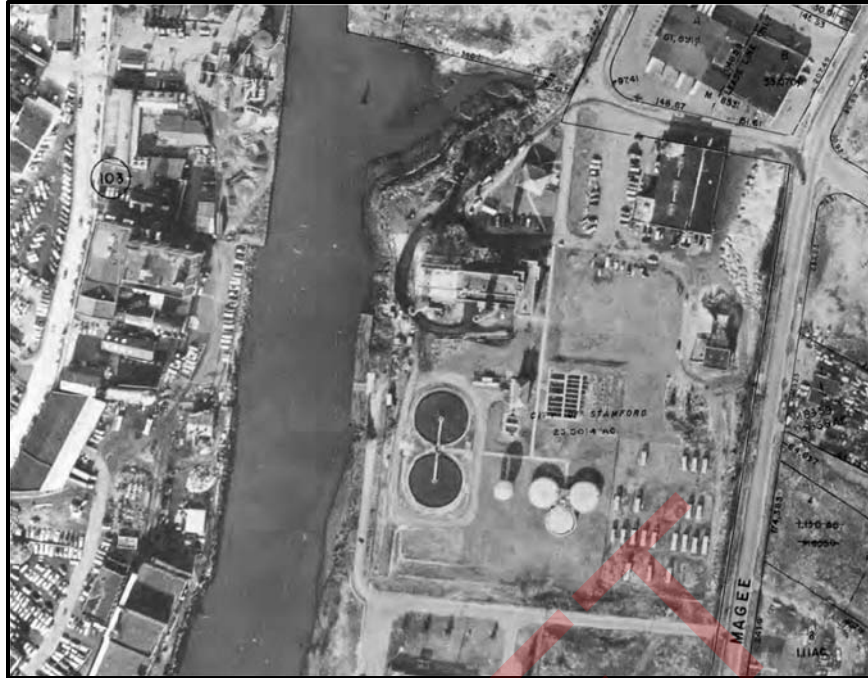
Based on a review of record documents provided by the City of Stamford's (the City's) Engineering Bureau and online resources, the existing site has reportedly been home to a municipal sewage/water treatment plant since 1949. For many years, the plant was situated on a predominantly undeveloped shoreline with a single timber wharf to provide waterfront access to the East Branch of the Stamford Harbor (Photo No. 1).

Photo No. 1:
Historic aerial photograph of the WPCA facility, circa 1959.

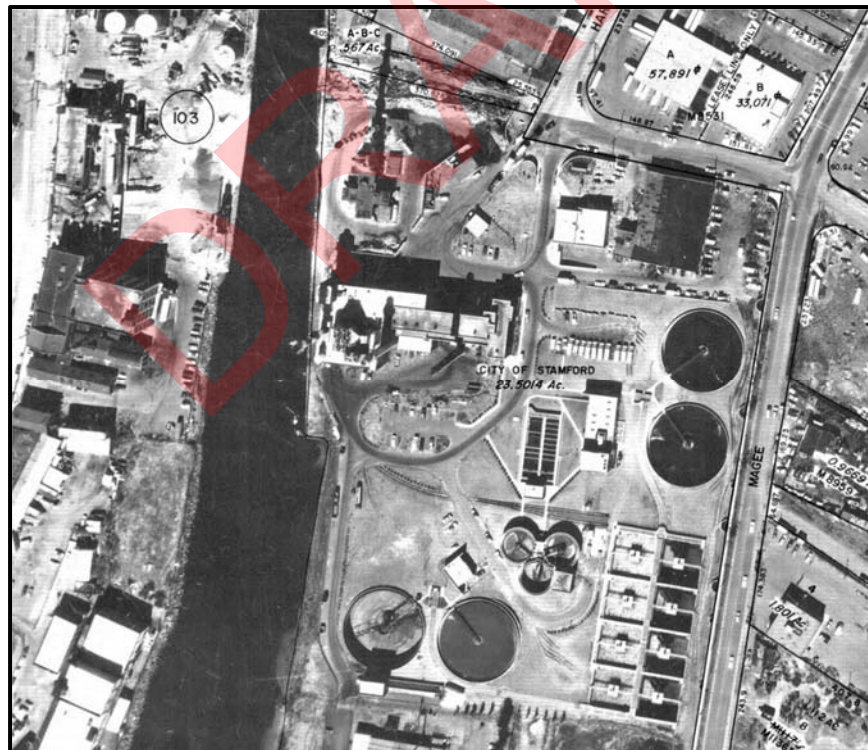
As the needs of the facility expanded, an anchored timber sheet pile bulkhead was installed across a cove at the north end of the property, and the cove was reportedly filled to provide additional space around 1971 (Photo No. 2). Since that time, the plant has undergone several major upgrades in the mid-1970's, late-1980's, and mid-2000's, including the addition of facilities for the Stamford Recycling and Sanitation Department (SRSD) and the replacement of the timber bulkhead with an anchored steel sheet pile bulkhead.

Photo No. 2:
Historic aerial photograph of the WPCA facility, circa 1979.

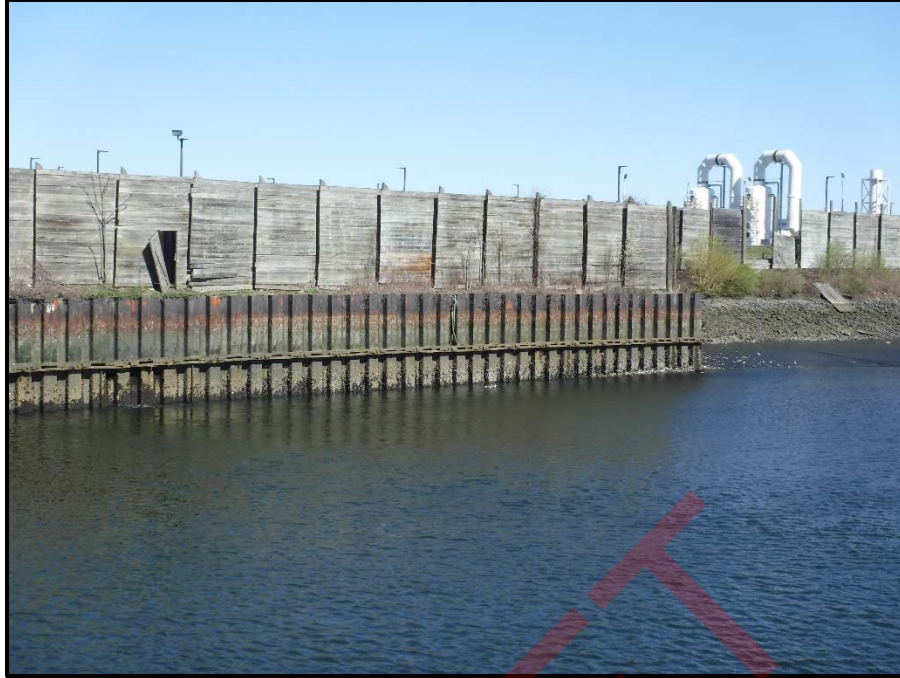
- Around 1972, what this report refers to as the Type "B" Bulkhead, was constructed at the southern end of the timber bulkhead (Station 5+55 to 7+40) (Figure 1) (Photo No. 3). The Type "B" Bulkhead consists of a US Steel PZ-38 sheet pile wall with a double C10 x 25 channel wale, and is anchored with one (1) 2.25-inch-diameter tie-rod every 6-feet on-center to an MP 115 steel sheet pile anchor wall (Figure 2).

The Type B Bulkhead is located from about Station 5+55 to 7+40 (Figure 1 and Photo No. 3). A typical section of this bulkhead type is shown in Figure 2. In summary:

Photo No. 3:
Type "B" Bulkhead, STA 5+80 to 6+90, facing east, photo taken by RTG on April 16th, 2019.

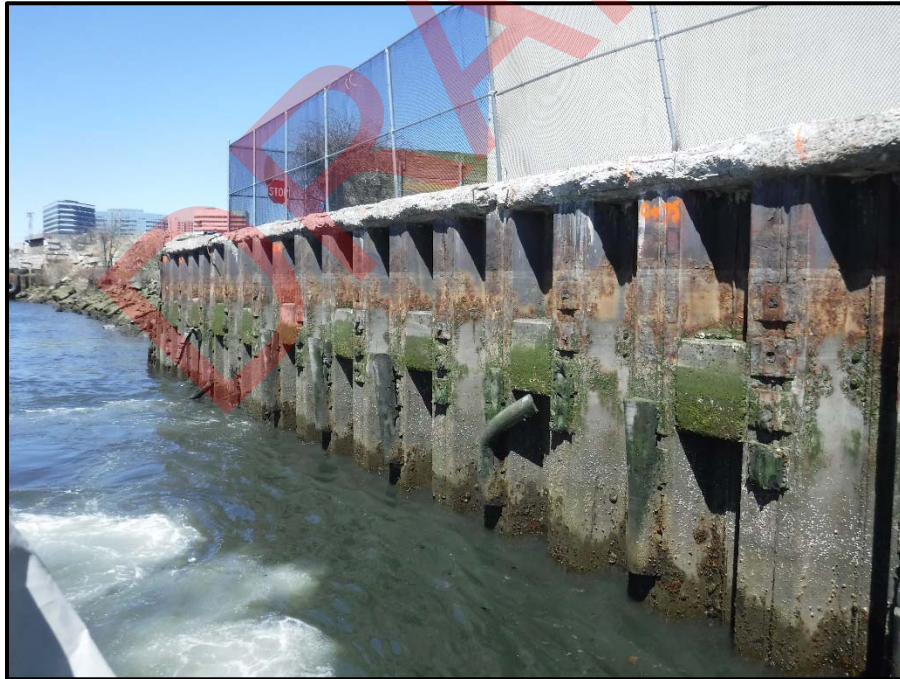
- At some point between 1981 and 1989, what this report refers to as the Type "A" Bulkhead, was constructed in front of the timber bulkhead (Station 0+00 to 5+55) (Figure 1). The Type "A" Bulkhead was installed approximately 2'-3" in front of the timber bulkhead (i.e., over-sheeted), and consists of anchored sheet piles of an unknown type and a concrete cap (Photo No. 4).

The Type A Bulkhead is located from about Station 0+00 to 5+55 (Figure 1 and Photo No. 4). A typical section of this bulkhead type is shown in Figure 2. In summary:

Photo No. 4:
Type "A" Bulkhead, STA 0+15 to 0+75, facing north, photo taken by RTG on April 16th, 2019.

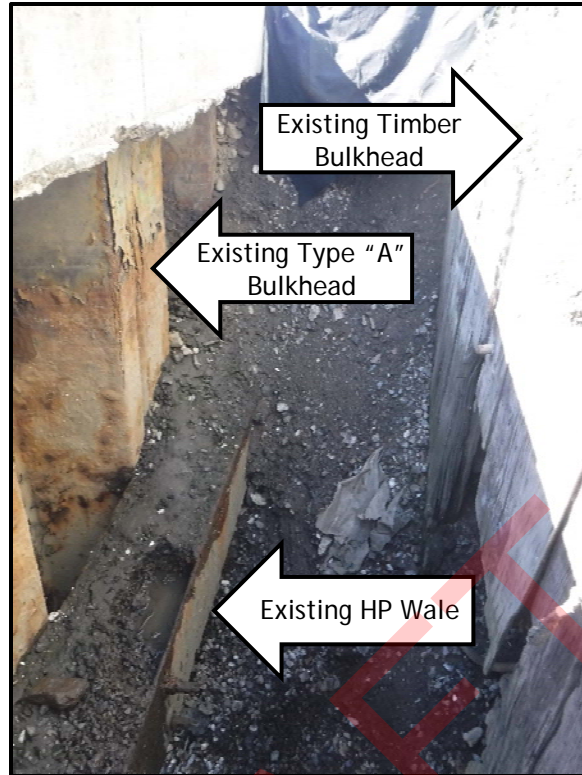
The anchor system for the Type "A" Bulkhead consists of what appears to be an HP12x63 wale mounted to the interior of the sheet piles (Photo No. 5), and tiebacks. However, it is not known if these are tie-rods or strand anchors, as their heads are fitted with steel caps and encased in concrete (Photo Nos. 6 and 7). Rubber "D" fenders are located on the outboard face of the Type "A" Bulkhead as well (Photo No. 8).

Photo No. 5:
Type "A" Bulkhead, STA 1+47, facing northwest, photo taken by RTG on April 16th, 2019.

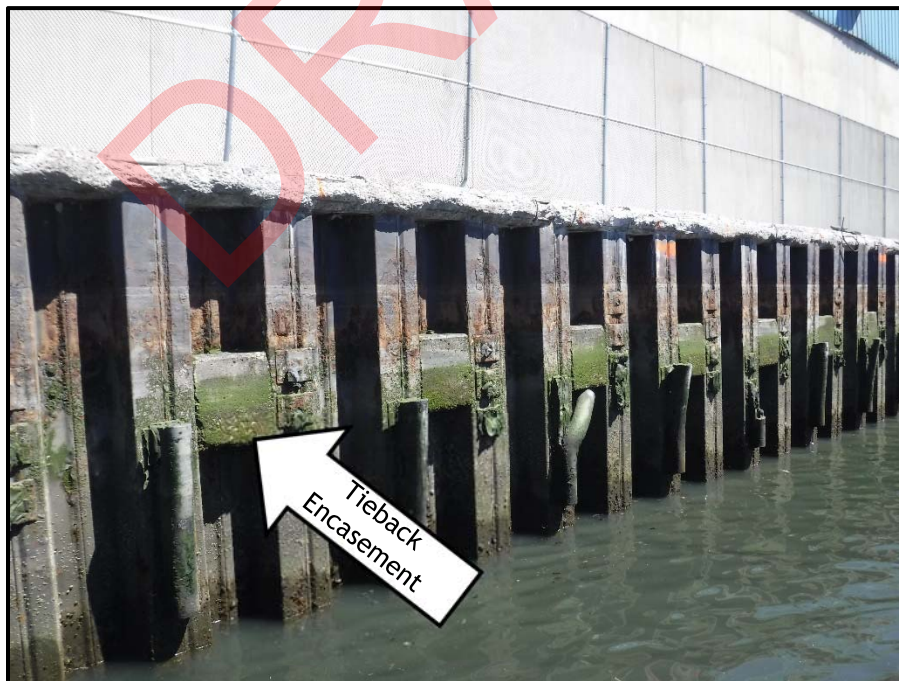
Tiebacks: The tieback anchors are fitted with steel caps and encased in concrete about 5'-8" below the top of the concrete cap (Figure 2) (Photo No. 6). Therefore, the tiebacks were not accessible for inspection. In general, the concrete encasements appeared to be in fair condition, except around Station 1+15, where two (2) encasements are spalled and the tieback caps are visible.

Photo No. 6:
Type "A" Bulkhead, STA 0+57 to 1+00, facing east, photo taken by RTG on April 16th, 2019.

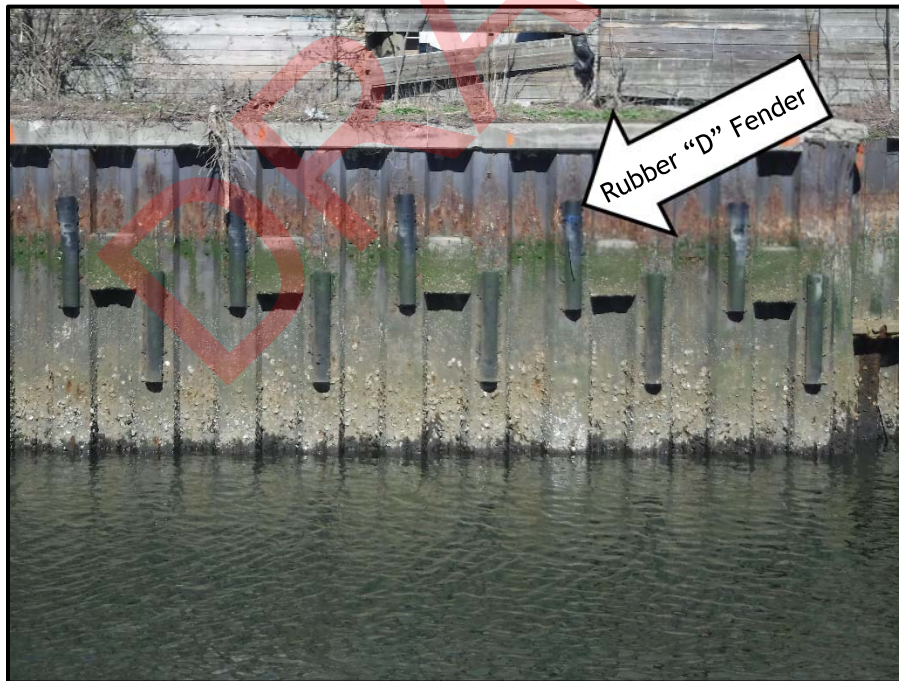
Photo No. 8:

Fendering: As previously mentioned, rubber "D" fenders were installed along this bulkhead type at two elevations (Photo No. 8). The upper level of fenders, about 5'-0" from the top of the concrete cap, are almost entirely missing between Station 0+15 and 4+00. The lower level of fenders, about 8'-6" from the top of the concrete cap, are generally intact, but

many are damaged and deteriorated. Overall, the fendering was observed to be in poor to failed condition.

Type "A" Bulkhead, STA 5+20 to 5+50, facing east, photo taken by RTG on April 16th, 2019.

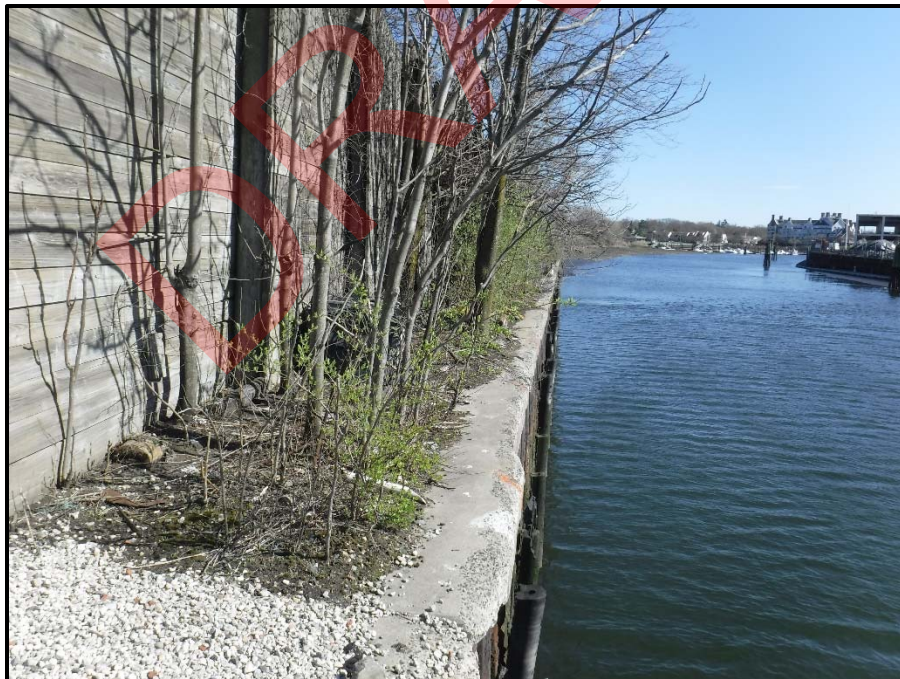
Photo No. 10:

From about Station 3+70 to 5+55, an approximately 15-foot-tall timber sound barrier is located approximately 4-feet behind the back of the cap. At the time of the inspection, dense vegetation, goose nests, and stowed fishing pots were situated between the cap and the sound barrier from Station 3+70 to 5+25, which prevented access to the top of the bulkhead in this area (Photo Nos. 10 and 11).

Type "A" Bulkhead, STA 3+70, facing southeast, photo taken by RTG on April 16th, 2019.

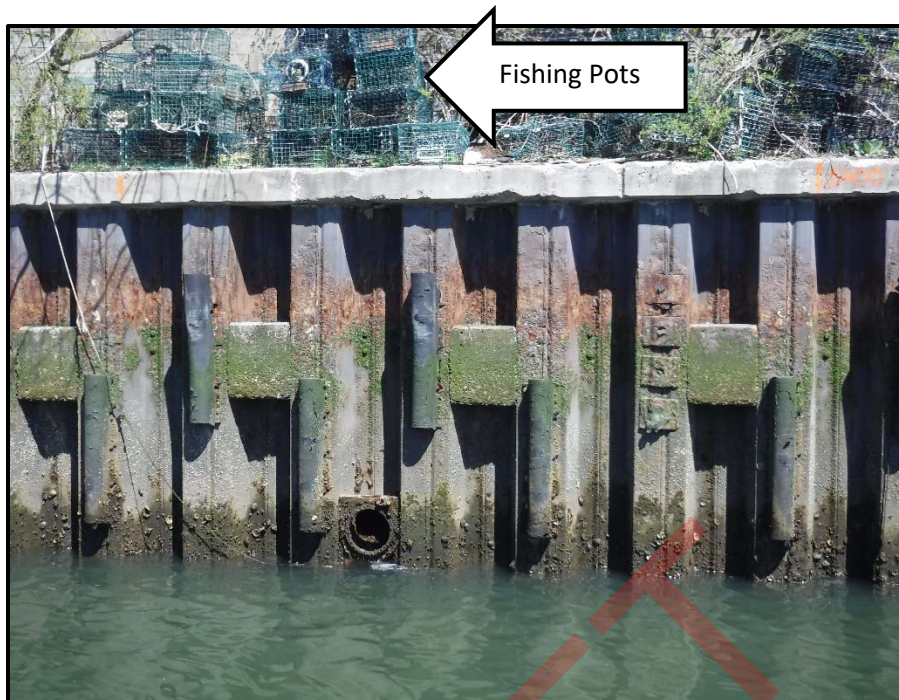
Photo No. 11:
Type "A" Bulkhead, STA 4+70 to 5+00, facing northeast, photo taken by RTG on April 16th, 2019.

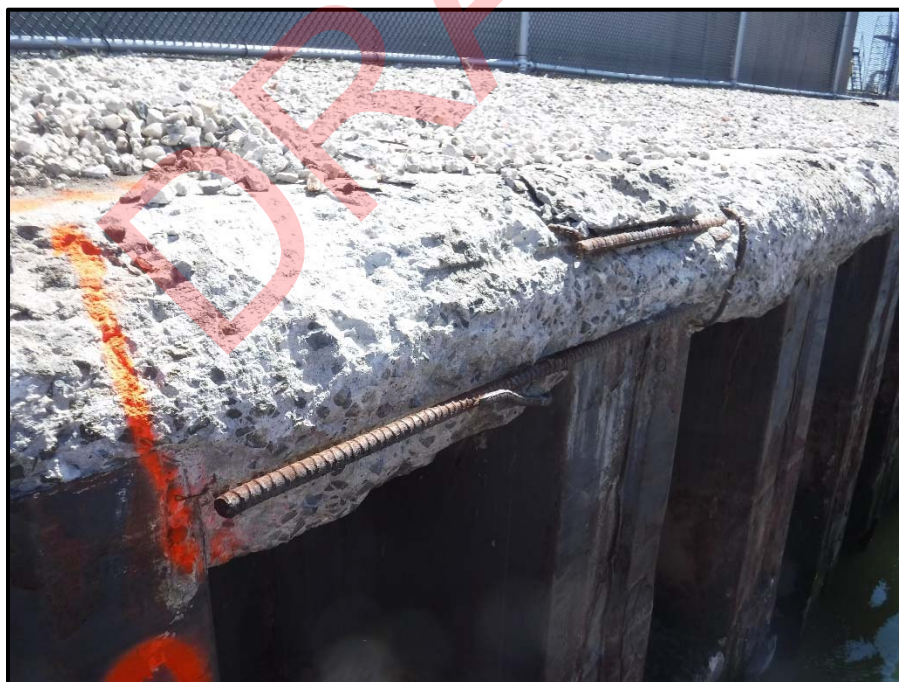
The concrete cap is heavily spalled along its outboard edge along its entire length, and rebar is exposed at many locations (Photo No. 12). At Stations 0+10 to 0+17, 2+45 to 2+51, and 5+53, the cap is almost entirely missing, exposing the tops of the sheet piles (Photo Nos. 13, 14, and 15).

Photo No. 12:
Type "A" Bulkhead, STA 1+00, facing east, photo taken by RTG on April 16th, 2019.

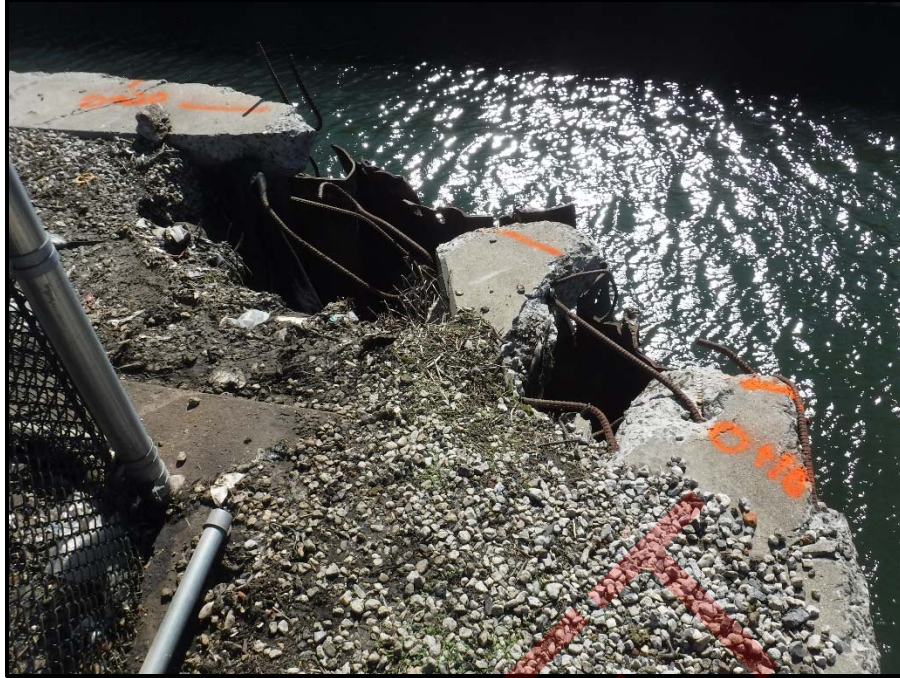
At Stations 0+15 and 5+50, the sheet piles are heavily damaged, possibly due to vessel impacts (Photo Nos. 13 and 15). At about Station 3+00, the sheet piles and cap lean inboard about 1-foot over a 5-foot length.

Photo No. 13:
Type "A" Bulkhead, STA 0+10 to 0+20, facing west, photo taken by RTG on April 16th, 2019.

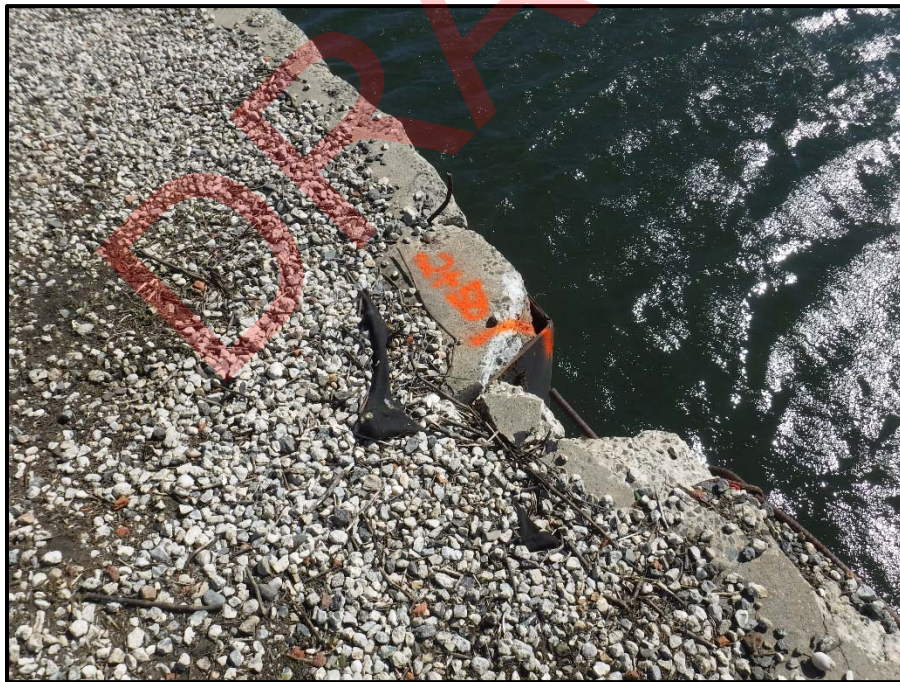
Photo No. 14:
Type "A" Bulkhead, STA 2+50, facing southwest, photo taken by RTG on April 16th, 2019.

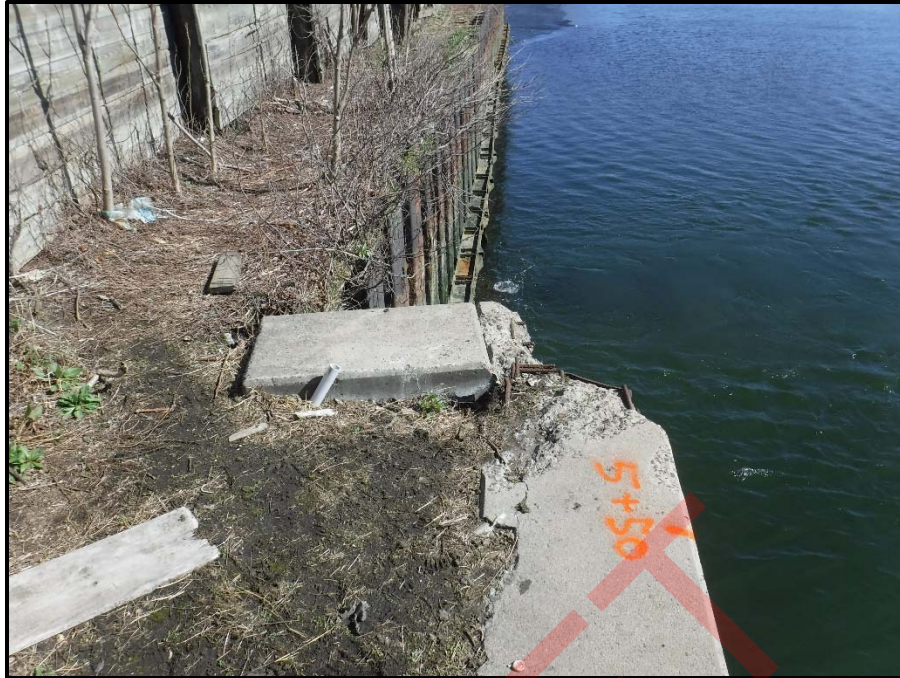
Photo No. 15:

Type "A" Bulkhead, STA 5+50, facing southeast, photo taken by RTG on April 16th, 2019.

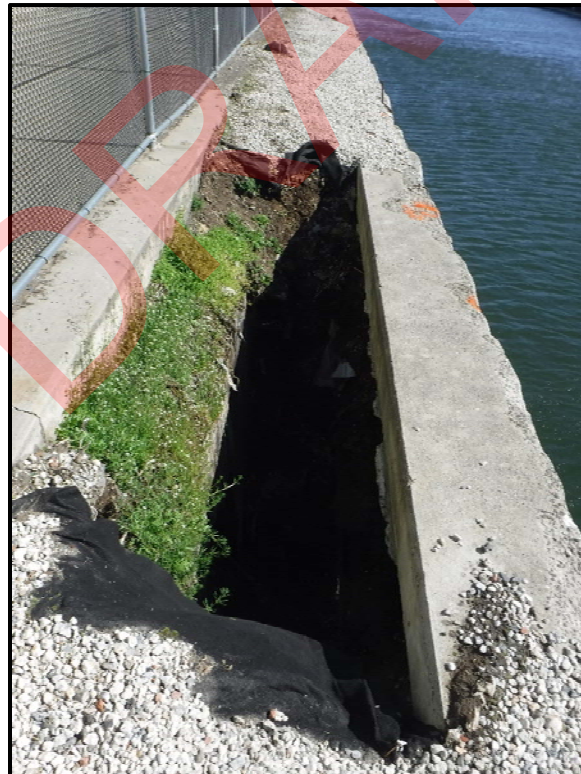
Photo No. 16:

Significant erosion of the backfill material (up to 6-feet deep from the top of the cap) was observed from Stations 1+40 to 1+55, 2+80 to 3+05, and 3+25 to 3+40 (Photo Nos. 16, 17, and 18). This erosion is undermining the adjacent concrete pavement, and appeared to be caused by torch-cut holes in the sheeting approximately 12-inches in diameter at about 7-feet from the top of the cap at each eroded location (Photo No. 19). Overall, the concrete cap was observed to be in poor to failed condition.

Type "A" Bulkhead, STA 1+40 to 1+55, facing southeast,
photo taken by RTG on April 16th, 2019.

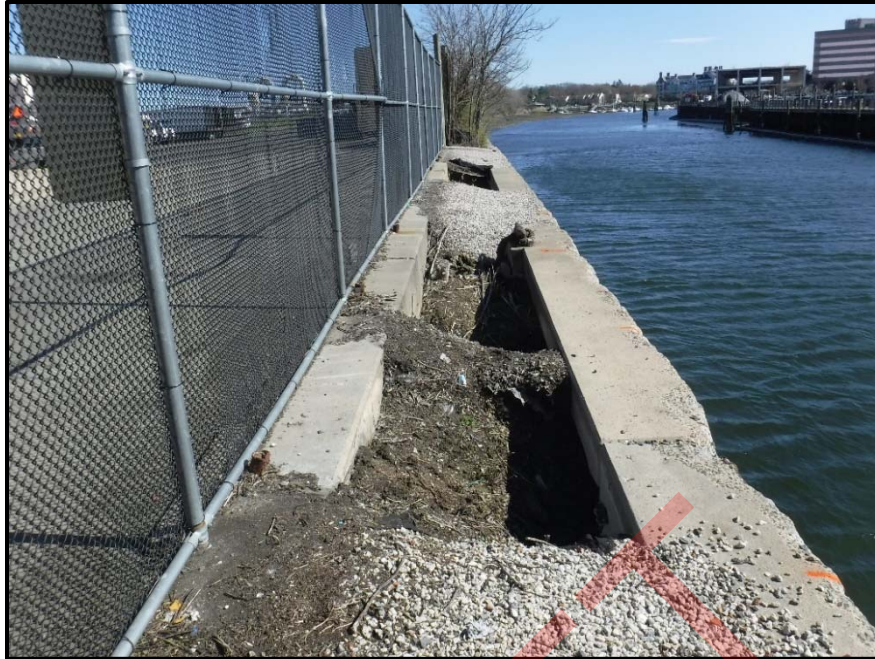
Photo No. 17:
Type "A" Bulkhead, STA 2+80 to 3+05, facing southeast,
photo taken by RTG on April 16th, 2019.

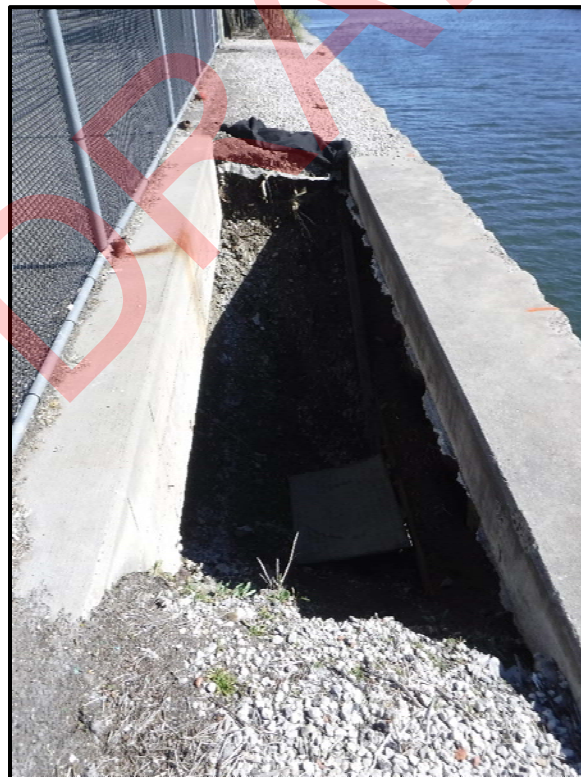
Photo No. 18:
Type "A" Bulkhead, STA 3+25 to 3+40, facing southeast,
photo taken by RTG on April 16th, 2019.

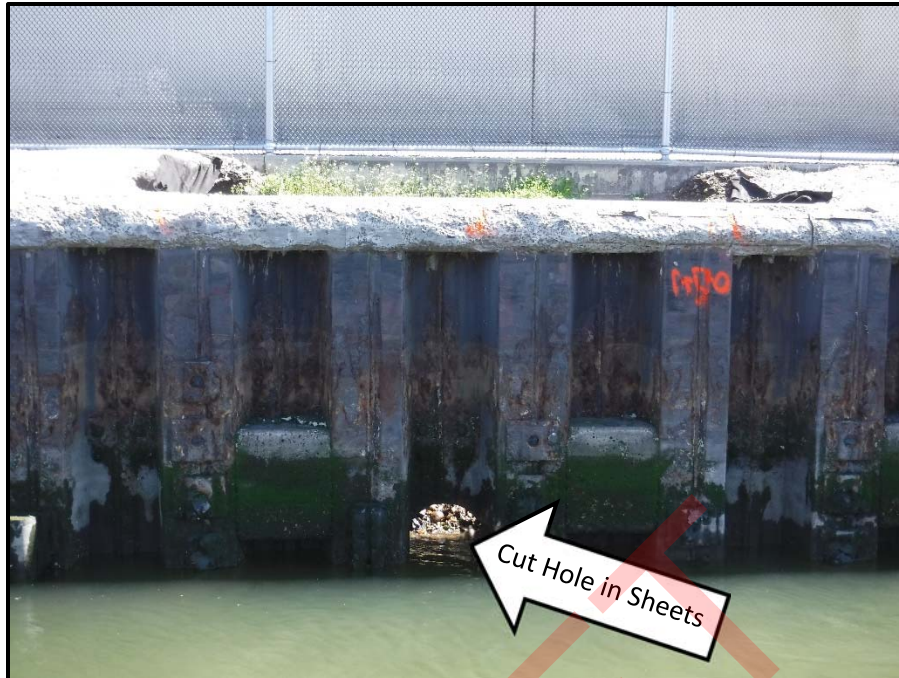
Photo No. 19:
Type "A" Bulkhead, STA 1+37 to 1+55, facing northeast,
photo taken by RTG on April 16th, 2019.

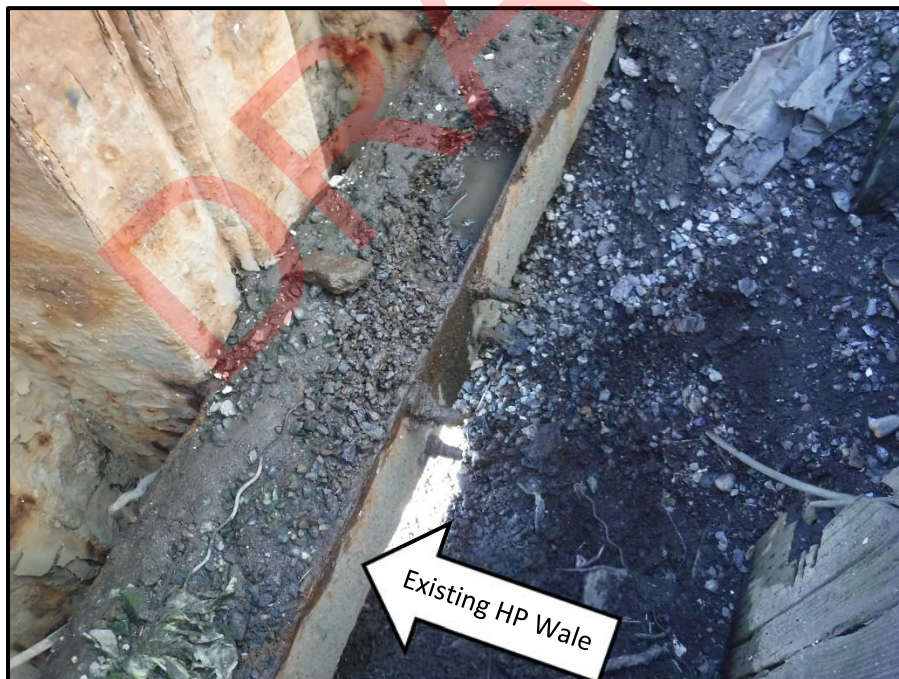
At the time of the inspection, water and soil were trapped in the web of the wale, and the web, flanges, and hardware were moderately corroded. Overall, the limited exposed area of the wale indicated it was in poor condition.

Photo No. 20:
Type "A" Bulkhead, STA 1+47, facing northwest, photo taken by RTG on April 16th, 2019.

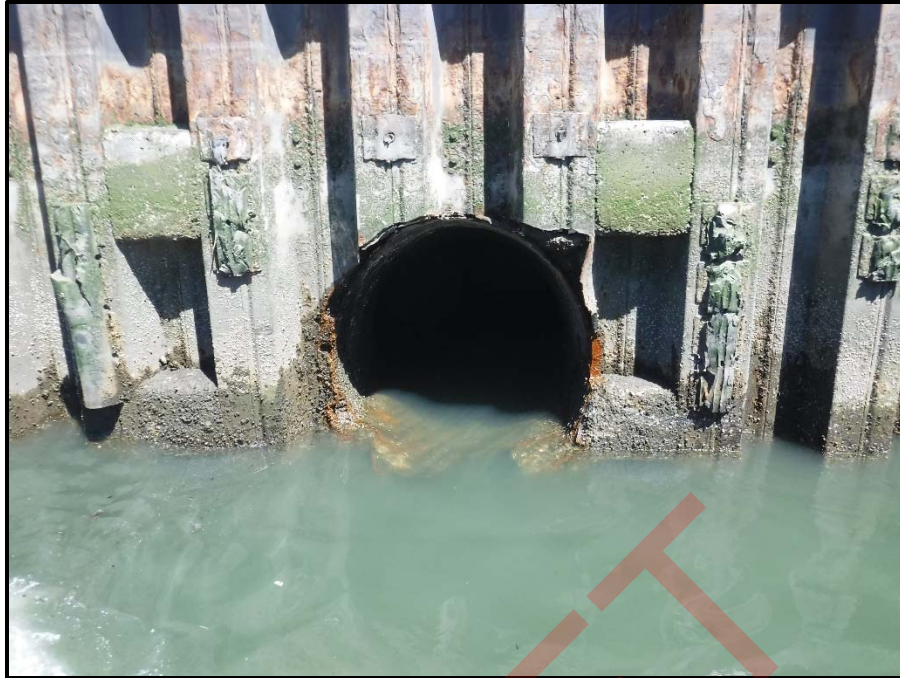
Photo No. 21:

Type "A" Bulkhead, STA 1+10, facing northeast, photo taken by RTG on April 16th, 2019.

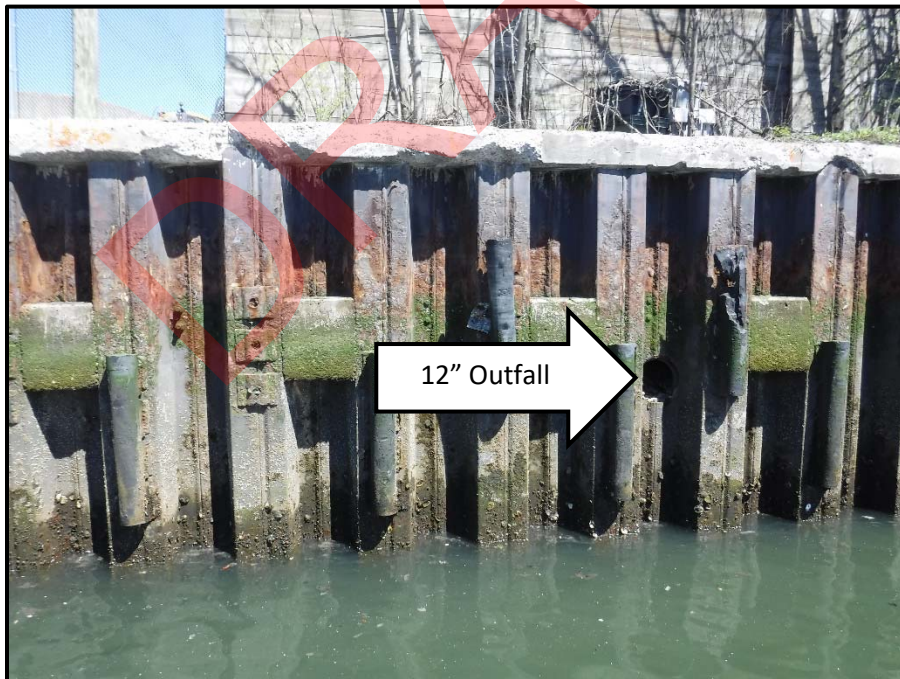
Photo No. 22:

Type "A" Bulkhead, STA 3+70 to 3+90, facing northeast,
photo taken by RTG on April 16th, 2019.

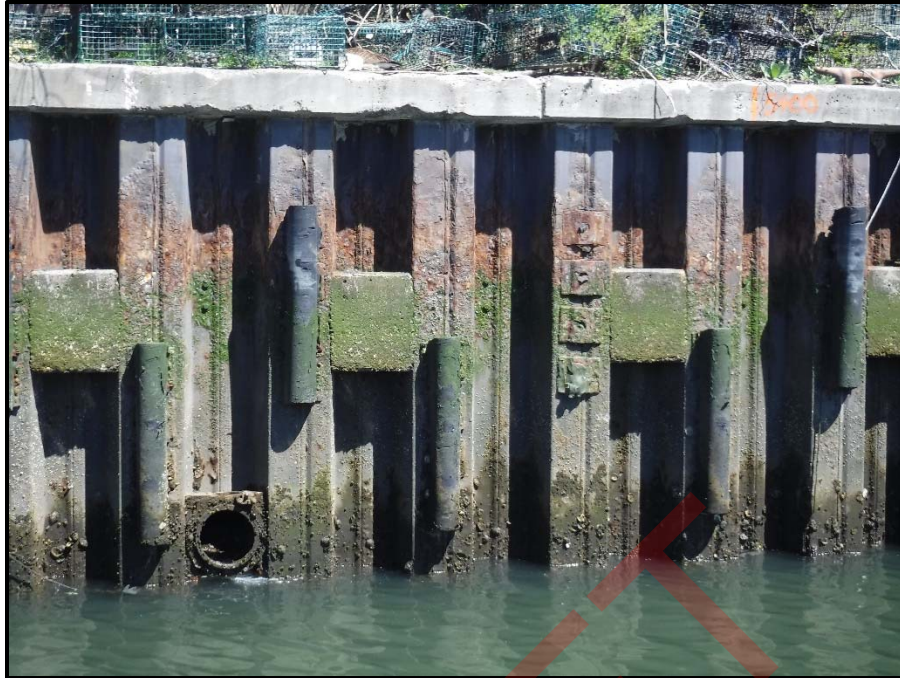
Photo No. 23:

Type "A" Bulkhead, STA 4+85 to 5+00, facing east, photo taken by RTG on April 16th, 2019.

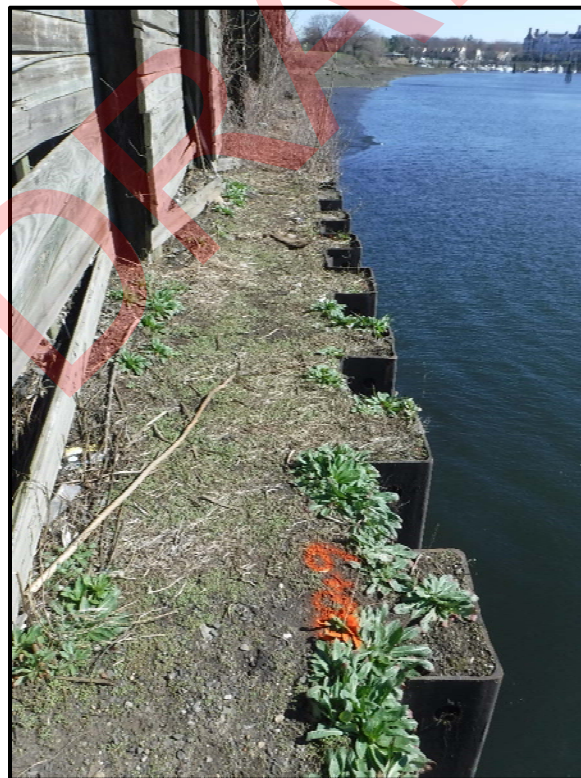
Photo No. 24:

Cap: The Type B bulkhead does not have a cap. The previously mentioned timber sound barrier is also located along the entire length of the Type B Bulkhead, approximately 4-feet behind the back of the sheeting. The top of the bulkhead is about El. 8.9, and grade between the sheeting and the timber sound barrier is flat and vegetated with brush and grass (Photo No. 24).

Type "B" Bulkhead, STA 6+00, facing southeast, photo taken by RTG on April 16th, 2019.

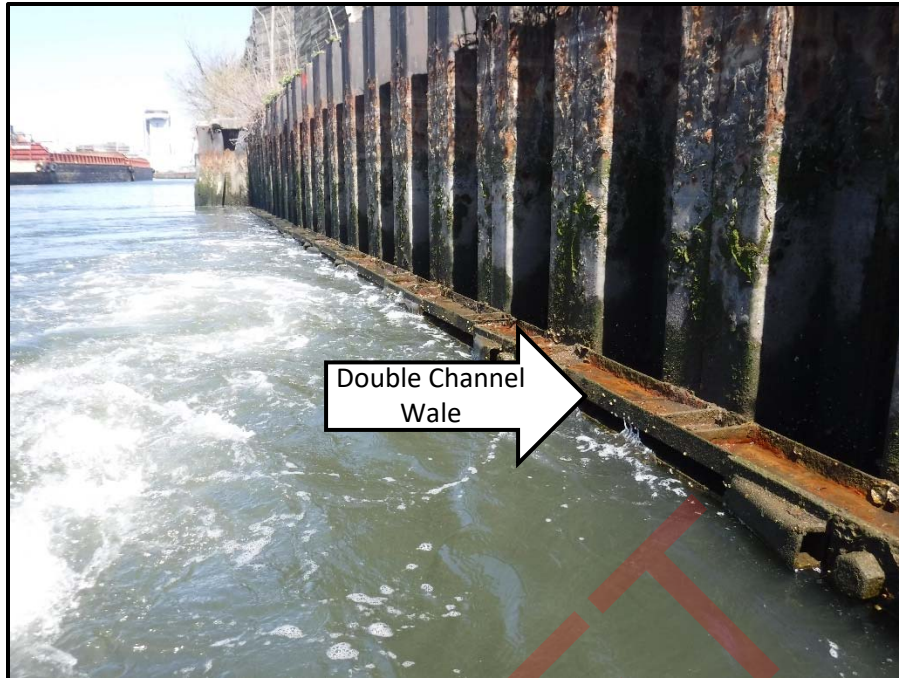
Photo No. 25:

Wale: The double C10x25 channel wale is mounted to the outboard face of the existing bulkhead about 7'-6" from the top of the sheeting (Photo No. 25). At the time of the inspection, it could not be determined how the wale was secured to the bulkhead, though the record documents indicate a welded connection between the channel flanges and the bulkhead.

Type "B" Bulkhead, STA 6+90, facing north, photo taken by RTG on April 16th, 2019.

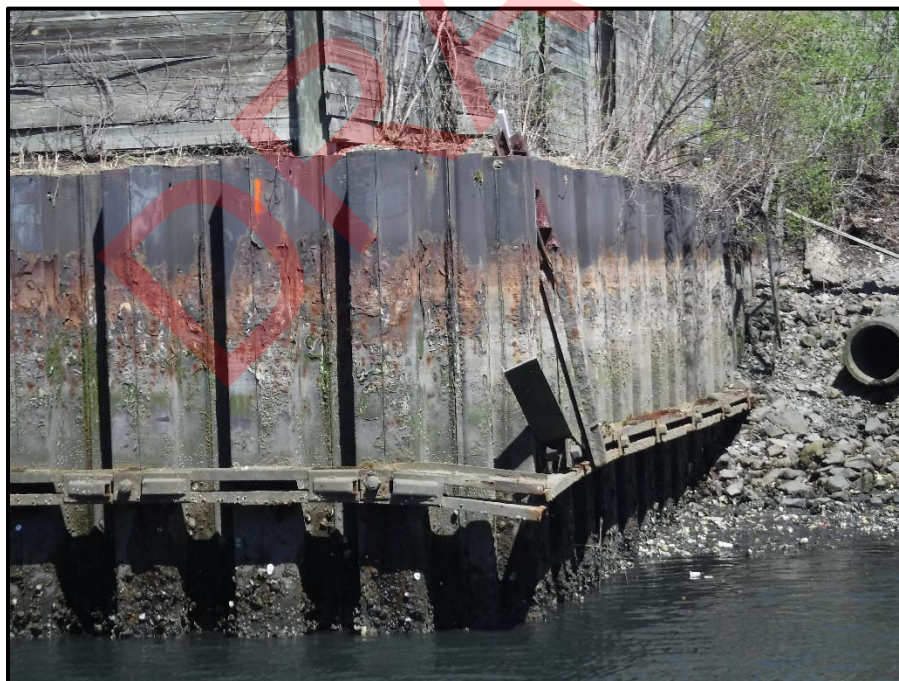
Photo No. 26:

Moderate pitting, corrosion, and section loss were observed throughout the length of the wale, and significant damage was noted between Station 6+90 and 7+00 (Photo No. 26). At several tie-rod connections, the flanges of the wale had completely corroded. Overall, the wale was observed to be in poor condition, with one section considered failed.

No major damage to the sheet piles was observed. The existing coating on the sheet piles is cracked and chipping above MHW, and is almost completely missing between MHW and MLW. Scale, rust, and marine growth were observed from about 2-feet above MHW to MLW (Photo No. 26). Overall, the sheet piles were observed to be in fair condition above MLW.

Type "B" Bulkhead, STA 6+85 to 7+40, facing northeast,
photo taken by RTG on April 16th, 2019.

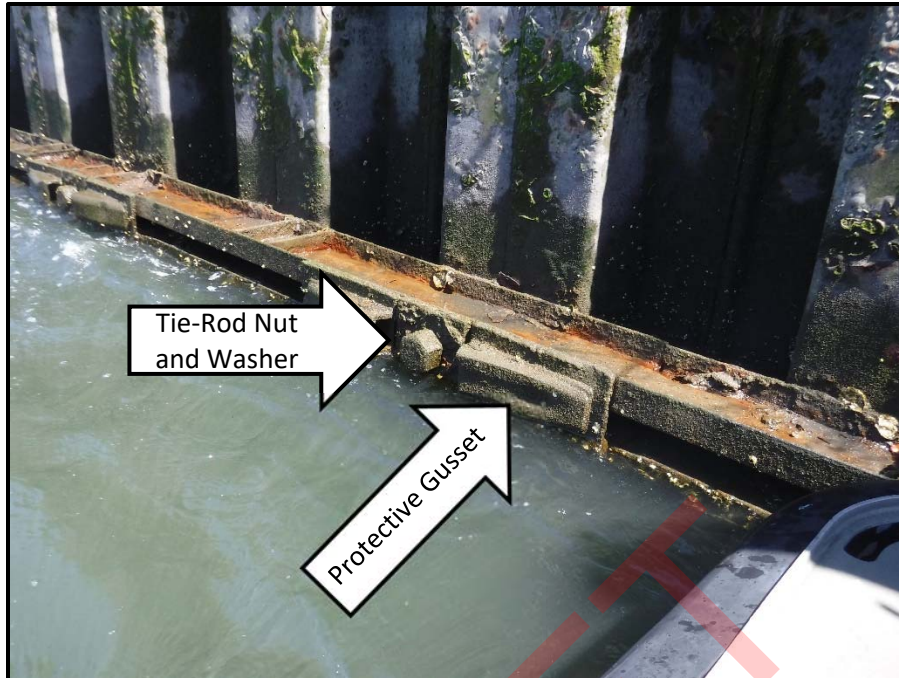
Tie-Rods: The tie-rods consist of threaded steel anchors with a nut, 9-inch square steel bearing plate, and protective gussets (Photo No. 27). The tie-rod spacing is about 6'-0" on-center (i.e., every other sheet pile pair). The majority of the tie-rod bearing plates, nuts, and protective gussets were observed to be intact, though three (3) tie-rods were observed to be bent and displaced between Station 5+88 to 6+00 (Photo No. 28). The tie-rod diameter and overall condition was not determined during the inspection due to limited access.

Photo No. 27:
Type "B" Bulkhead, STA 6+80, facing north, photo taken by RTG on April 16th, 2019.
