PLAYGROUND SAFETY INSPECTION REPORT

DATE: May 16, 2019

SITE: K T Murphy Elementary School
19 Horton Street
Stamford, CT 06902

DATE OF INSPECTION: April 26, 2019

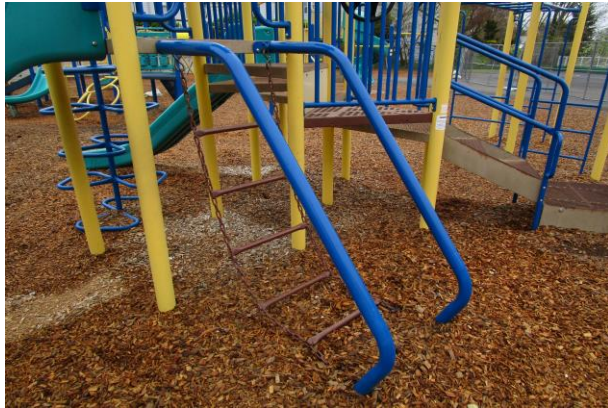
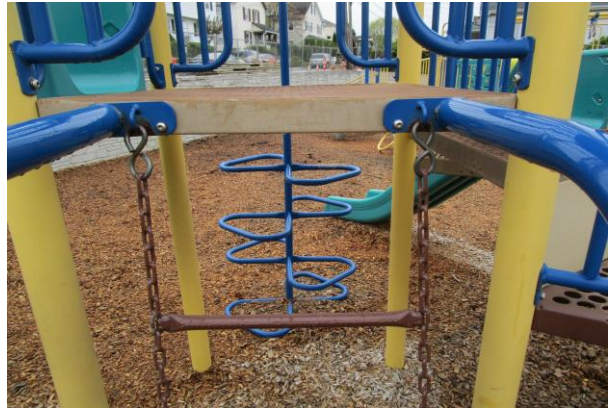
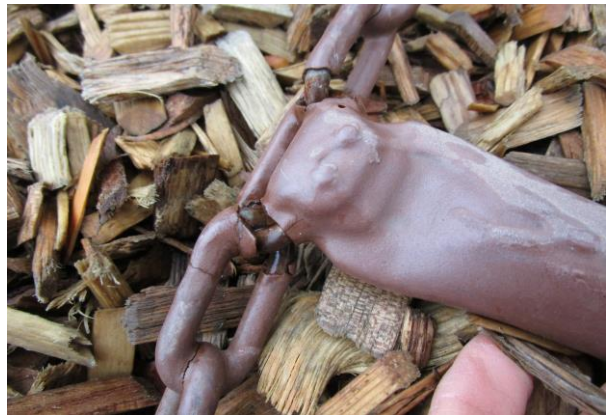
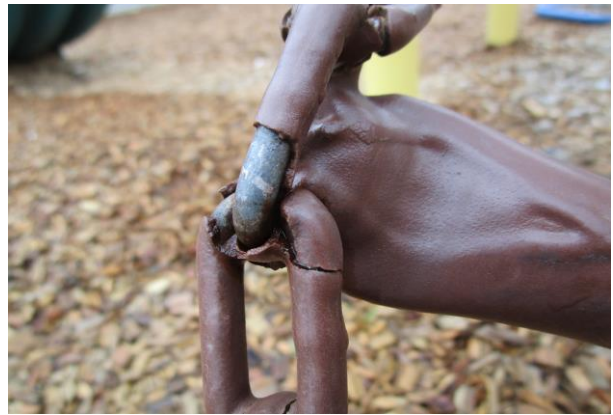
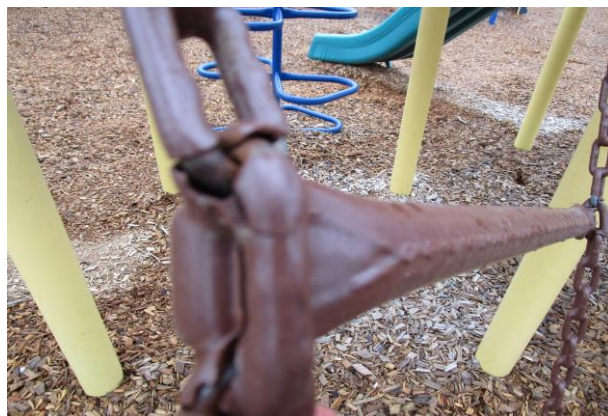
Small Composite Structure #1 - GameTime
Chain Net Climber - Plastisol cracked at chain - MAINTENANCE

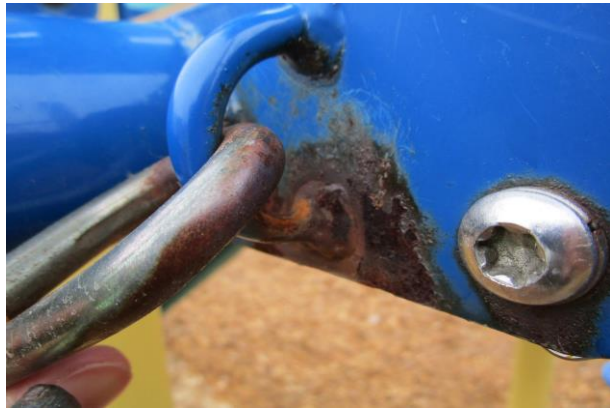
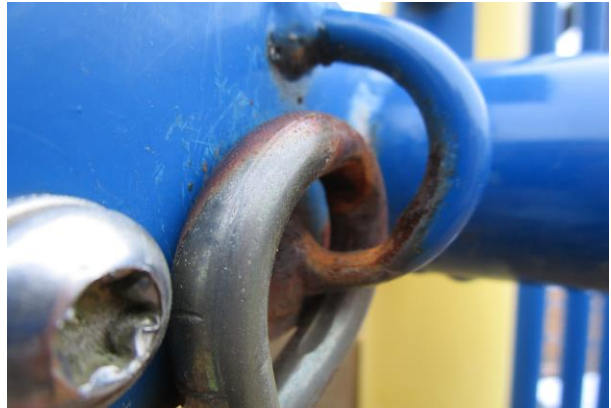
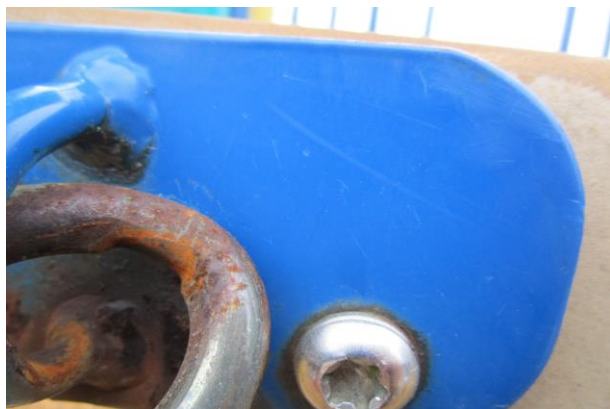
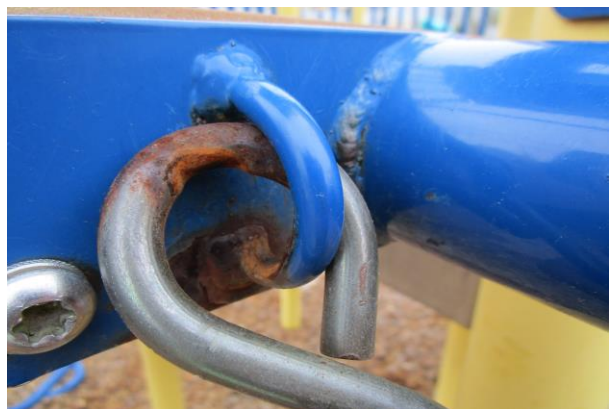
Condition	Hazard Priority	Recommendation
Small Composite Structure #1 (GameTime)				
Components				
Swift Rider Slide		Good		
Chain Net Climber with Rails		Brackets & "S"-Hooks worn	B	Replace rail/bracket combo (2) & two "S"- Hooks
		Plastisol cracked at chain	Maint.	Monitor
Transfer Platform		Plastisol worn & missing	Maint.	Monitor
"S" Horizontal Loop Ladder		Good		
Overhead Ladder		Good		
Rung Ladders (3)		Good		
Glide Slide		Good		
Clover Climber		Good		
Decks (7)		Plastisol worn & missing	Maint.	Monitor
Pyramid Roof (1)		Good		
Stairs (1)		Cracked at joint	Maint.	Replace stairs at Transfer Platform
Surfacing	EWf 9-12"	Good		
		No wear mats at slide exits	C	See Notes
Use Zone		Good		
Structural Stability		Good		
Large Composite Structure #2 (GameTime)				
Components				
Bubble Climber		Good		
Double Trapeze Rings		Good		
Inverted Arch Ladder		Good		
Three Level Chinning Bar		Good		
Bannister Rails		Good		
Stairs (2)		Good

Chain Net Climber w/ Rails - Brackets & "S"- Hooks worn - CLASS B HAZARD

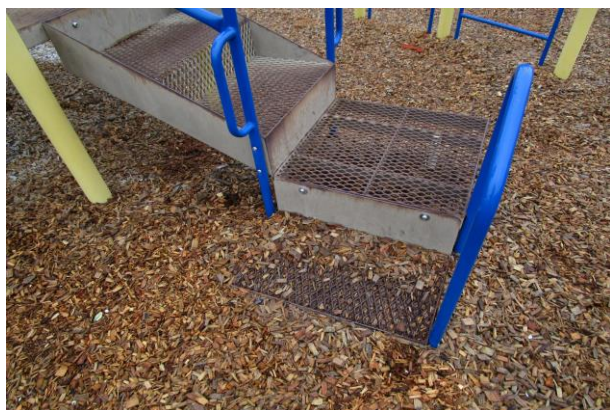
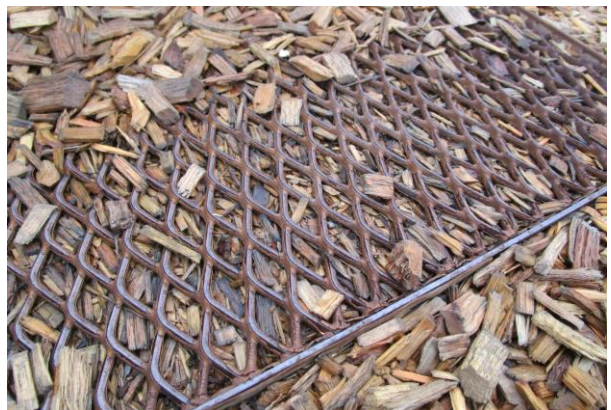
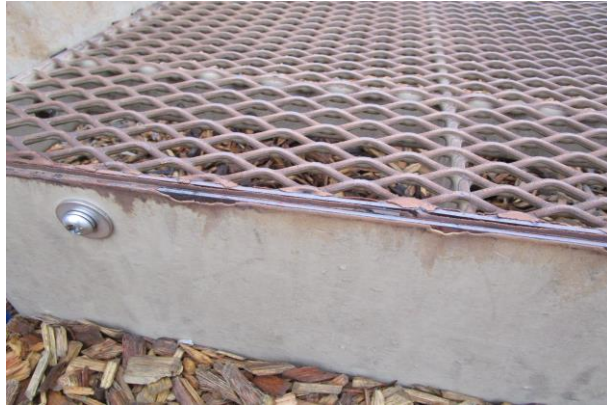
Transfer Platform - Platisol worn & missing - MAINTENANCE

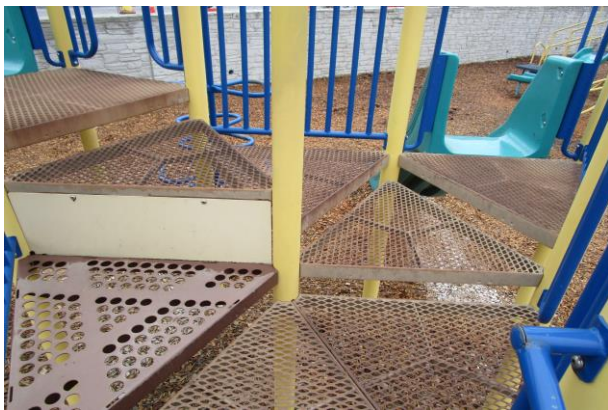
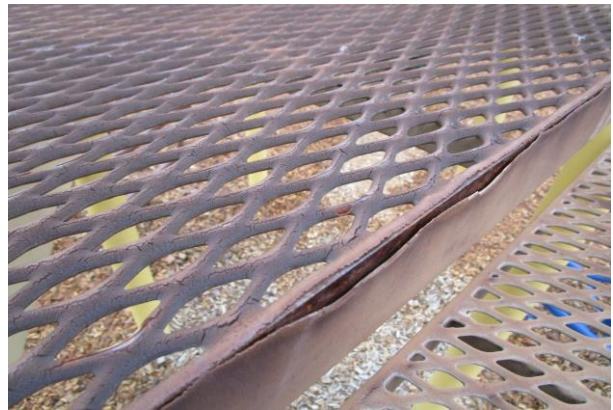
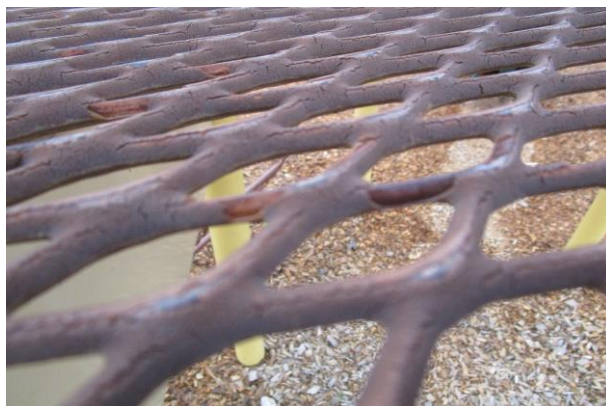
Decks (7) - Plastisol worn & missing - MAINTENANCE

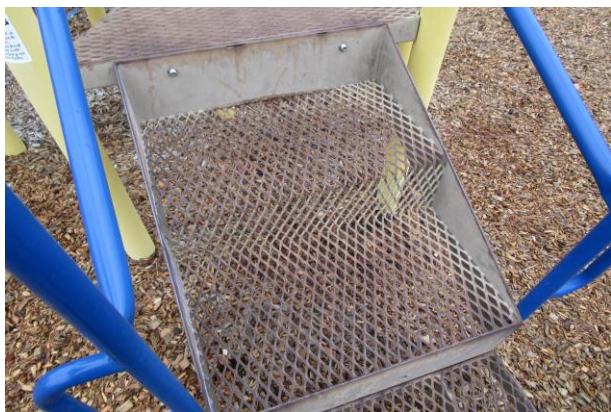
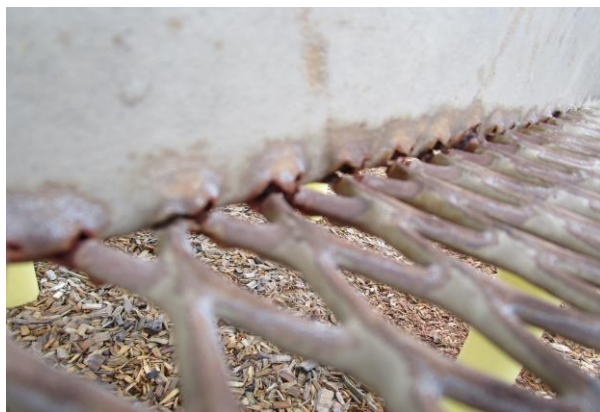
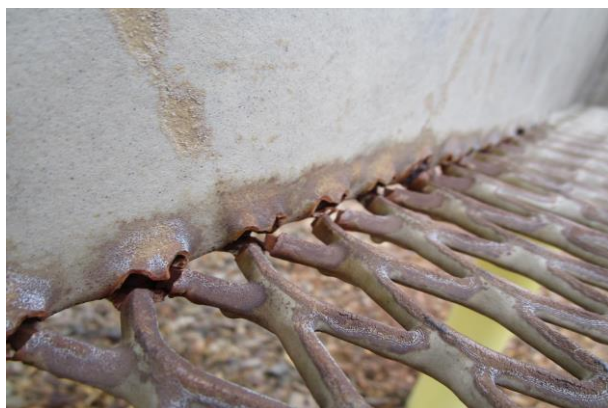
Stairs (1) - Cracked at joint - MAINTENANCE

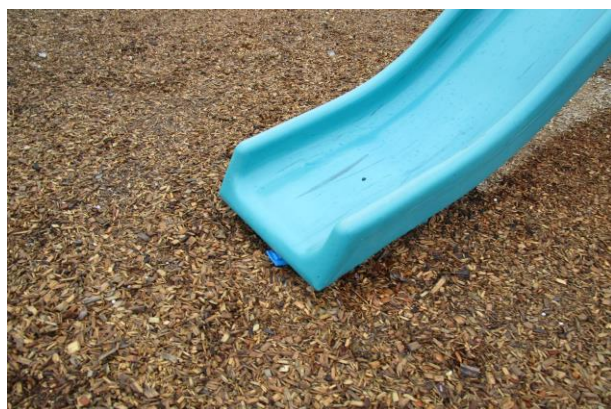
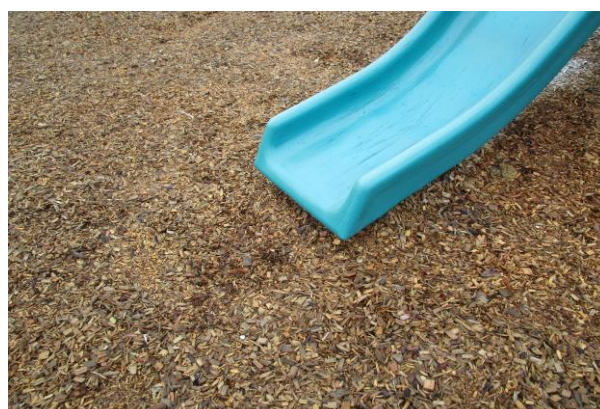
There are no wear mats at the slide exits. ADA requires wear mats for accessibility and the prevention of holes at the slide exits.

Surfacing - No wear mats at slide exits - CLASS C HAZARD

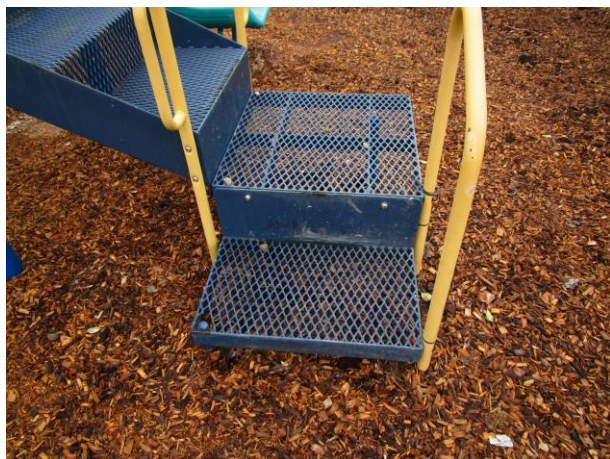
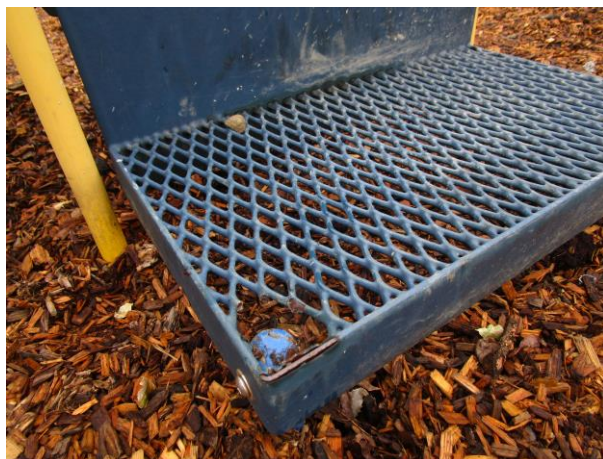
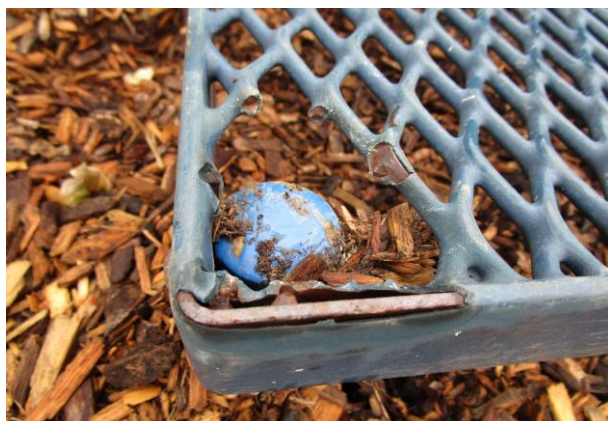
Condition	Hazard Priority	Recommendation
Arch Bridge		Good		
Straight Poly Slide		Good		
Tree Climber		Good		
Transfer Platform		Step broken & sharp	B	Replace step at Transfer Platform
Curved Slide		Bed way cracked at support	Maint.	Monitor
Crawl Tube		Good		
Suspension Bridge		Good		
Crazy Eight Climber		Good		
Spiral Slide		Good		
Chain Net Climber		Good		
Bugeye Bubble Panel		Good		
Tic Tac Toe (Baseball)		Good		
Solar System Panel		Good		
Decks (11)		Two □ decks cracked, one Δ deck at joints	Maint.	Replace one Δ deck & two □ deck
Surfacing	EWf 8-12"	Good		
		No wear mats at slide exits	C	See Notes
Use Zone		Good		
Structural Stability		Good		
Freestanding Equipment				
Funnel Ball (BCI Burke)		Bucket very loose at bolts	Maint.	Tighten hardware
Surfacing		N/A		
Use Zone		N/A		
Structural Stability		Good

Transfer Platform - Step broken & sharp - CLASS B HAZARD

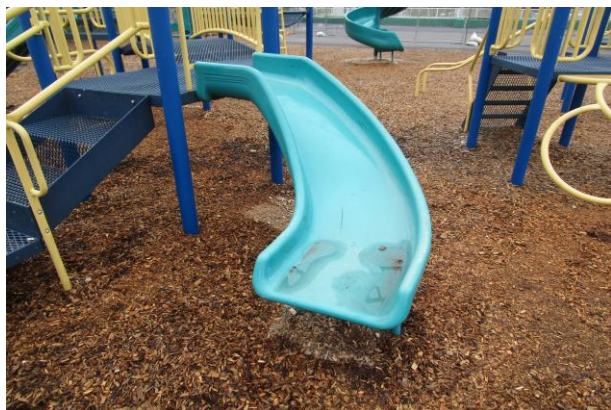
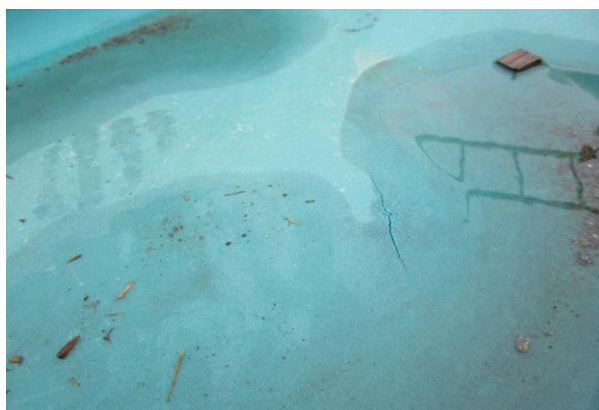
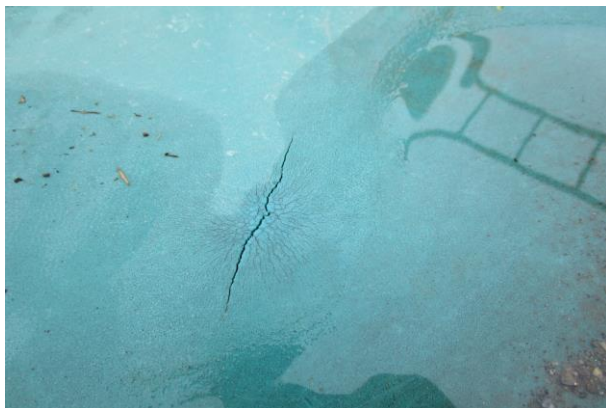
Curved Slide - Bed way cracked at support - MAINTENANCE

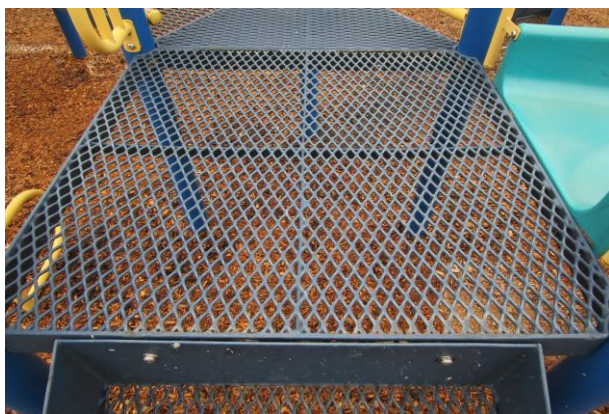
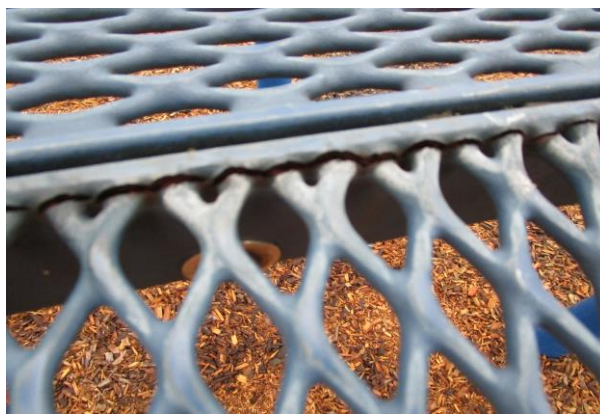
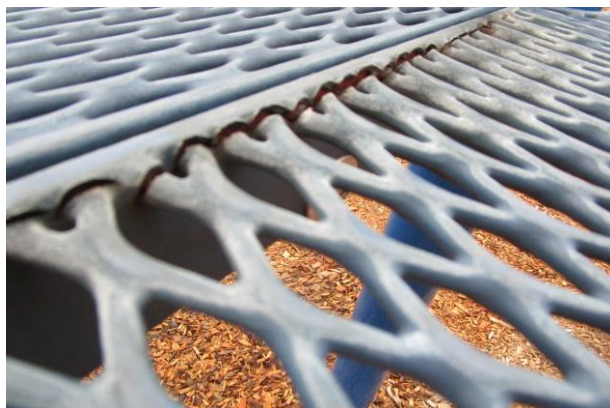
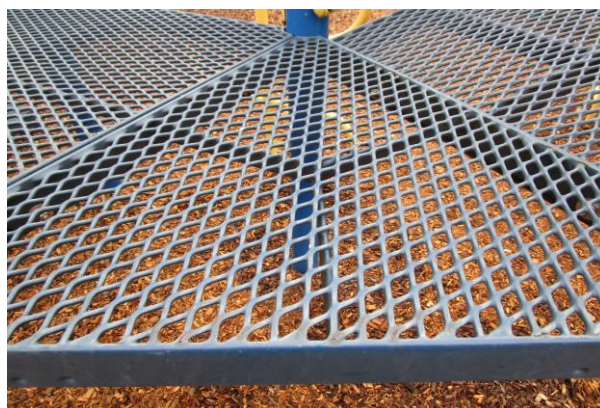
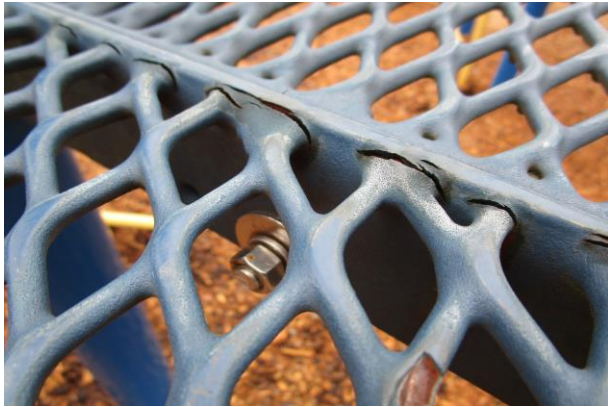
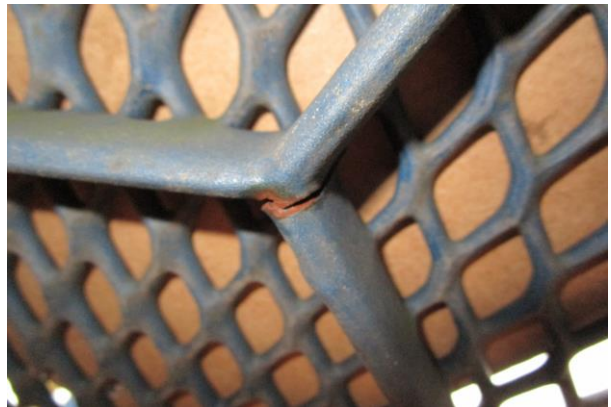
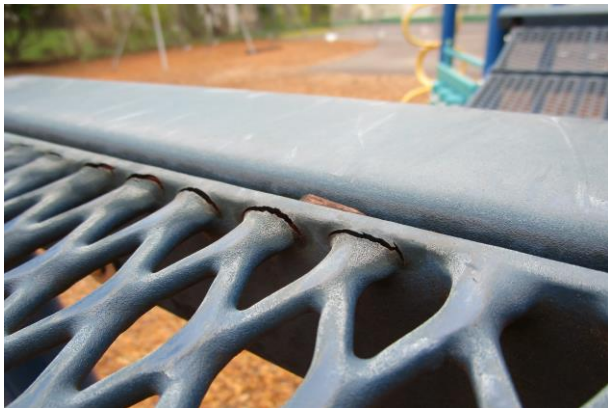
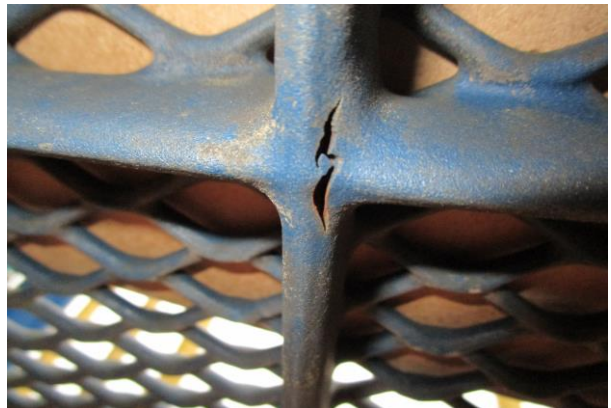
Decks (11) - Two square decks cracked & one triangle deck at joints - MAINTENANCE

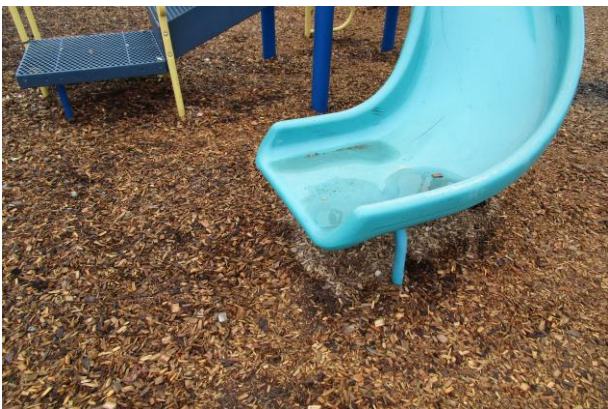
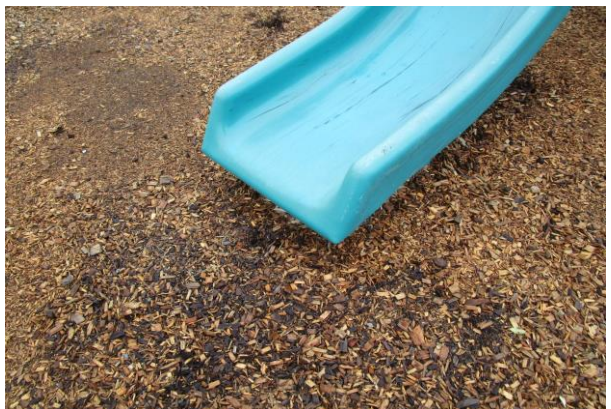
Surfacing - No wear mats at slide exits - CLASS C HAZARD

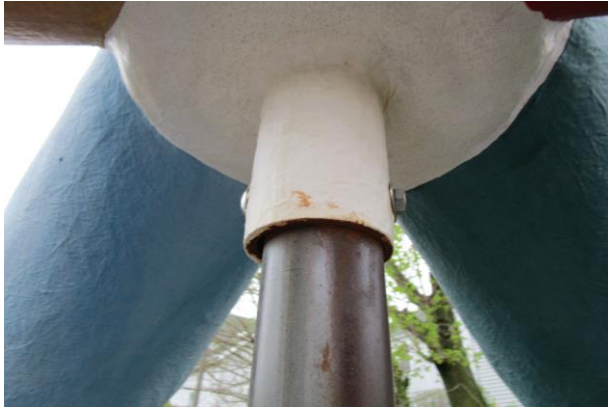
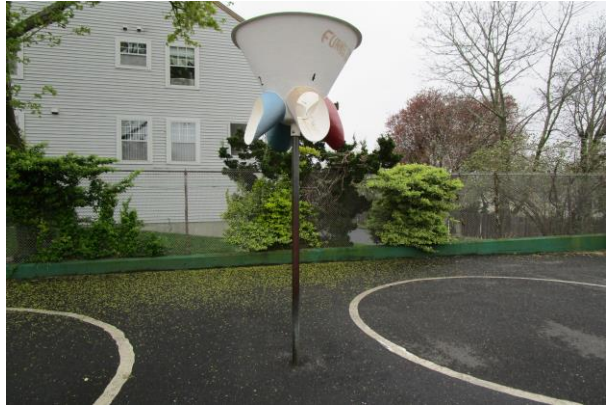
Funnel Ball - Bucket very loose at bolts - MAINTENANCE

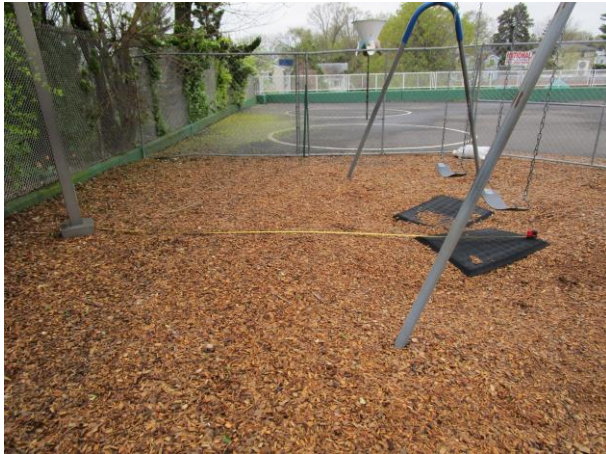
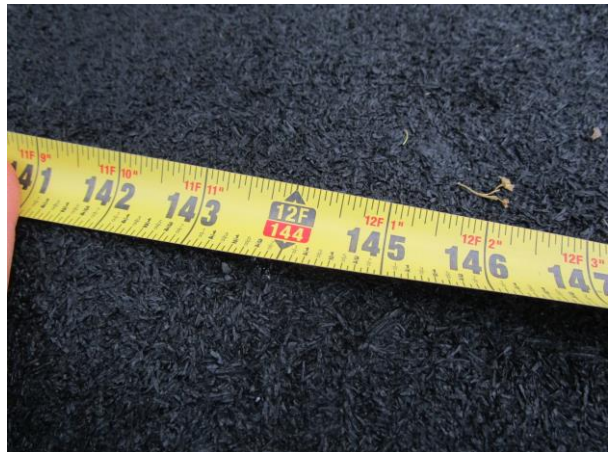
Condition	Hazard Priority	Recommendation
8ft. Swing Set #1(2 Bays/4 Belt Seats (Unknown)			Good		
Surfacing	EWF 9-12"		Good		
Use Zone		Light post in use zone 12ft. from center		B	Relocate post outside of use zone
Structural Stability		Frame not level, pitched up at center		Maint.	Monitor
9ft. Swing Set #2 (2 Bays/4 Belt Seats (Unknown)			Good		
Surfacing	EWF 6-12"	Low in spots		B	Add EWF & level
Use Zone		Overlaps with composite structure, 22 ft. to composite, 13ft. to wall & 15ft. to bench		B	Relocate swing set & create clear 18ft. use zone at front & back & 6ft. at sides
Structural Stability		One post bent		Maint.	Monitor

8ft. Swing Set #1 (2Bay/4Belts)(Unk) - Light post in use zone, 12ft. from center -
CLASS B HAZARD

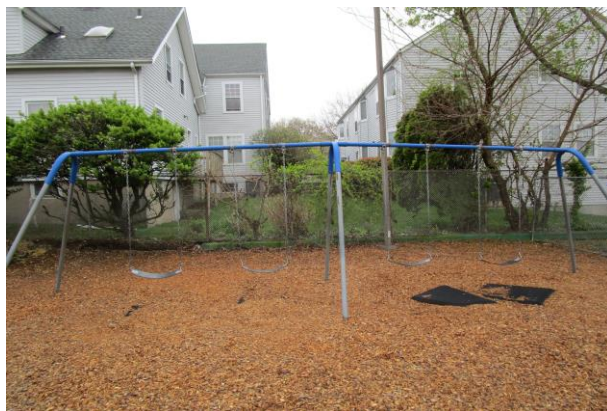
8ft. Swing Set #1 - Frame not level, pitched up at center - MAINTENANCE

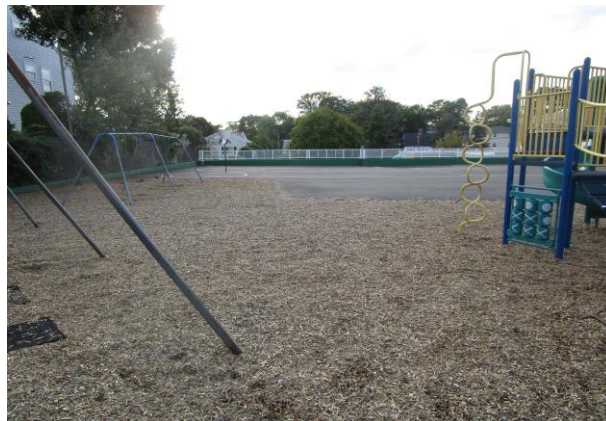
9ft. Swing Set - Use Zone overlaps with composite structure use zone - CLASS B HAZARD

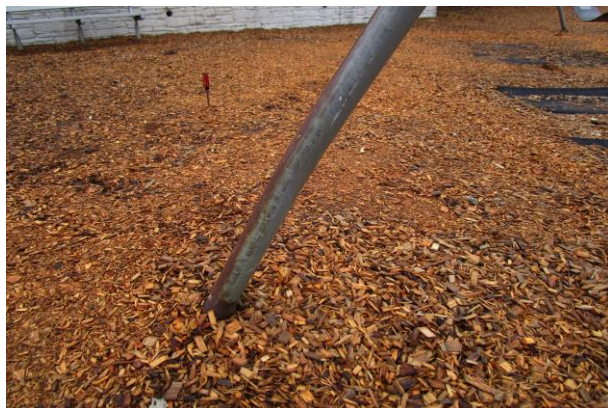
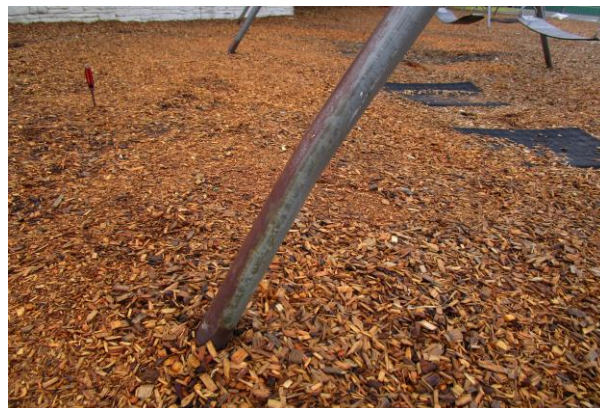
Structural Stability - One post bent - MAINTENANCE

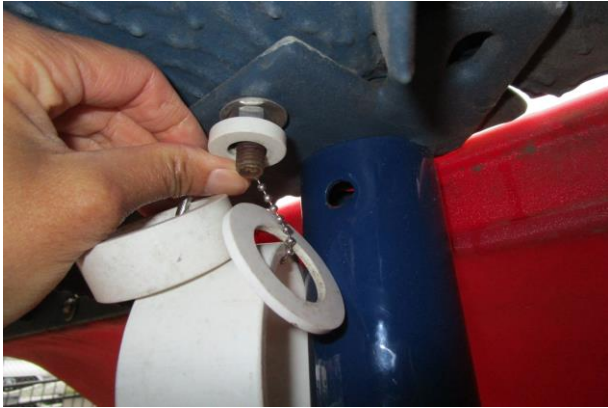
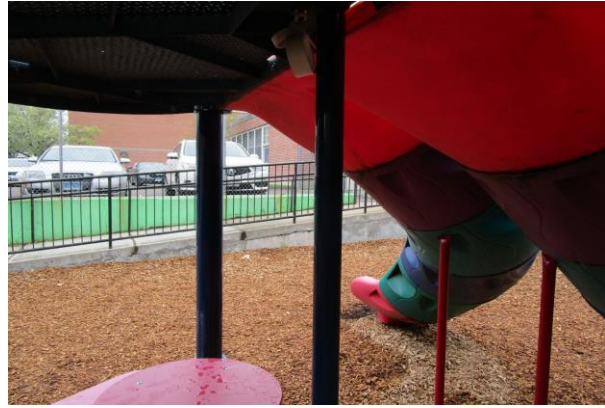
Condition	Hazard Priority	Recommendation
Small Composite Structure (Play & Park Structures)				
Components				
Stairs (2)		Good		
Apex Climbing Link		Good		
Max Climb Ridge Top		Good		
Chime Panel (below)		Good		
Table & Bench (below)		Good		
Avalanche Slide		One protruding bolt at deck under center slide	B	Cut one bolt down
Fire Pole		Good		
Spiral Step Climber		Good		
Balcony with Wheel		Wheel missing	Maint.	Replace wheel
Decks (4)		Good		
Transfer Platform		Good		
Surfacing	EWf 5-12"	Insufficient	A	Add EWf & level
		One wear mat deteriorated & two wear mats missing at slide exits	C	See Notes
Use Zone		Good		
Structural Stability		Good

Avalanche Slide - Protruding bolt under center slide - CLASS B HAZARD

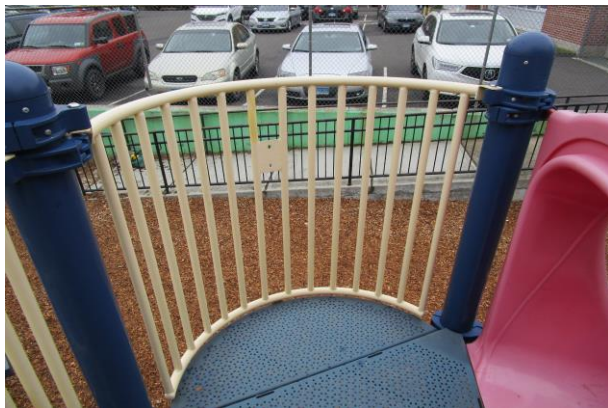
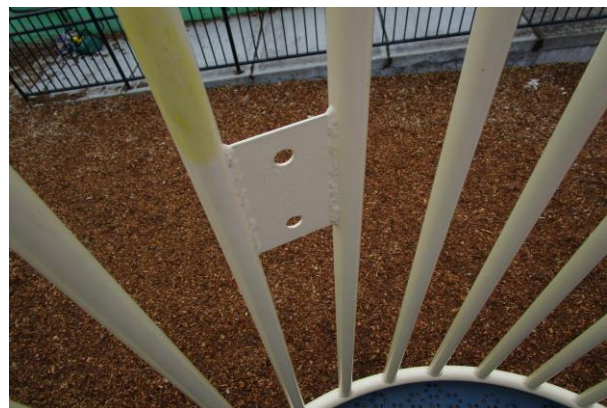
Balcony with Wheel - Wheel missing - MAINTENANCE

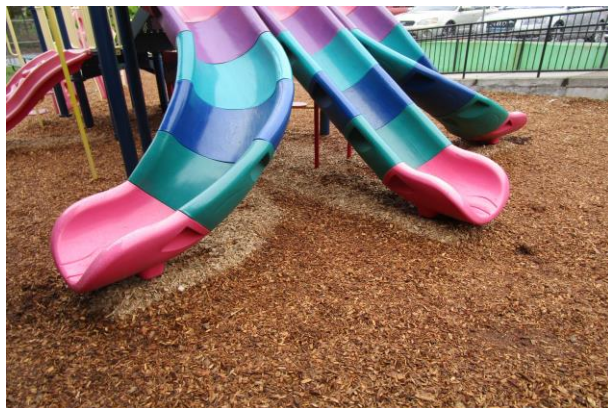
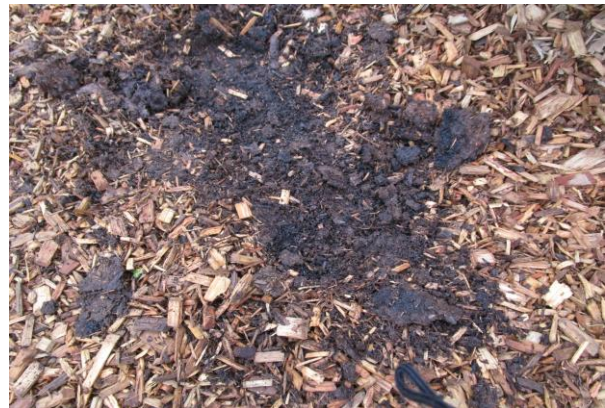
Surfacing - One wear mat deteriorated & two mats missing at slide exits -

CLASS C HAZARDS

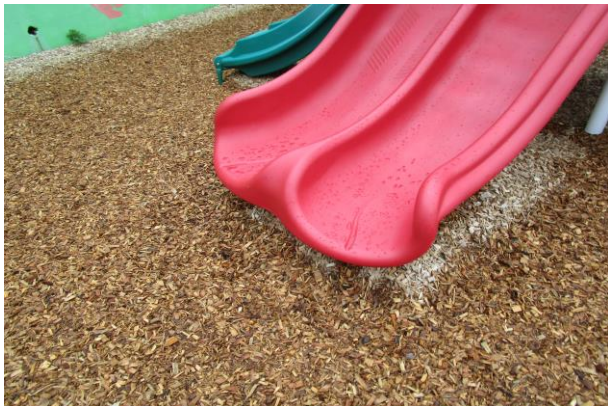
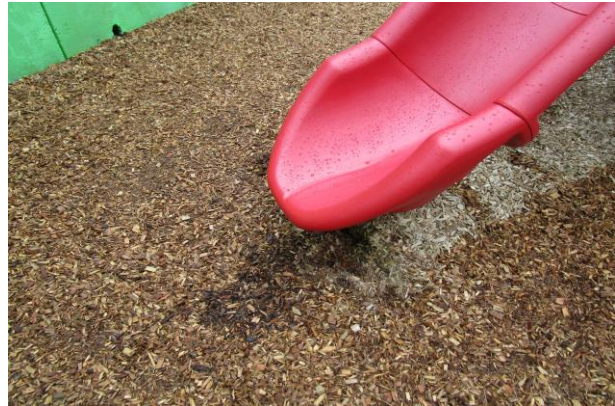
There are no wear mats at the slide exits. ADA requires wear mats for accessibility and the prevention of holes at the slide exits.

Surfacing - No wear mats at slide exits - CLASS C HAZARD
