## **PLAYGROUND SAFETY INSPECTION REPORT**

**DATE:** May 16, 2019

**SITE:** Rogers International School  
202 Blachley Road  
Stamford, CT 06902

**DATE OF INSPECTION:** April 24, 2019

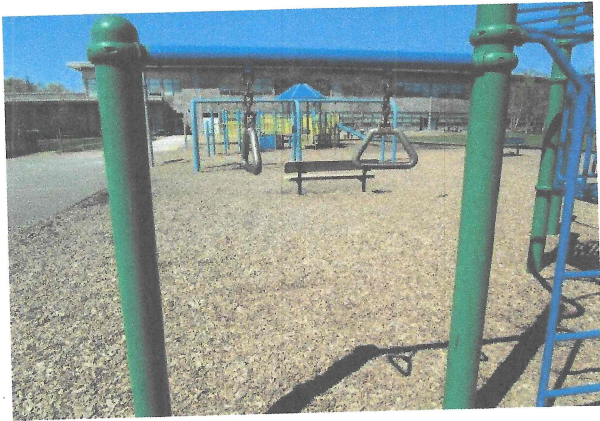
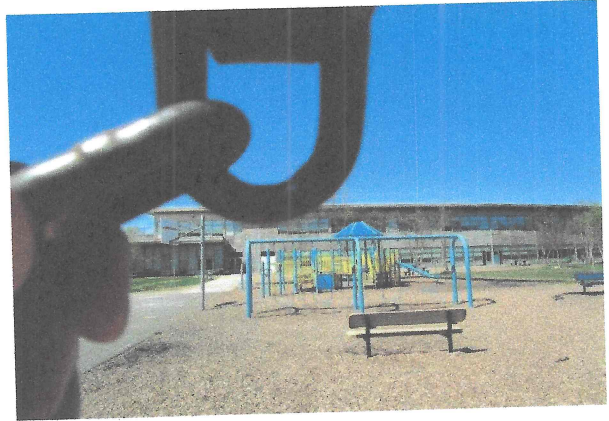
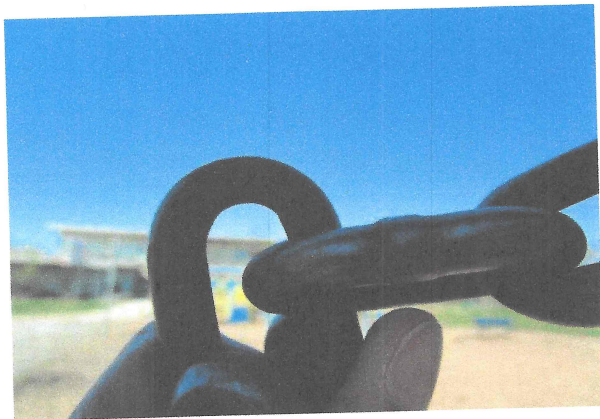
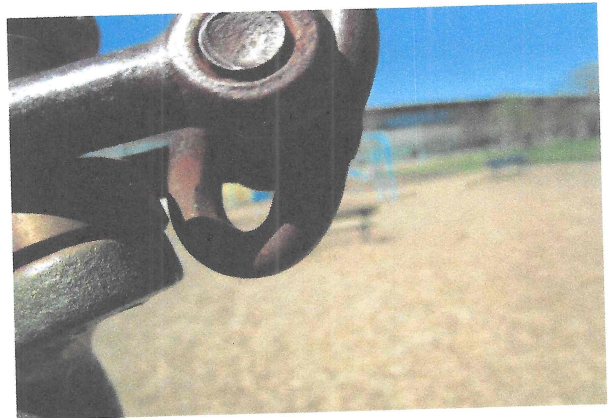
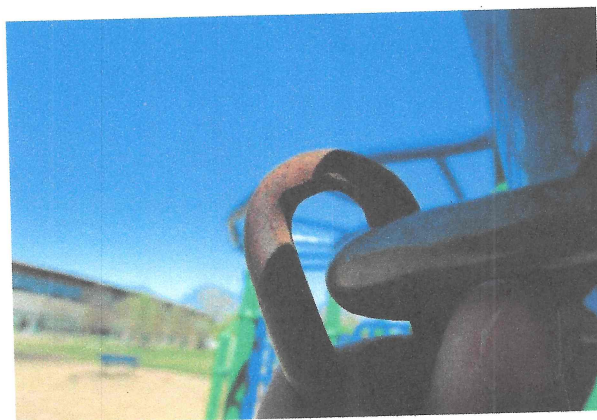
### Metal Composite Structure #1 (Miracle) Trapeze Rings - Chains & two hangers wearing - MAINTENANCE

Condition	Hazard Priority	Recommendation
<b>Metal Composite Structure #1 (Miracle Recreation) for 5-12</b>				
<b>Components</b>				
Toboggan Wave Slide		Good		
Climbing Pole (1)		Good		
Transfer Platform		Good		
Handring Bridge		Good		
Trapeze Rings		Chains & two hangers wearing	Maint.	Monitor
Horizontal "L" Ladder		Good		
3-Chin Up Bars		Good		
Bongo Steps (2)		Good		
Orbit Climber		Good		
Horizontal Spider Climber		Good		
Toboggan Slide-metal		May heat up in summer	Maint.	Monitor for heat
Spider Climber		Good		
Square Roof (1)		Good		
Decks (17)		Good		
Surfacing	EWf 4-8"	Insufficient One wear mat missing	A C	Add EWf & level See Notes
Use Zone		Good		
Structural Stability		Good		
<b>Metal Composite Structure #2 (Miracle Recreation) for 2-5</b>				
<b>Components</b>				
Lookout Panel		Cracked at top	Maint.	Monitor
Crawl Thru Panel		Good		
Wide Toboggan Slide-metal		May heat up in summer	Maint.	Monitor for heat

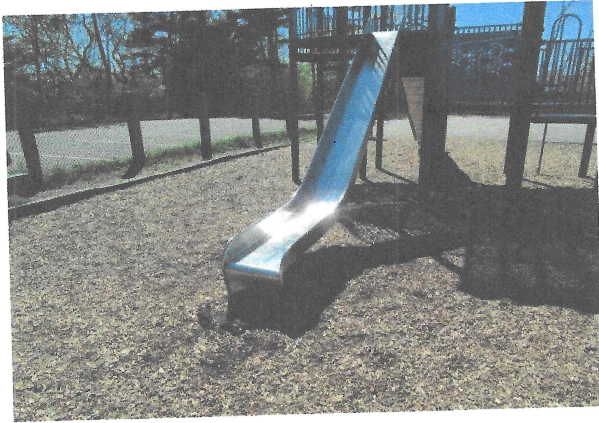
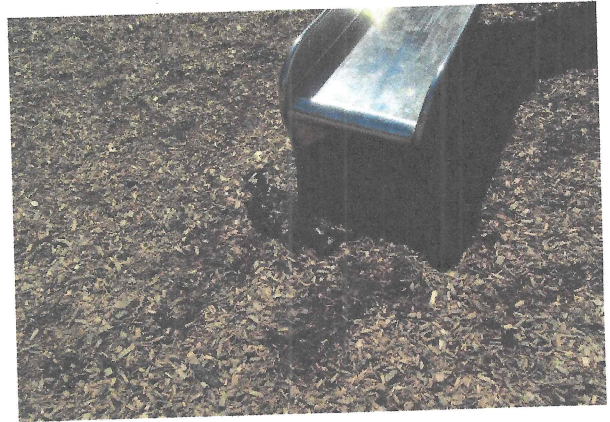
Wear mats are missing under some slide exits. ADA requires wear mats for accessibility and the prevention of holes at the slide exits.

**Surfacing - One wear mat missing - CLASS C HAZARD**

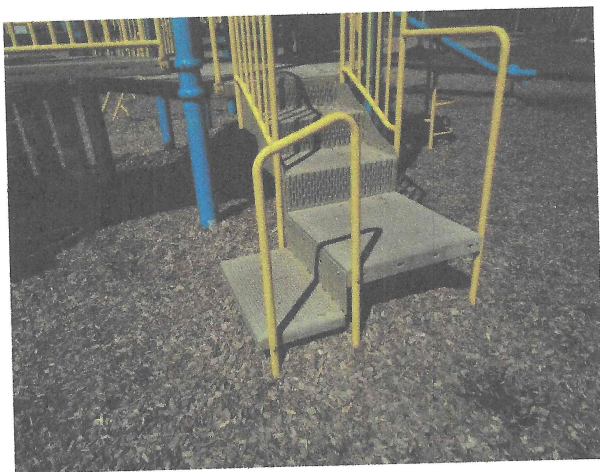
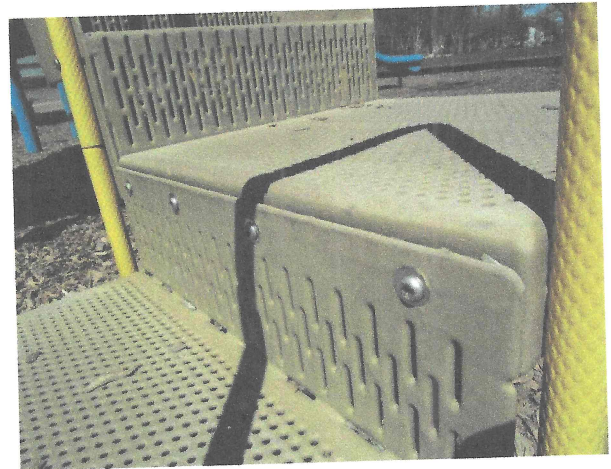
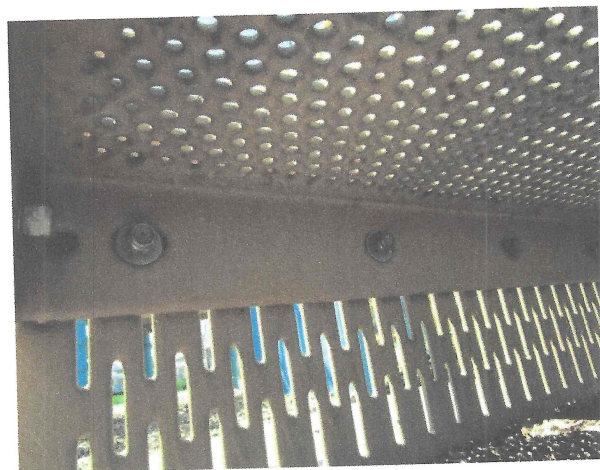
**Metal Composite Structure #2 (Miracle)  
Transfer Step - Step loose at bolts - MAINTENANCE**

Canyon Climber		Good		
Transfer Platform		Good		
Transfer Step		Step loose at bolts	Maint.	Tighten four bolts at step
Spanish Panel		Good		
Steering Wheels (2)		Good		
Trapeze Rings		Chains starting to wear	Maint.	Monitor
Horizontal "L" Ladder		Good		
Spider Climber		Good		
Rung Ladder		Good

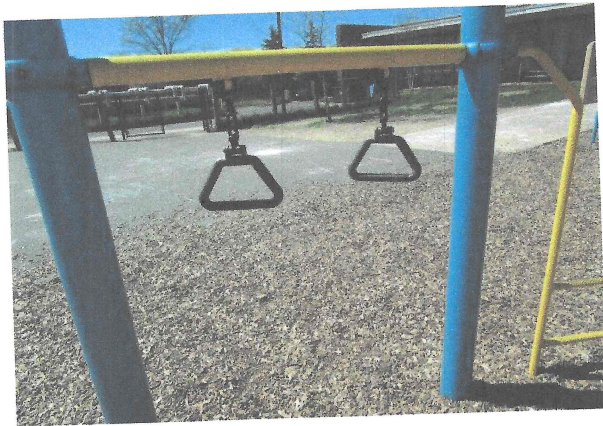
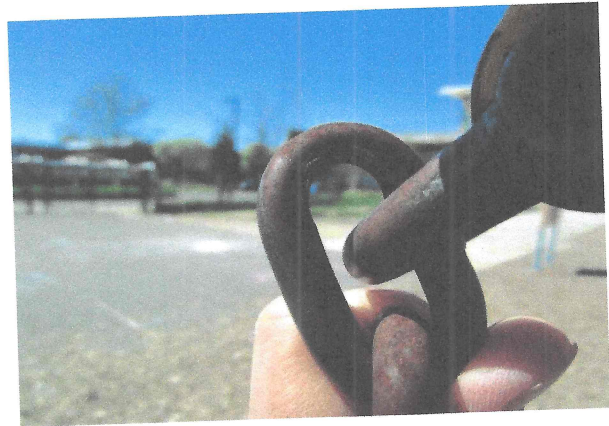
**Trapeze Rings - Chains starting to wear - MAINTENANCE**

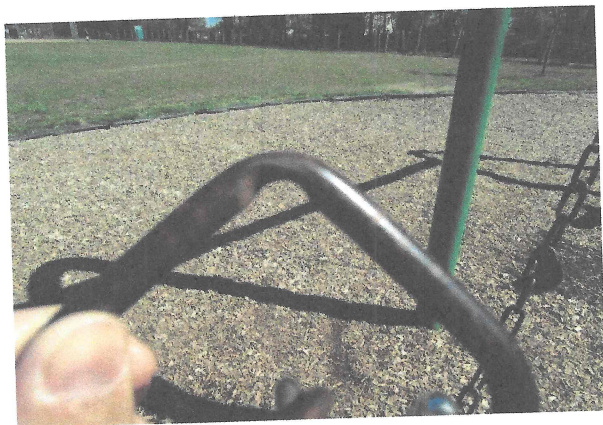
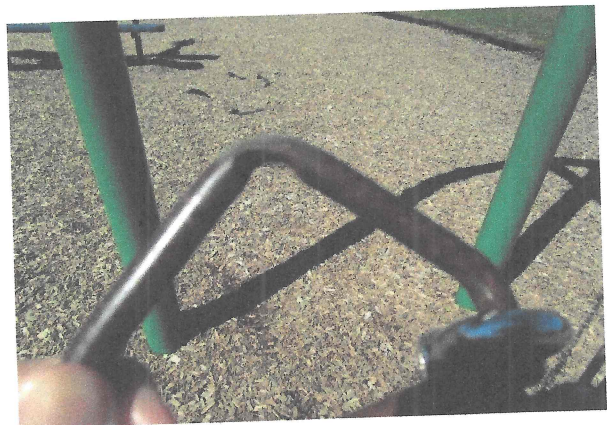
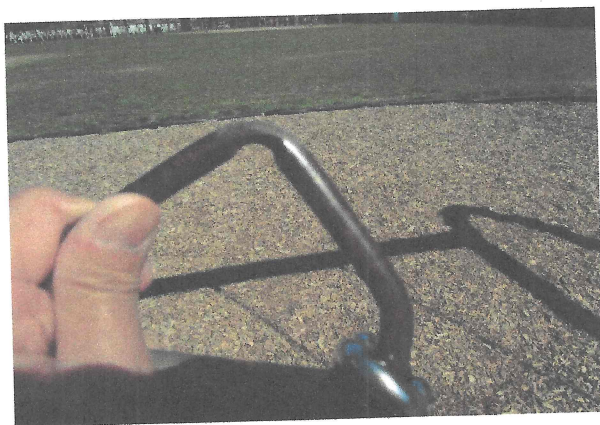
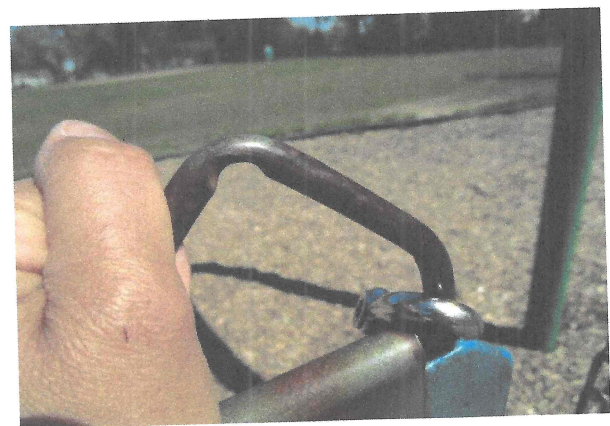
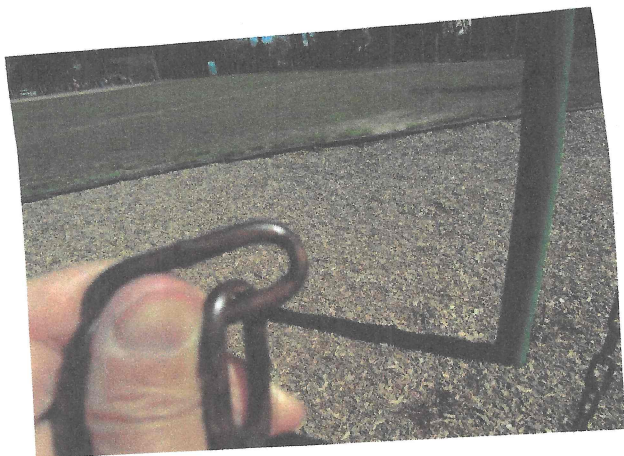
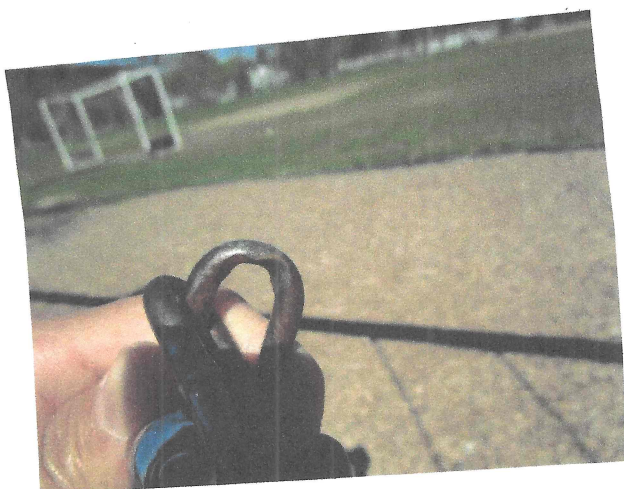
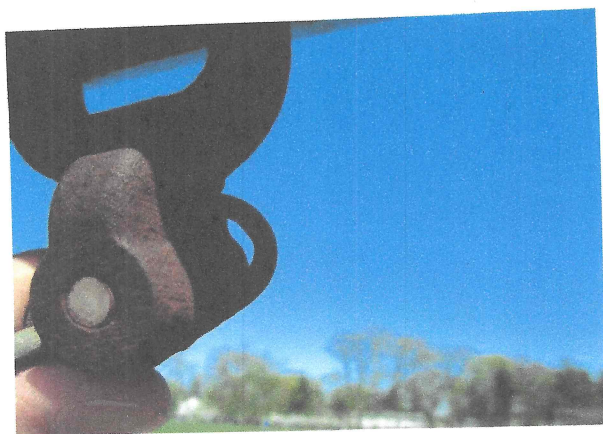
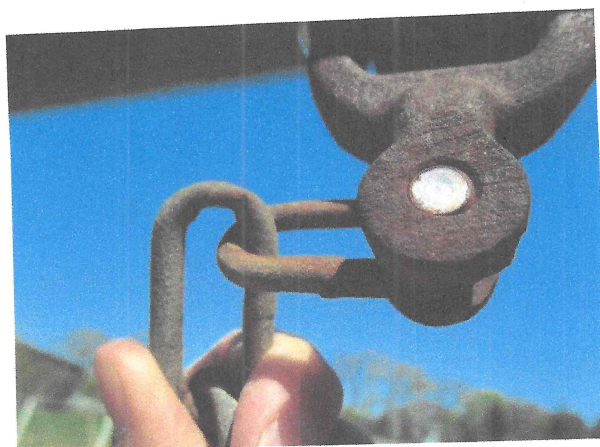
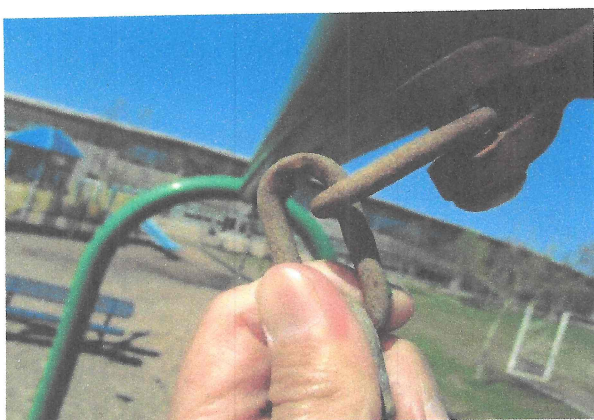
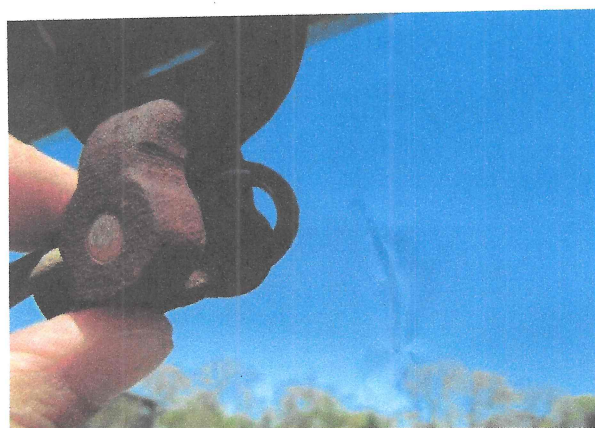
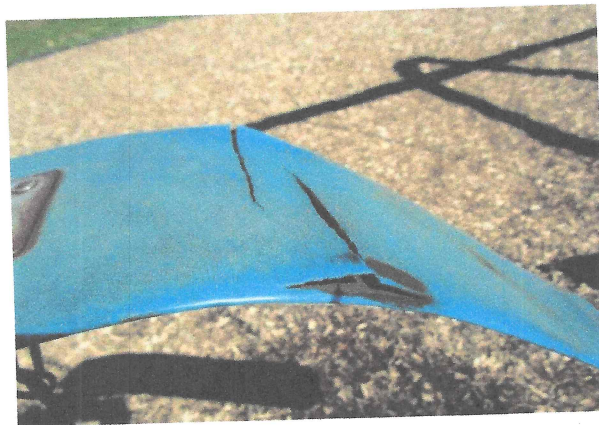
**8ft. Swing Set #1(Green) - Four belts seats worn & cracked, all chains worn -  
CLASS A HAZARD**

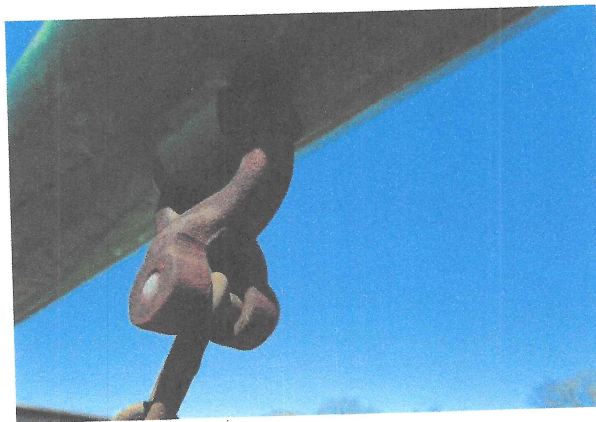
**8ft. Swing Set #1 (Green)- Swing hangers rusted - MAINTENANCE**

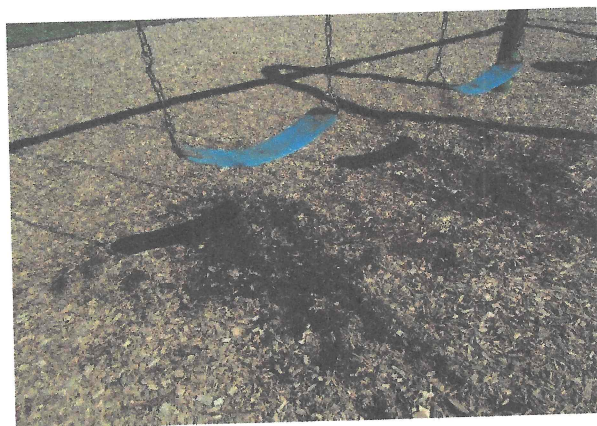
Wear mats are missing under some swings seats. ADA requires wear mats for accessibility and the prevention of "holes" under the swings.

**8ft. Swing Set #1 (Green) - One wear mat missing - CLASS C HAZARD**

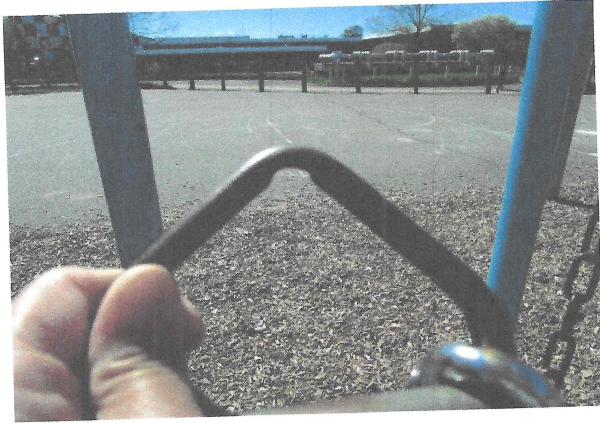
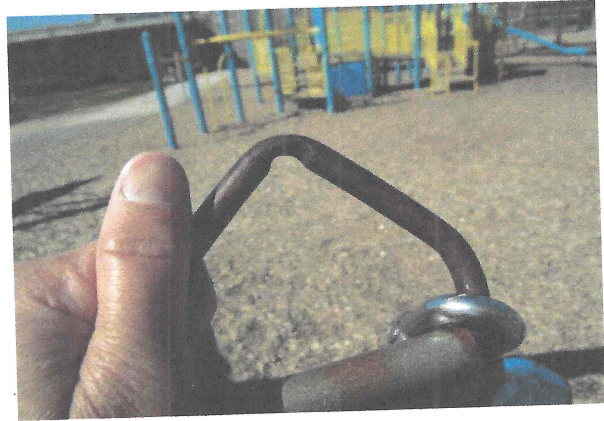
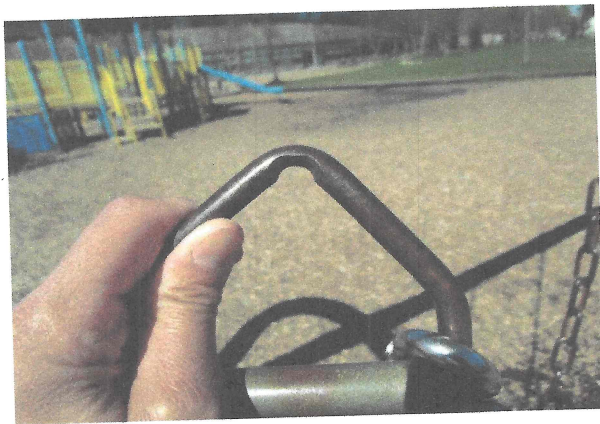
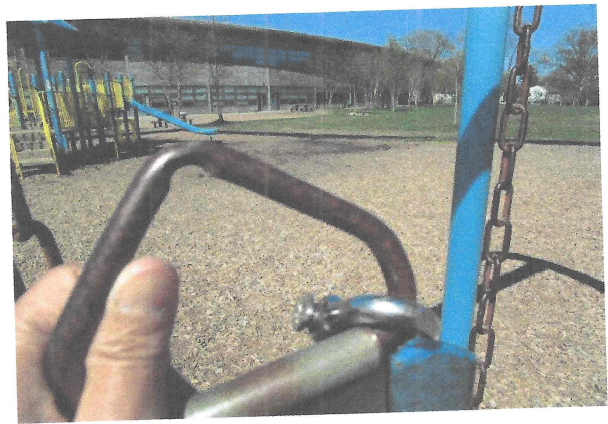
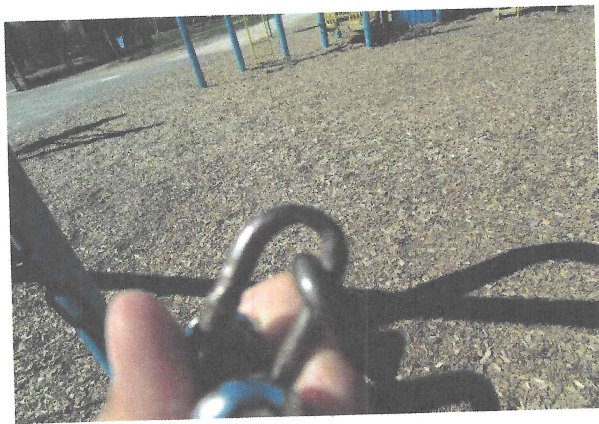
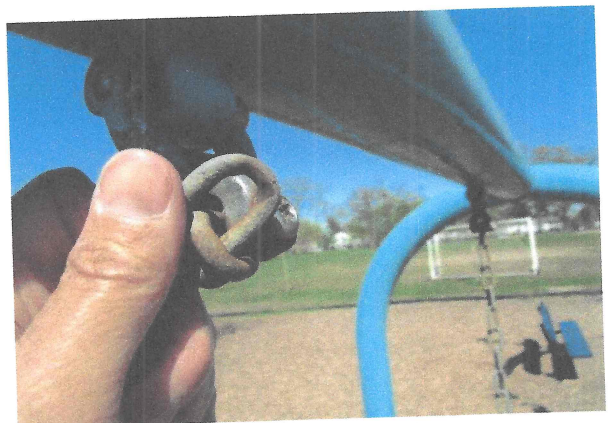
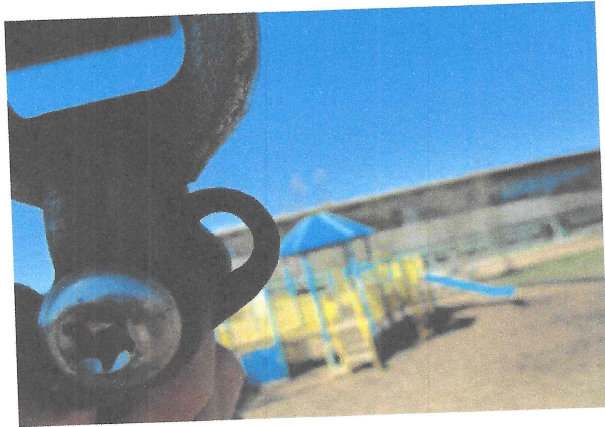
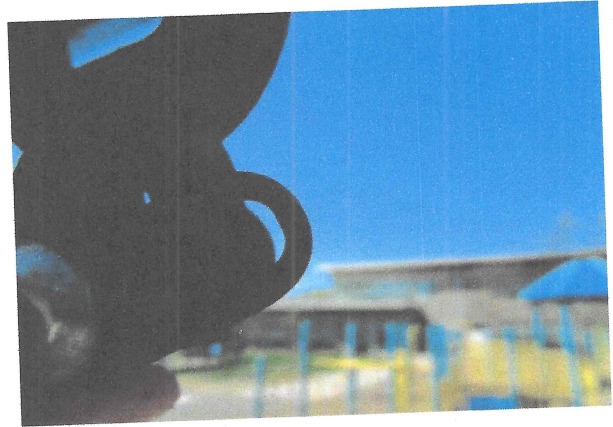
**8ft. Swing Set #2 (Blue) - Four belt seats & all chains worn - CLASS A HAZARD**

Four belt seats & all chains worn	A	Replace four belt seats & all chains
		Eight swing hangers rusted	Maint.	Recommend replacing eight swing hangers
Surfacing	EWF 6-12"	Insufficient, low under swings	A	Add EWF & level
Use Zone		Good

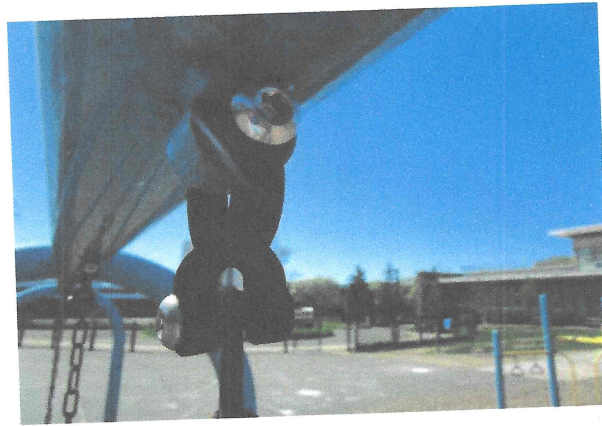
**8ft. Swing Set #2 (Blue)(2Bay/4Belts) - Eight swing hangers rusted - MAINTENANCE**

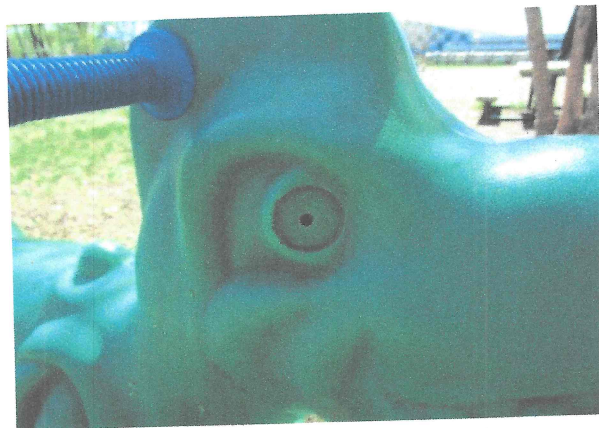
**T-Rex Spring Rocker (Unknown) - One eye missing - MAINTENANCE**

Condition	Hazard Priority	Recommendation
<b>T-Rex Spring Rocker (Unknown)</b>		Spring Rocker not in play area		Appropriate for ages 2-5
		One eye missing Footing exposed, tripping hazard	Maint. B	Replace one eye Bury footing under EWF
Surfacing	EWF 0"	Insufficient	A	Add 6-8" of EWF throughout use zone
Use Zone		Create use zone 6' all around Overhanging branches	B Maint.	Install containment border Trim back to 7' above rocker
Structural Stability		Good		
Environment	Border/ Edging Bench	Three damaged timbers	Maint.	Monitor
		Fabric exposed, tripping hazard	B	Bury fabric under EWF

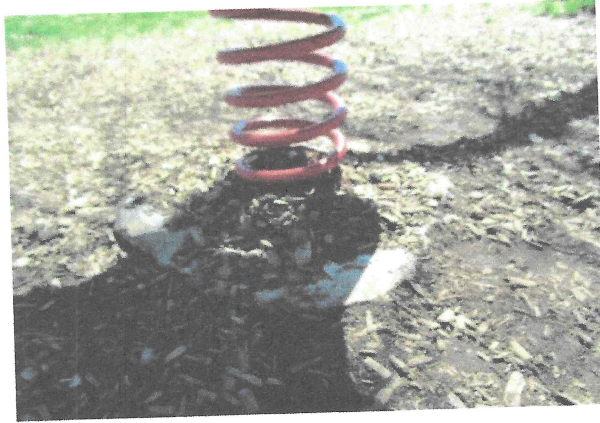
**T-Rex Spring Rocker (Unknown) - Footing exposed, tripping hazard - CLASS B HAZARD**

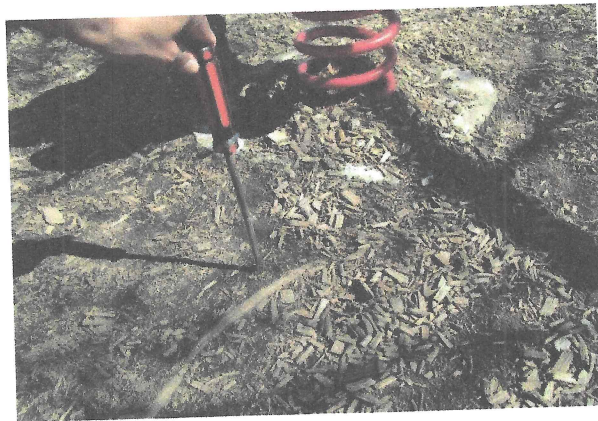
**Surfacing - No EWF, insufficient - CLASS A HAZARD**

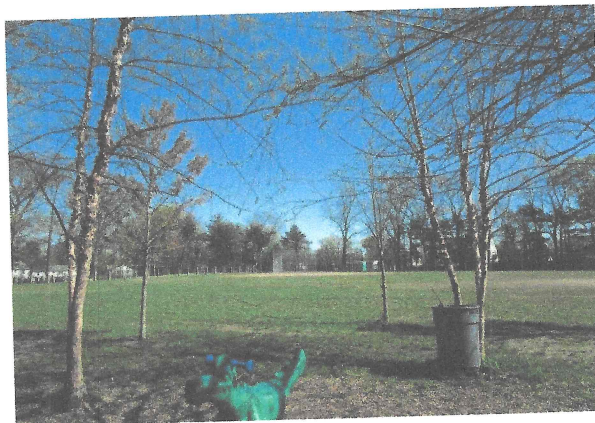
**Use Zone - Overhanging branches - MAINTENANCE**

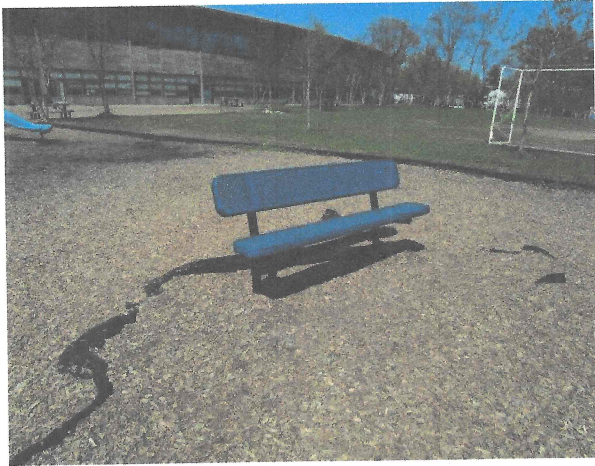
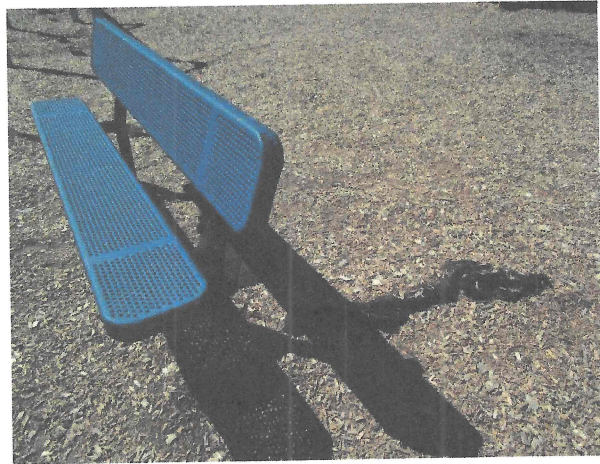
**Site Amenities - Fabric exposed around bench, tripping hazard - CLASS B HAZARD**

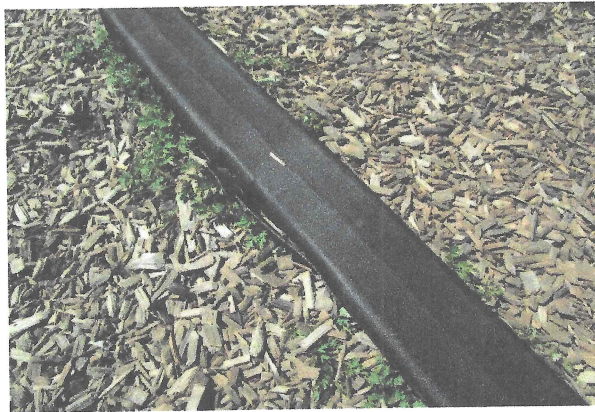
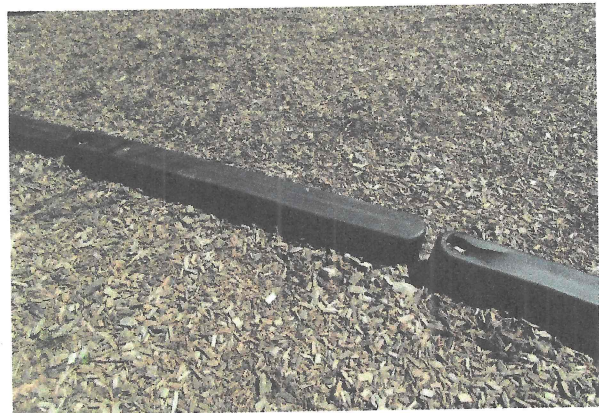
**Border/Edging - Three damaged timbers - MAINTENANCE**
