## **PLAYGROUND SAFETY INSPECTION REPORT**

**SITE:** Toquam Magnet Elementary School  
123 Ridgewood Avenue  
Stamford, CT 06907

**CLIENT:** Stamford Public Schools  
Attention: Rich Lyons  
888 Washington Boulevard  
Stamford, CT 06901

**DATE OF INSPECTION:** April 26, 2019

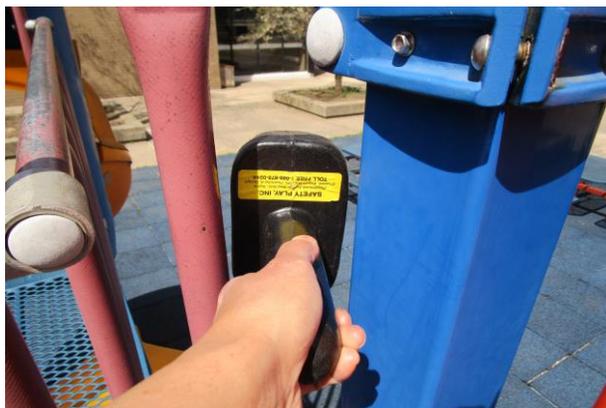
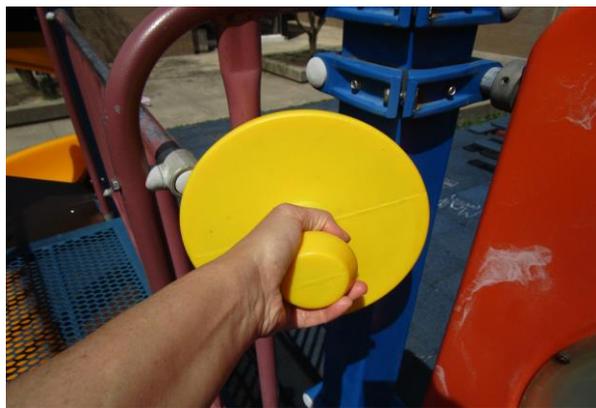
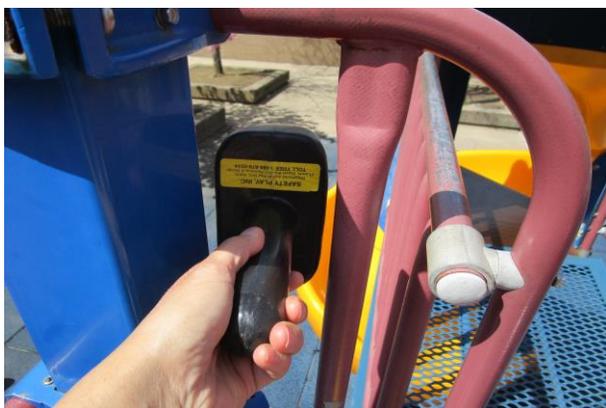
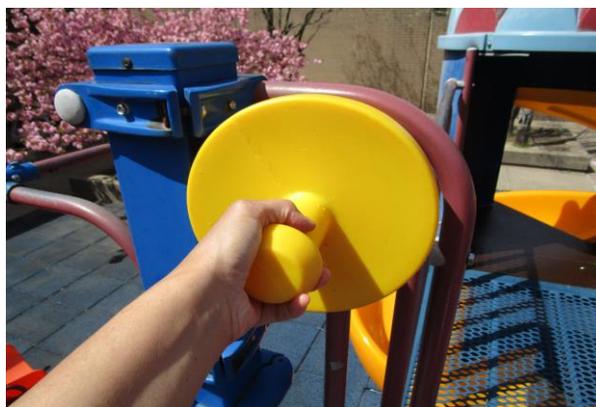
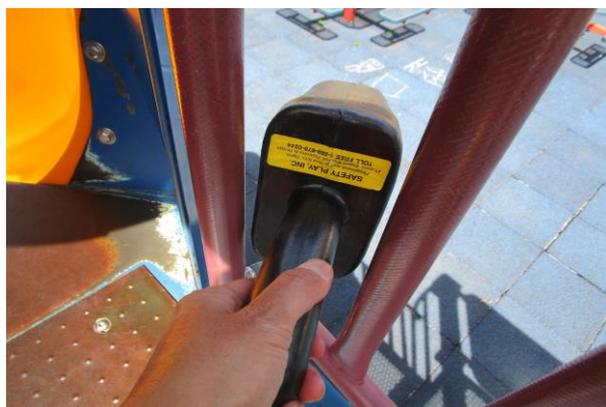
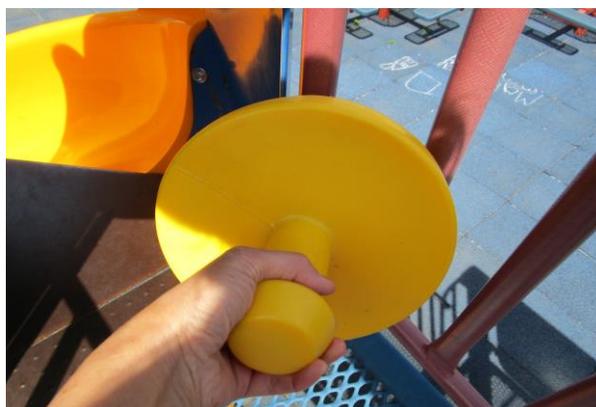
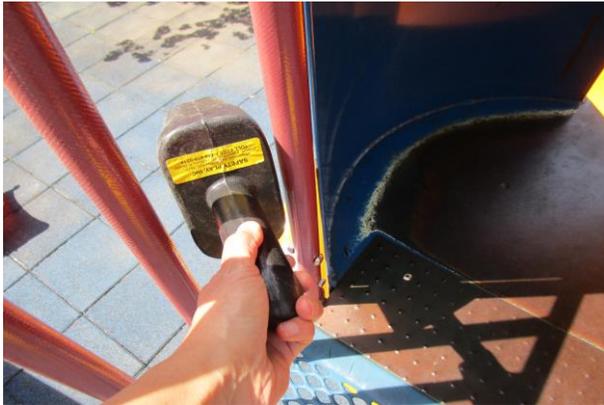
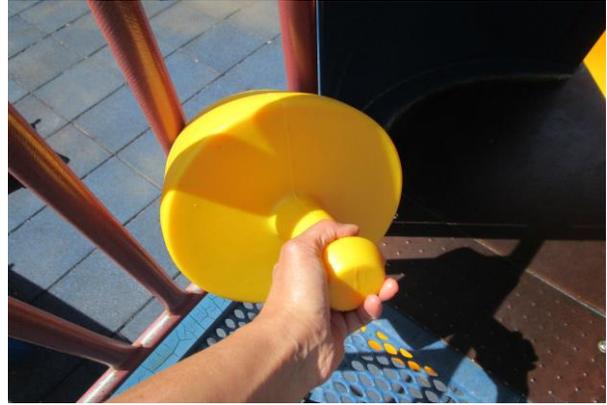
**Small Composite Structure - Miracle Recreation  
Spiral Slide - Four head entrapments at rails - CLASS A HAZARD**

**This playground is in very poor condition. The play structure and surfacing should be removed.**

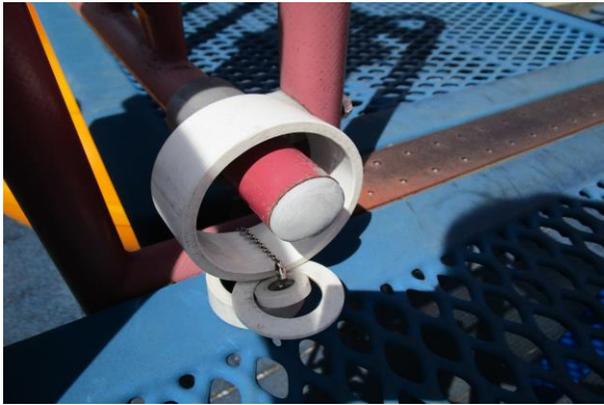
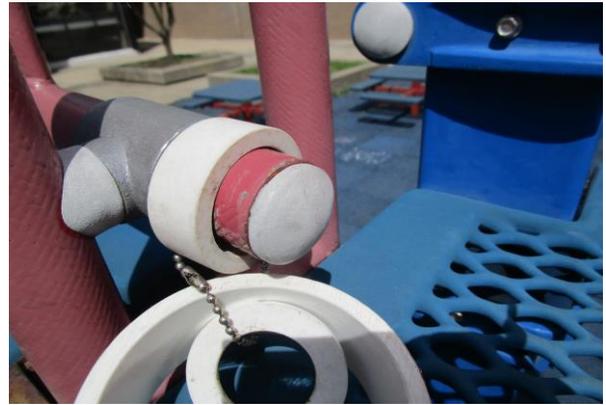
**Spiral Slide - Two protruding pipes - CLASS B HAZARD**

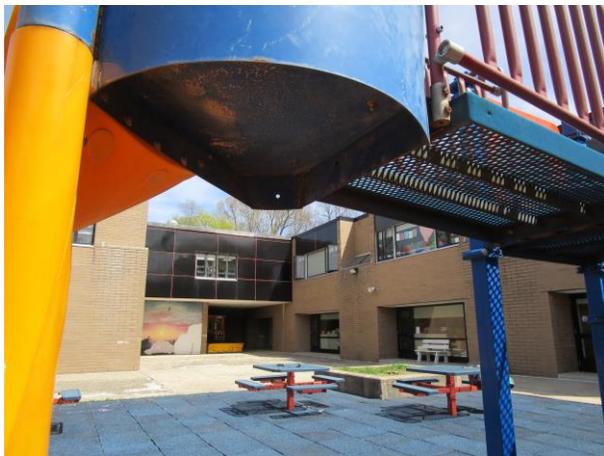
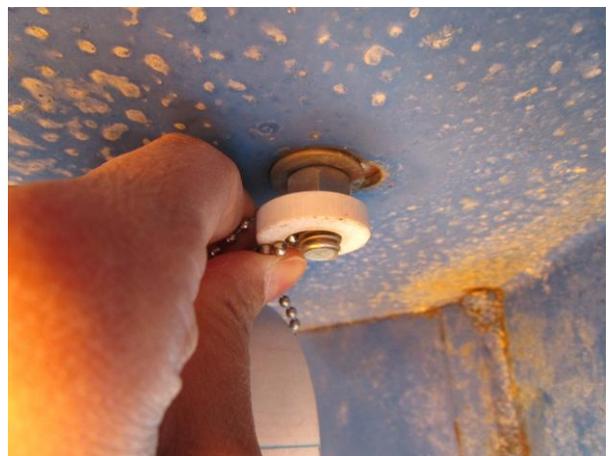
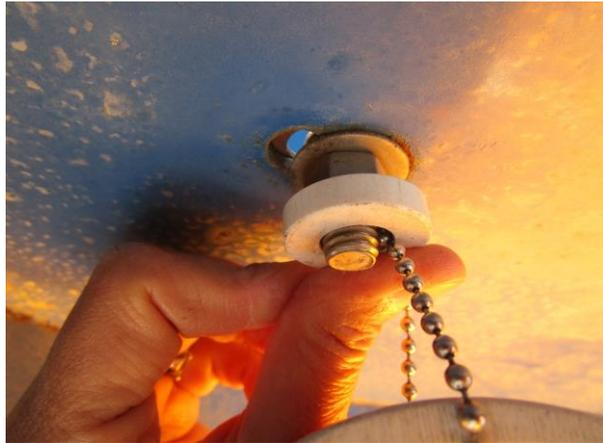
**Spiral Slide - Two bolts protruding below - CLASS A HAZARD**

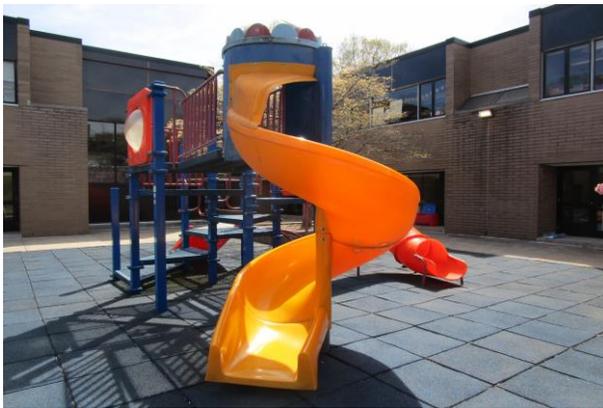
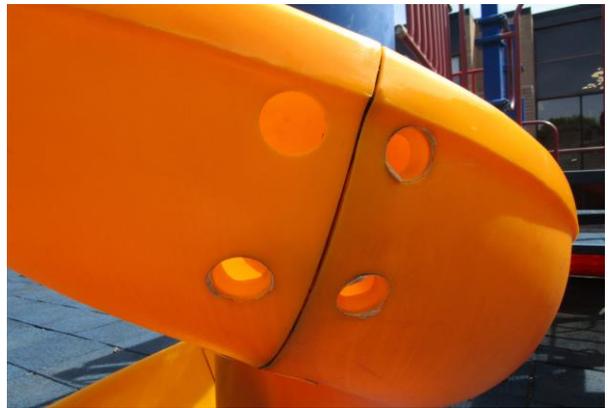
**Spiral Slide - Eight plugs missing or damaged, crack at bolt of center post-  
MAINTENANCE**

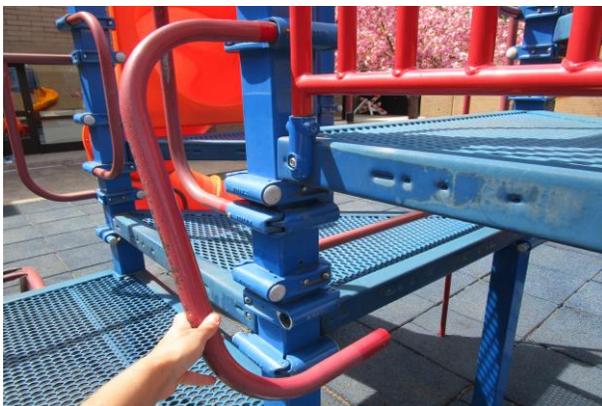
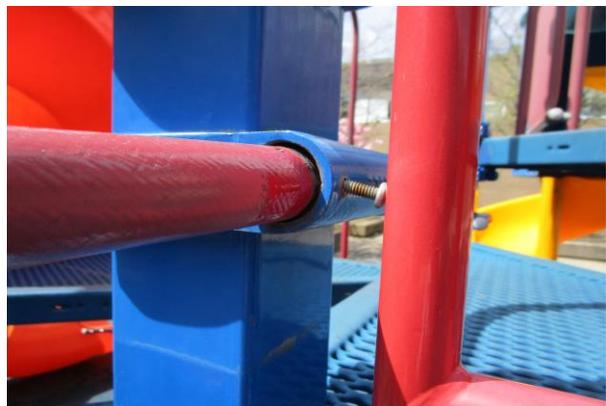
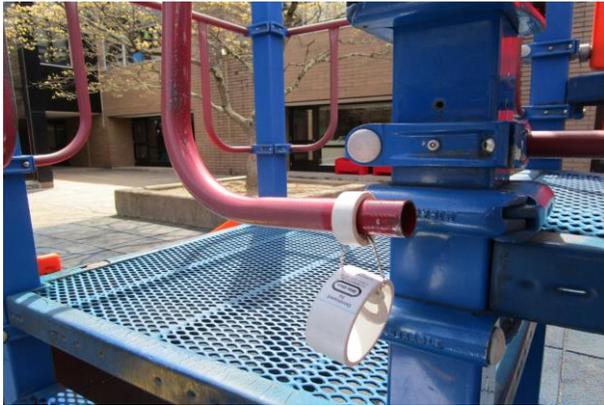
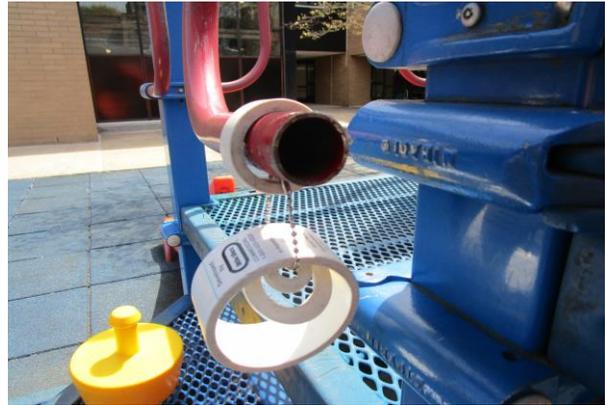
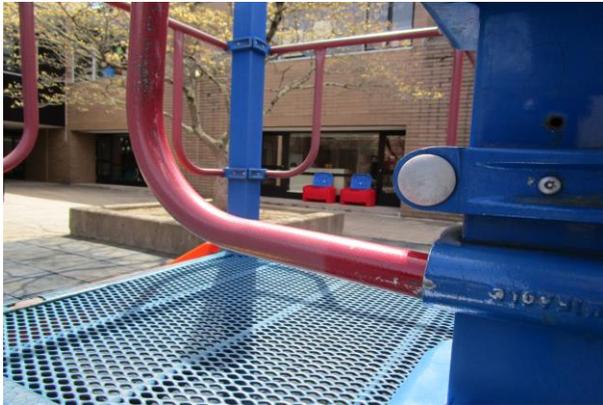
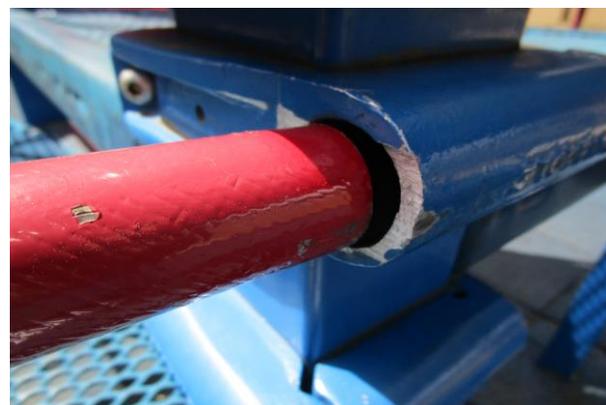
**Handholds - One handhold not attached creating protrusion - CLASS A HAZARD**

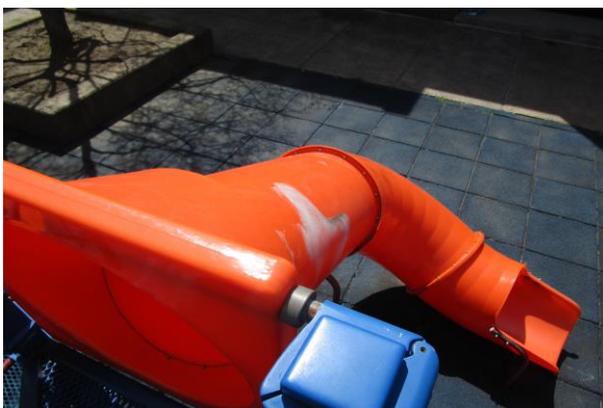
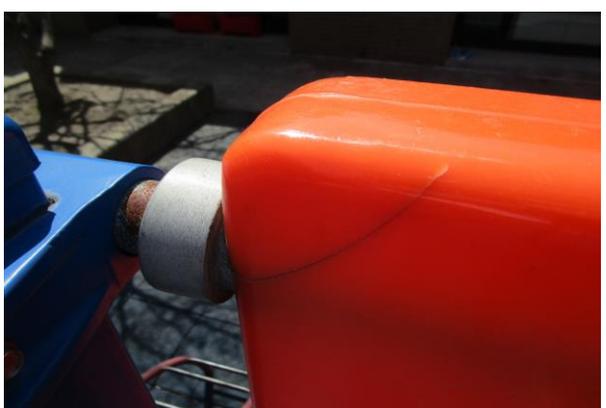
**Curved Tube Slide - Hood cracked at top at bolts - MAINTENANCE**

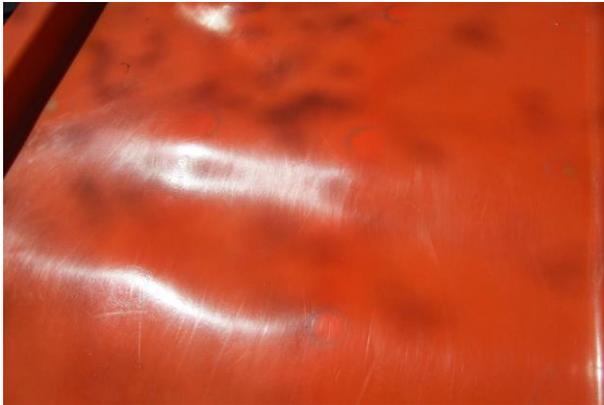
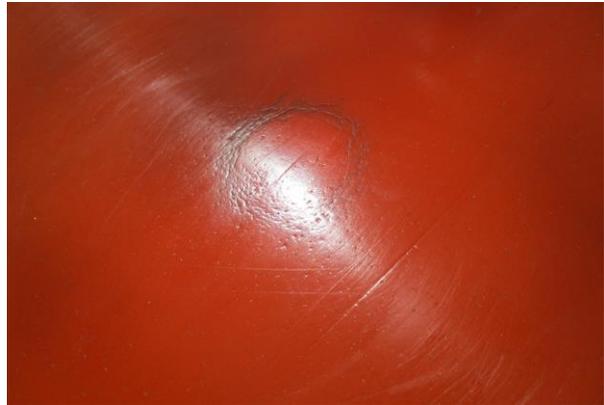
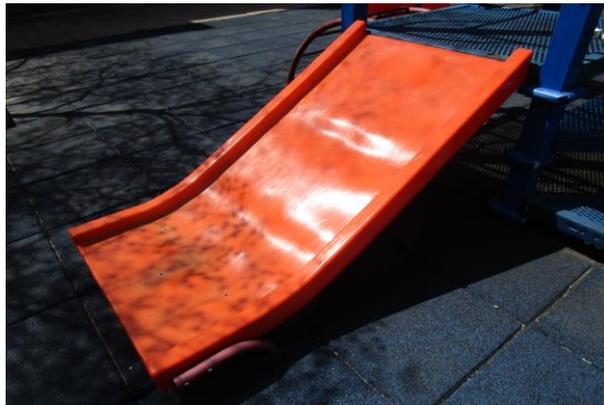
**Wide Slide - Cracks throughout bed way - MAINTENANCE**

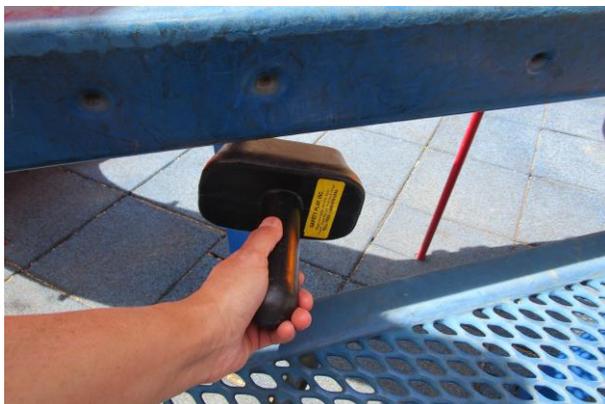
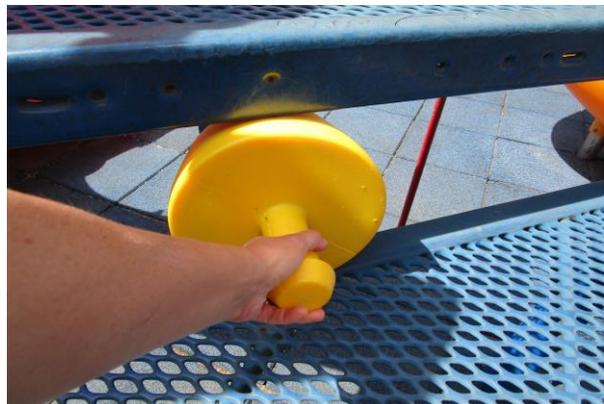
**Decks (7) - One head entrapment between decks - CLASS A HAZARD**

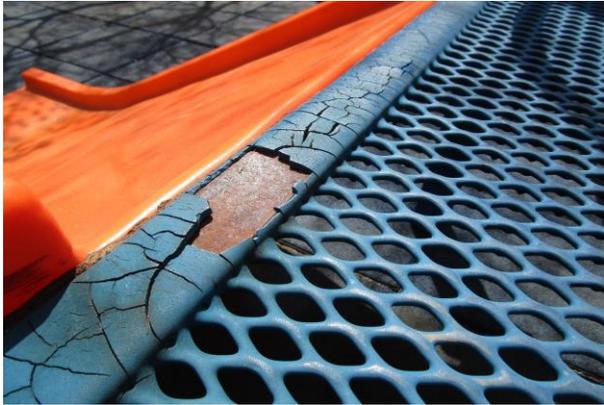
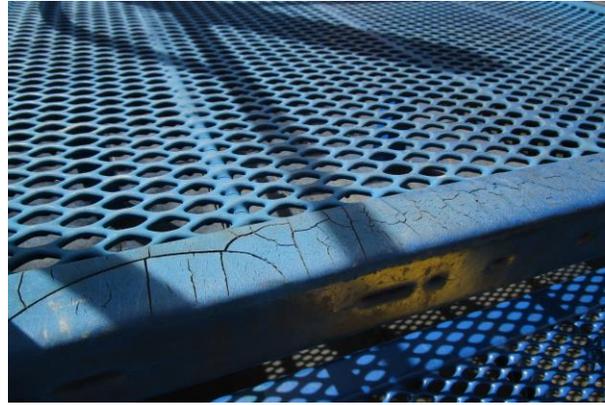
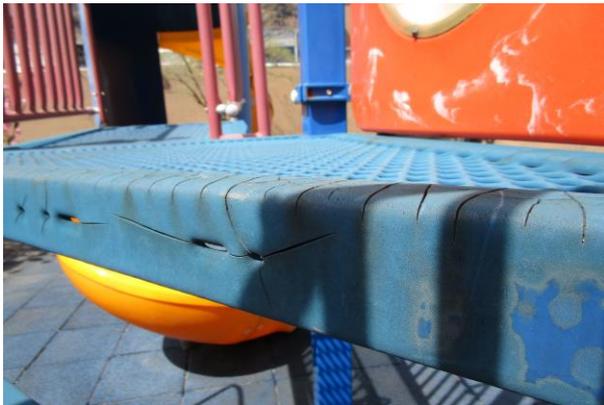
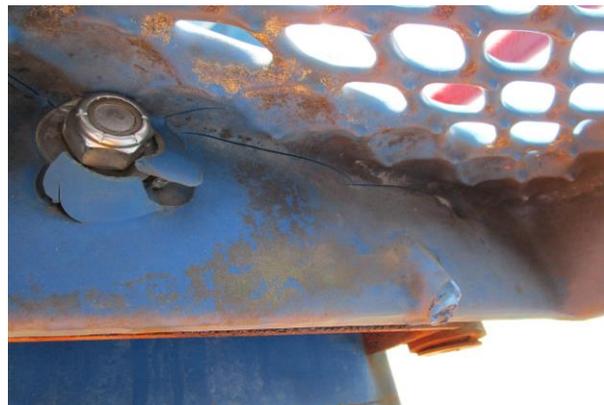
**Decks (7) - Plastisol worn/missing - MAINTENANCE**

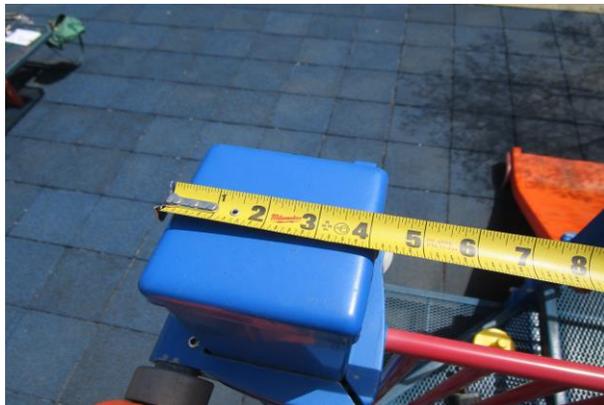
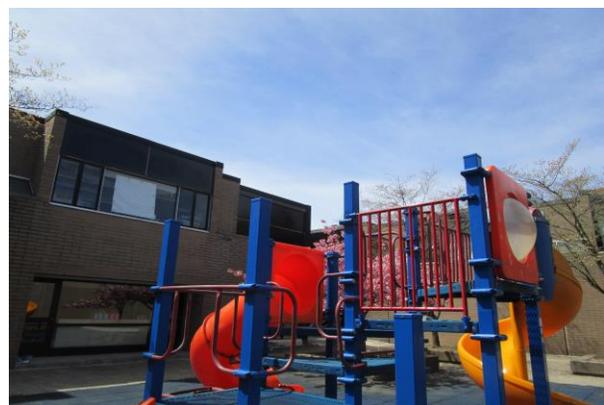
**Support Posts - Not compliant 4x4 flat post caps create designated play surface -  
CLASS B HAZARD**

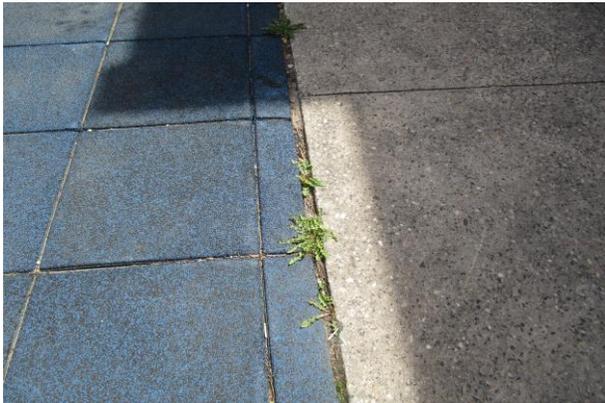
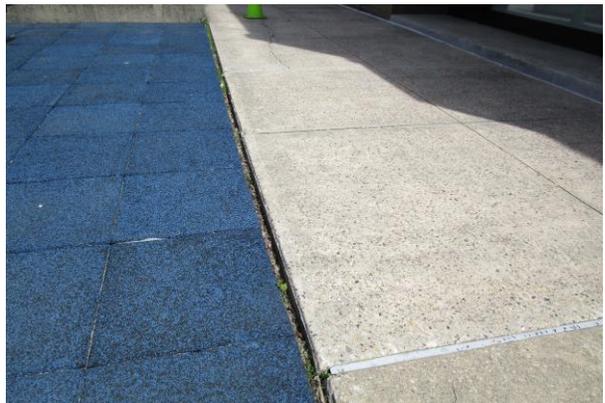
**Surfacing - Rubber tiles have gaps - MAINTENANCE**
