M. Gottfried, Inc.

RE: Roof report and repair quotation
Davenport Ridge Elementary School
Stamford, CT

As per your request we went to the above school to perform a visual inspection of the roofs, look for possible sources of water leaks, provide a price to repair the current leaks and provide recommendations and a price for comprehensive roof maintenance to extend the useful life of the existing roofing system.

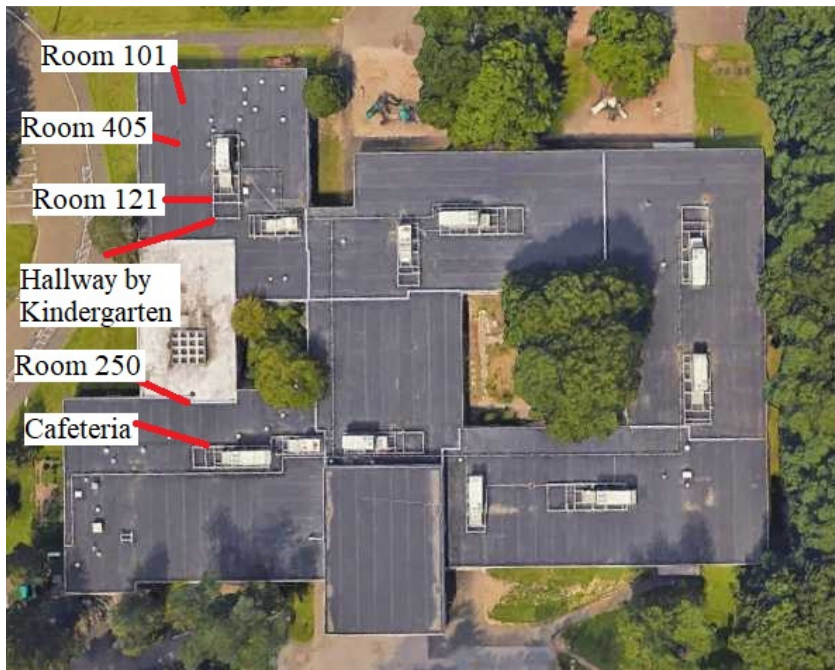
Davenport Ridge Elementary School layout and leak locations

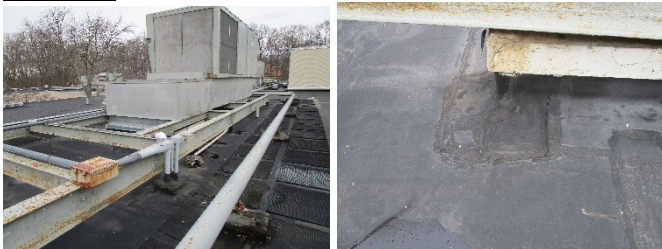
Cafeteria

The leaks over the cafeteria are appearing in the area of a penetration pocket and steel dunnage post. We can see cracking and opening of the lap at these items. They need to be cleaned and overlaid with new flashing. The area around them must also be checked for holes or other open items.

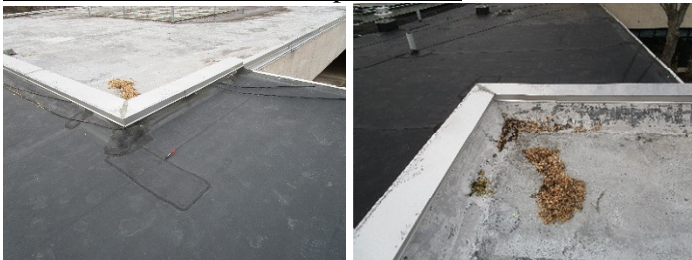
Room 250 Assistant Principals office

The leak over this room is either coming from an open patch or open flashing on the concrete roof. Both areas need to be patched and repaired.

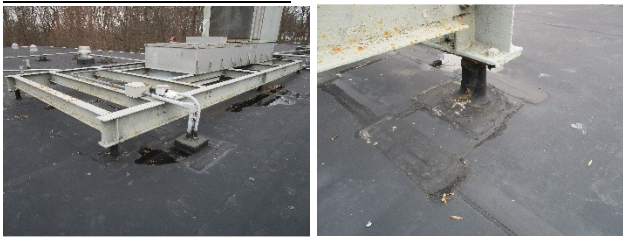
Room 121 Main Office

The leaks in the main office appear to be coming from a penetration pocket or dunnage post flashing.

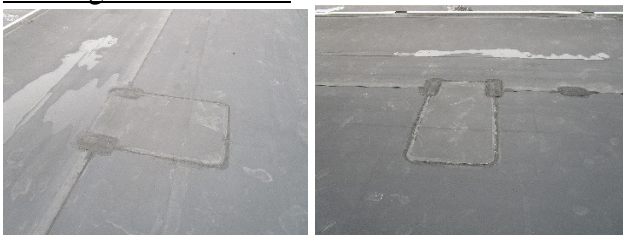
Kindergarten room 404

A lap that has patches on a patch lies over the leak occurring in this room. The patches need to be cleaned, primed and overlaid.

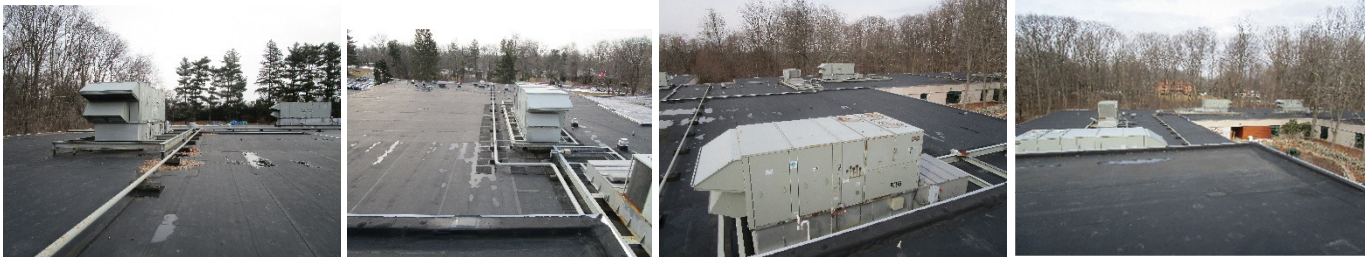
Overall views of the roof

The EPDM roof at Davenport Ridge School is in acceptable condition. The main issues we saw during our visual inspection of the roof dealt with flashings, laps and patches adhered using an adhesive (newer systems use a tape technology). There are also other items in need of attention or proper flashing.

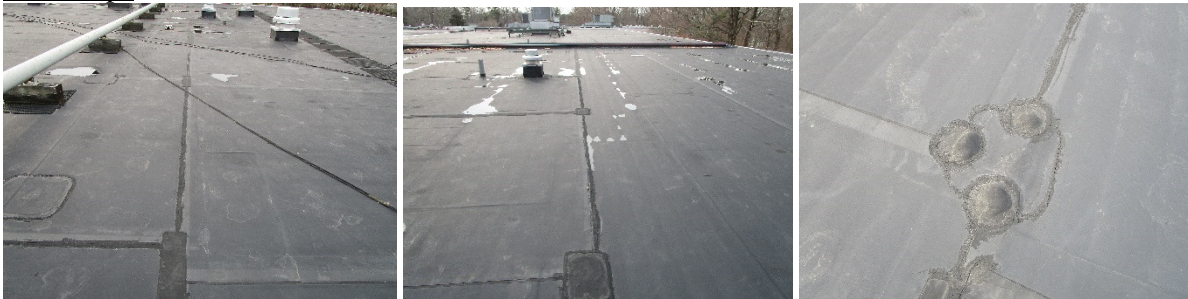
Field Laps

A good portion of the field laps (between the sheets of EPDM membrane) appear to have been bonded using tape technology. Some, however, look like they were adhered with glue. These laps have been caulked (not needed with tape). Items adhered with glue, as we shall see in the subsequent sections, tend to pull, lift and open over time. For this reason, we recommend cleaning, priming and overlaying approximately 3,000 lf of caulked field laps. This is an approximate estimate and will be a “good start” to periodically overlaying field laps as a means of extending the life of the roofing system.

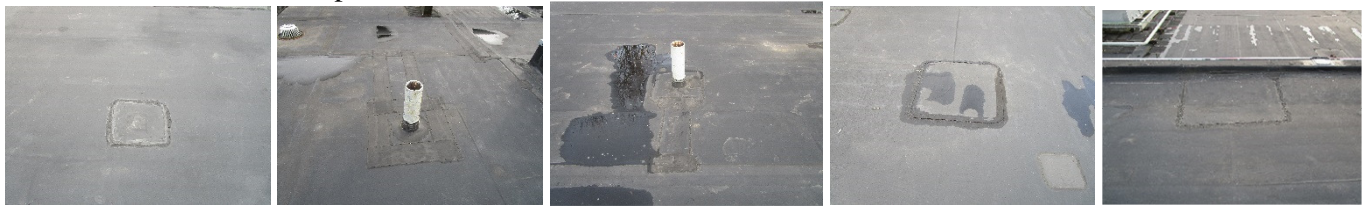
Patches and membrane strips in the field of the roof

There are many EPDM patches and EPDM strips that cover holes, sheet cuts, etc., These are starting to lift, and water can be seen coming out of some of them. These should be cleaned and overlaid with new flashing membrane.

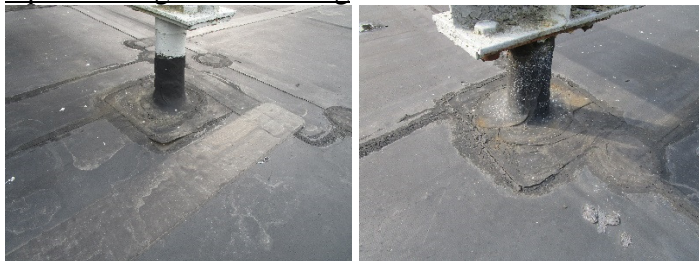
Open dunnage Post flashing

Many of the dunnage post flashings are starting to peel and lift. We believe some of these are causing current leaks. As the roof ages more of these will lift and let water into the roofing system. The membrane should be cleaned and overlaid to reseal this detail.

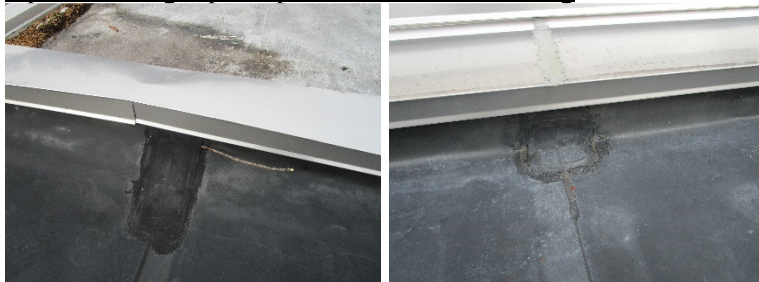
Open flashing laps or patches on base flashing

A number of Patches at the base perimeter flashings have bridged, pulled away from the wall, leaving a pathway for water to enter the roof. These need to be patched to prevent leaks.

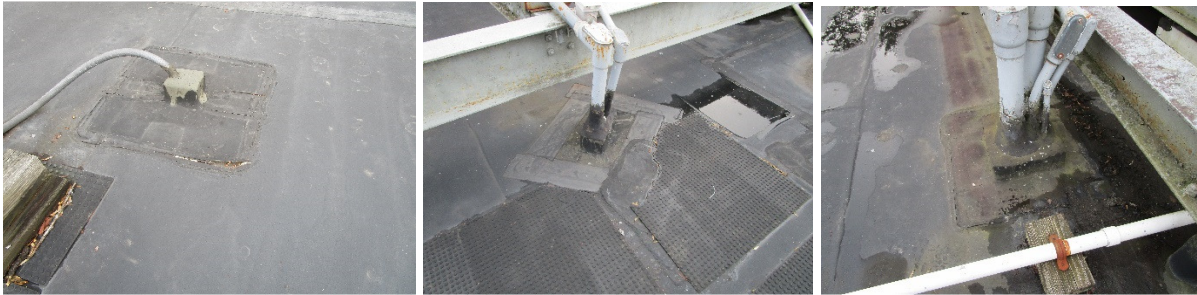
Penetration Pockets

Penetration pockets need to be "topped off" with additional sealer where the existing sealer has pulled away from either the penetration or edge of the pocket. The base flashings on the field sheet of the penetration pockets are lifting as well. These need to be overlaid with new membrane.

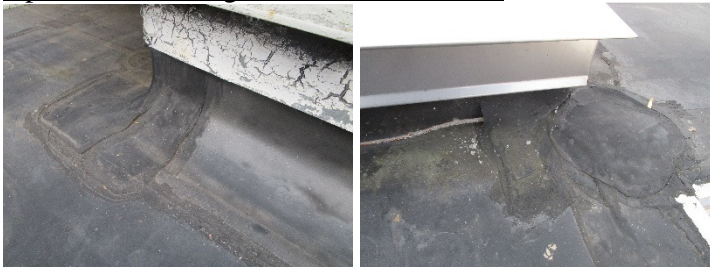
Open curb flashings and corners at curbs

All of the corners and curb flashings must be checked and overlaid with new flashing membrane if they are bridging, peeling or separating from the EPDM sheet.

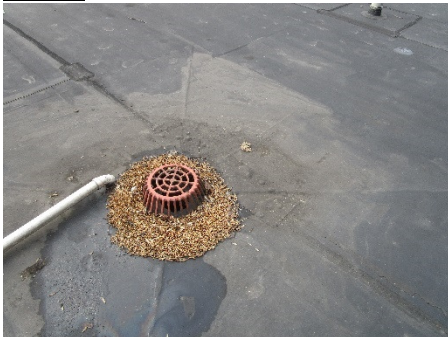
Drains

In addition to needing cleaning, (the whole roof must have debris removed) the drains need to be inspected to make sure the sealant and flashings are intact. At the above drain, there is a patch partially covered by debris that looks questionable. It should be overlaid.

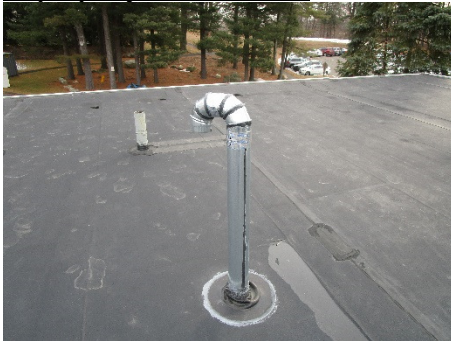
Improperly flashed vents

This vent does not appear to be properly flashed. The boot is squished down to the roof, and the perimeter of the boot has been caulked, usually a sign that problems have occurred. The boot should be removed, and the pipe field wrapped.

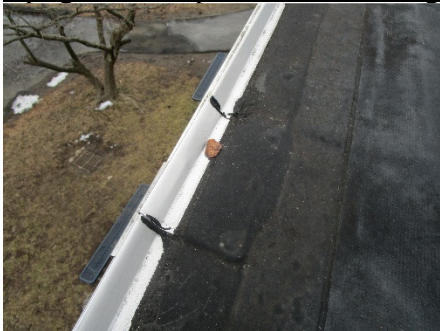
Uprights in the perimeter metal edging

It looks like water had been getting in through the vertical uprights on the perimeter edging and they were caulked to close the joint. These uprights should be patched with EPDM flashing material.

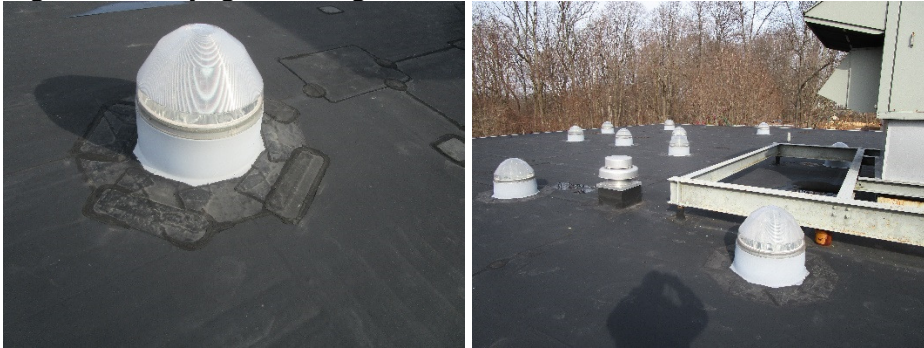
Light tunnel skylight flashing

There are a number of light tunnel skylights that have been installed on the roof. These have been sealed using small pieces of flashing going around the base flange. This is not a proper flashing installation. A large sheet of EPDM should be installed over all the patches. The sheet would have the round skylight cut out from the middle. EPDM flashing should then be applied to the vertical of the skylight and turned out and onto the new EPDM piece.

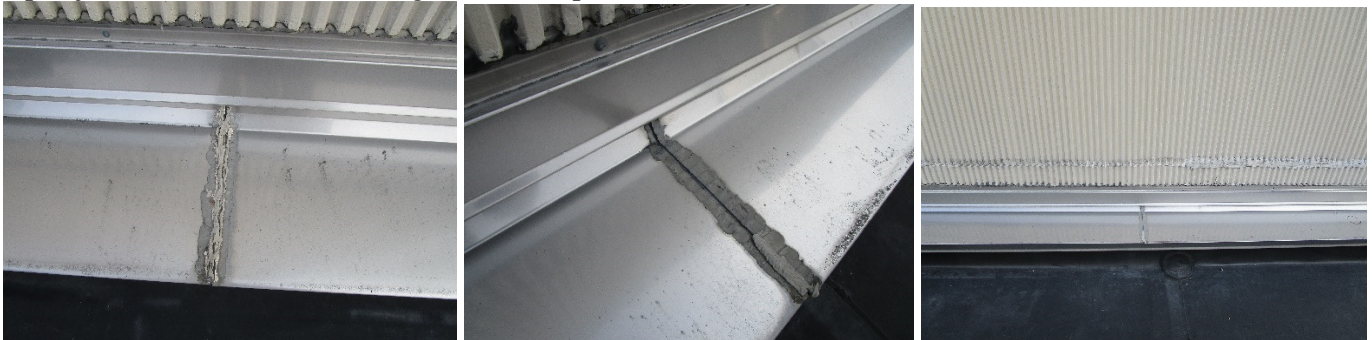
Open joints in metal shelf flashing around the perimeter of the raised section of roof

There is a raised section of the roof surrounded by vertical panels that sit on a metal shelf. The joints in the shelf have opened. They should be sealed with an EPDM patch. In addition, the Owner may want to have the panels and the frame inspected to see if that should be caulked by a professional caulking company.

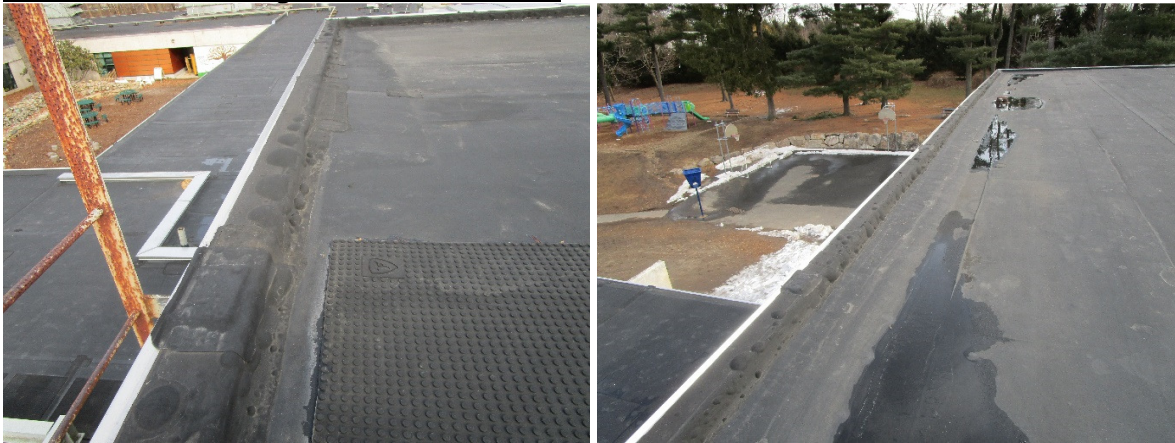
Perimeter curb flashing on raised area of roof

The membrane flashing on the perimeter curb of the raise roof section of roof is bubbling. The membrane on these bubbles will dry, crack and most likely break, creating entry points for water. These should be cut and overlaid with new membrane before problems develop around this roof area.

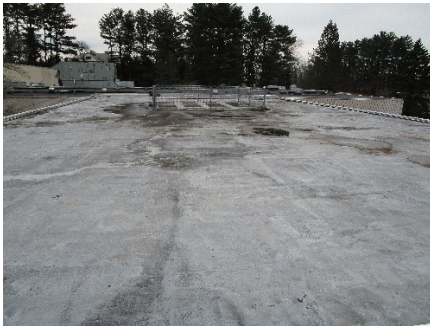
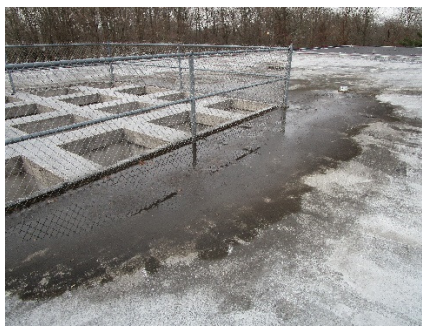
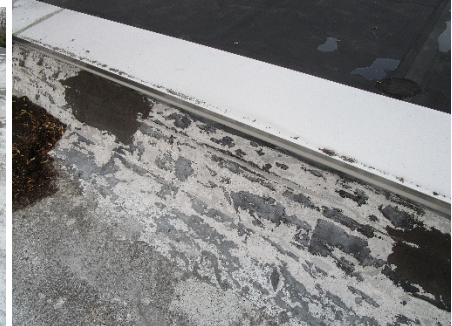
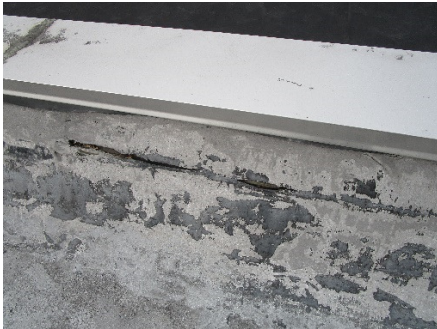
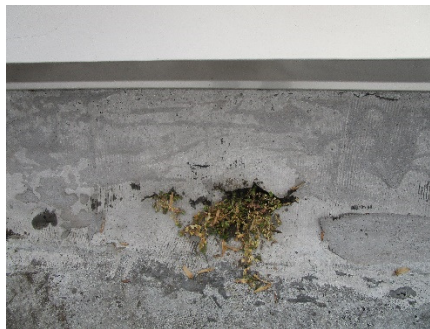
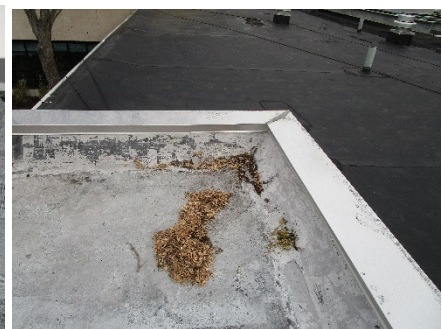
Concrete roof

The other area of roofing on the school is on the concrete deck over the entryway. This is a concrete deck that has a coating on it. The perimeter parapet walls appear to have an asphaltic base flashing that had also been coated. The coating on the deck is in poor shape. The perimeter base flashing is also in poor condition. There are cracks, splits, holes, etc., in the flashing. Some of the cracks even have organic growth. Repairs on this roof can be approached in a couple of ways. If the deck is not of concern; the perimeter flashing should be cleaned, loose material and organics removed, and new base flashing installed. If it is desired to install a new coating on the deck that can be done as well. This area should be discussed with the Owner and schools project architect to see the extend of the work desired and to determine a product and specification for the work. We can provide pricing after those items are determined.
