Assessment & Growth Removal -Photographic Log **Tighe&Bond**

Client: City of Stamford Mold Task Force

Job Number: S-2087-033

Site: Hart Magnet Elementary School

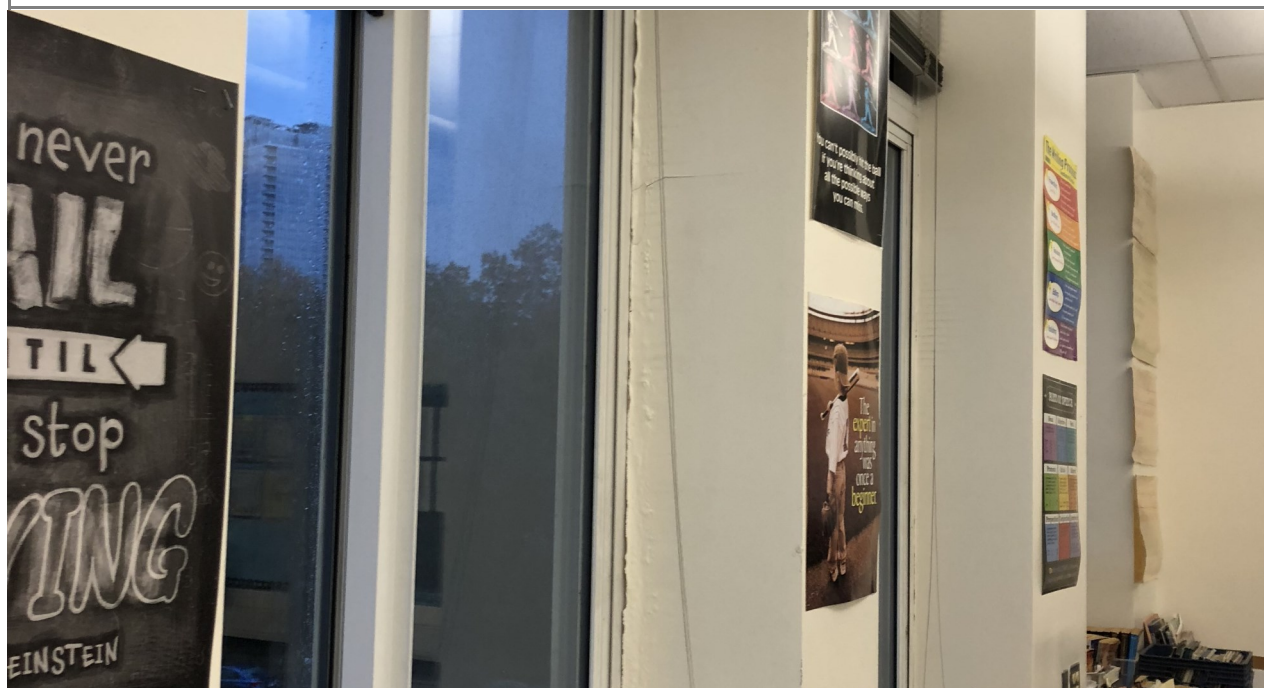
Photograph No.: 7	Date: 11/5/18	Direction Taken: —
Description: Room 232— Water Damaged Drywall at Window

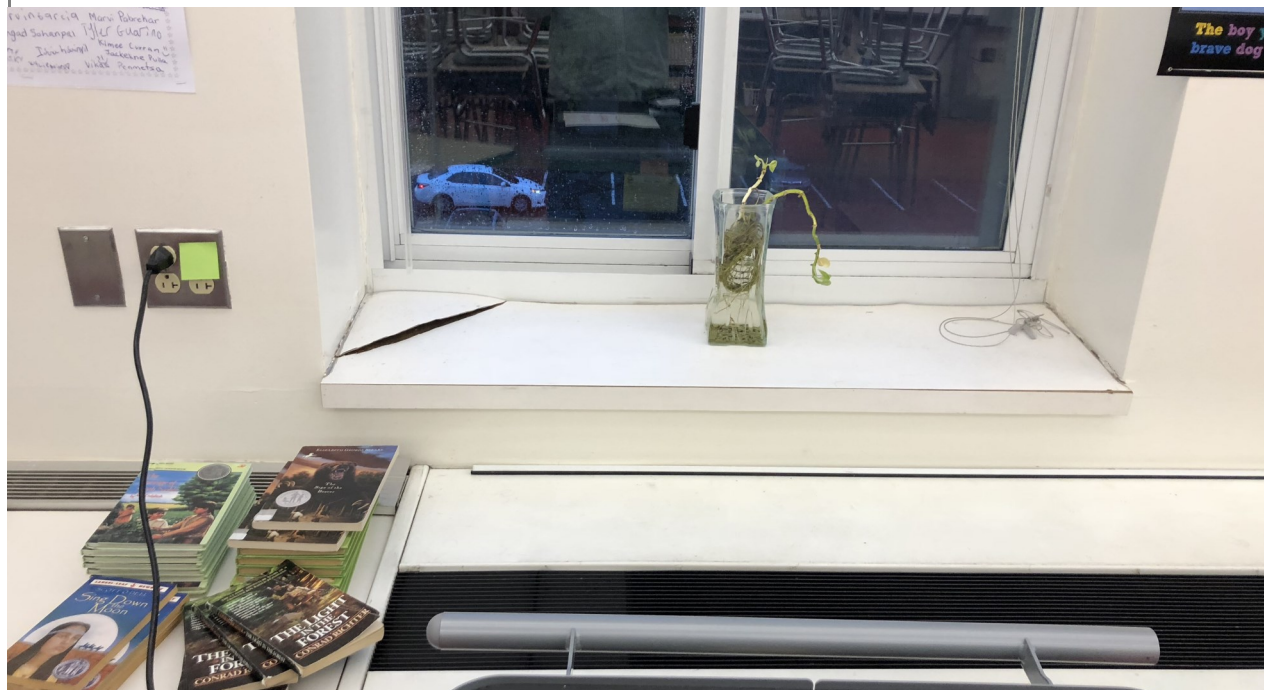
Photograph No.: 8	Date: 11/5/18	Direction Taken: —
Description: Room 232 — Water Damaged Window Sill

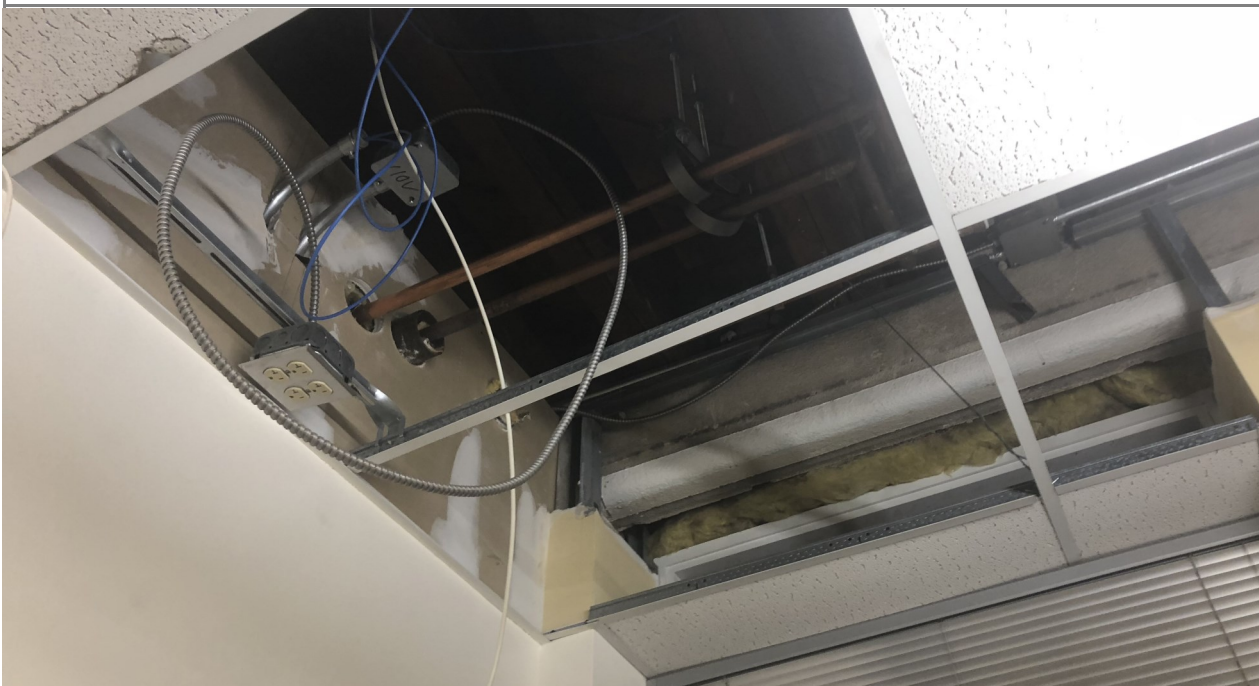
Photograph No.: 15	Date: 11/8/18	Direction Taken: —
Description: Room 147— Post-Removal Water Stained/Growth Impacted Ceiling Tiles/Pipe Insulation

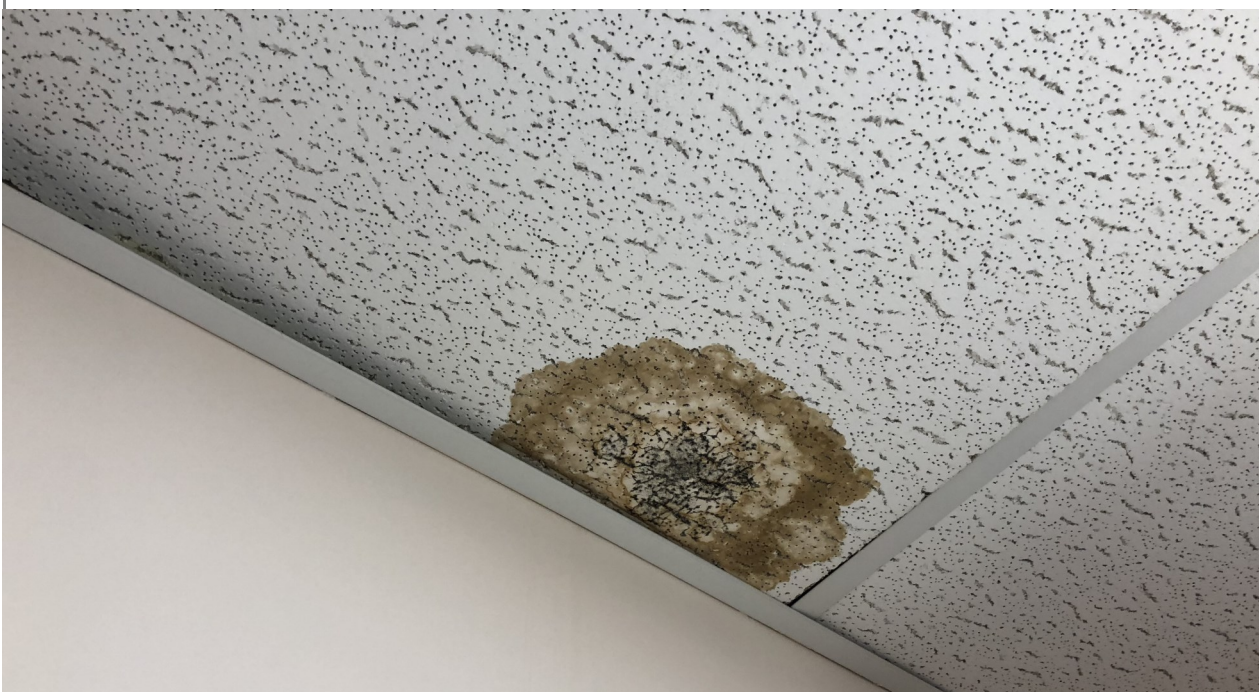
Photograph No.: 16	Date: 11/5/18	Direction Taken: —
Description: Room 140 Storage —Water Stained and Black Growth Impacted Ceiling Tile

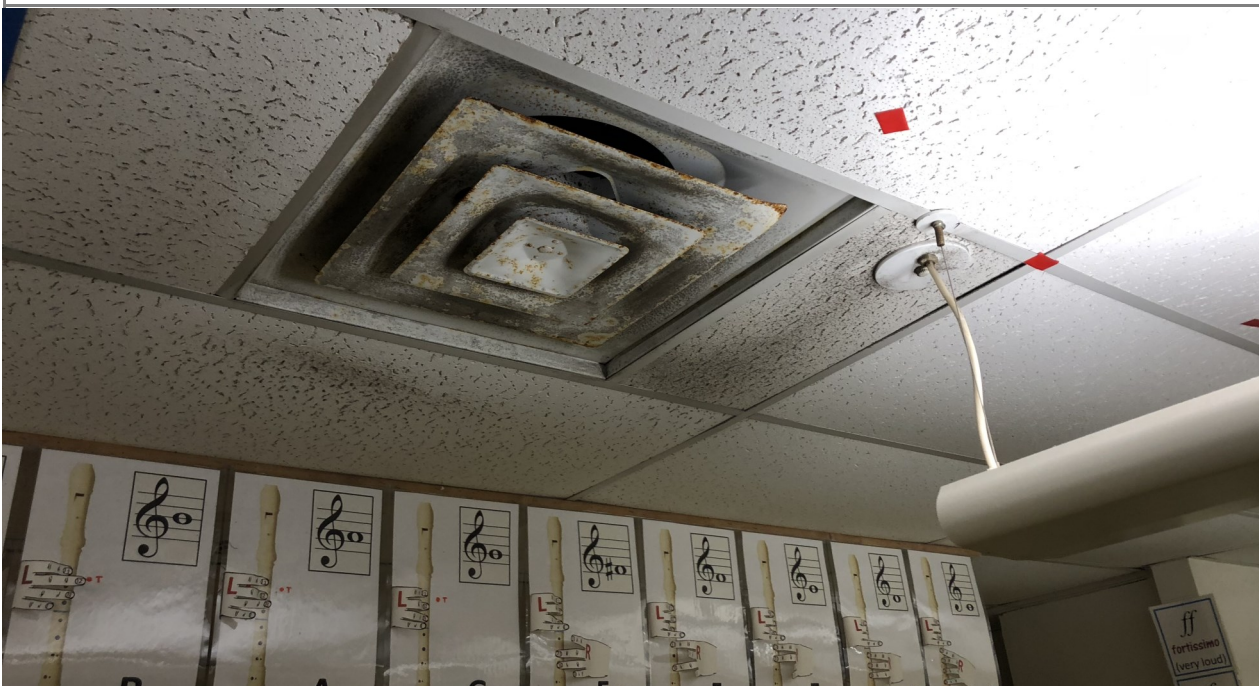
Photograph No.: 21	Date: 11/5/18	Direction Taken: —
Description: Room 040—Black Growth on HVAC Diffuser and Adjacent Ceiling Tiles

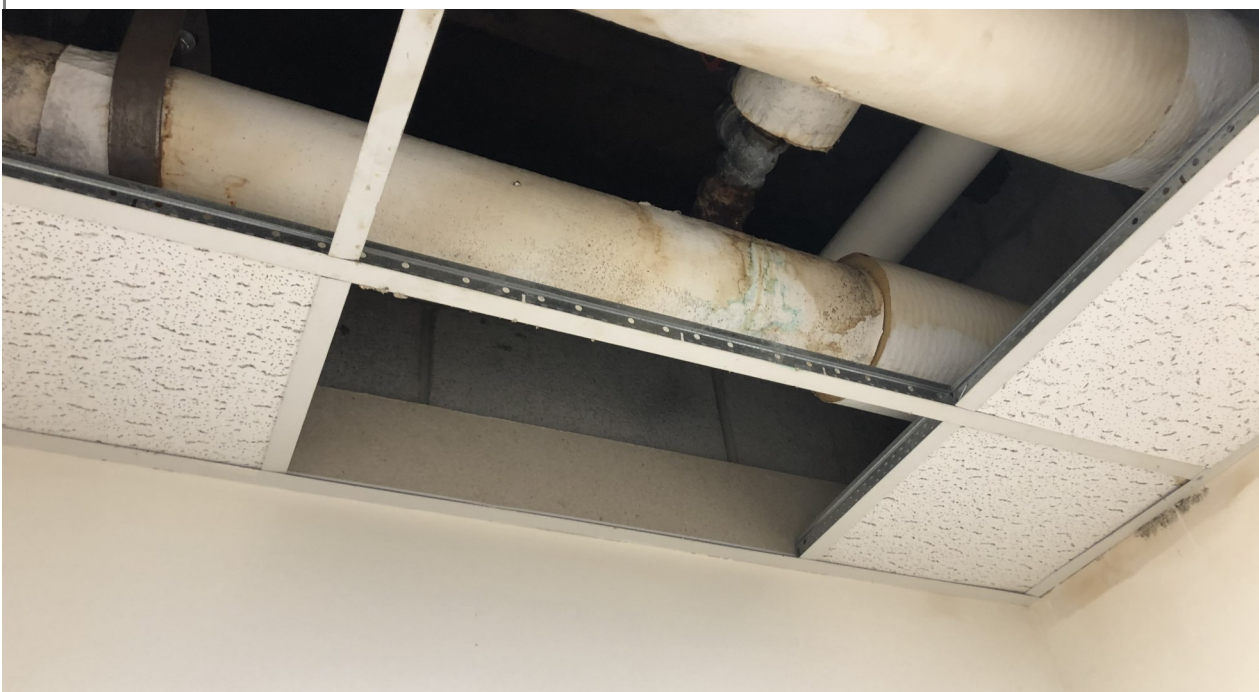
Photograph No.: 22	Date: 11/5/18	Direction Taken: —
Description: Boiler Room Entryway—Water Stained and Black Growth Impacted Pipe Insulation
