# **Limited Indoor Air Quality Assessment Report**

February 24, 2020  
Toquam Elementary School – Room 34  
123 Ridgewood Avenue  
Stamford, Connecticut

**RE: Limited Indoor Air Quality Assessment  
Toquam Elementary School – Room 34  
123 Ridgewood Ave, Stamford, CT**  
Fuss & O'Neill Project No. 20140748.A10

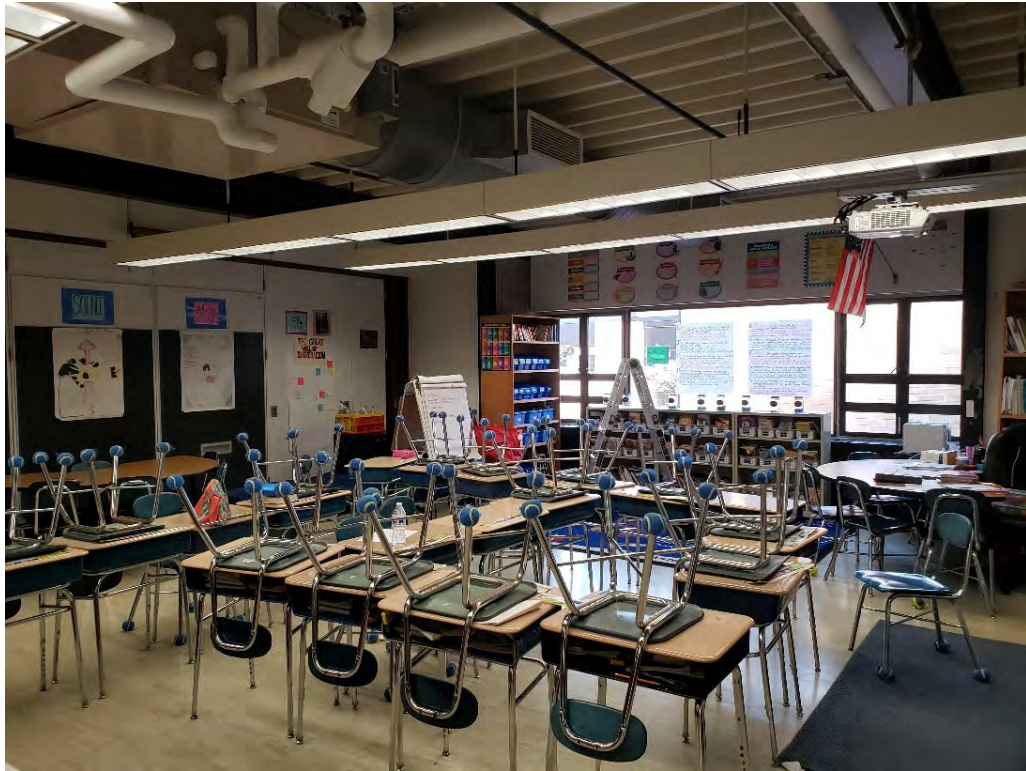
Classroom 34

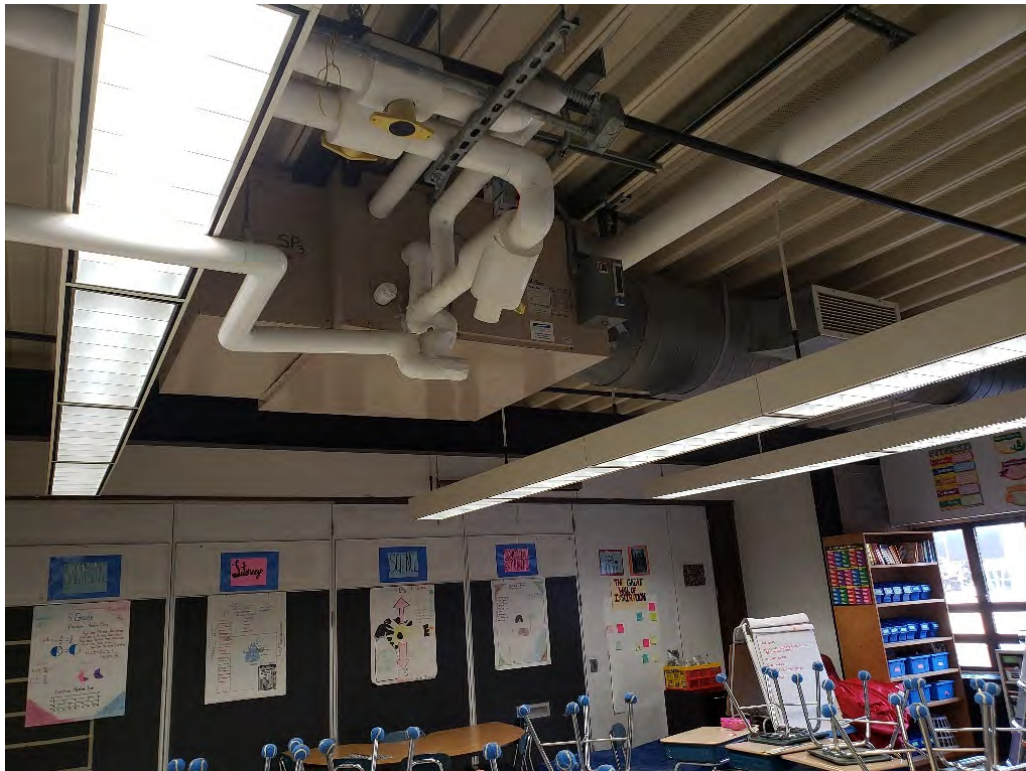
- Filter was observed to have an excess of particulate accumulation
  - Air handler within room is operated during summer season; equipment was not operating at time of the assessment

HVAC unit – Not operating; runs during summer season

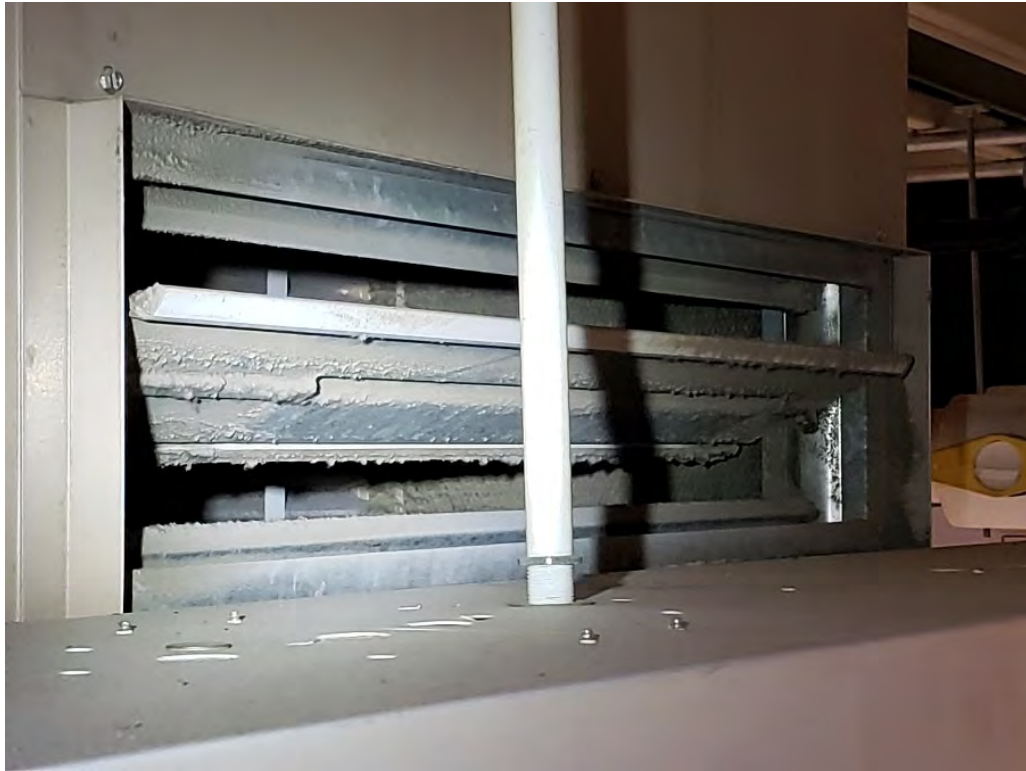
- Observed large amount of dust/particulate within return vent of the unit
- Hallway – Adjacent Area
  - No odor observed
  - Hallway contains newly installed air supply vents which provides fresh air for nearby classrooms

- An accumulation of dust and particulate was observed on the return air register of ceiling mounted cooling unit within classroom 34. This condition may be present in other locations.

Classroom 34 – Return vent of HVAC unit

- This may include periodic cleaning of HVAC supply and return vents as well as air purifying equipment and review of proper use in accordance with the manufacturer's recommendations.

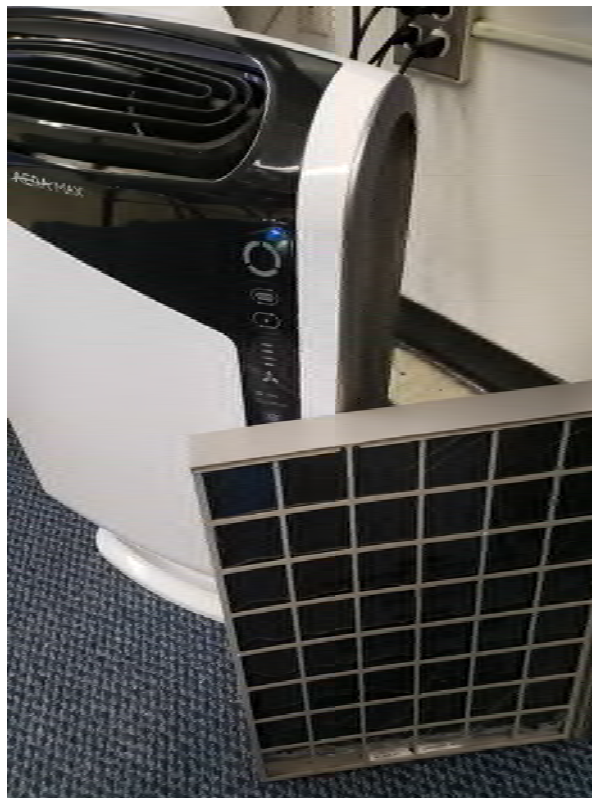
- The air purification units within classroom 34 and classroom 33 were observed to be improperly used and/or maintained
  - The filter located within the unit in Classroom 34 was observed to be sealed in the original plastic wrapping

Classroom 34 – Tower-style Air Purifying equipment and pre-filter

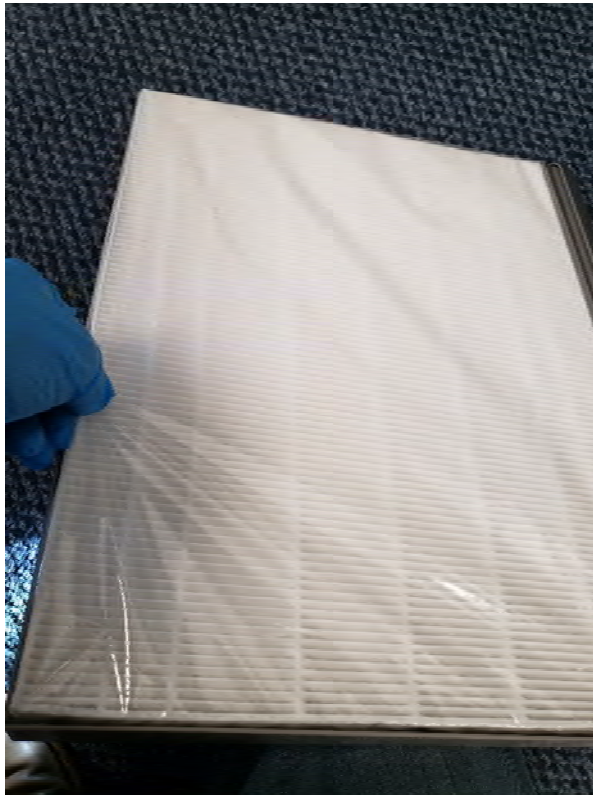
Classroom 34 – Filter in original manufacturer's plastic wrapping

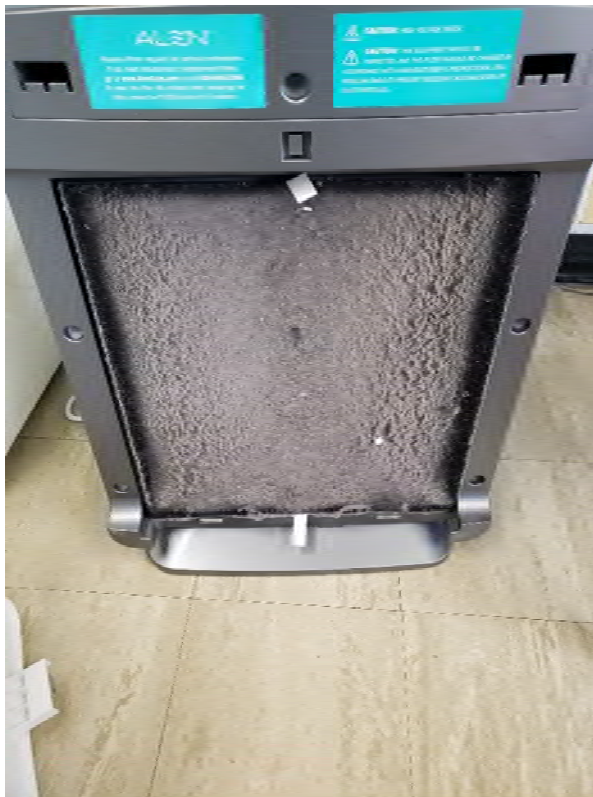
- The filter located within the unit in Classroom 33 was found with an excess of particulate accumulation that may restrict proper air flow
- At the time of this assessment, it could not be determined if (exhaust) ventilation systems or were operational.

Classroom 33 – Filter of Tower-style Air Purifying equipment showing significant particulate loading

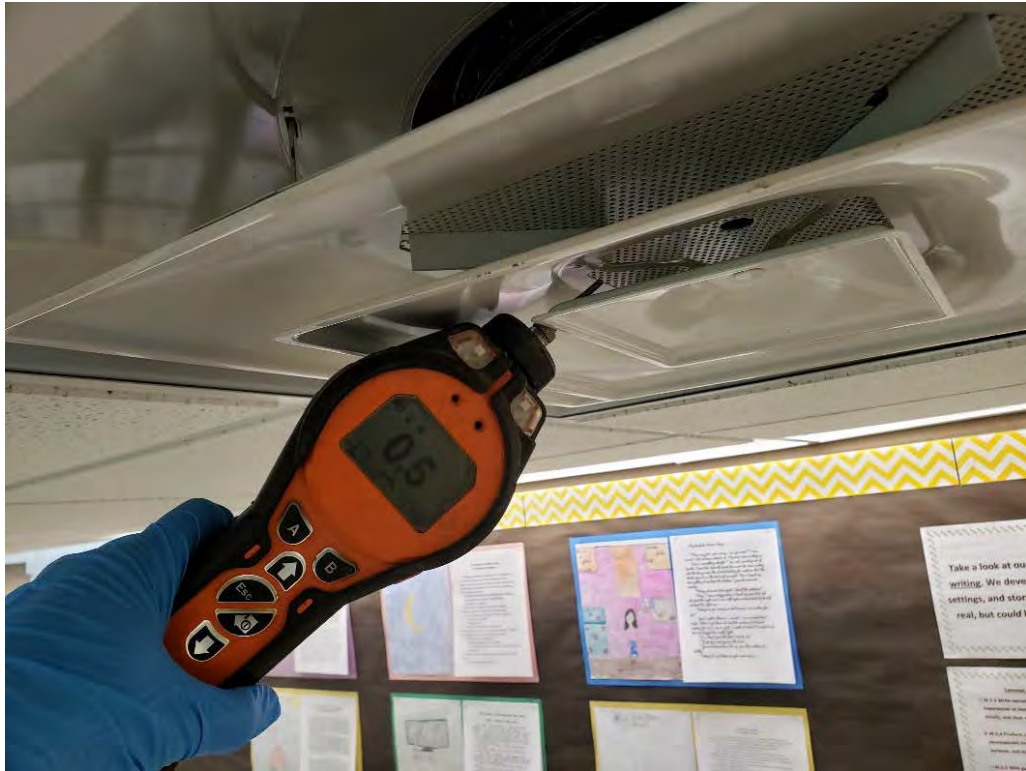
At the time of the assessment, an odor similar to that of a cleaning solvent was briefly identified in Classroom 34 however, at the time of the assessment; no interior measurements of TVOCs were recorded within this space. Within the hallway adjacent to Classroom 34, interior measurements of TVOCs were recorded at various concentrations with the highest measurement of 0.7 parts per million (ppm) documented at the HVAC supply vent in the hallway adjacent to classroom 34.

Hallway – Air Supply vent adjacent to Classroom 33 and 34

- Conduct a review of the HVAC system to ensure the ventilation system is operating as designed.

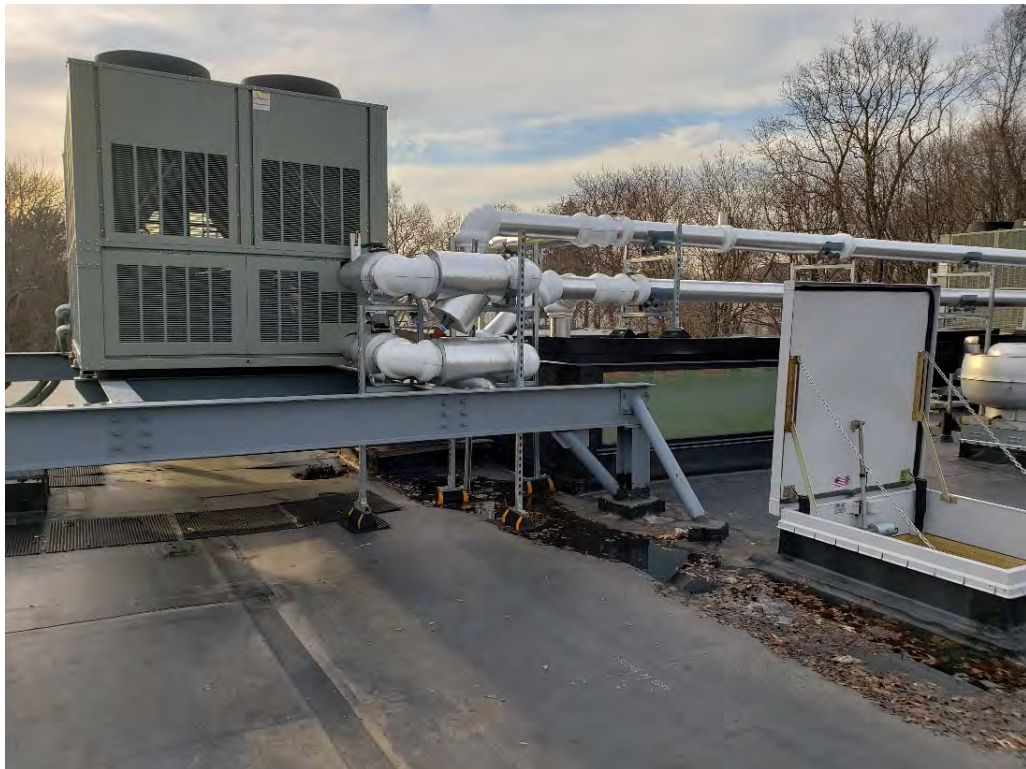
- Filters within HVAC housing units did not display excessive loading indicating they were recently changed
  - The unit appears clean and well maintained

Roof-mounted HVAC systems

- Continue regular maintenance of the HVAC system(s), including regular filter change/cleaning and maintenance.
  - This may include alternative storage locations of maintenance products such as anti-freeze.

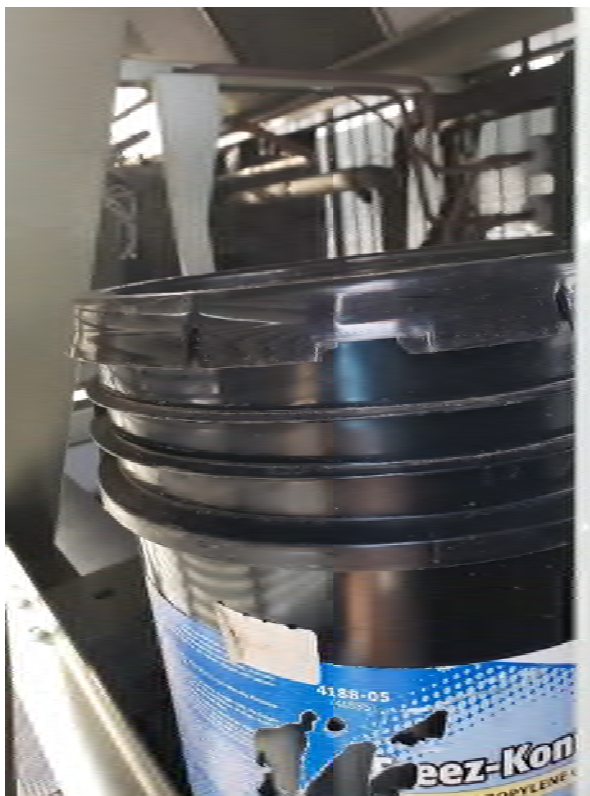
- At the time of this assessment, it could not be determine if air supplies were operating or not.
- Roof – Rooftop air handling cooling unit
  - Observed sealed five-gallon containers of heat transfer and anti-freeze fluid (inhibited propylene glycol) within two HVAC housing units

Roof – Anti-freeze container within HVAC housing

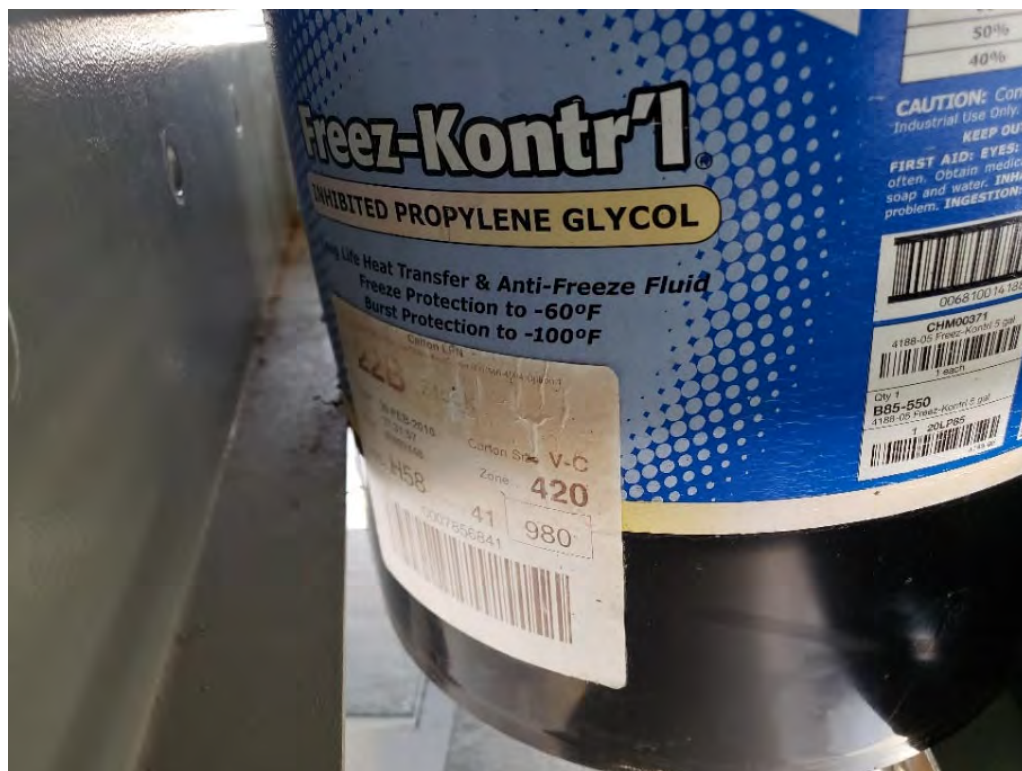
Roof – Additional view of anti-freeze container in 2<sup>nd</sup> HVAC housing

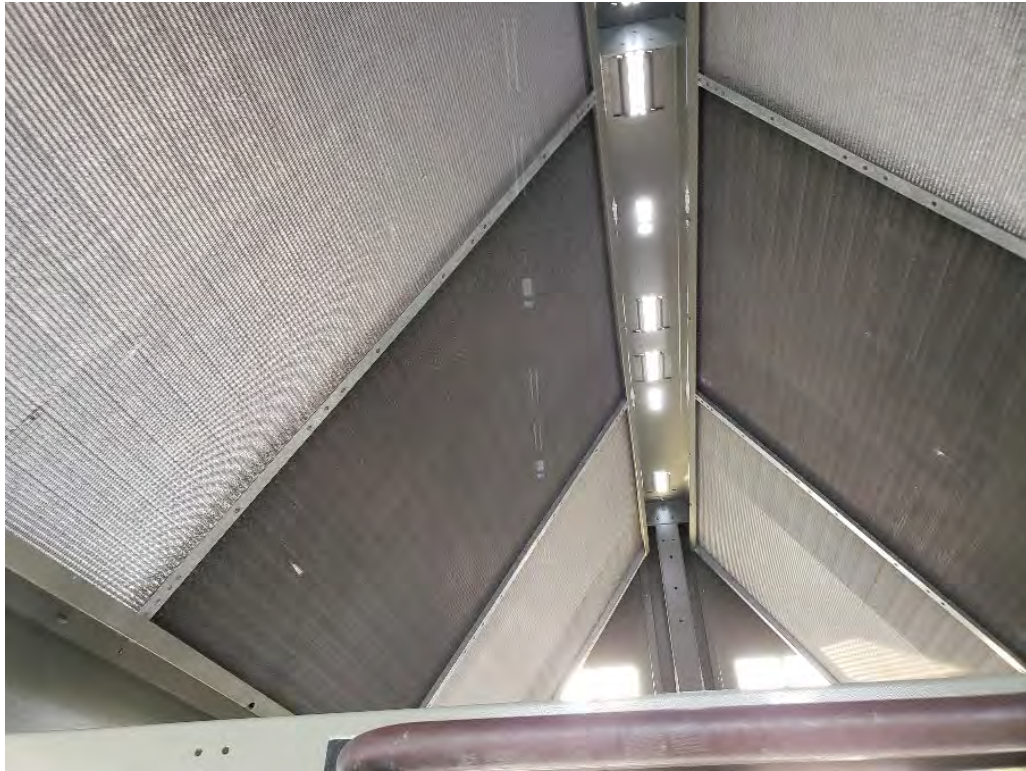
Roof – View of air intake filters
