WESTHILL SCHOOL  
STAMFORD, CONNECTICUT

SUMMER 2019 WORK  
LOWER LEVEL

FIGURE: 3.1

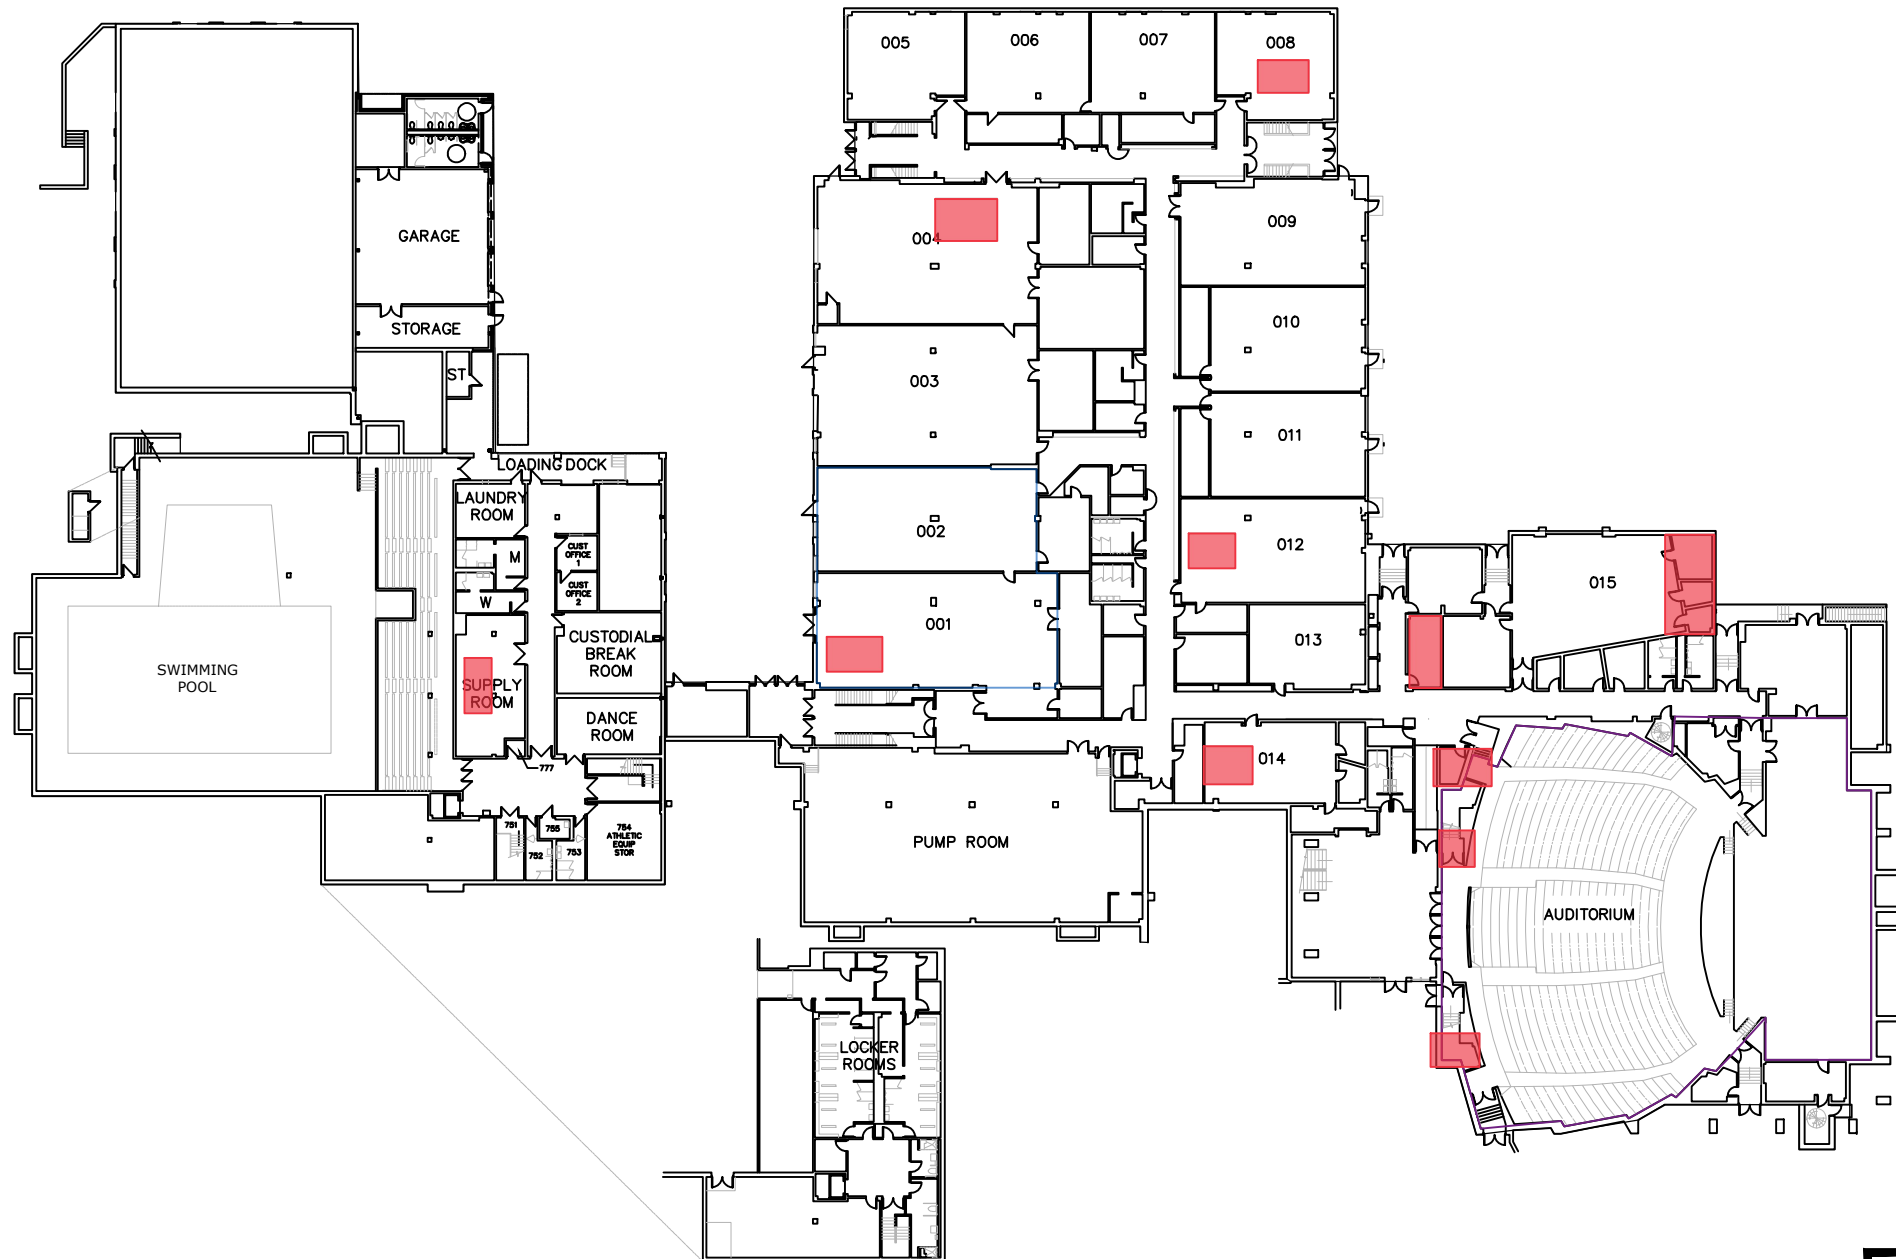
REMOVE MOLD CONTAMINATED / WATER STAINED CEILING TILES

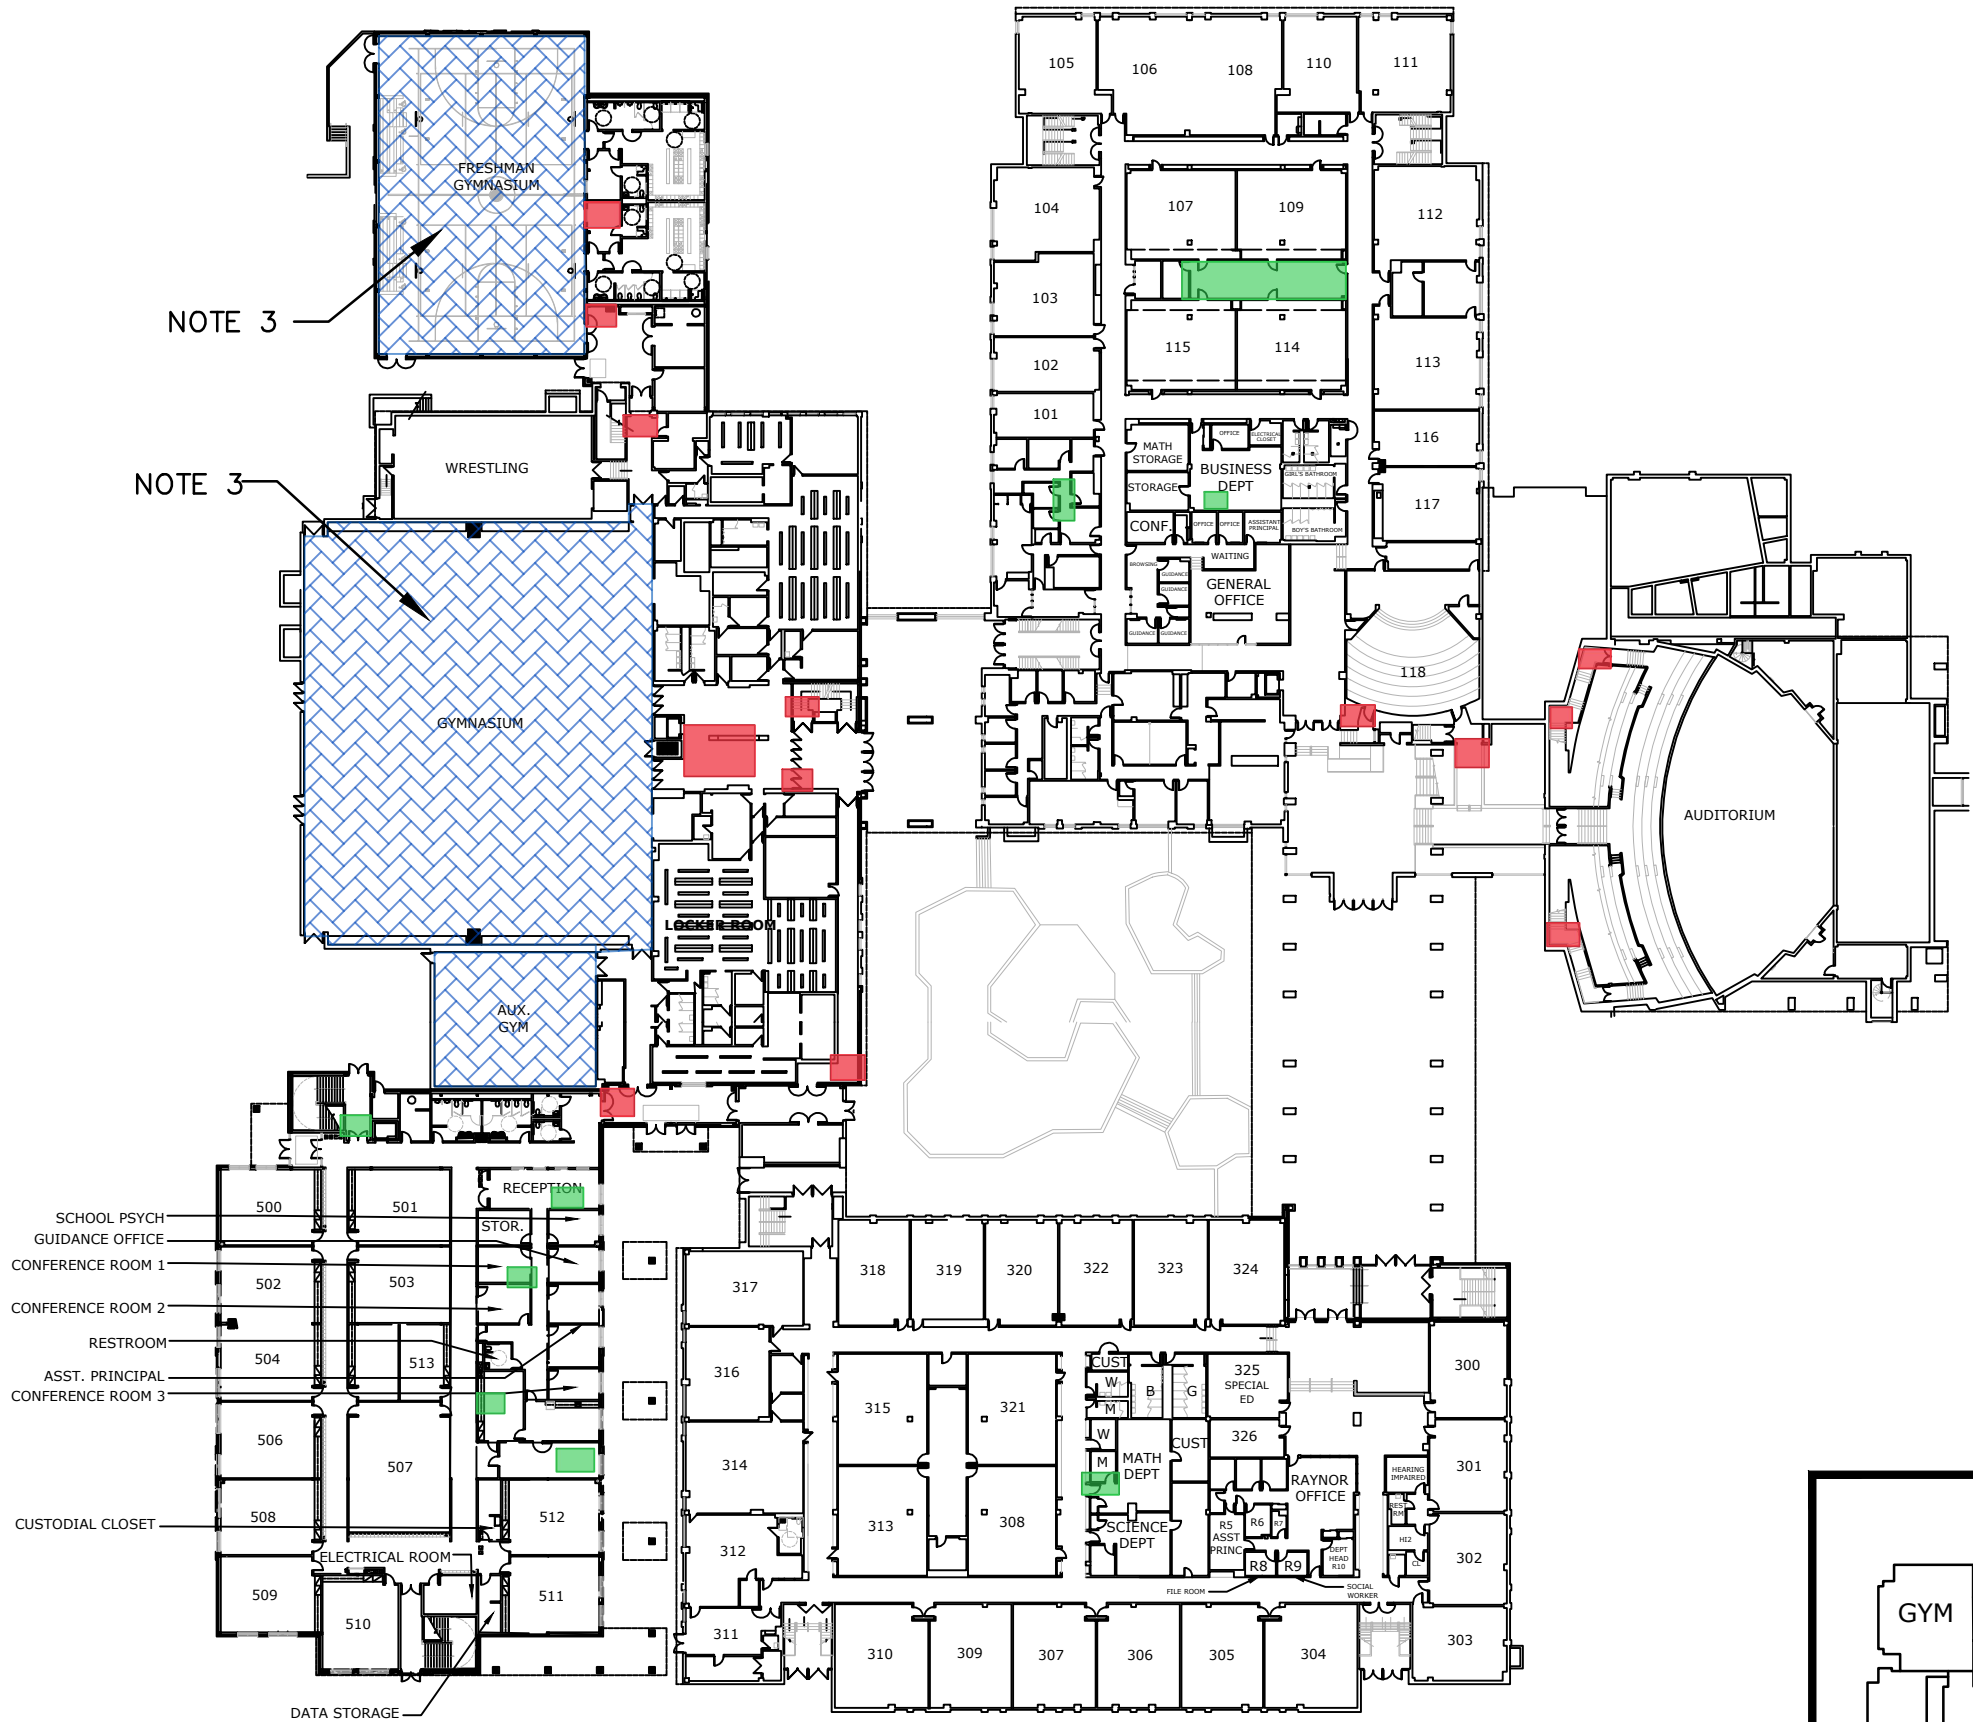
FIGURE: 3.2

NOTE-03 -  
REMOVE DUCT INSULATION THROUGHOUT INCLUDING  
ASBESTOS-CONTAINING TAN GLUE AND NON-ASBESTOS FIBERGLASS  
INSULATION  
CLEAN AND DISINFECT AREA INCLUDING HIGH CEILINGS, DUCTWORK,  
HVAC VENTS, SPRINKLER PIPE, AND LIFTS  
CONDUCT WORK WITHIN NEGATIVE PRESSURE TWO LAYER CONTAINMENT  
WITH CONTIGUOUS THREE STAGE WORKER DECONTAMINATION UNIT AND  
TWO STAGE WASTE LOAD OUT DECONTAMINATION UNIT

REMOVE MOLD CONTAMINATED / WATER STAINED CEILING TILES

WORK COMPLETED TO REMOVE MOLD CONTAMINATED / WATER STAINED  
CEILING TILES

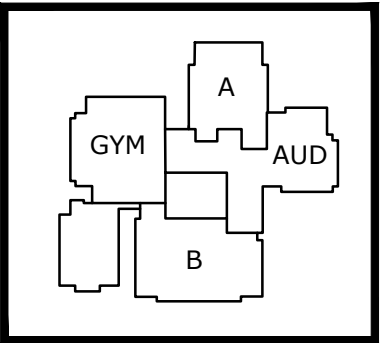
SUMMER 2019 WORK  
FIRST FLOOR

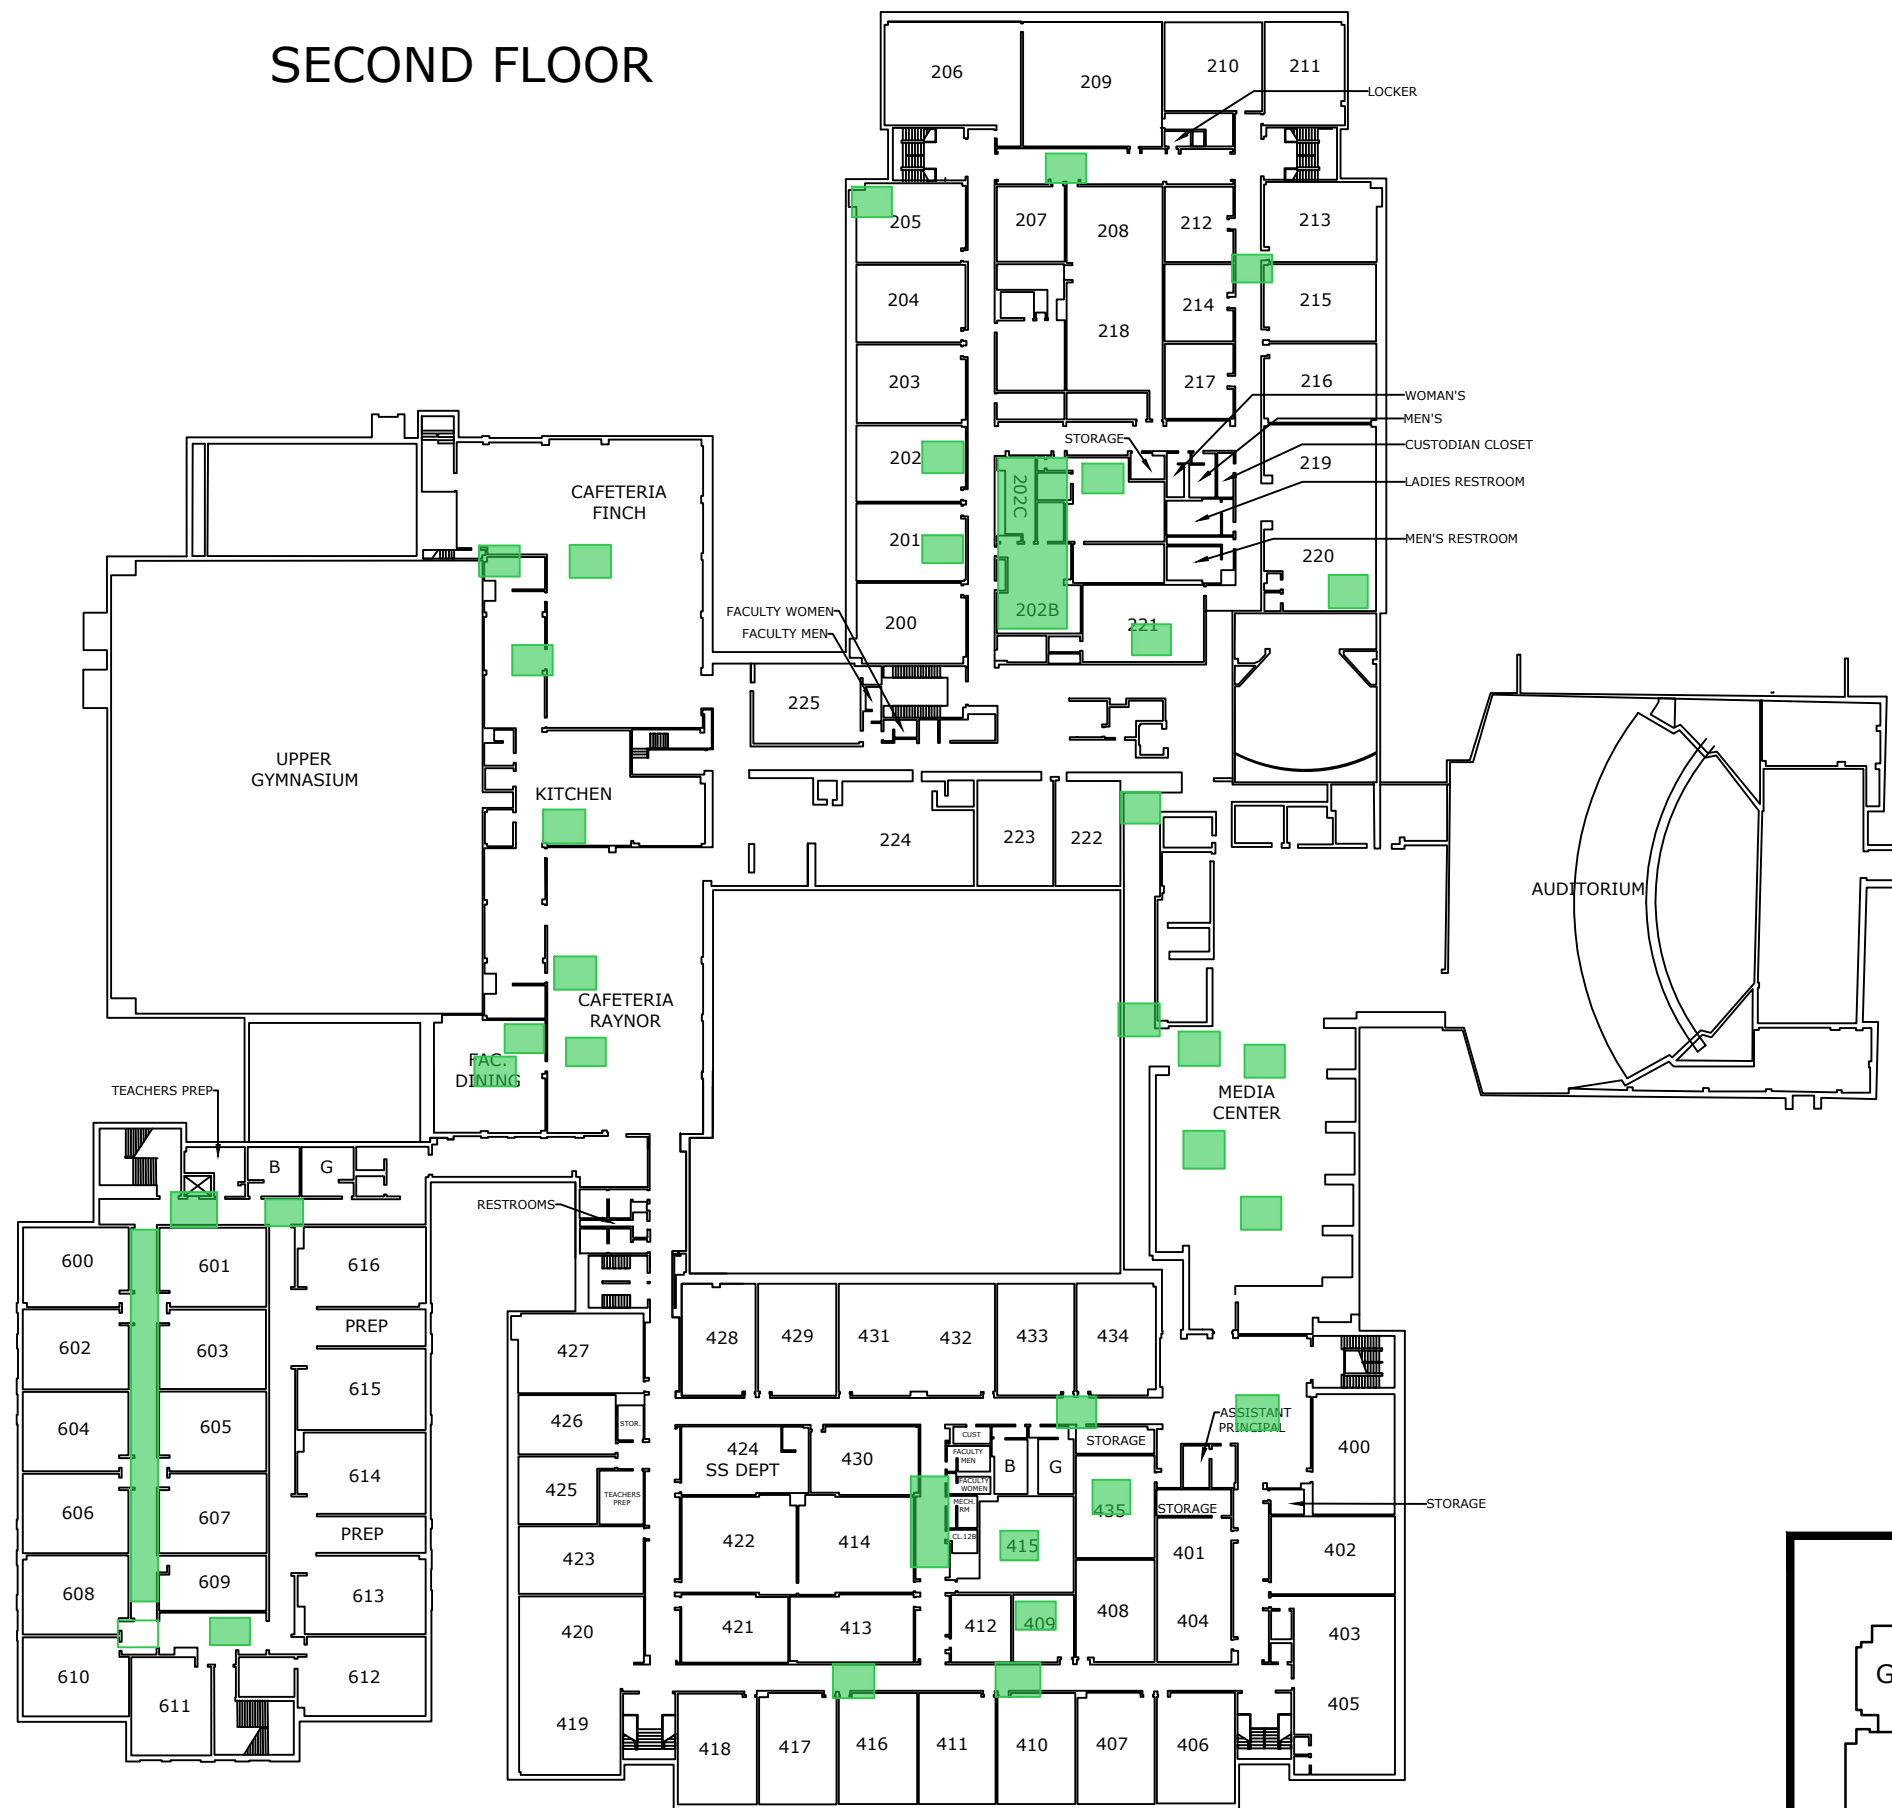
FIGURE: 3.3

WORK COMPLETED TO REMOVE MOLD CONTAMINATED / WATER STAINED  
CEILING TILES

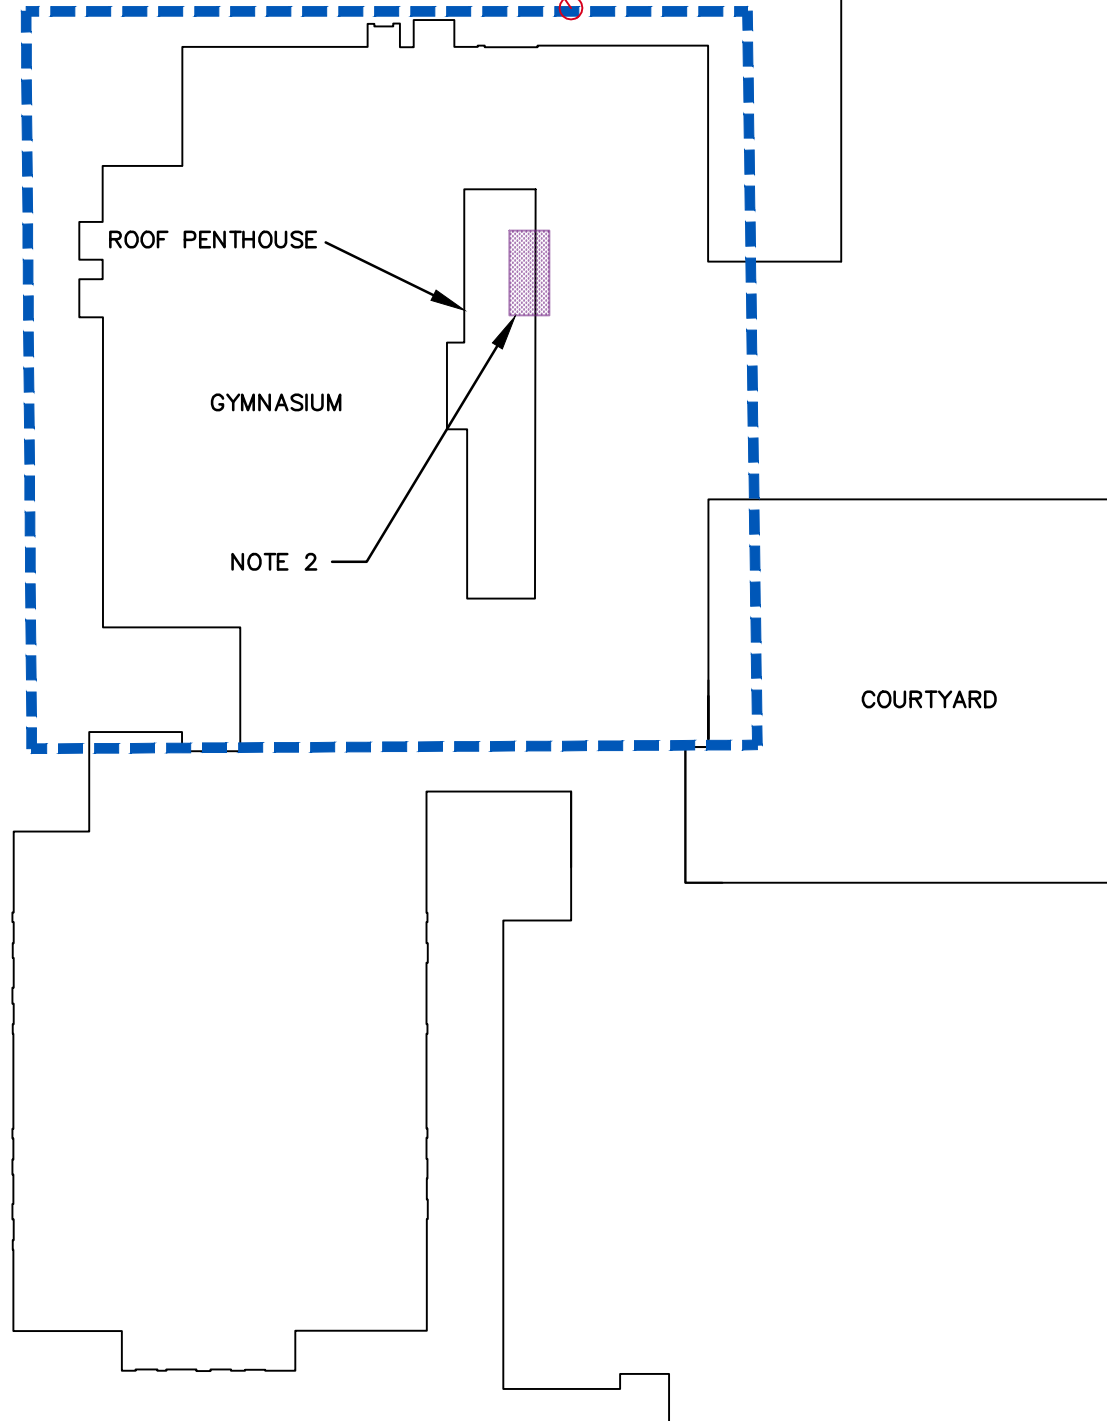
FIGURE: 3.4

REMOVE TAR PAPER / FELT BEHIND BRICK FAÇADE AROUND LOUVER  
CONDUCT WORK WITHIN ONE LAYER DROP CLOTH REGULATED WORK  
AREA DEMARCATED BY CAUTION TAPE AT THE BOUNDARY WITH CRITICAL  
BARRIERS AND REMOTE DECONTAMINATION UNIT

SEE SATELLITE  
OVERHEAD

SATELLITE OVERHEAD VIEW

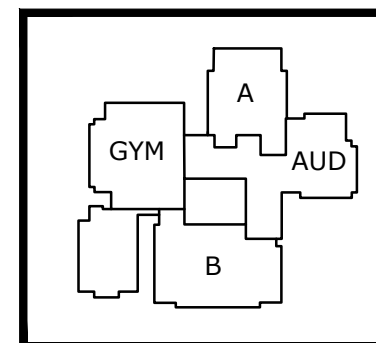
SUMMER 2019 WORK  
ROOF
