LOCAL ROAD ACCIDENT REDUCTION PROGRAM

Project Proposal Summary – 2017

1. **Project Sponsor:** CITY OF STAMFORD
2. **Project Title:** BROAD STREET CORRIDOR SAFETY IMPROVEMENTS
3. **Project Locations:** BROAD STREET AT ATLANTIC, GAY AND GREYROCK STREETS
4. **Written Description of Proposed Project:**

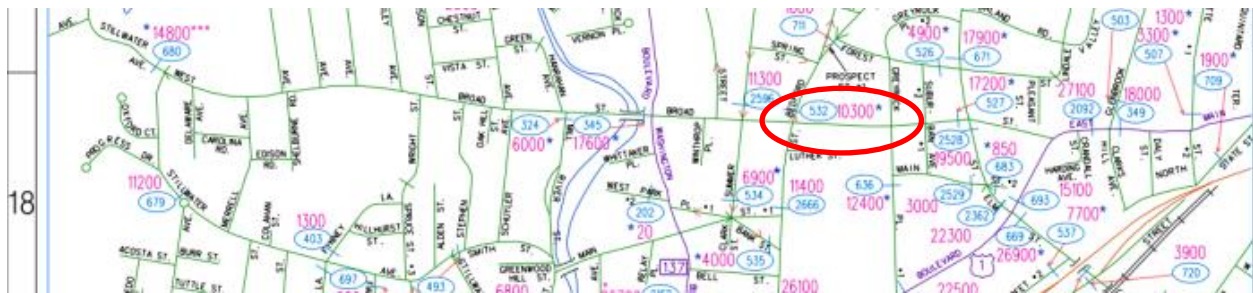
Figure 3: CTDOT Average Daily Traffic, 2014

The intersection of Broad and Atlantic Street hosts a high volume of pedestrians, bicycles, CTtransit buses, delivery trucks and motorists. Table 1 below shows peak hour volumes by mode, collected by Urban Engineers, for the Citywide Signal Synchronization Study. This data shows AM, Mid-day and PM periods for all transportation modes, and demonstrates how truly multi-modal this intersection is.³ The traffic counts demonstrate that there is no off-peak for this corridor because there is consistent activity throughout the day. Table 2 below shows average daily bus ridership data, provided by CTtransit, for the Atlantic Square bus hub, which includes all of the bus routes that use the intersection of Broad and Atlantic Streets. CTDOT traffic data, as shown in Figure 3, which is collected with traffic tubes, shows that average daily traffic is 11,400 on Atlantic Street near this intersection.⁴

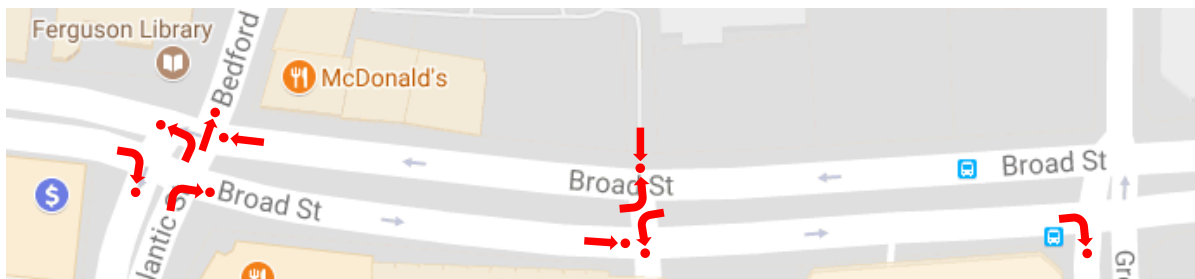
Figure 5: Direction of Travel for Pedestrian Crashes

From 2012-2016, 11 pedestrians were involved in crashes in the area of Broad Street at Atlantic, Gay and Greyrock Streets, which is 42% of all injuries sustained in the area during that time. Only 1% of crashes involving pedestrians resulted in no injury, and of the other 99%, 63% resulted in minor injuries and 27% resulted in serious injury. There is a positive correlation between travel speed and the severity of crashes. This proposal includes strategies to increase visibility of pedestrians and slow traffic, with countermeasures such as high-visibility crosswalks and curb extensions. 64% of pedestrian-involved crashes occurred when the pedestrian was crossing the roadway. Curb extensions and pedestrian refuge islands could help prevent these crashes and increase safety for those that are slower to cross the roadway 18% of pedestrian-involved crashes included failure to yield to pedestrian in the crosswalk on the part of the driver as a contributing factor. To prevent these crashes, the City proposes warning signs for turning drivers to yield to pedestrian in crosswalk. The weather conditions were clear and dry during 100% of these pedestrian crashes. It was daylight during 55% of crashes and after dark during 45% of crashes. To address crashes that took place after dark, the City proposes brighter light and increased lighting in this corridor. 10% of crashes took place during the AM peak hour and mid-day, 50% during the PM peak hour, and 40% at between midnight and 2:00 AM.

Seven out of the eleven crashes occurred when cars were turning, three of which were turning right and four turning left. Three out the eleven crashes occurred when cars were driving straight. To address all pedestrian crashes in the corridor, the City proposes FHWA approved countermeasures such as high visibility crosswalks and curb extensions where feasible to increase visibility of the pedestrians and shorten crosswalk distance. To address turning crashes in particular, the City proposes illuminated warning signs that are programmed in synch with the vehicle turning signals.
