14 January 2019

Project 182094 – Building Enclosure Investigation and Consulting Services, City of Stamford Public Schools, Stamford, CT

Per your request, this report provides the results of our investigation of the reported water leakage at the Julia A. Stark Elementary School in Stamford, CT. It includes our summary of background information provided by others, a summary of our field observations and test results, a discussion of pertinent issues, conclusions as to the sources of the water leakage, and conceptual recommendations for remedial repair options.

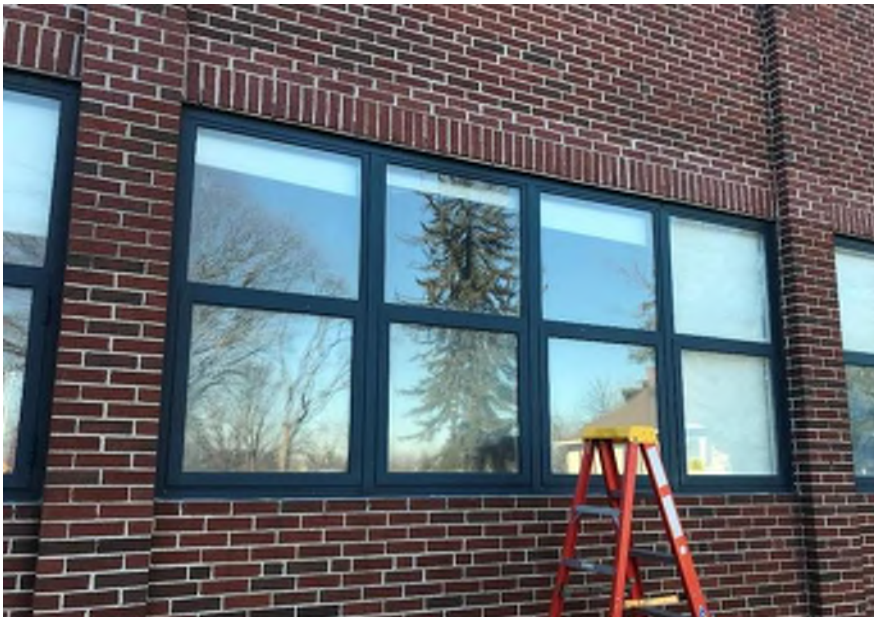
Photo 29

- The windows appear to be a "combination assembly," in which individual window units are combined and butted together (i.e., mulled) at the jambs with a cover plate (Photo 29).

Typical window assembly shows individual window units mullered together.

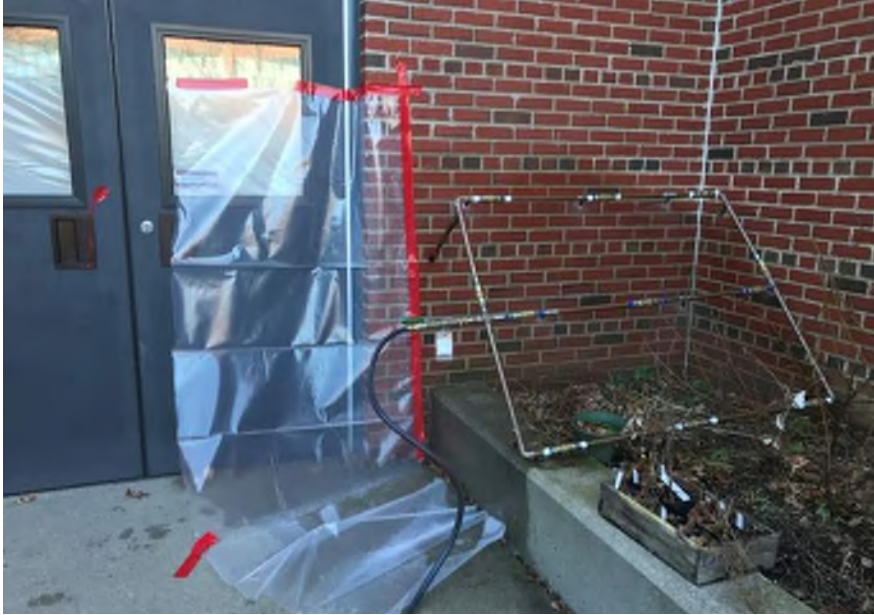
Photo 36

We used a spray rack to apply water to the exterior wall at the planter on the north elevation of the south hallway. The interior finishes were removed due to the abatement work that was ongoing during our testing (Photo 36). The CIH and Bismark reported biological growth on the interior finishes adjacent to the planter. We observed corrosion on the light-gage steel framing in this area (Photo 8). During testing, we isolated the planter wall from the adjacent door by covering the door with a plastic sheet. We performed the test for 1 hr and observed approximately 2 in. of accumulated water on top of the plater soil during testing, which then slowly drained down into the soil. We did not observe leakage to the interior.

Water Test Location No. 1 at planter.

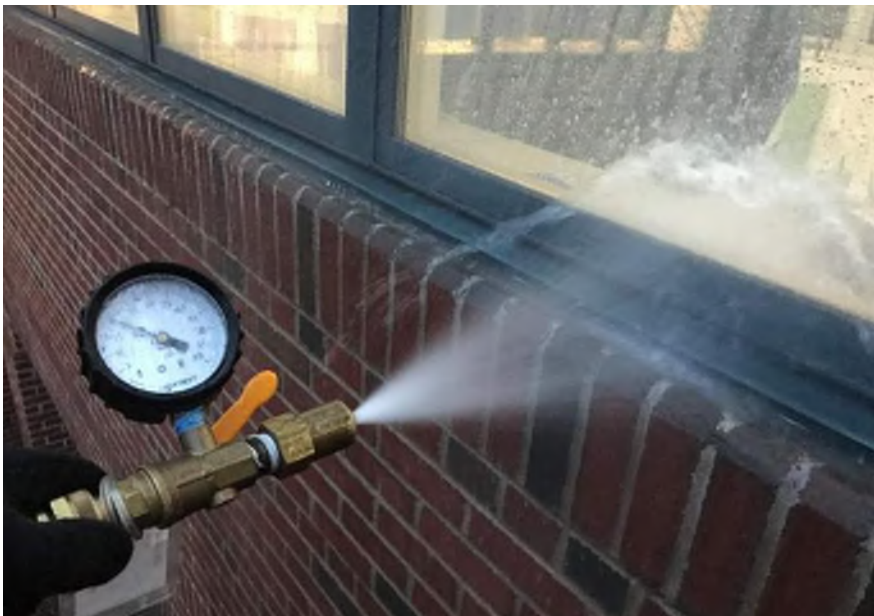
Photo 37

We tested three windows without head flashing repairs on the 1997 addition using both spray racks and handheld nozzles (Photo 37). We installed plastic sheets over windows or perimeter sealant joints to isolate conditions for testing (i.e., test the head flashing, perimeter joints, or sections of the perimeter joints only). We observed water leakage to the interior at the following locations:

Water test at window on second-floor north elevation of the bridge with handheld nozzle.

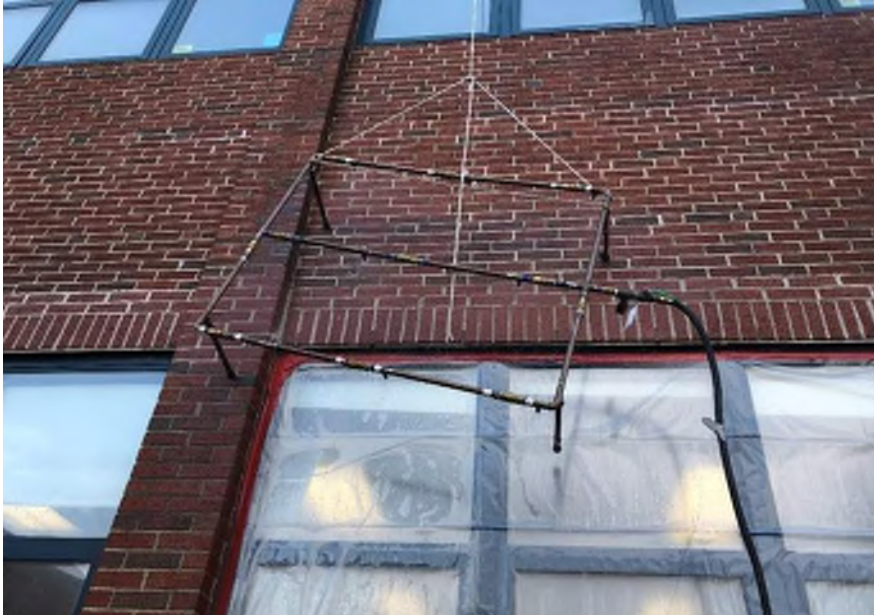
Photo 42

We tested the sheet metal through-wall flashing repair on one window on the first building addition. We isolated the head flashing by installing a plastic sheet over the window and perimeter seals (similar to our test procedure at the window head for the windows on the 1997 addition, described above). We applied water above the window using a spray rack for 30 min. and did not observe leakage to the interior (Photo 42).

Water testing window outside Room 168 with spray rack.

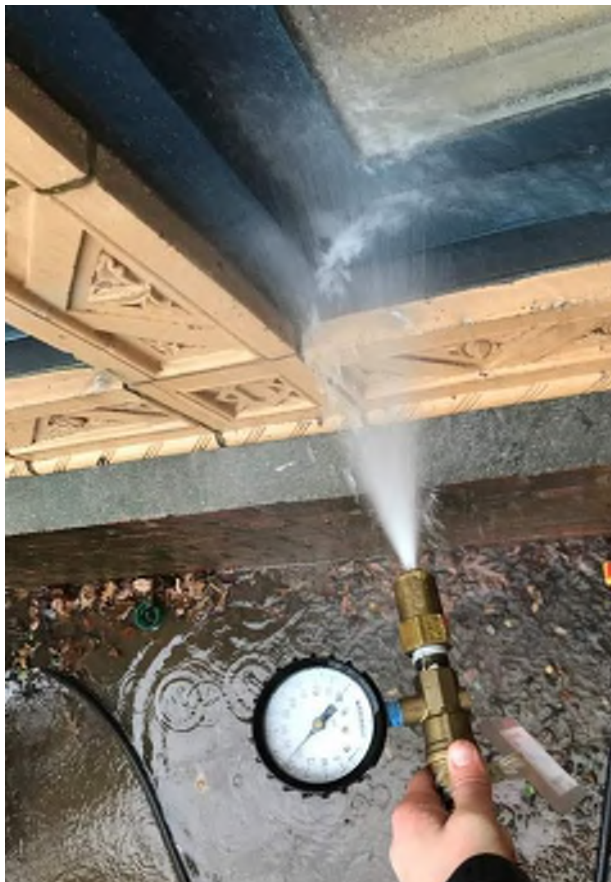
Photo 43

We tested one window on the original building using a handheld nozzle. We applied water spray to all joints in the window assembly at a rate of 1 min. per foot, generally following the procedure in AAMA 501.2) and did not observe water leakage to the interior (Photo 43).

Water testing window in Room 117 with handheld nozzle.

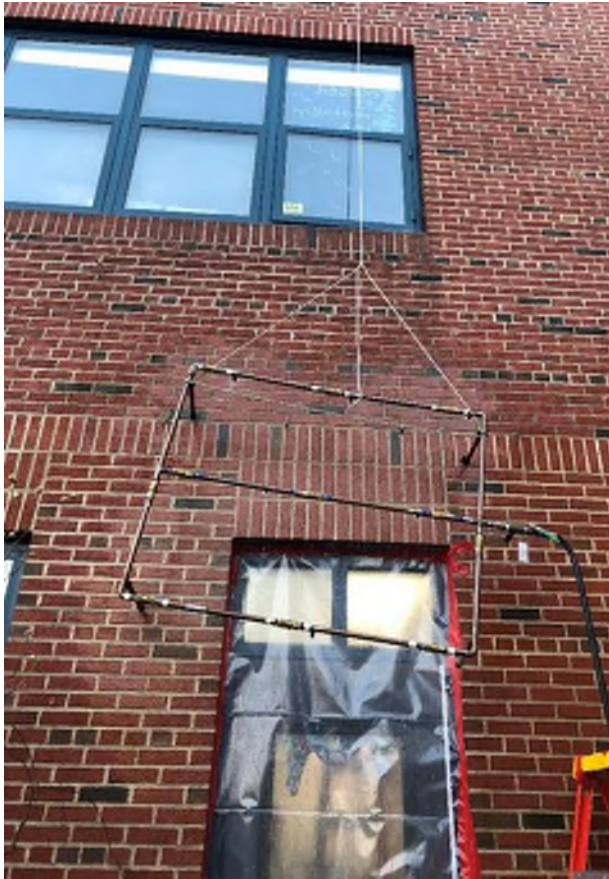
Photo 44

We used a spray rack to apply water to the brick masonry above the door (Photo 44). We isolated the head flashing by installing a plastic sheet over the door frame and split perimeter seals (to prevent water leakage through the perimeter seals from affecting our results, since our previous testing showed water penetration through split and open perimeter seals around the windows). We performed the test for 30 min. and did not observe leakage to the interior. During our testing, the plastic sheeting allowed some water penetration and we observed water leakage through the glazing in the exterior door (Photo 45, we also observed water leakage around this glazing during the 28 December 2018 rain event).

Water testing Door in Room 102 with spray rack.

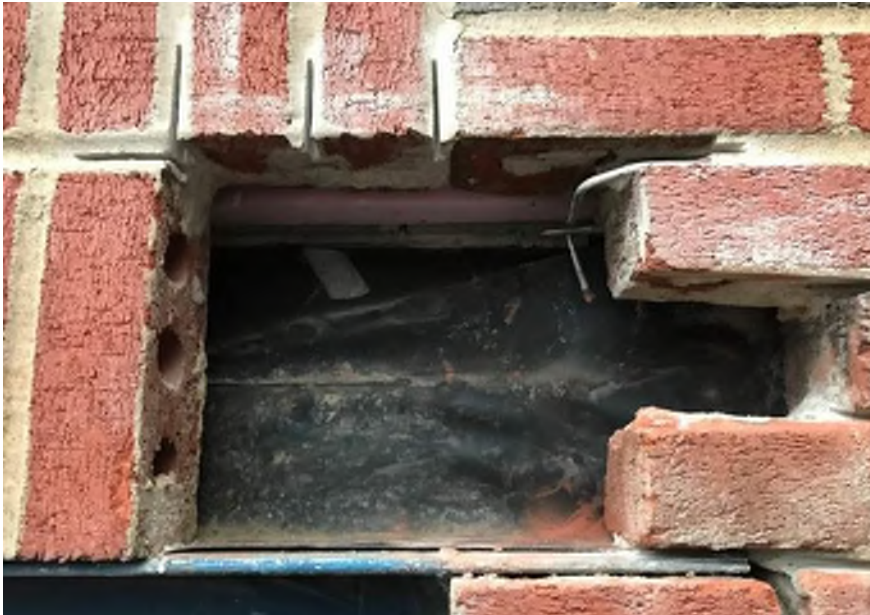
Photo 46

We removed brick above the door to Room 102 in the 1997 addition (Photos 46 and 47). We observed the following conditions at this opening:

Exterior Opening No. 1.

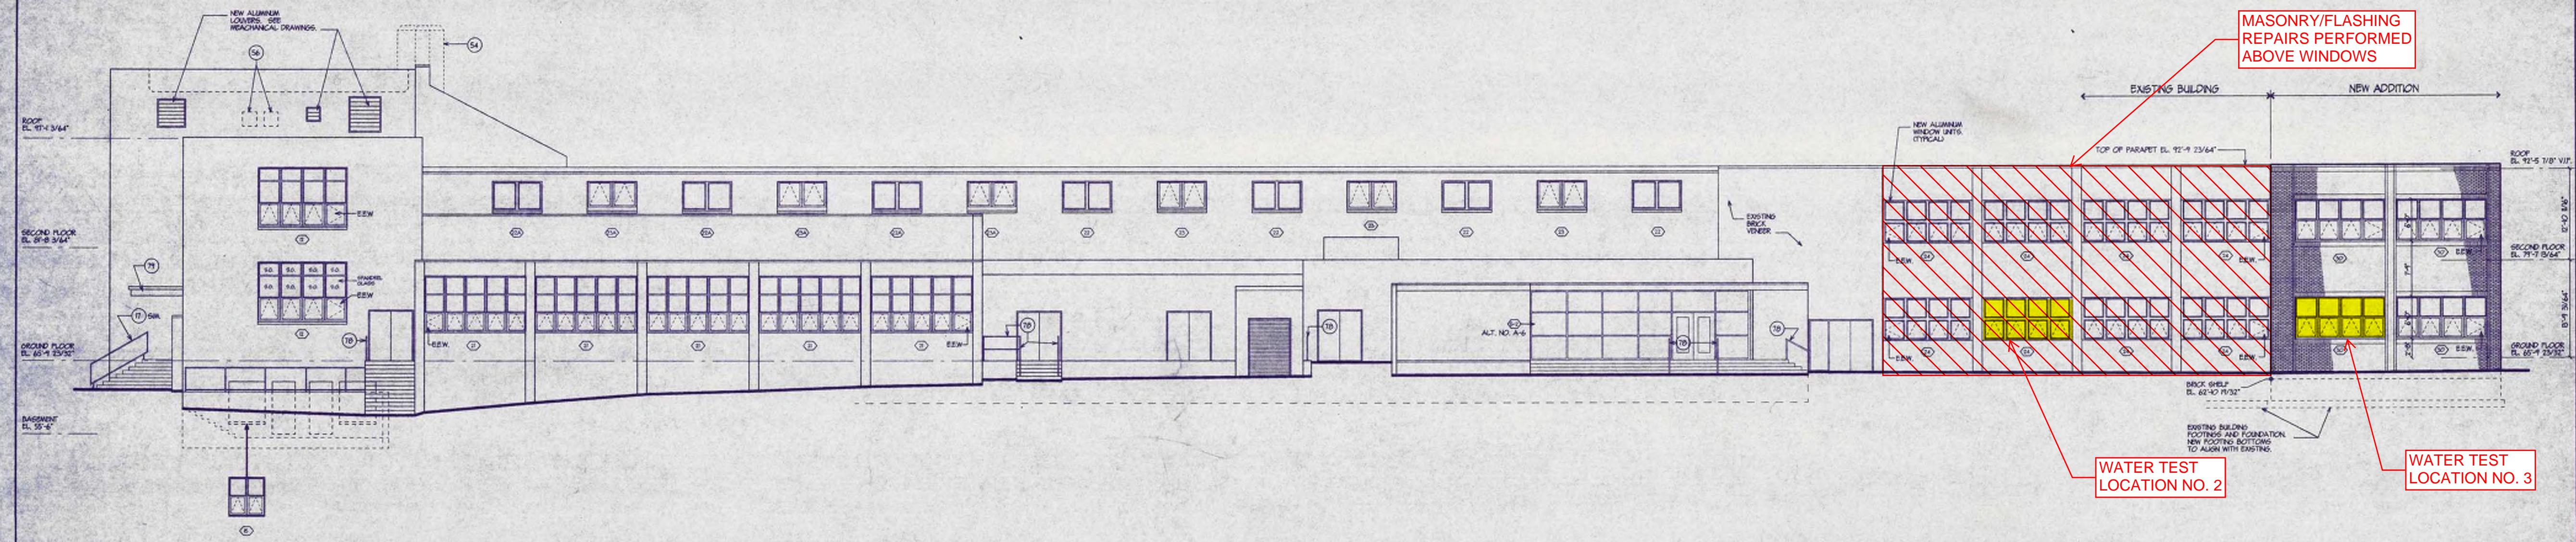
ELEVATION - 1
 SCALE: 1/8" = 1'-0"

WATER TEST LOCATION NO. 2

WATER TEST LOCATION NO. 3
