Wiss, Janney, Elstner Associates, Inc.  
2 Trap Falls Road, Suite 502  
Shelton, Connecticut 06484  
203.944.9424 tel  
www.wje.com

August 18, 2022

## Harbor Point- The Allure: P4 & P5- Local Slab Failure Final Report

WJE No. 2022.0759

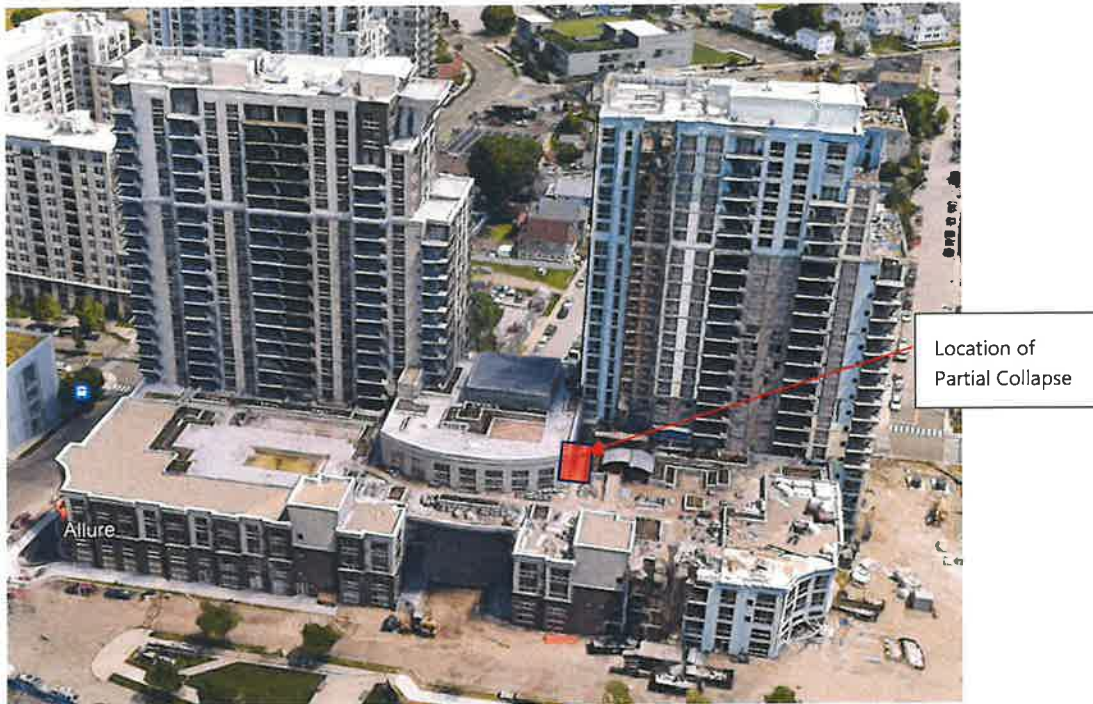
Figure 1- Overall View of Allure. West Looking East

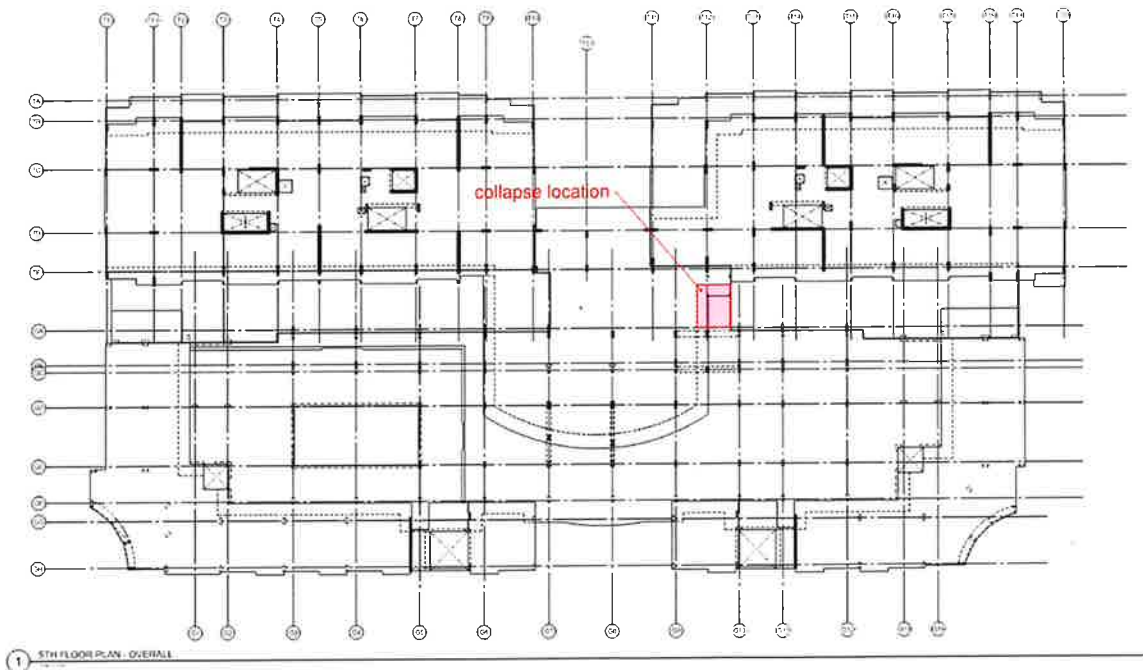
On February 1, 2022, a partial collapse of the Level 5 slab occurred in the amenities area. The collapsed area measures approximately 20 ft. east/west by 15 ft. north/south and is bound within column lines G9/G10 and TE/GA (Figures 4 & 5). The section of slab that collapsed is adjacent to a transition zone where there is a 10-inch-high step in the slab along its north and east sides. At the south edge of the collapsed area, there is an expansion joint. The step in the slab was provided to accommodate waterproofing and pavers installed at the topside of the amenities deck. The original design drawings indicate that the east/west oriented post tensioning at this area was to be continuous through slab step and the concrete slab construction was to be monolithic (Figure 6).

Figure 2- Collapse Location From Structural Drawings

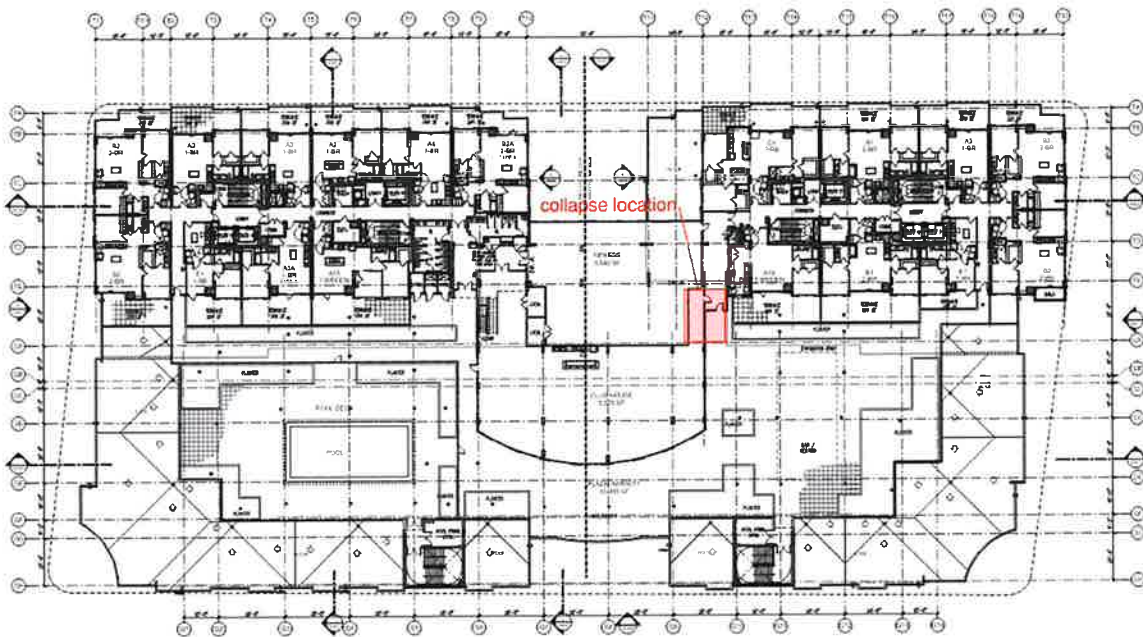
Figure 3- Collapse Location from Architectural Drawings

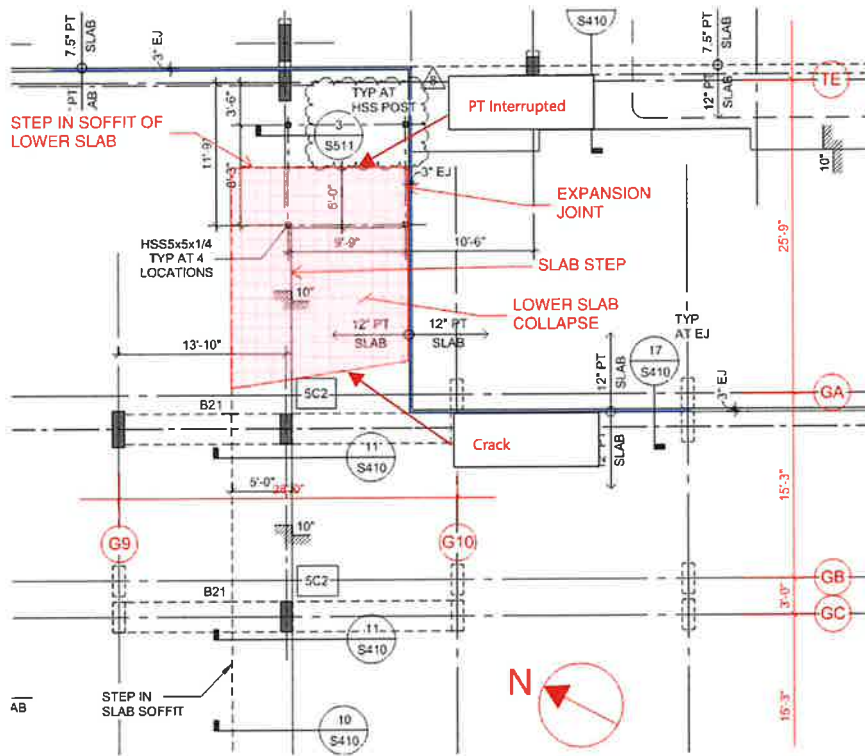
Figure 5- Partial Floor Plan from HRSE Report

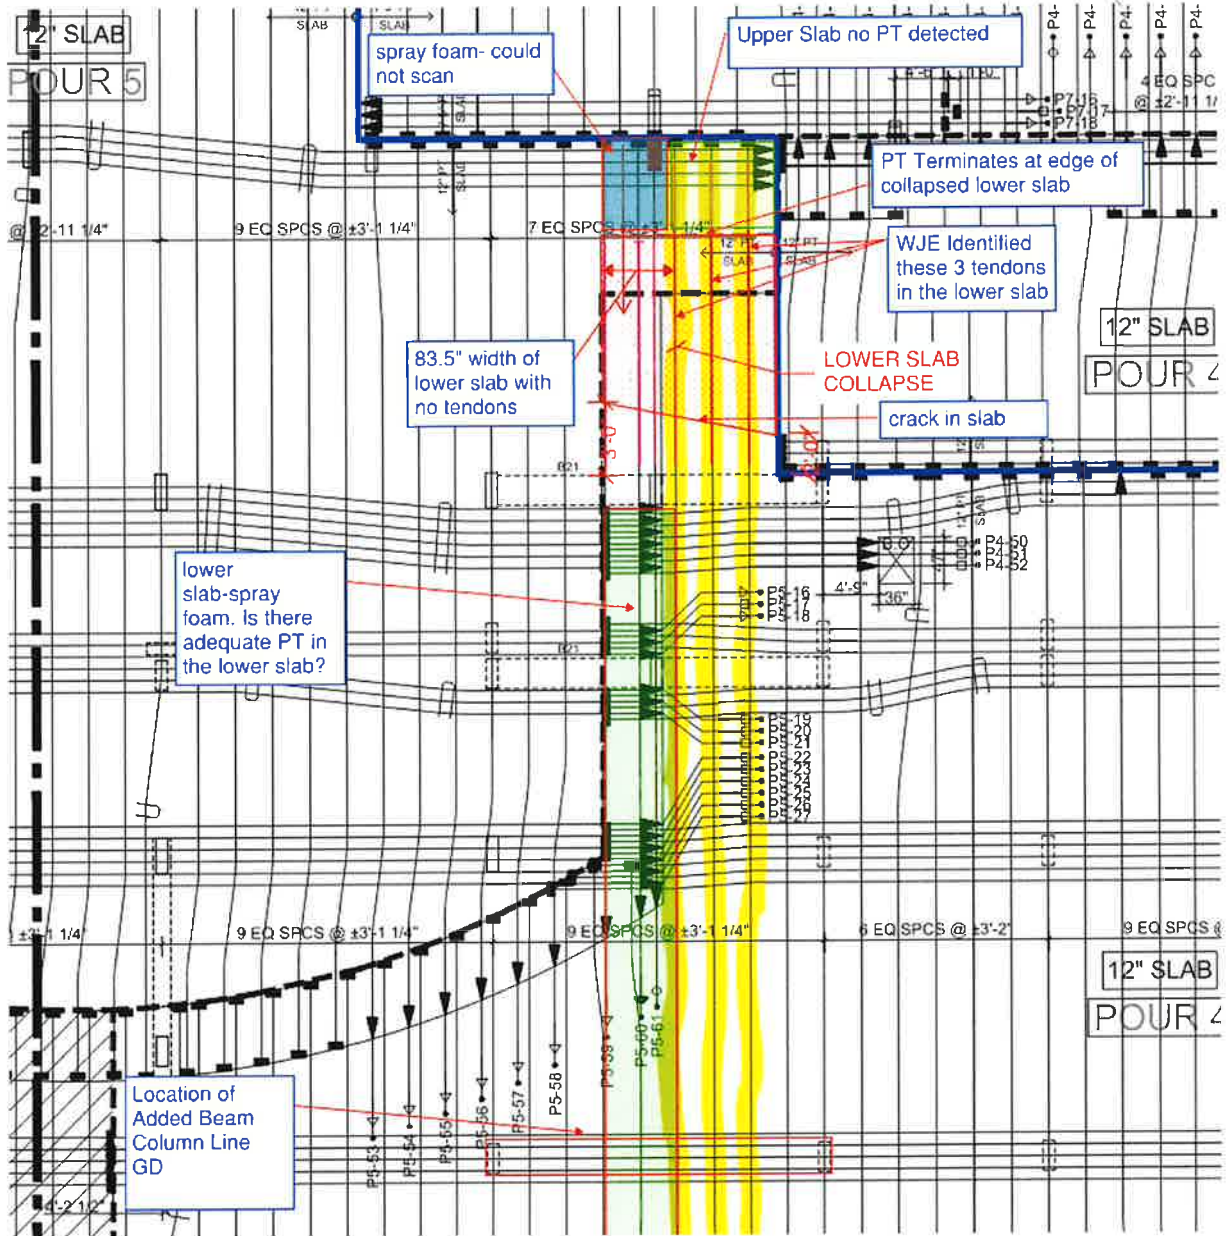
- WJE utilized a ground penetrating radar (GPR)<sup>4</sup> to identify the PT tendons and mild reinforcing in the east/west direction of the partially collapsed slab. Starting from the north end of the slab, the first band is approximately 14.5 in. from the edge and the next two bands are spaced at approximately 36 in. and 43 in. on center. This results in an approximately 83.5 in. section of the south end of the slab that does not have any tendons (Figure 10). Furthermore, WJE used the GPR to identify the tendons at the remaining west lower slab. The existing 3 bands of tendons span over the existing B21 beam at the GA column line and continue west. Due to spray foam insulation on the ceiling, WJE was not able to verify if there are additional tendons to the south outside of the failure area as none were visually observed at the failure plane. (Figure 13-15).

Figure 15- Sketch of Existing PT Layout

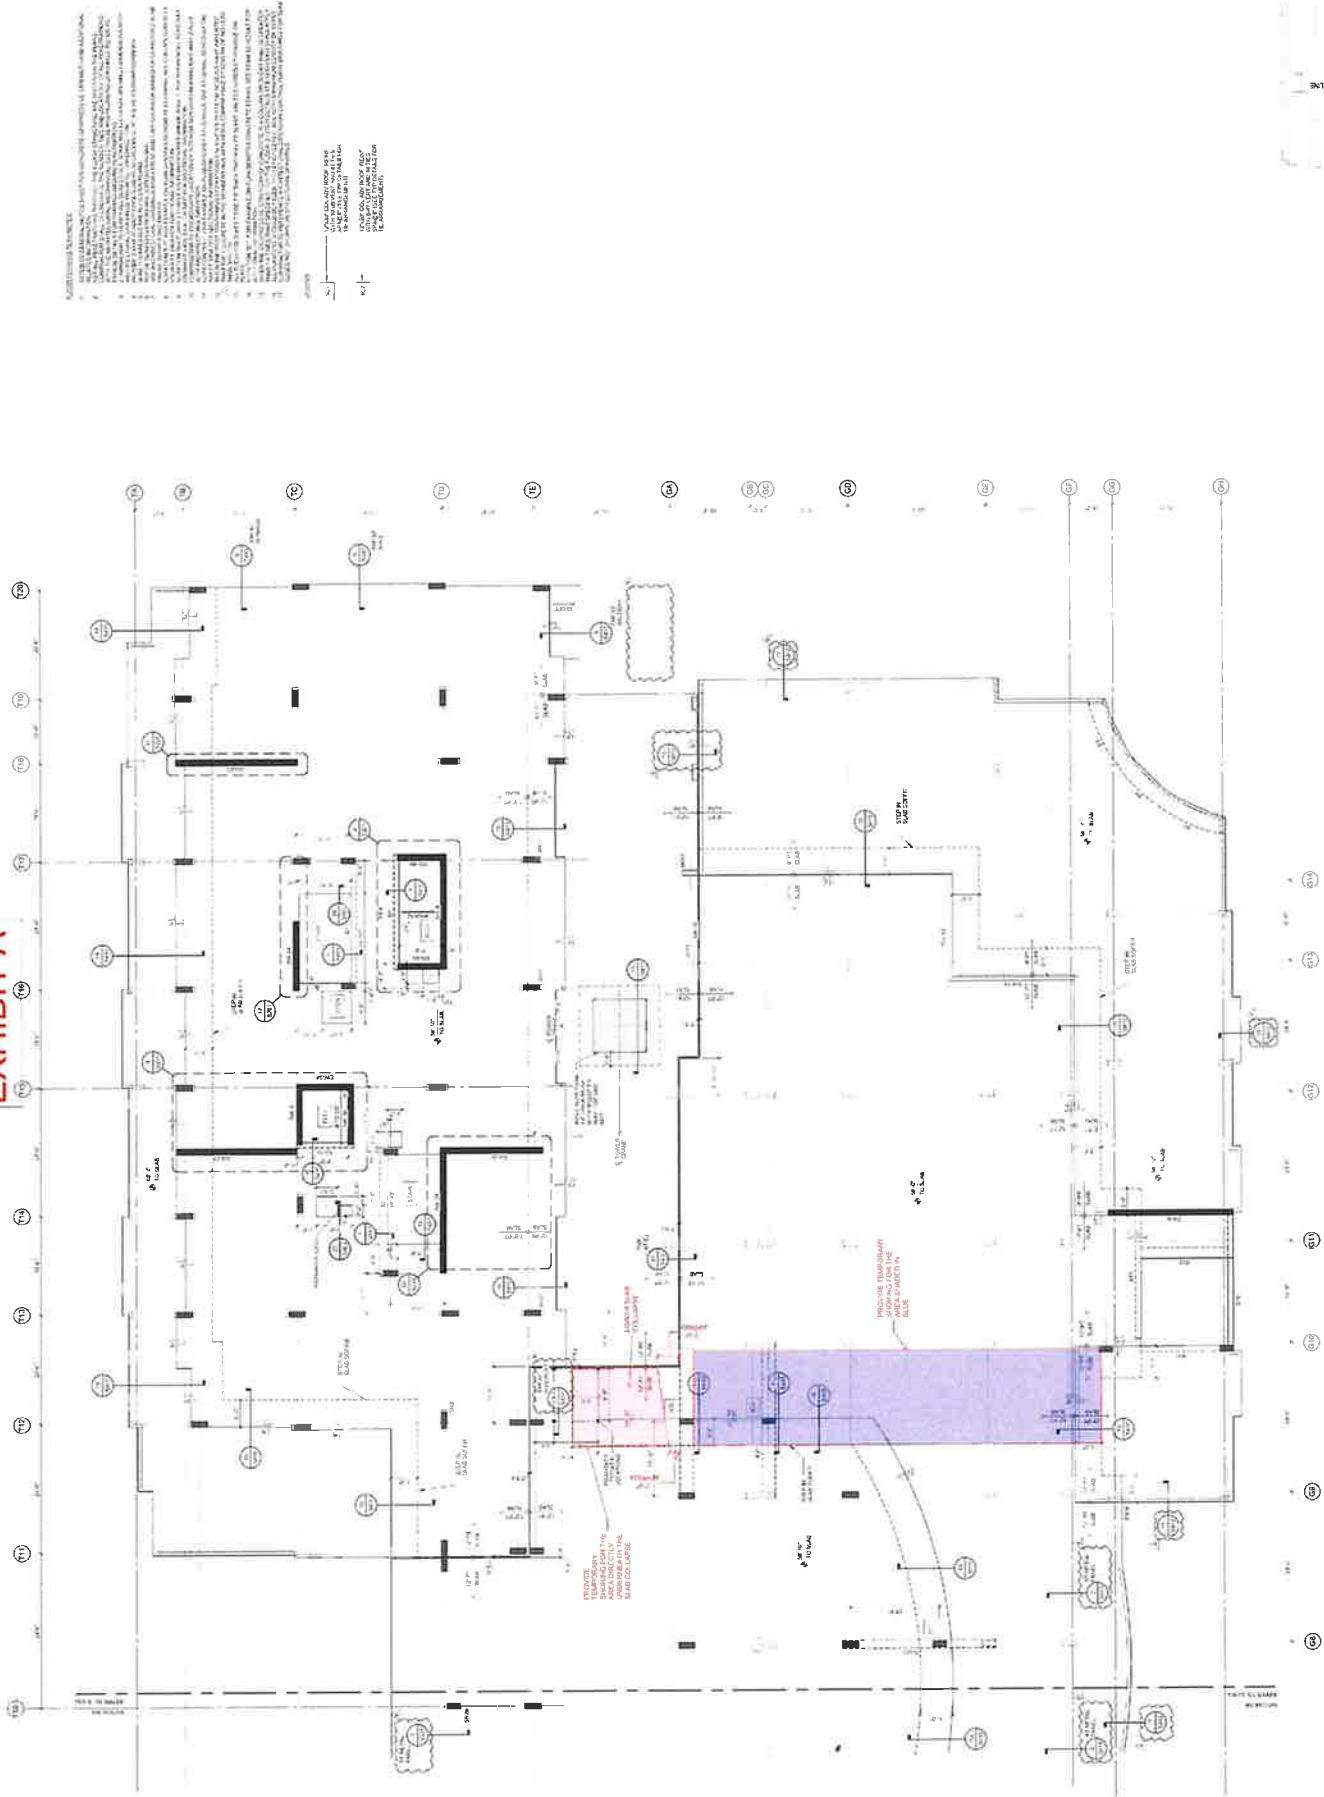
1 5TH FLOOR PLAN - SOUTH  
 10/11/18

Yesterday afternoon, we were advised of a partial floor failure at the amenities deck (Level 5) above the existing parking garage. Subsequent our discussion and review of the photos, we visited the site this morning to assess the condition in person and found the floor failure to be local and isolated within a segment of the stepped slab region of the amenities deck. Based on our findings at the time of our visit, the condition should not impact the global stability of the overall building structure and the areas outside of the impacted region can be considered safe to occupy. Shoring will be needed; however, in the shaded regions of the attached plan to prevent future serviceability issues until the area can be properly repaired. We should note that the failed stepped slab condition within the interior bay is unique to this building and does not occur at any of the other Harbor Points P-Block buildings.

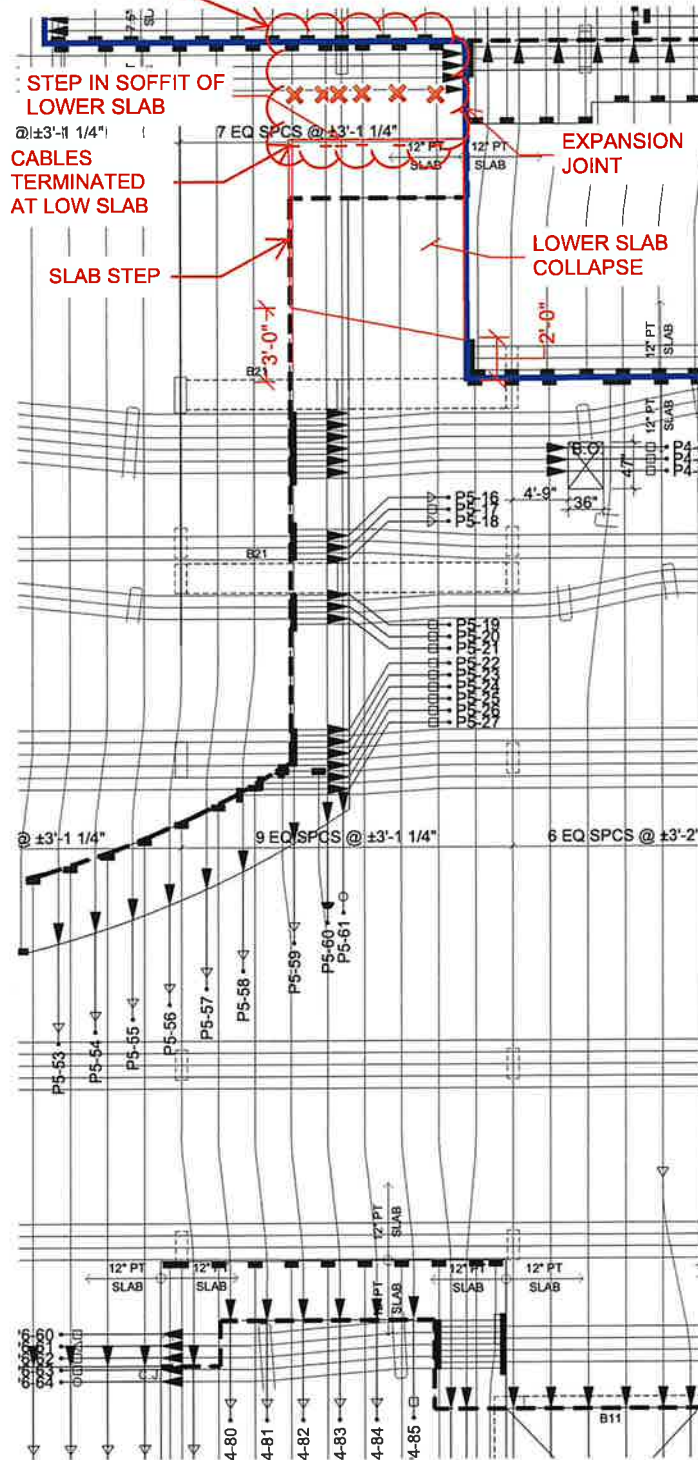
**SK-3**

CABLES NOT CONTINUED TO THE EDGE OF EXPANSION JOINT

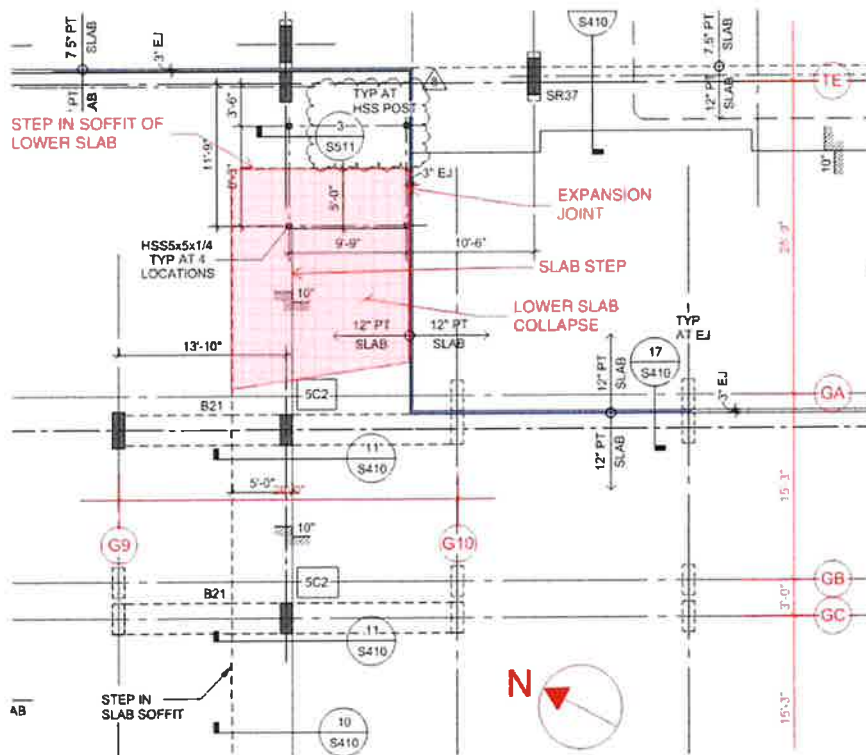
On February 1, 2022 a partial collapse of the 5<sup>th</sup> floor amenities level occurred. The collapsed area is approximately 20 ft. east/west by 15 ft. north/south and bound within column lines G9/G10 and TE/GA (Figures 1 & 2). The section of slab that collapsed is adjacent to a transition zone where there is a 10" step in the slab along the north and east sides. At the south edge of the collapsed area there is an expansion joint (Figure 2). The step in the slab allows for the installation of waterproofing and pavers at the top side of the amenities deck. The original design drawings indicate that the east/west spanning PT at this area was to be continuous through the slab step and the concrete slab construction was to be monolithic (Figure 3).

Figure 2- Partial Floor Plan from HR Report

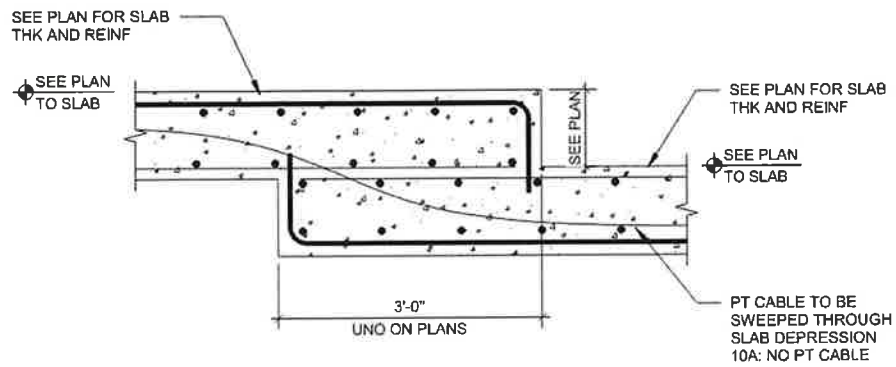
Figure 3- PT Step Detail from Original Drawings and HR Report

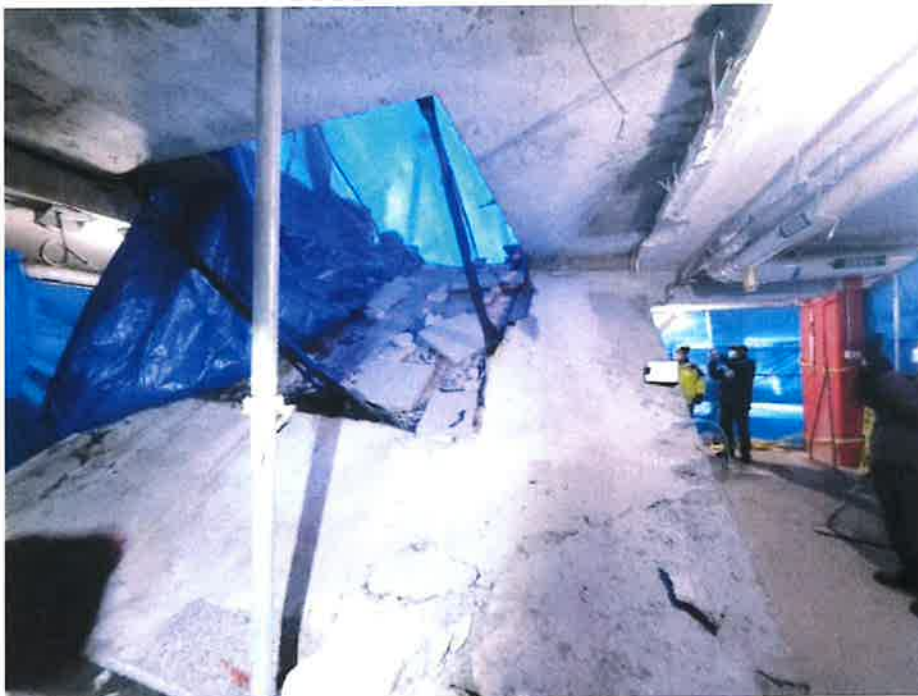
- The partially collapsed 5<sup>th</sup> level slab is confined to a 20 ft by 15 ft. portion of the lower slab at column lines G9/G10 and TE/GA. There is a crack in the west end of the slab in the failure area approximately 3 ft. east of the face of the north-south spanning B21 beam at column line GA and the east end of the collapsed portion of the slab is resting on the 4<sup>th</sup> floor level (Figure 4 & 5).

Figure 4- Partially Collapsed Slab looking West

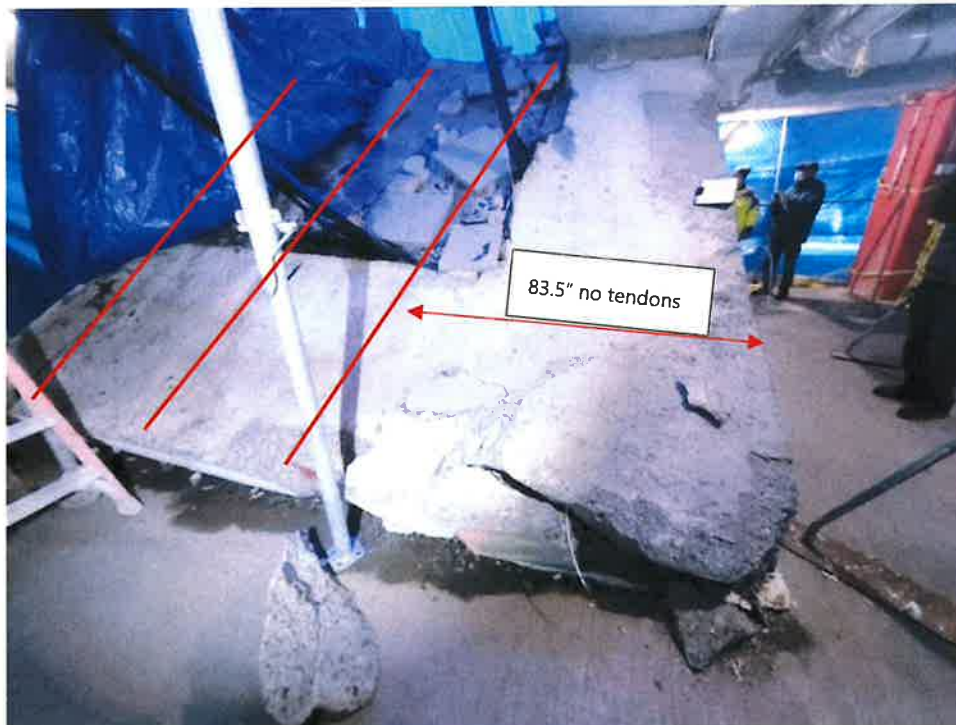
Figure 10- PT Layout at Slab Looking East to West

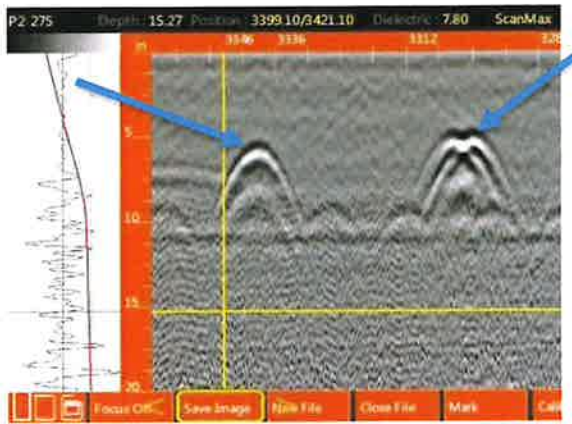
GPR data screenshot of PT cables found in the rec room. The depth scale is on the left and the distance of the scan is across the top, forming a cross section view of the subsurface. The arrows point to the multiple pieces of PT cable that are present.

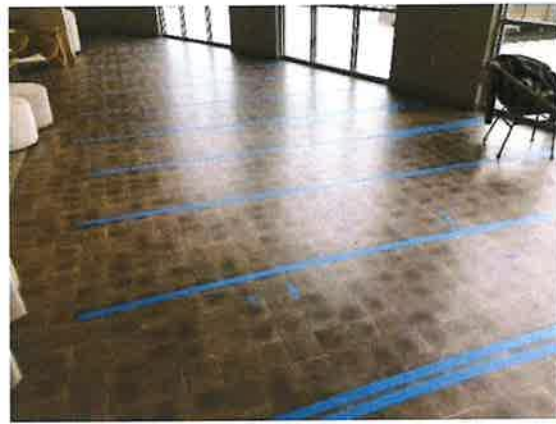
**Photo 1**

Photo of the rec room floor. Pictured above is some of the scanned area where PT cables were found. All PT cables were marked in blue tape

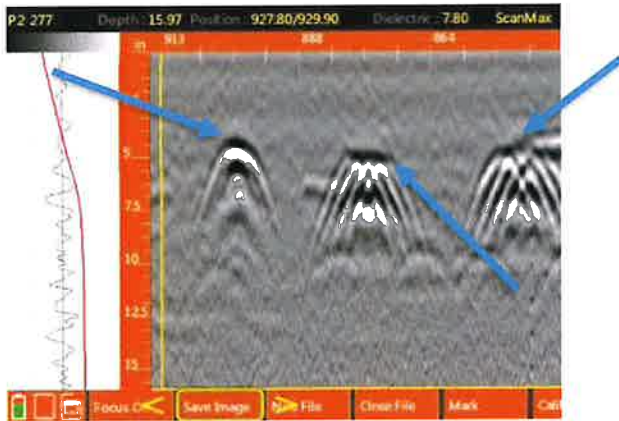
GPR data screenshot of more PT cables found in the rec room. All arrows point to PT cables

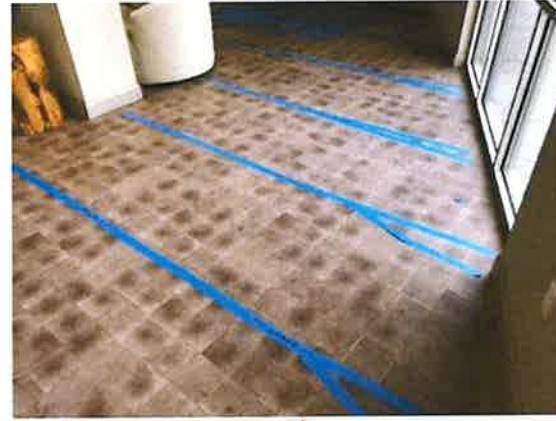
**Photo 2**

Photo of the rec room floor. Pictured above is another of the scanned area where PT cables were found. All PT cables were marked in blue tape

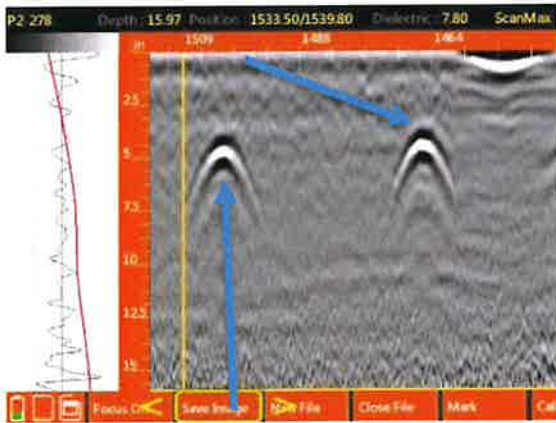
GPR data screenshot of more PT cables found in the rec room. All arrows point to PT cables

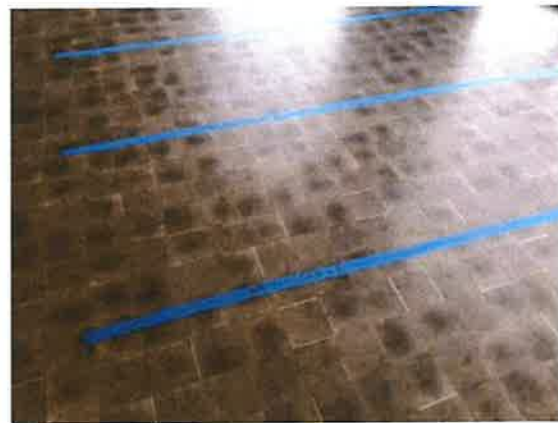
**Photo 3**

Photo of the rec room floor. Pictured above is another of the scanned area where PT cables were found. All PT cables were marked in blue tape

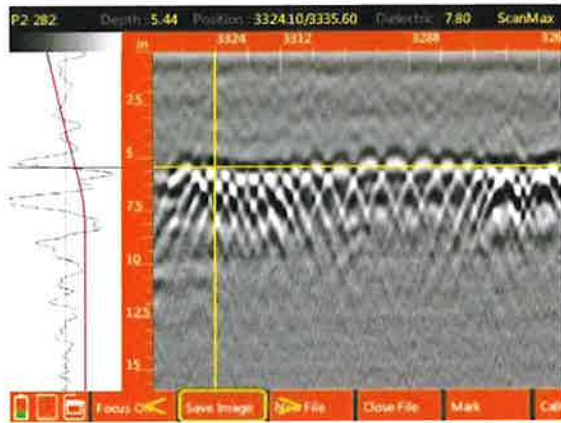
GPR data screenshot of the lateral PT cables bunches that ran through the columns in the rec room. All those reactions are PT cables at 5" depth

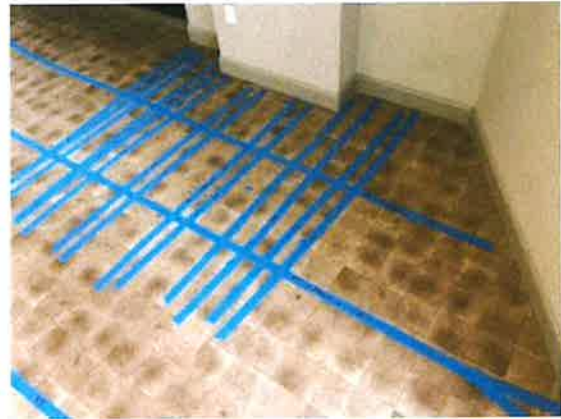
**Photo 4**

Pictured above is one of those lateral PT bunches that run through the column. All PT cables were marked in blue tape

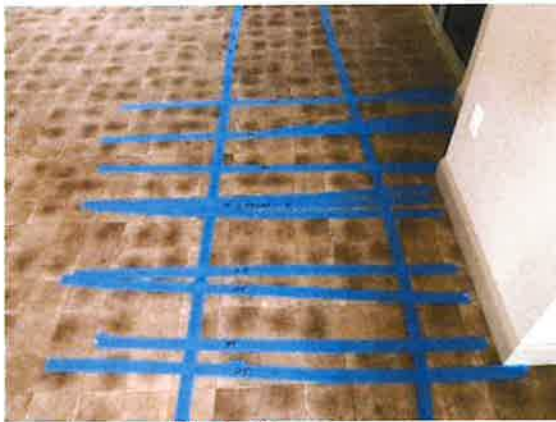
**Photo 6**

Pictured above are more lateral PT bunches that run through the column. All PT cables were marked in blue tape

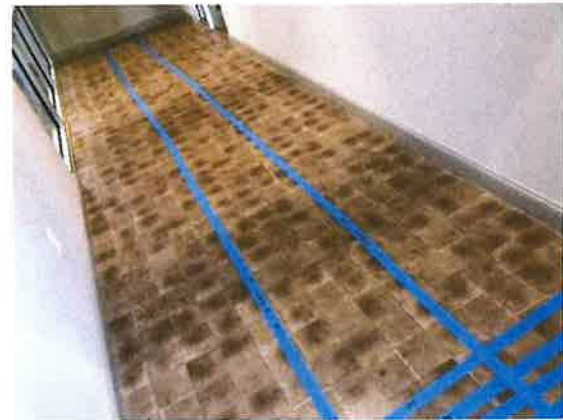
**Photo 7**

Pictured above is another area in the rec room where more PT was found. All PT is marked in blue tape

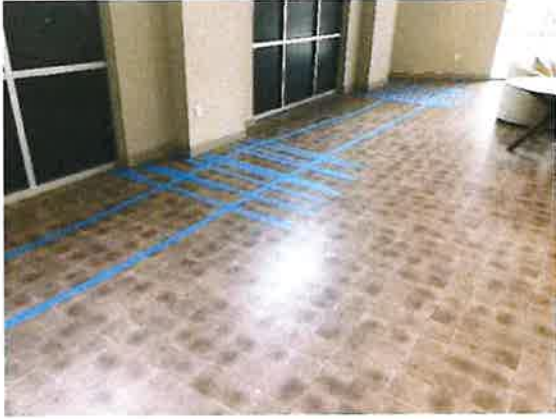
**Photo 8**

Pictured above is another area in the rec room showing the lateral PT bunches along with the long PT cables. All PT is marked in blue tape

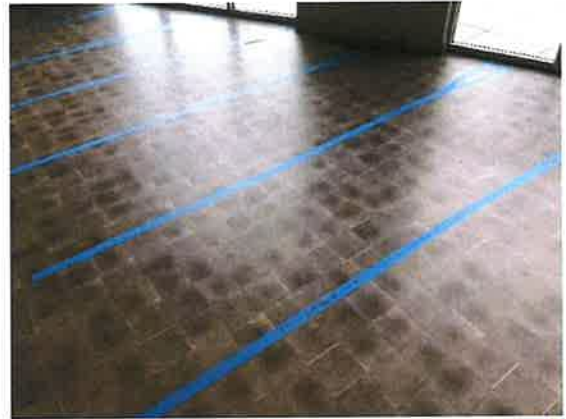
**Photo 9**

Pictured above is another area in the rec room showing the long PT cables spaced evenly at approximately 3'.

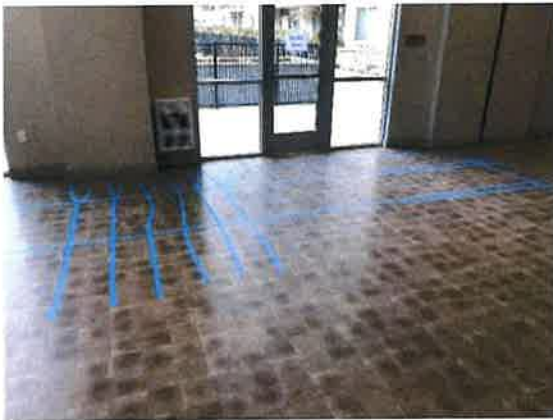
**Photo 10**

Pictured above is another area in the rec room where more PT was found. All PT is marked in blue tape

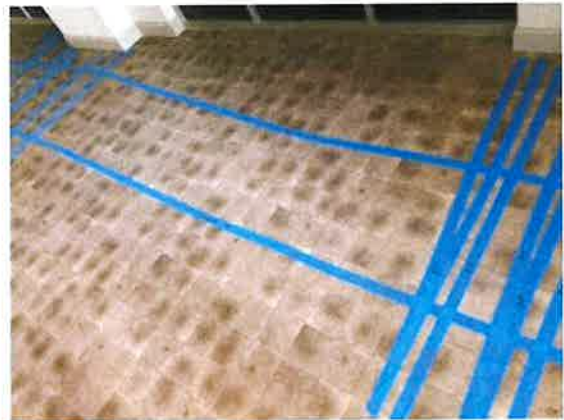
**Photo 11**

Pictured above is another area in the rec room where more PT was found. All PT is marked in blue tape

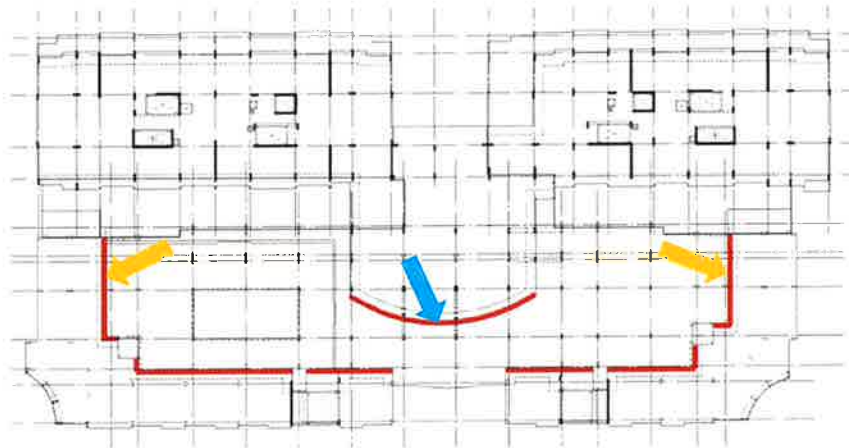
Figure 1. 5th Floor Overall

1. For slab steps highlighted red in Figure 1, the EOR's analytical approach appeared to be the following: The "upper slab" and "lower slab" were modeled separately. To simulate the support provided by the lower slab, the upper slab was modeled with a concrete wall at the location of the step, and the lower slab was modeled with applied loads (intended to be reactions from the wall) at the same location.

In the "upper slab" models, the wall was modeled with moment fixity at the slab connection (i.e. moments were not released). However, no applied moments were then transferred to the "lower slab" models (only vertical forces). This is analytically inconsistent and should be resolved.

2. As described above, "lower slab" models included applied loads at the location of the step, which were intended to simulate support of the upper slab. At the two slab steps indicated with orange arrows in Figure 1, these loads were not linearly applied as would be expected, but were instead point loads located at column locations only. This load application is not consistent with the "lower slab as a continuous support of the upper slab" analytical concept and should be corrected.

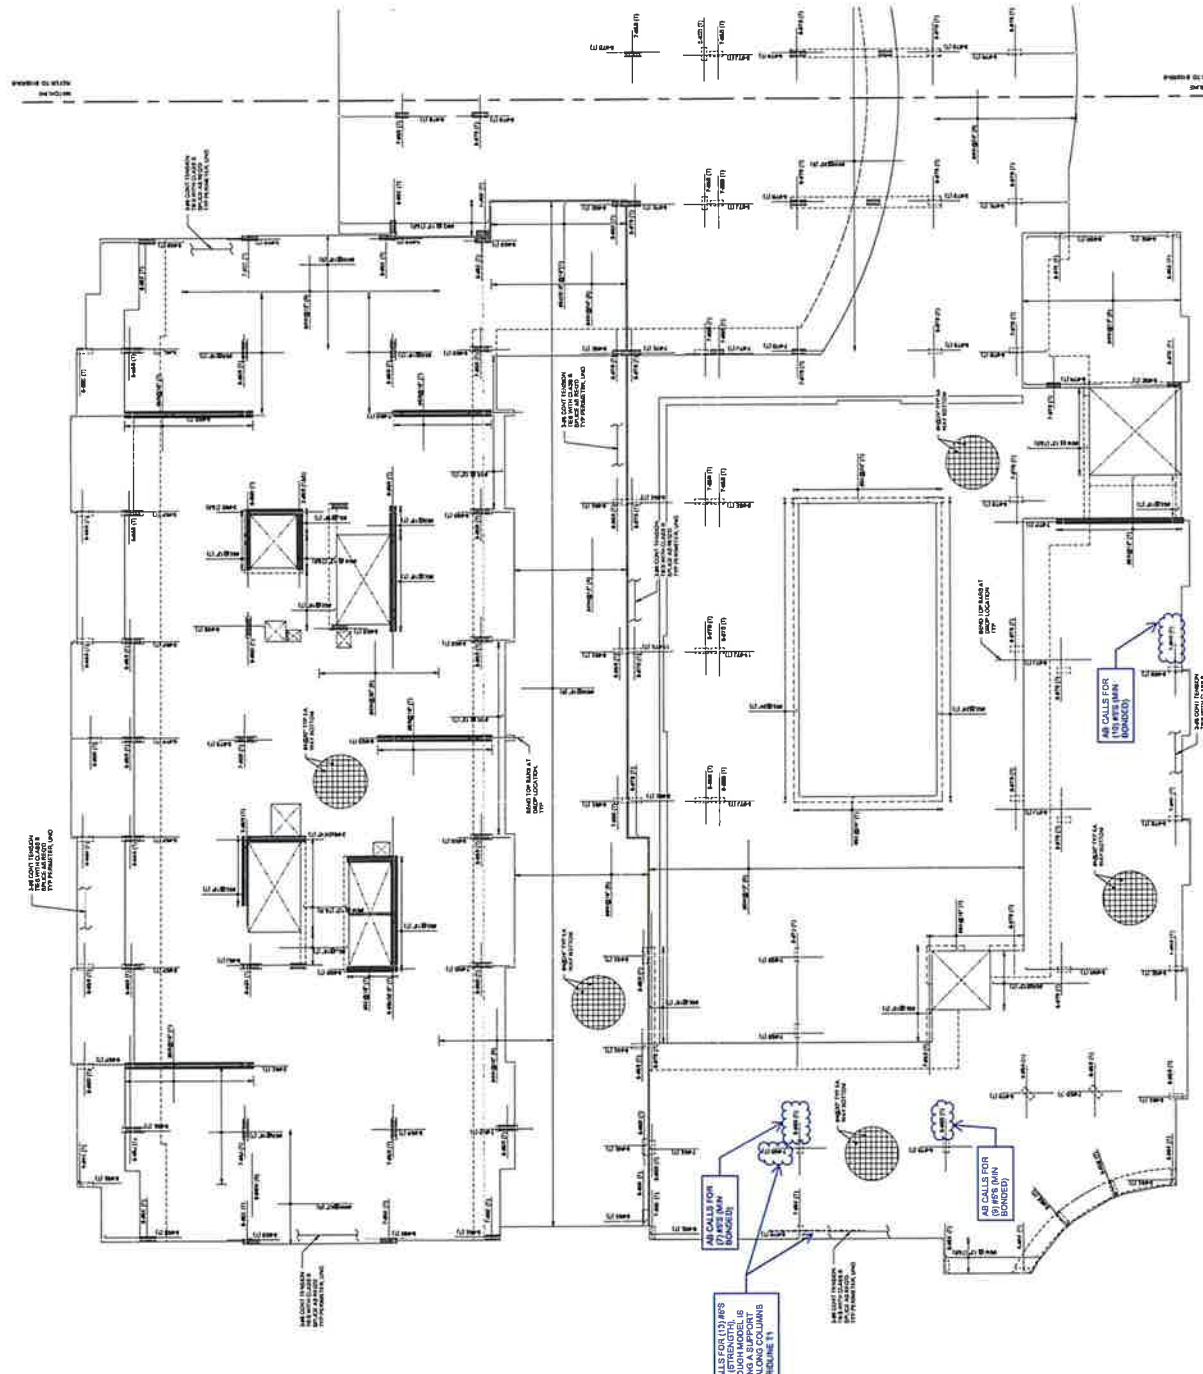
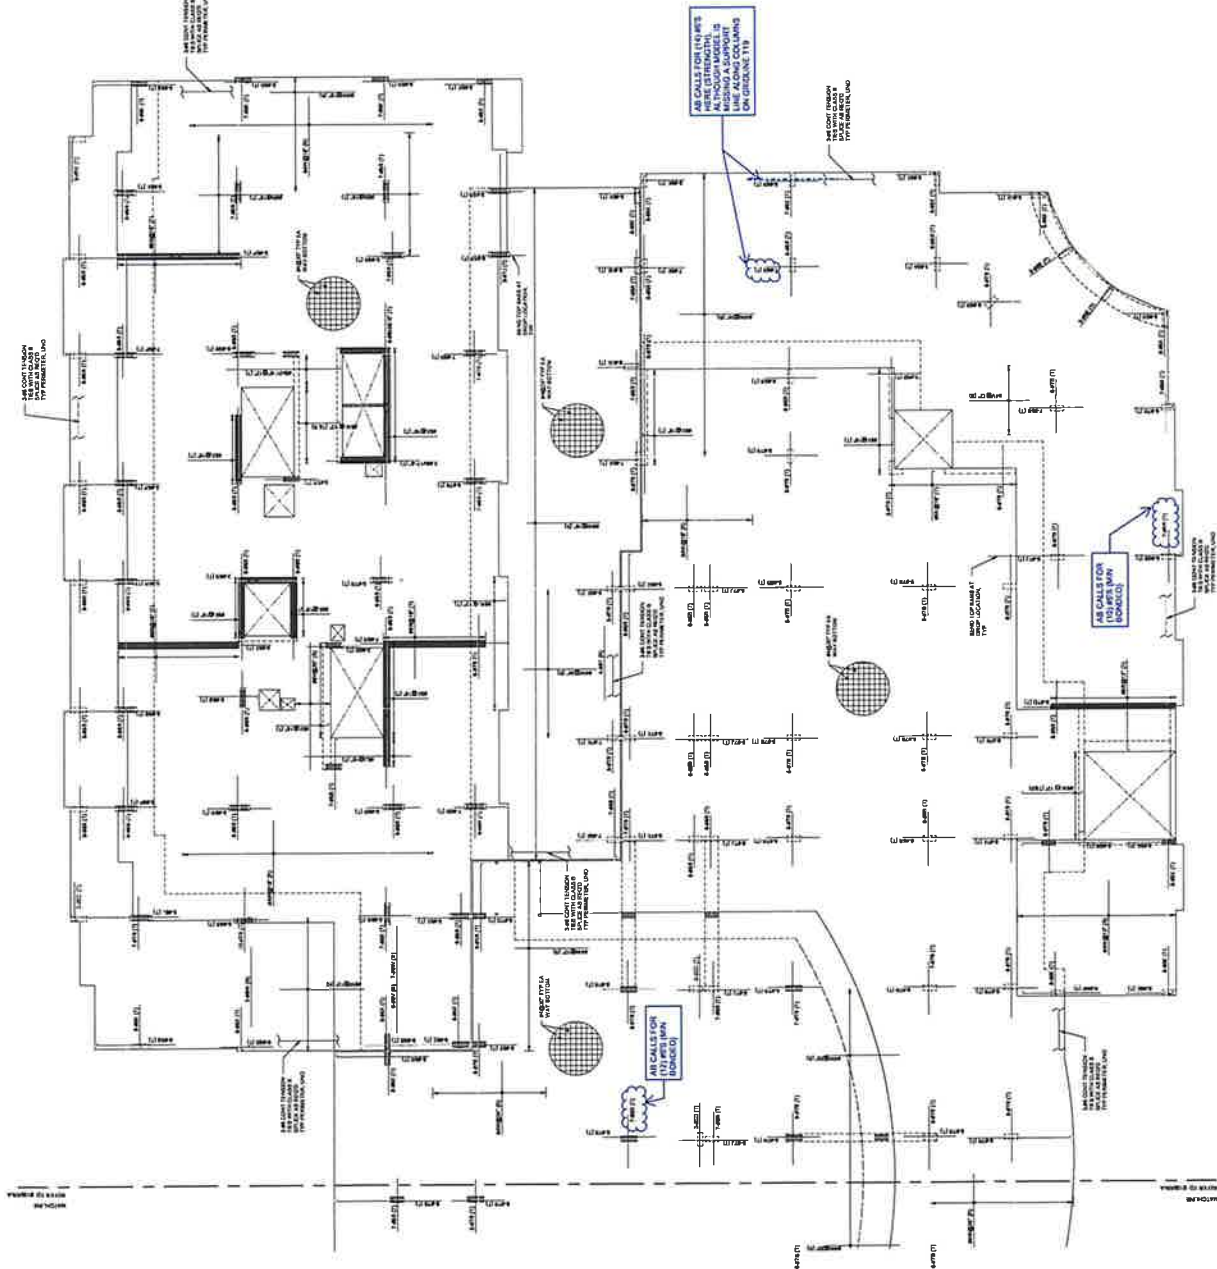
S105RR-B

5. While just a "spot check" and not a comprehensive review, we noted seven locations in which ADAPT called for a greater number of top reinforcing bars than is shown on the design drawings. These are indicated on the attached excerpted sheets (S105RR-A and S105RR-B).

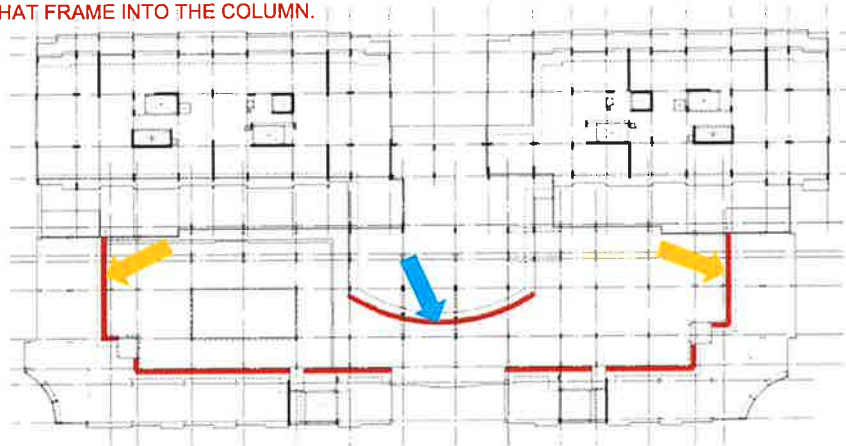
Figure 1. 5th Floor Overall

In the "upper slab" models, the wall was modeled with moment fixity at the slab connection (i.e. moments were not released). However, no applied moments were then transferred to the "lower slab" models (only vertical forces). This is analytically inconsistent and should be resolved.

HRSE: THE MOMENTS WERE NOT RELEASE AT THE LOW SLAB SUPPORT CONDITION, THESE MOMENT VALUES ARE VERY SMALL AS THE UNIFORM CABLES ARE PARALLEL TO THE STEP AND TRANSFER THE FORCE TO THE BANDED CABLE THAT FRAME INTO THE COLUMN.

2. As described above, "lower slab" models included applied loads at the location of the step, which were intended to simulate support of the upper slab. At the two slab steps indicated with orange arrows in Figure 1, these loads were not linearly applied as would be expected, but were instead point loads located at column locations only. This load application is not consistent with the "lower slab as a continuous support of the upper slab" analytical concept and should be corrected.

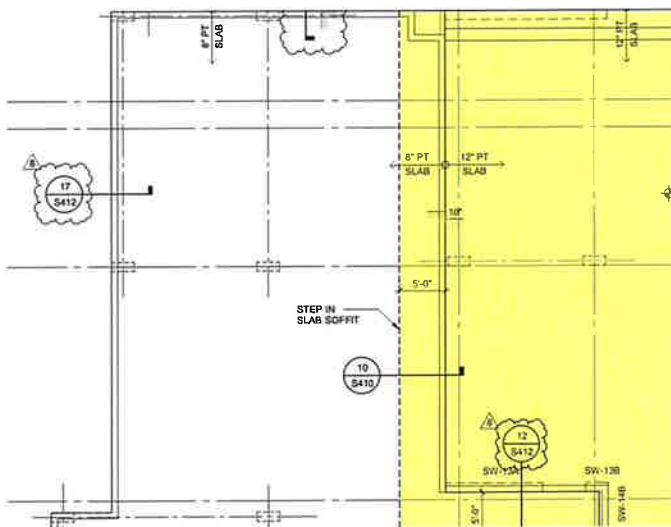
1. An area load (Roof Live & Snow) was applied on the lower slab as shown in with the yellow area:

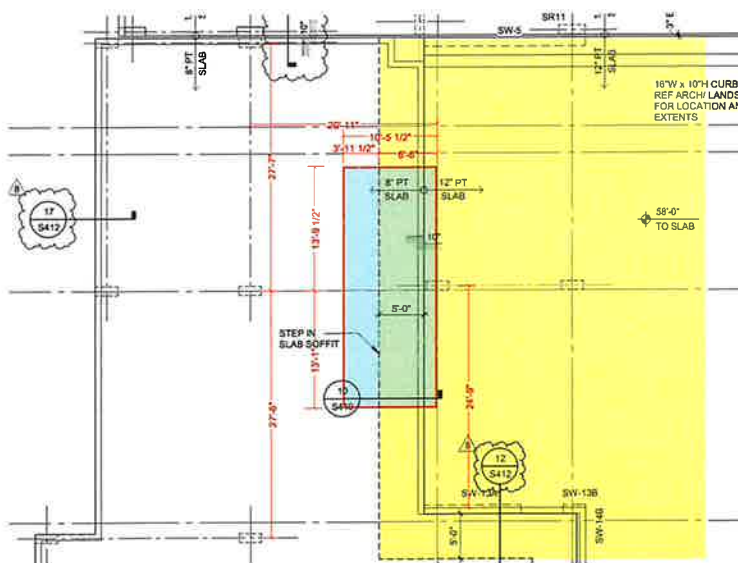
2. The tributary area for the column at G1/GD on the plan left side of the column is shown by the red box. Since the tributary area overlaps the area load for the roof live and snow load, the load shown in blue was calculated and applied as the point load.
