CONDITION ASSESSMENT REPORT

WATER POLLUTION CONTROL AUTHORITY BULKHEAD City of Stamford Stamford, Connecticut

May 2019

RTG Project No. 19106.00

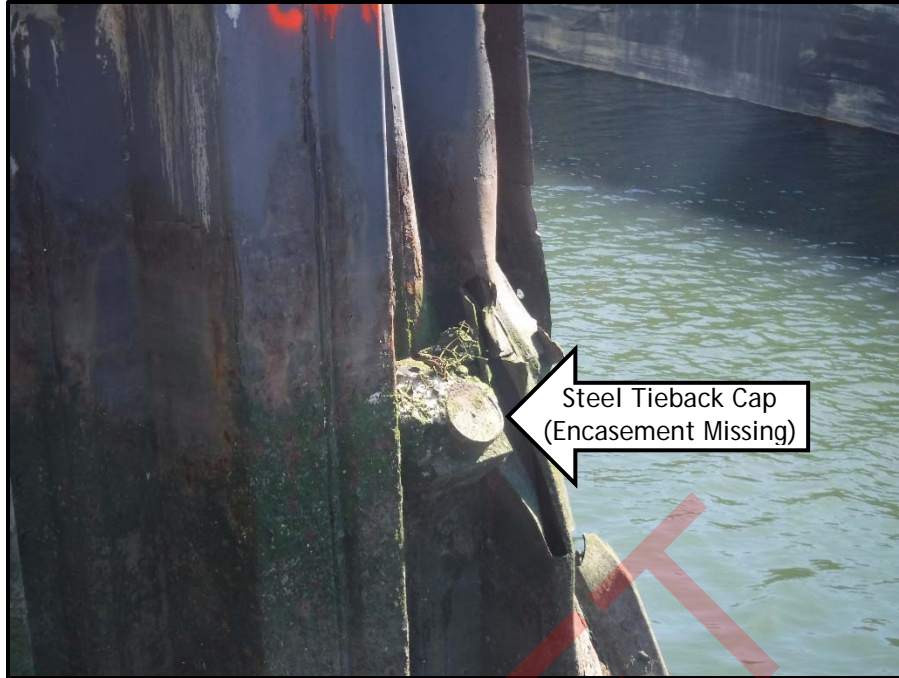
Photo No. 7:

The anchor system for the Type "A" Bulkhead consists of what appears to be an HP12x63 wale mounted to the interior of the sheet piles (Photo No. 5), and tiebacks. However, it is not known if these are tie-rods or strand anchors, as their heads are fitted with steel caps and encased in concrete (Photo Nos. 6 and 7). Rubber "D" fenders are located on the outboard face of the Type "A" Bulkhead as well (Photo No. 8).

Type "A" Bulkhead, STA 0+10, facing southwest, photo taken by RTG on April 16th, 2019.

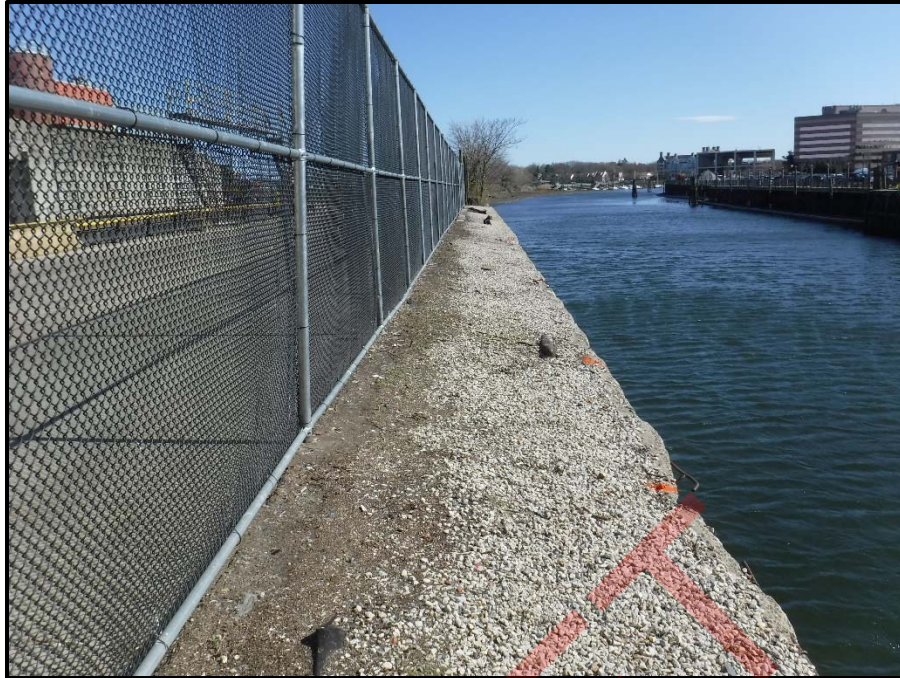
Photo No. 9:

Cap: The concrete cap is approximately 24-inches-wide by 12-inches-high with a top elevation of about El. 9.4 (Figure 2). From about Station 0+00 to 3+70, a 4-foot-wide gravel surface treatment slopes upward from the back of the cap to the existing concrete pavement within the WPCA facility, which is about 1-foot higher than the top of the cap (Photo No. 9). A chainlink fence is located at the edge of the concrete pavement along this section.

Type "A" Bulkhead, STA 1+90, facing southeast, photo taken by RTG on April 16th, 2019.

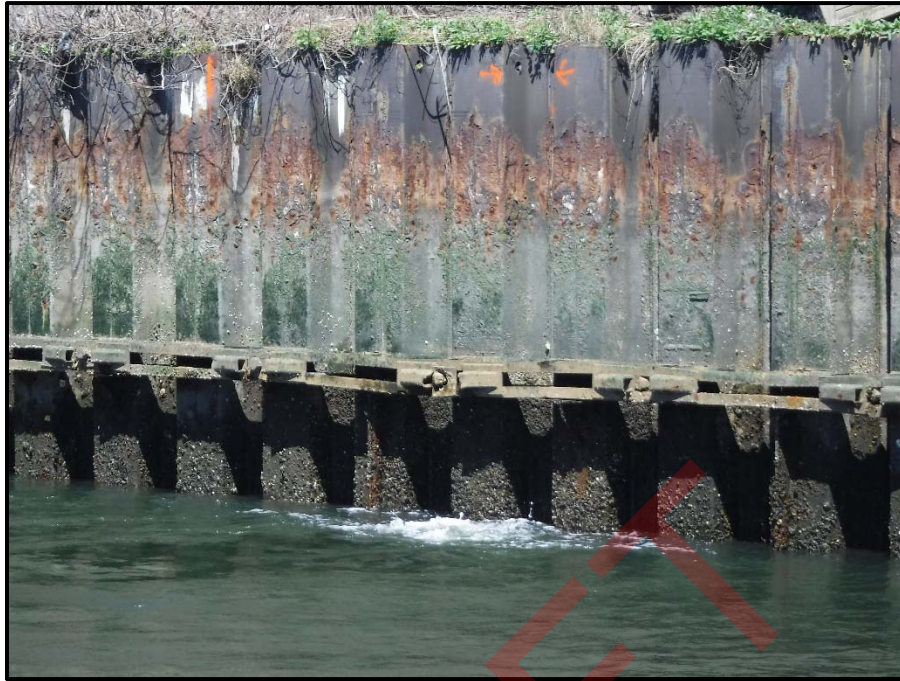
Photo No. 29:
Type "B" Bulkhead, STA 5+80 to 6+00, facing north, photo taken by RTG on April 16th, 2019.

Sheet Piles: The PZ-38 steel sheet piles are approximately 18-inches-wide (i.e., 36-inches per pair) by 12-inches-deep (Figure 2). The facility's main effluent line outfall was observed at Station 5+90, but was located below MLW and identified by active flow coming to the water surface (Photo No. 29). The outfall diameter could not be determined, but the record documents indicate that it is a 60-inch diameter Class IV RCP pipe.
