ENGINEERING SUMMARY REPORT

FOR "Delamar Residences"

LOCATED AT 68-70 SEAVIEW AVENUE STAMFORD, CONNECTICUT

May 20, 2022

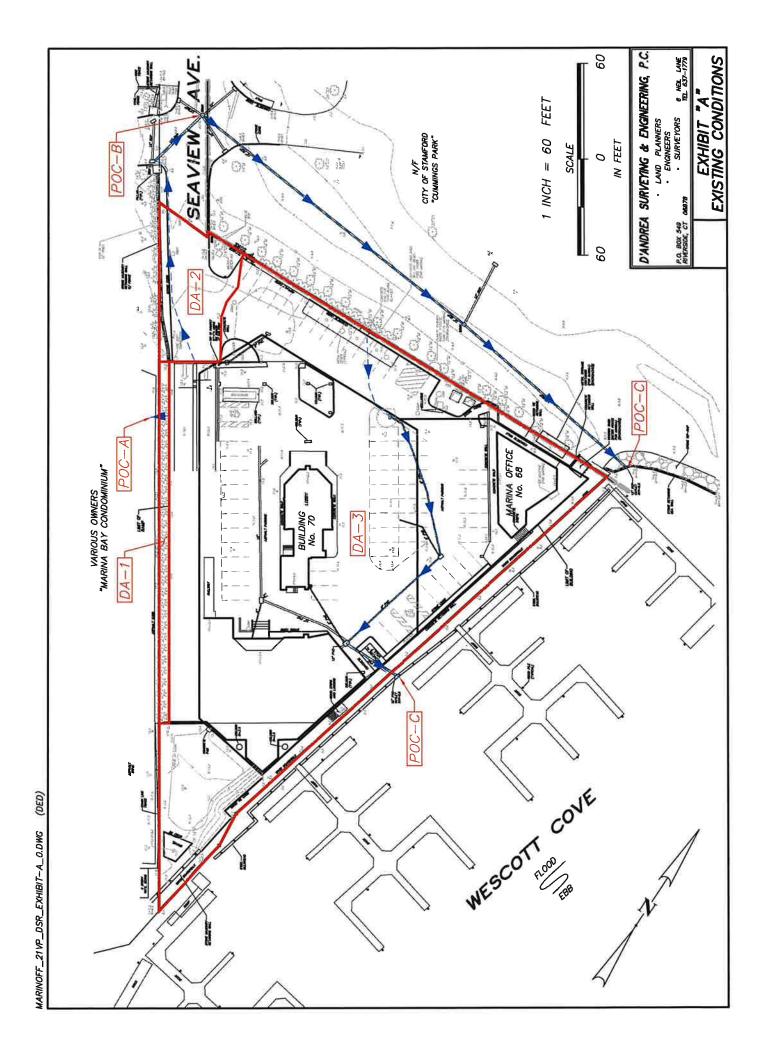
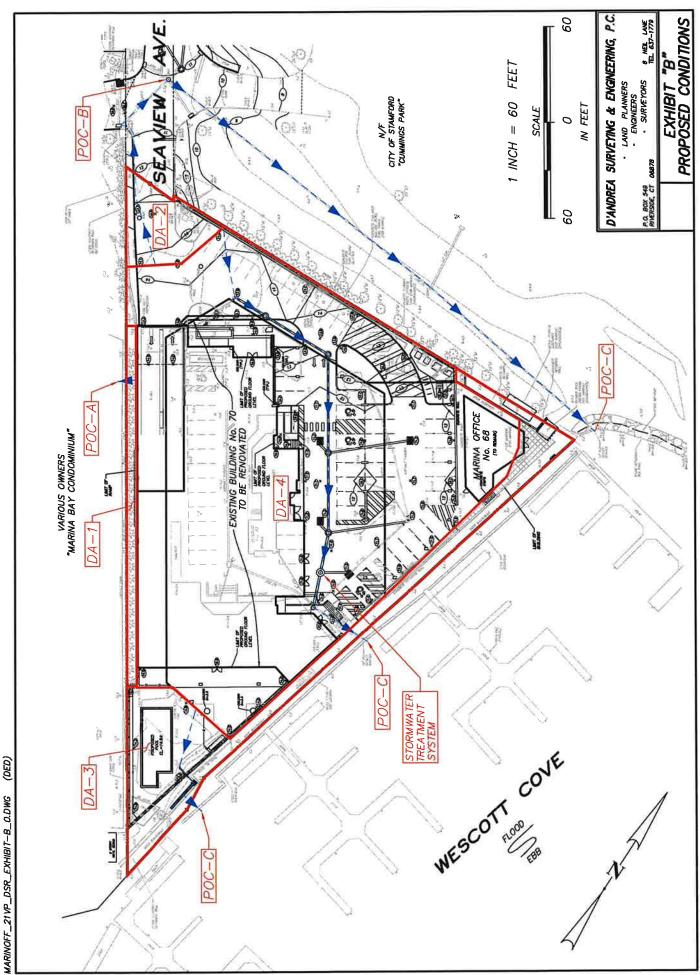
Exhibits "A" & "B"

Watershed Maps **Existing & Proposed Conditions**

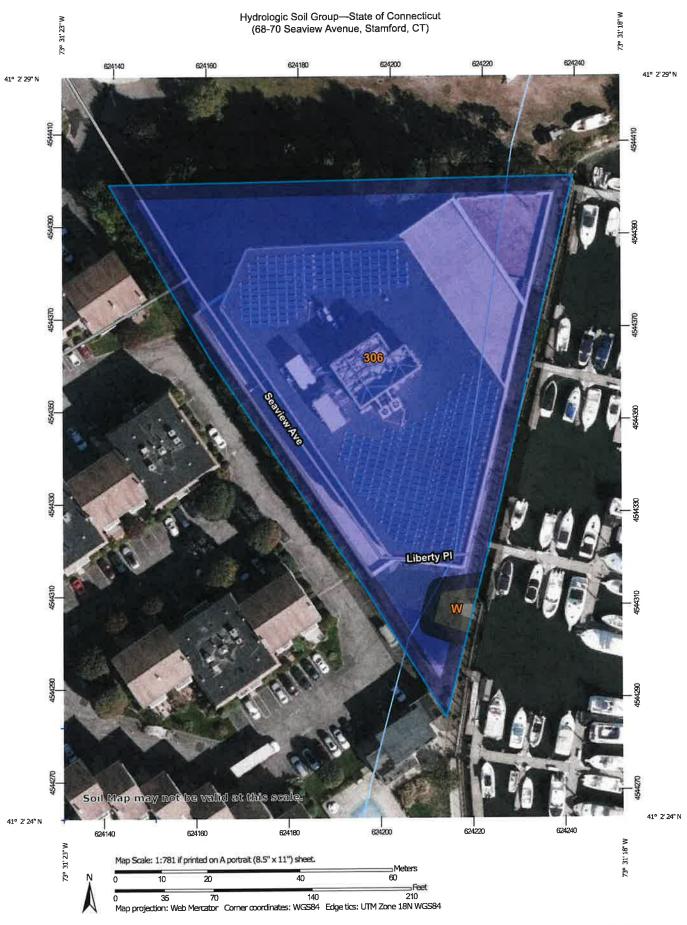
Exhibit "C"

NRCS Soil Map & Hydraulic Soil Group Rating

Hydrologic soil groups are based on estimates of runoff potential. Soils are assigned to one of four groups according to the rate of water infiltration when the soils are not protected by vegetation, are thoroughly wet, and receive precipitation from long-duration storms.

Group A. Soils having a high infiltration rate (low runoff potential) when thoroughly wet. These consist mainly of deep, well drained to excessively drained sands or gravelly sands. These soils have a high rate of water transmission.

Group B. Soils having a moderate infiltration rate when thoroughly wet. These consist chiefly of moderately deep or deep, moderately well drained or well drained soils that have moderately fine texture to moderately coarse texture. These soils have a moderate rate of water transmission.

Group C. Soils having a slow infiltration rate when thoroughly wet. These consist chiefly of soils having a layer that impedes the downward movement of water or soils of moderately fine texture or fine texture. These soils have a slow rate of water transmission.

Group D. Soils having a very slow infiltration rate (high runoff potential) when thoroughly wet. These consist chiefly of clays that have a high shrink-swell potential, soils that have a high water table, soils that have a claypan or clay layer at or near the surface, and soils that are shallow over nearly impervious material. These soils have a very slow rate of water transmission.

If a soil is assigned to a dual hydrologic group (A/D, B/D, or C/D), the first letter is for drained areas and the second is for undrained areas. Only the soils that in their natural condition are in group D are assigned to dual classes.

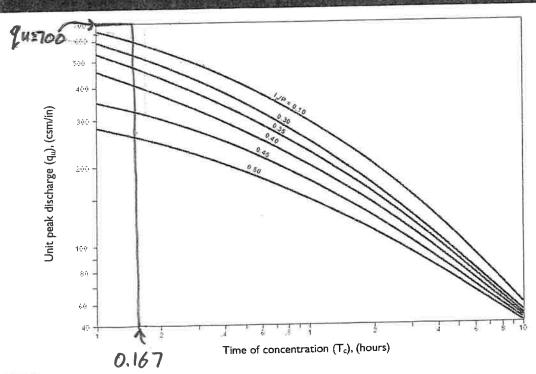
Exhibit 4-111 Unit peak discharge (qu) for NRCS (SCS) type III rainfall distribution

Read the unit peak discharge (q_u) from Exhibit 4-III in Chapter 4 of TR-55 (reproduced below) for appropriate t_c
