SECOND FLOOR

Stark Elementary School
City of Stamford
Stamford, CT

Area 7

Figure 3.4

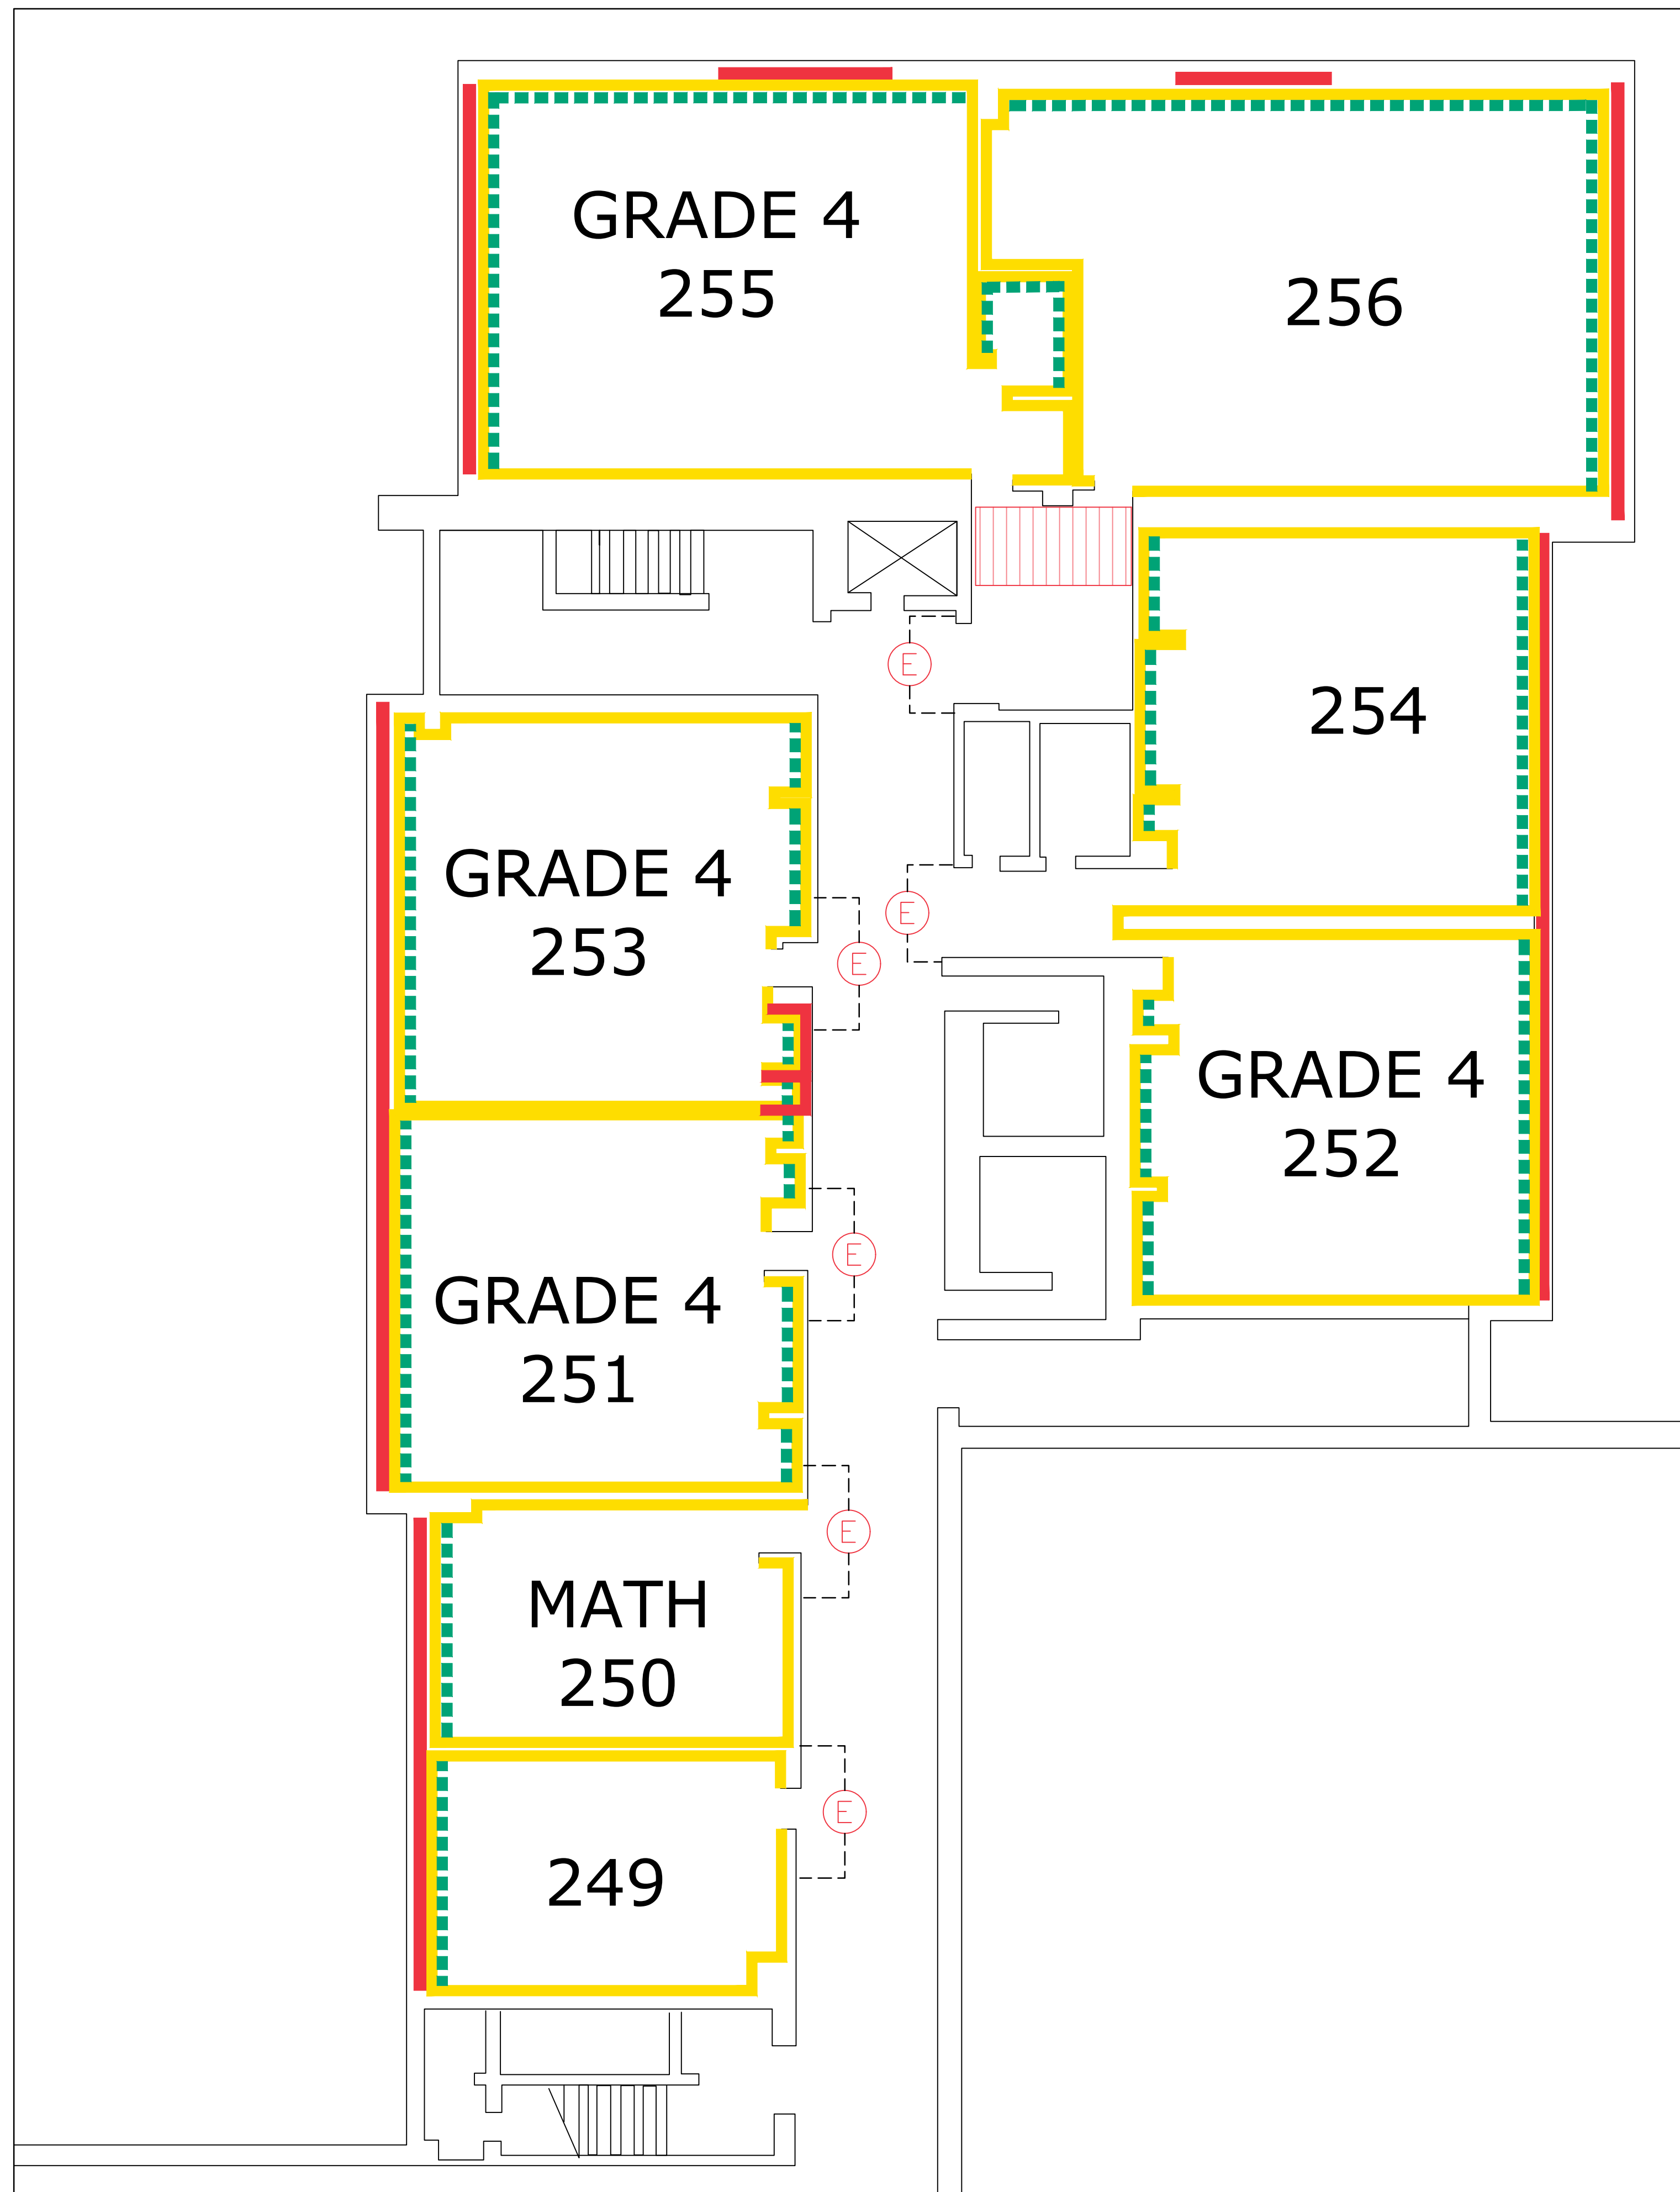
- ROOM 249 SCOPE OF WORK NOTES PHASE I**
 - SET UP EDGE GUARD AT ROOM ENTRANCE
 - SET UP CONTAINMENT, WASH ROOM, NEGATIVE AIR MACHINE AND CRITICAL BARRIERS ON WINDOWS, VENTS AND DOORS

- REMOVE MILLWORK;
 - REMOVE APPROXIMATELY 650 SF OF VINYL WALL PAPER;
 - REMOVE APPROXIMATELY 90 SF OF DRYWALL AROUND WINDOW SYSTEM;
 - CLEAN EXPOSED FIN TUBE,

- CLEAN 2 RETURNS AND 1 VENT;
 - REMOVE 2 CEILING TILE
- ROOM 250 SCOPE OF WORK NOTES PHASE I**
 - SET UP EDGE GUARD AT ROOM ENTRANCE
 - SET UP CONTAINMENT, WASH ROOM, NEGATIVE AIR MACHINE AND CRITICAL BARRIERS ON WINDOWS, VENTS AND DOORS

- REMOVE MILLWORK;
 - REMOVE APPROXIMATELY 650 SF OF VINYL WALL PAPER;
 - REMOVE APPROXIMATELY 90 SF OF DRYWALL AROUND WINDOW SYSTEM;
 - CLEAN EXPOSED FIN TUBE, CLEAN 1 RETURN AND 1 VENT; REMOVE 2 CEILING TILE

- ROOM 251 SCOPE OF WORK NOTES PHASE 2**
 - SET UP EDGE GUARD AT ROOM ENTRANCE
 - SET UP CONTAINMENT, WASH ROOM, NEGATIVE AIR MACHINE AND CRITICAL BARRIERS ON WINDOWS, VENTS AND DOORS

- REMOVE MILLWORK;
 - INSPECT ROOF DRAIN AND REPAIR ROOF DRAIN IF NEEDED
 - REMOVE APPROXIMATELY 775 SF OF VINYL WALL PAPER;
 - REMOVE APPROXIMATELY 130 SF OF DRYWALL AROUND WINDOW SYSTEM;

- CLEAN EXPOSED FIN TUBE, CLEAN 2 RETURNS AND 1 VENT; REMOVE 4 CEILING TILE
- ROOM 252 SCOPE OF WORK NOTES (DIMENSIONS SAME AS 167) PHASE 3**
 - SET UP EDGE GUARD AT ROOM ENTRANCE

- SET UP CONTAINMENT, WASH ROOM, NEGATIVE AIR MACHINE AND CRITICAL BARRIERS ON WINDOWS, VENTS AND DOORS
 - REMOVE MILLWORK;
 - INSPECT ROOF DRAIN AND REPAIR ROOF DRAIN IF NEEDED

- REMOVE APPROXIMATELY 840 SF OF VINYL WALL PAPER;
 - REMOVE APPROXIMATELY 75 SF OF DRYWALL AROUND WINDOW SYSTEM;
 - CLEAN EXPOSED FIN TUBE,
 - CLEAN 2 RETURNS AND 1 VENT;

- REMOVE 7 CEILING TILE
- ROOM 253 SCOPE OF WORK NOTES PHASE 2**
 - SET UP EDGE GUARD AT ROOM ENTRANCE
 - SET UP CONTAINMENT, WASH ROOM, NEGATIVE AIR MACHINE AND CRITICAL BARRIERS ON WINDOWS, VENTS AND DOORS

- REMOVE MILLWORK;
 - INSPECT ROOF DRAIN AND REPAIR
 - REMOVE APPROXIMATELY 775 SF OF VINYL WALL PAPER;
 - REMOVE APPROXIMATELY 130 SF OF DRYWALL AROUND WINDOW SYSTEM;

- CLEAN EXPOSED FIN TUBE,
 - CLEAN 2 RETURNS AND 1 VENT;
 - REMOVE 5 CEILING TILE
- ROOM 254 SCOPE OF WORK NOTES PHASE 3**
 - SET UP EDGE GUARD AT ROOM ENTRANCE

- SET UP CONTAINMENT, WASH ROOM, NEGATIVE AIR MACHINE AND CRITICAL BARRIERS ON WINDOWS, VENTS AND DOORS
 - REMOVE MILLWORK;
 - INSPECT ROOF DRAIN AND REPAIR IF NEEDED

- REMOVE APPROXIMATELY 840 SF OF VINYL WALL PAPER;
 - REMOVE APPROXIMATELY 90 SF OF DRYWALL AROUND WINDOW SYSTEM;
 - CLEAN EXPOSED FIN TUBE,
 - CLEAN 2 RETURNS AND 1 VENT;

- REMOVE 10 CEILING TILE;
 - REPAIR INSULATION ALONG 4-INCH PVC PIPING (MULTIPLE LOCATIONS)
- ROOM 255 SCOPE OF WORK NOTES PHASE**
 - SET UP CONTAINMENT, WASH ROOM, NEGATIVE AIR MACHINE AND CRITICAL BARRIERS ON WINDOWS, VENTS AND DOORS

- REMOVE APPROXIMATELY 825 SF OF VINYL WALL PAPER
 - REMOVE APPROXIMATELY 70 SF OF SHEETROCK AROUND WINDOW UNIT
 - CLEAN EXPOSED FIN TUBE RADIANT PIPING AFTER MILLWORK IS REMOVED

- CLEAN 2 RETURNS AND 1 HEAT VENT
 - REMOVE 10 CEILING TILE
 - INSPECT INSULATION ON PIPING AND HVAC SYSTEM AND REPAIR ACCORDINGLY
- ROOM 256 SCOPE OF WORK NOTES PHASE**

- SET UP CONTAINMENT, WASH ROOM, NEGATIVE AIR MACHINE AND CRITICAL BARRIERS ON WINDOWS, VENTS AND DOORS
 - REMOVE APPROXIMATELY 1,100 SF OF VINYL WALL PAPER

- REMOVE APPROXIMATELY 130 SF OF SHEETROCK AROUND WINDOW UNIT
 - CLEAN EXPOSED FIN TUBE RADIANT PIPING AFTER MILLWORK IS REMOVED
 - CLEAN 3 RETURNS AND 1 HEAT VENT

- REMOVE 10 CEILING TILE
 - INSPECT INSULATION ON PIPING AND HVAC SYSTEM AND REPAIR ACCORDINGLY
- AREA BETWEEN ROOMS 255 & 256**
 - SET UP EDGE GUARD AT ROOM ENTRANCE

- SET UP CONTAINMENT, WASH ROOM, NEGATIVE AIR MACHINE AND CRITICAL BARRIERS ON WINDOWS, VENTS AND DOORS
 - HEPA VAC ABOVE CEILING TILE
 - REMOVE APPROXIMATELY 40 SF OF SHEETROCK AROUND EXPANSION JOINT

- REMOVE APPROXIMATELY 10 LF OF STAINED PIPE INSULATION
 - REMOVE BLACK WATER COLLECTION BUCKET LOCATED ABOVE CEILING TILE
 - REPAIR ROOF DRAIN (WITH PLASTIC BAG WRAPPED AROUND IT)

- REMOVE 11 CEILING TILE
