1/18/2019 11:11:11am By: wechamps
Plotted On: Jan 18, 2019 11:11am
Tighe & Bond: S2087 Stamford 1031 Mold Remediation.dwg

MARK	DATE	DESCRIPTION
PROJECT NO: S2087		
DATE: 1/18/2019		
FILE: Stark Mold Remediation.dwg		
DRAWN BY: WAC		
CHECKED: XX		
APPROVED: XX

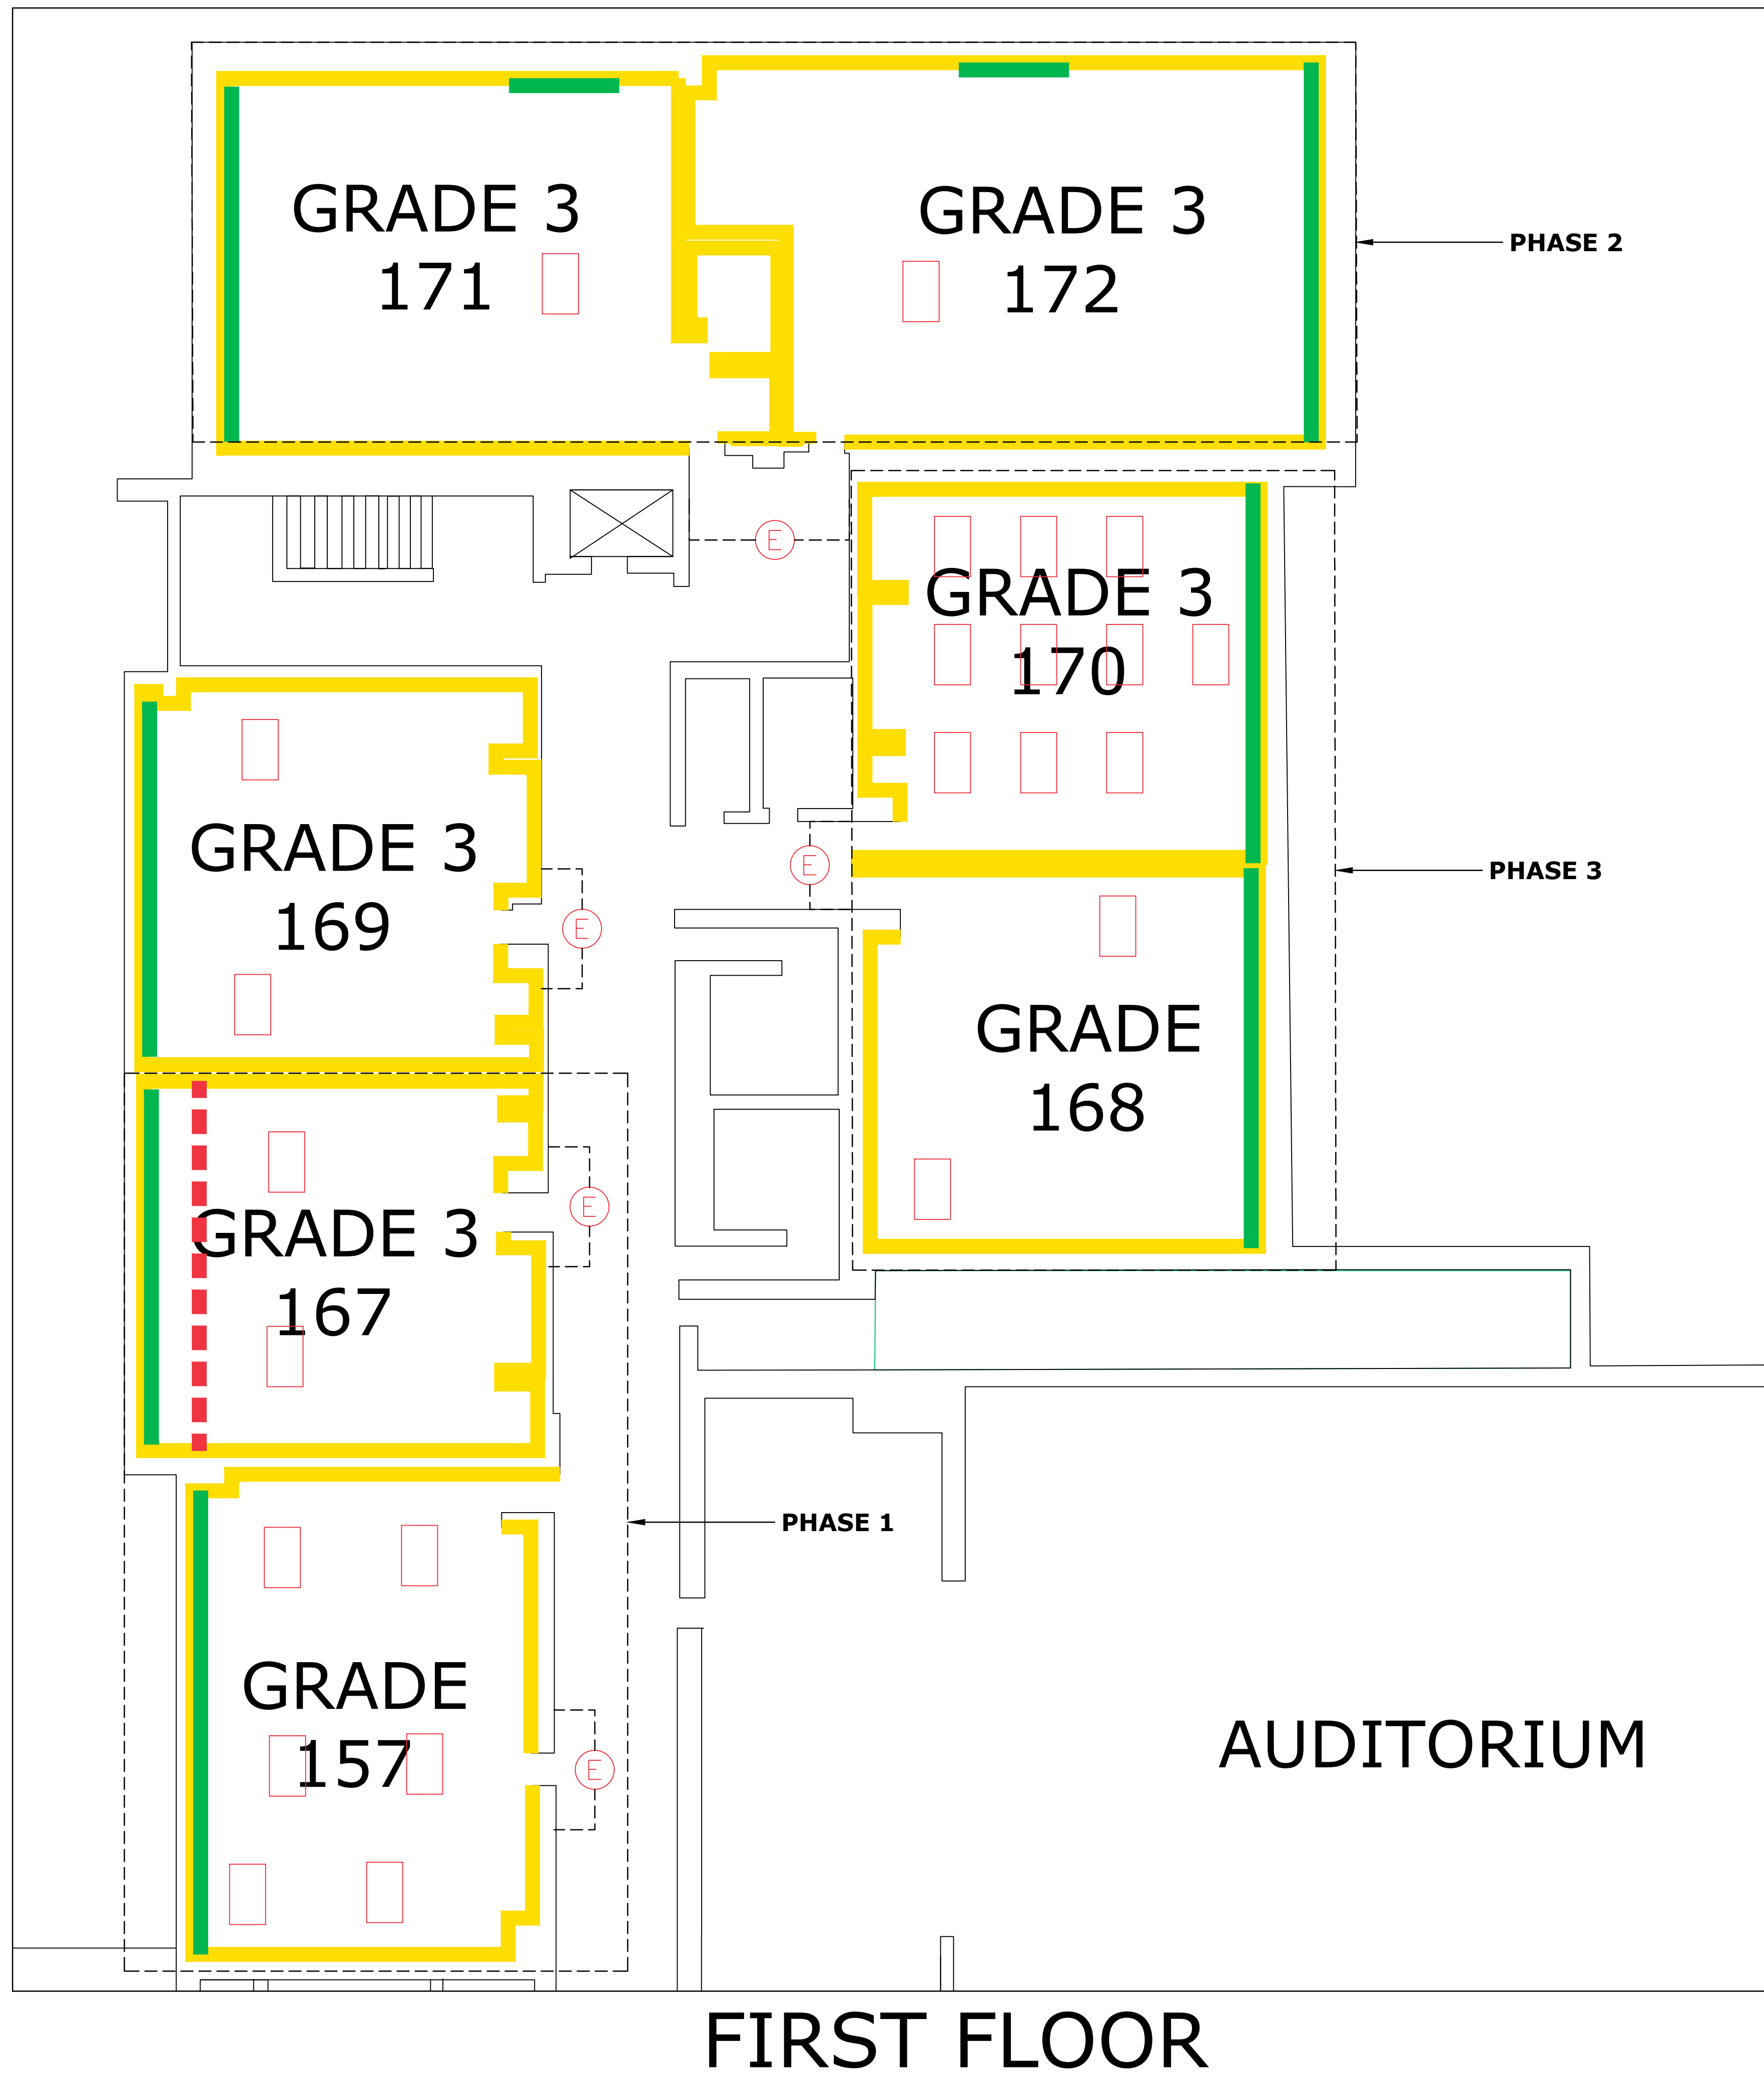
- ROOM 157 SCOPE OF WORK NOTES PHASE 1**
- SET UP EDGE GUARD AT ROOM ENTRANCE
 - REMOVE APPROXIMATELY 800 SF OF VINYL WALL PAPER
 - REMOVE APPROXIMATELY 60 SF OF SHEETROCK AROUND WINDOW UNIT

- CLEAN EXPOSED FIN TUBE RADIANT PIPING AFTER MILLWORK IS REMOVED
 - CLEAN 2 RETURNS AND ONE HEAT VENT
 - REMOVE 6 ACT
 - INSPECT PIPING ABOVE ACT POSSIBLE DRIPPAGE FROM PIPING AS CORROSION WAS OBSERVED

- ROOM 167 SCOPE OF WORK NOTES PHASE 1 AND PHASE 5 (FEBRUARY BREAK)**
- SET UP EDGE GUARD AT ROOM ENTRANCE
 - REMOVE APPROXIMATELY 875 SF OF VINYL WALL PAPER

- REMOVE APPROXIMATELY 60 SF OF SHEETROCK AROUND WINDOW UNIT
 - CLEAN EXPOSED FIN TUBE RADIANT PIPING AFTER MILLWORK IS REMOVED
 - CLEAN 2 RETURNS AND ONE HEAT VENT

- PHASE 5 - ABATE 25 MUDDLED ELBOWS AND FITTINGS AND 175 FEET OF YELLOW FIBERGLASS INSULATION (ALL COVERED IN MOLD)
 - REMOVE 2 ACT
- ROOM 168 SCOPE OF WORK NOTES PHASE 3**

- SET UP EDGE GUARD AT ROOM ENTRANCE
 - REMOVE APPROXIMATELY 860 SF OF VINYL WALL PAPER
 - REMOVE APPROXIMATELY 60 SF OF SHEETROCK AROUND WINDOW UNIT
 - CLEAN EXPOSED FIN TUBE RADIANT PIPING AFTER MILLWORK IS REMOVED

- CLEAN 2 RETURNS AND ONE HEAT VENT
 - REMOVE 1 ACT
- ROOM 169 SCOPE OF WORK NOTES (DIMENSIONS SAME AS 167) PHASE 4**
- SET UP EDGE GUARD AT ROOM ENTRANCE

- REMOVE APPROXIMATELY 875 SF OF VINYL WALL PAPER
 - REMOVE APPROXIMATELY 60 SF OF SHEETROCK AROUND WINDOW UNIT
 - CLEAN EXPOSED FIN TUBE RADIANT PIPING AFTER MILLWORK IS REMOVED

- CLEAN 2 RETURNS AND ONE HEAT VENT
 - REMOVE 2 ACT
- ROOM 170 SCOPE OF WORK NOTES PHASE 3**
- SET UP EDGE GUARD AT ROOM ENTRANCE
 - REMOVE APPROXIMATELY 800 SF OF VINYL WALL PAPER

- REMOVE 13 ACT
- ROOM 171 SCOPE OF WORK NOTES PHASE 2**
- SET UP EDGE GUARD AT ROOM ENTRANCE
 - REMOVE APPROXIMATELY 825 SF OF VINYL WALL PAPER
 - REMOVE APPROXIMATELY 70 SF OF SHEETROCK AROUND WINDOW UNIT

- CLEAN EXPOSED FIN TUBE RADIANT PIPING AFTER MILLWORK IS REMOVED
 - CLEAN 2 RETURNS AND ONE HEAT VENT
 - REMOVE 1 ACT
- ROOM 172 SCOPE OF WORK NOTES PHASE 2**

- SET UP EDGE GUARD AT ROOM ENTRANCE
 - REMOVE APPROXIMATELY 850 SF OF VINYL WALL PAPER
 - REMOVE APPROXIMATELY 60 SF OF SHEETROCK AROUND WINDOW UNIT
 - CLEAN EXPOSED FIN TUBE RADIANT PIPING AFTER MILLWORK IS REMOVED

- CLEAN 3 RETURNS AND ONE HEAT VENT
 - REMOVE 1 ACT
