Scofield  
Magnet School

City of Stamford

SECOND FLOOR  
WORK PLAN

Mold Growth Removal Work Plan

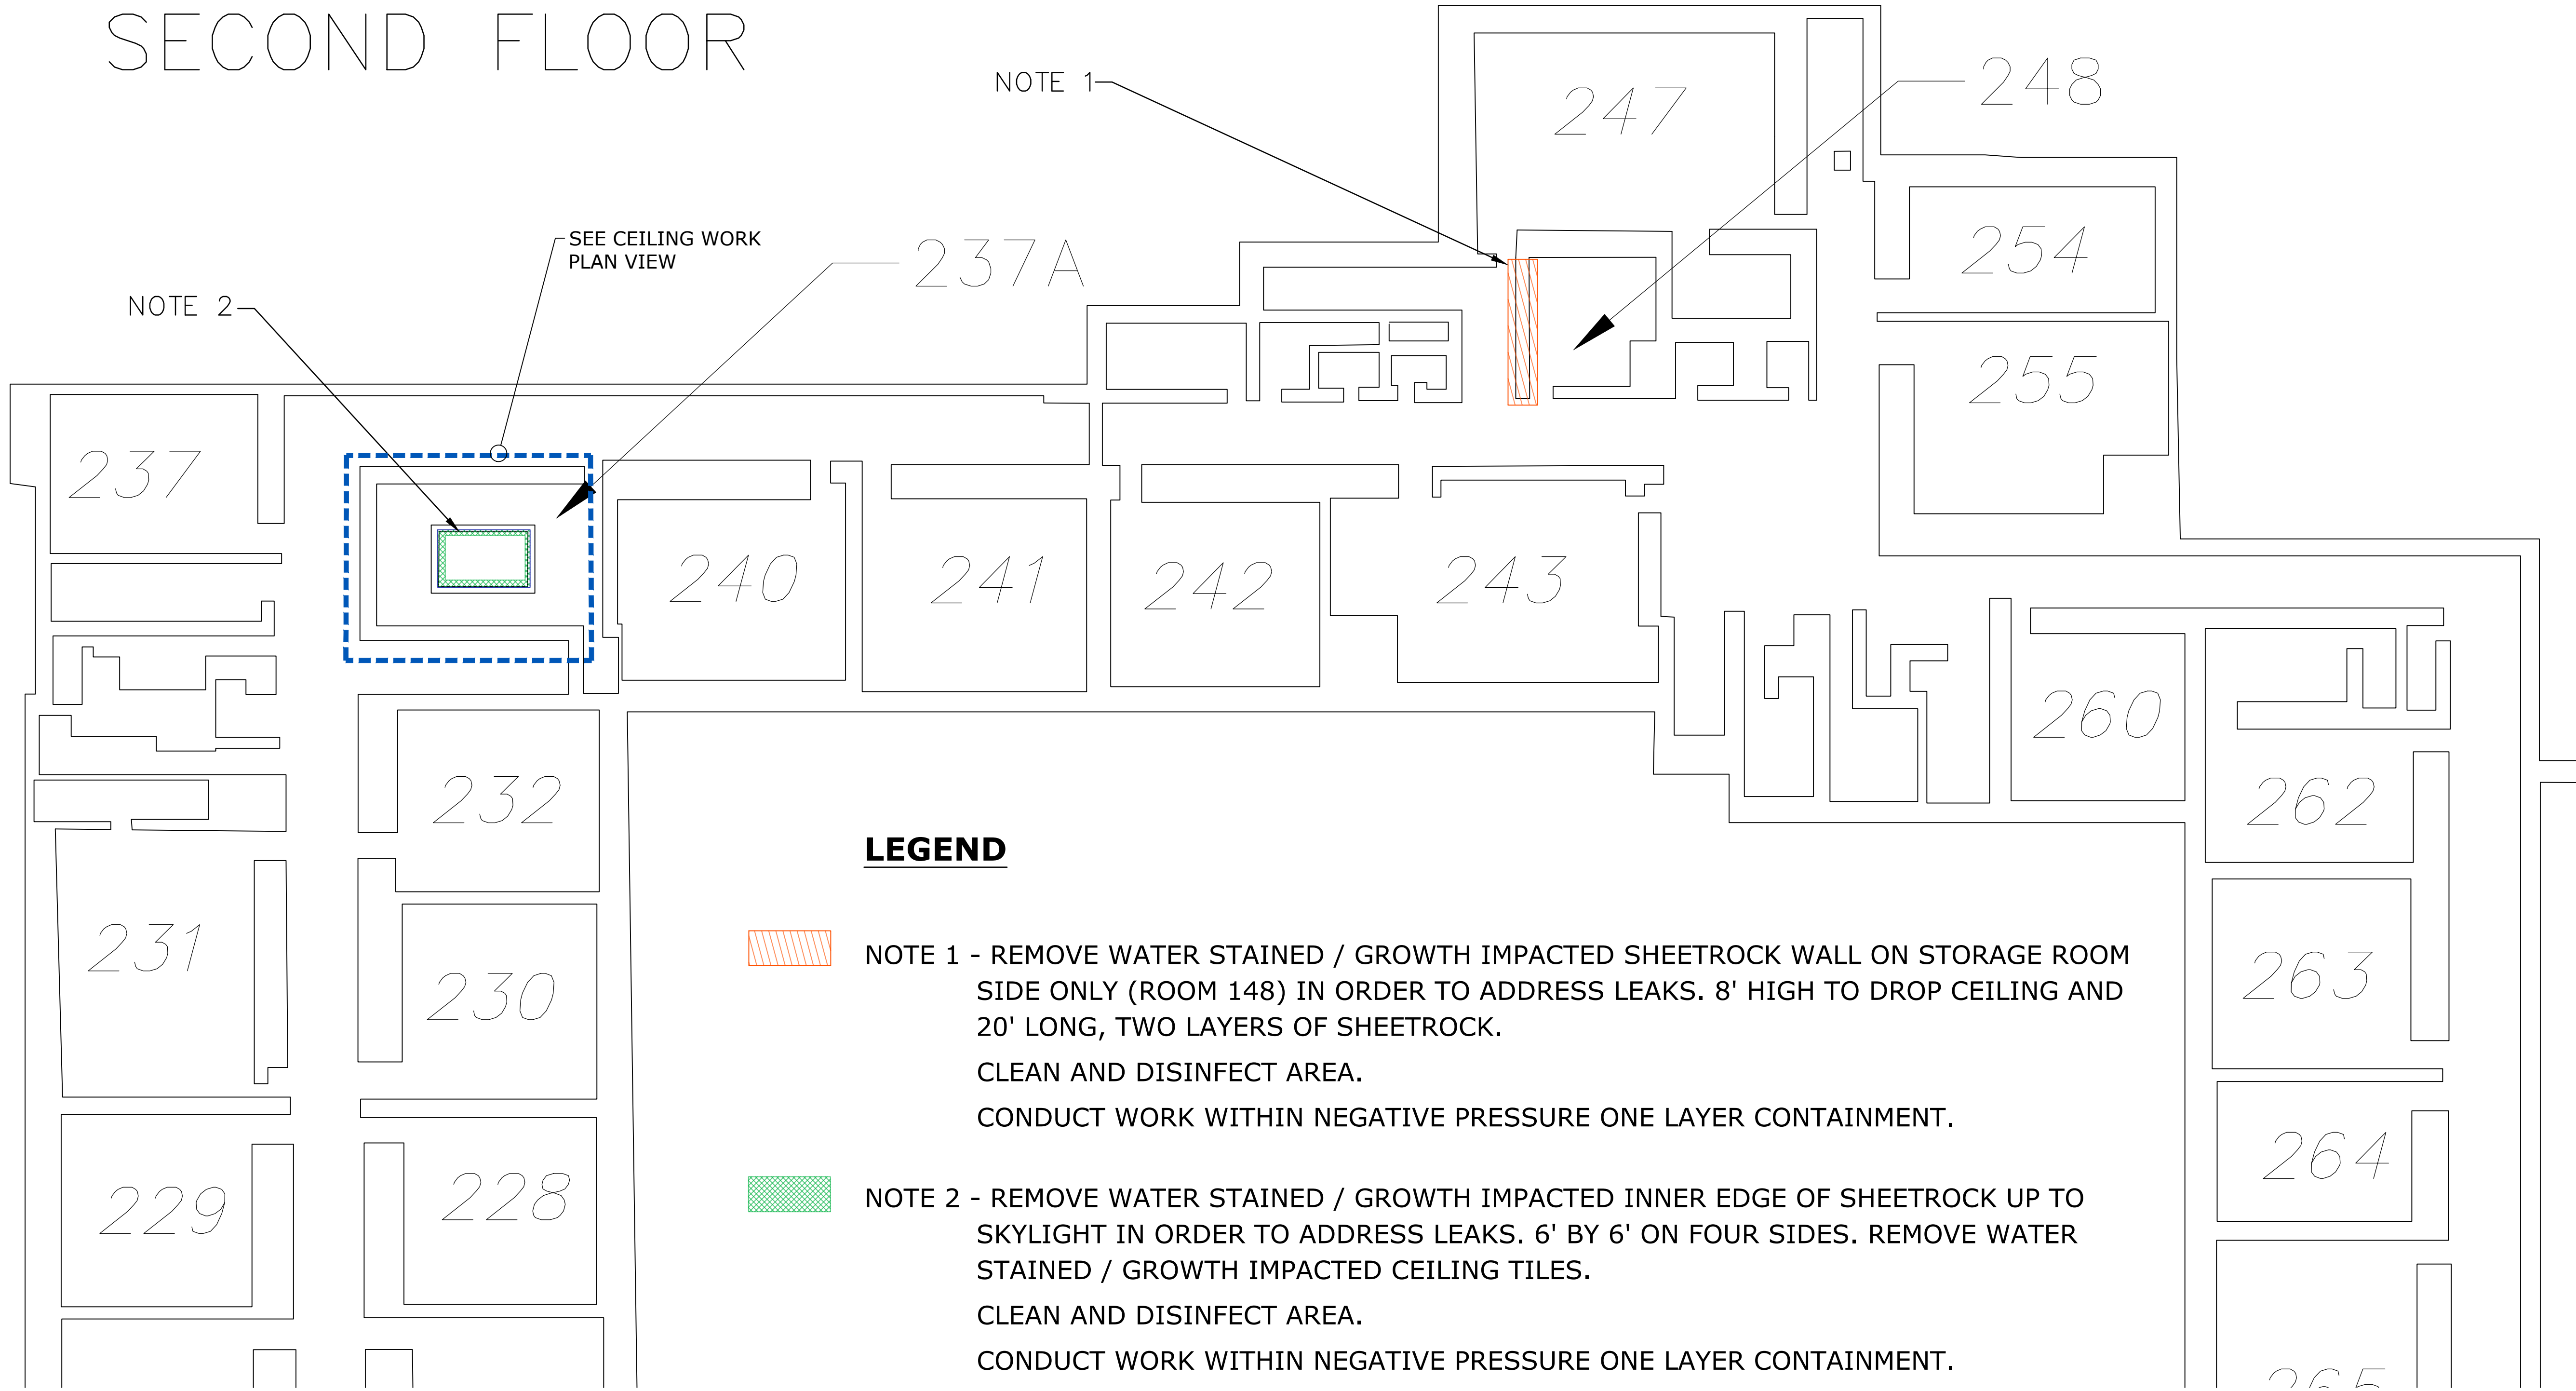
NOTE 1 - REMOVE WATER STAINED / GROWTH IMPACTED SHEETROCK WALL ON STORAGE ROOM SIDE ONLY (ROOM 148) IN ORDER TO ADDRESS LEAKS. 8' HIGH TO DROP CEILING AND 20' LONG, TWO LAYERS OF SHEETROCK. CLEAN AND DISINFECT AREA. CONDUCT WORK WITHIN NEGATIVE PRESSURE ONE LAYER CONTAINMENT.

NOTE 2 - REMOVE WATER STAINED / GROWTH IMPACTED INNER EDGE OF SHEETROCK UP TO SKYLIGHT IN ORDER TO ADDRESS LEAKS. 6' BY 6' ON FOUR SIDES. REMOVE WATER STAINED / GROWTH IMPACTED CEILING TILES. CLEAN AND DISINFECT AREA. CONDUCT WORK WITHIN NEGATIVE PRESSURE ONE LAYER CONTAINMENT.
