FACILITIES NEEDS ASSESSMENT

STAMFORD PUBLIC SCHOOLS

Facilities Needs Assessment of JULIA A. STARK ELEMENTARY SCHOOL 398 Glenbrook Road Stamford, Connecticut 06906

EMG Project #: 88166.09R-013.017
Date of Report: August 29, 2009
On site Date: March 9, 2009 and March 10, 2009

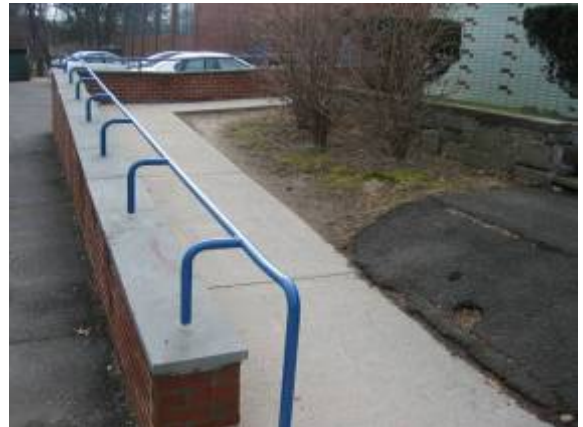
Photo #4: View of a concrete ramp near the auditorium entrance - a 2nd handrail is required

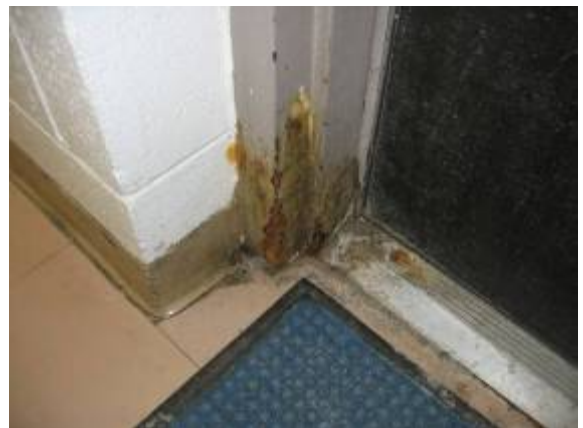
Photo #6: Several of the exterior common and service doors are badly rusted frames

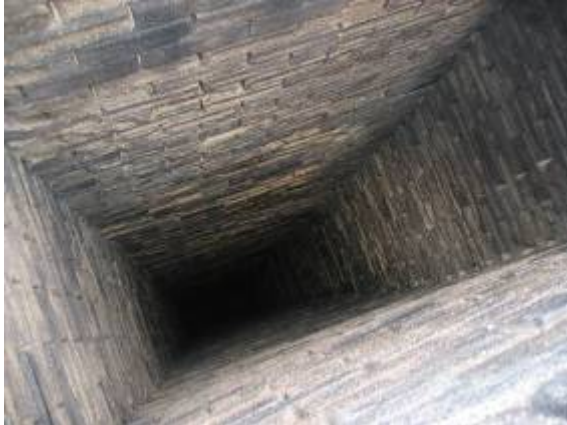
Photo #13: Portions of the interior brick of the chimney appeared bulging in

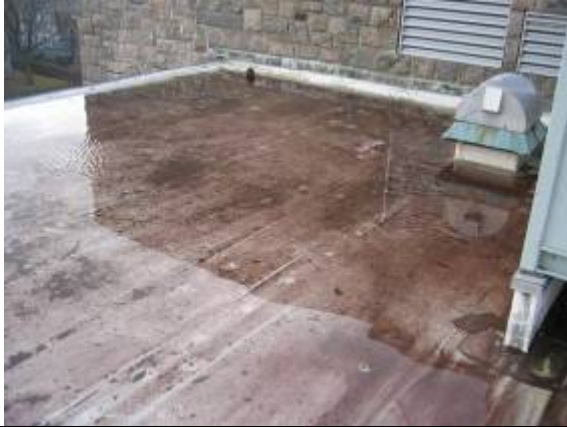
Photo #31: Flat roof section over rooms 234-238 has approximately 3" of ponding water

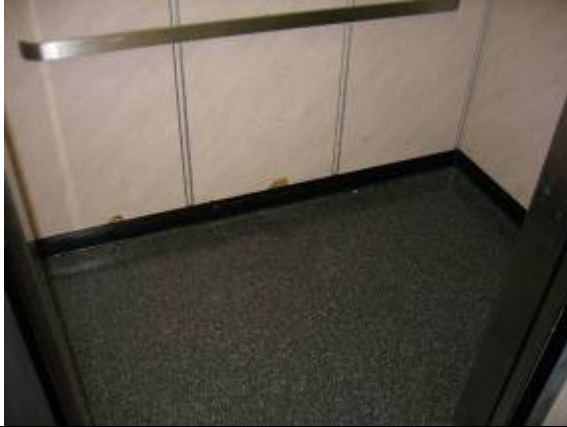
Photo #55:	Passenger elevator has chipped cab walls and inoperable door re-opener system
------------	---

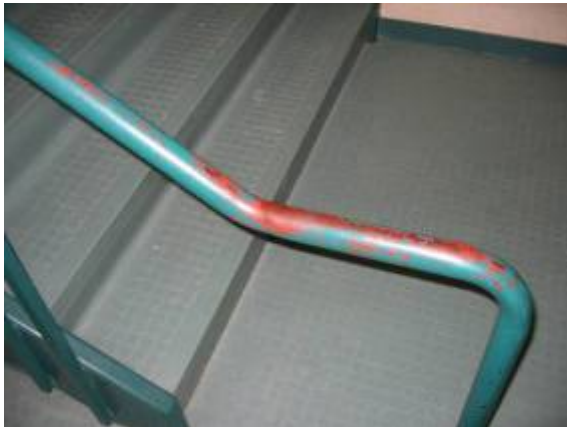
Photo #57:	Fairly widespread stair and railing repainting is needed
------------	--

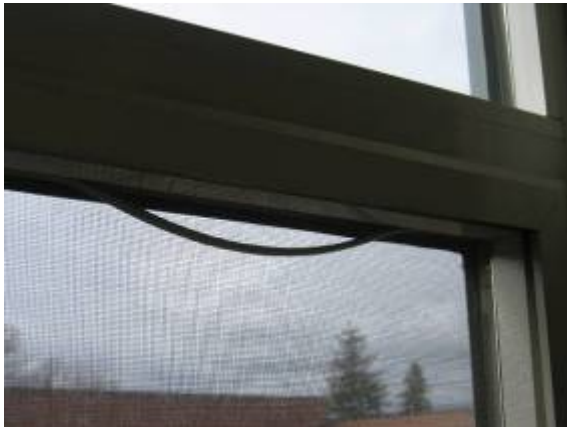
Photo #63: A few isolated internal window gaskets sagging

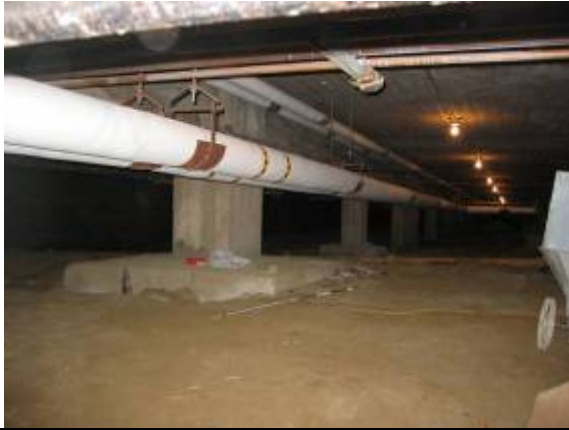
Photo #67: The majority of the building is set on a crawlspace type foundation

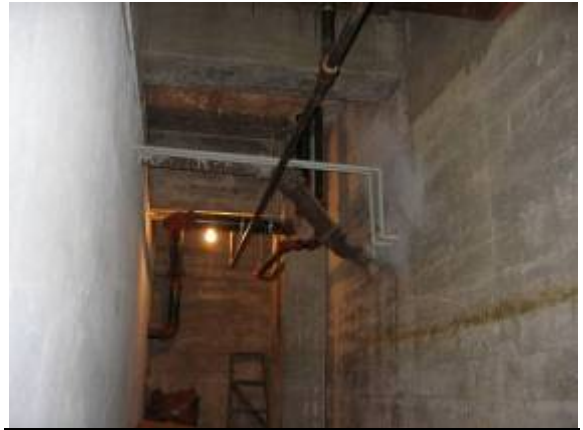
Photo #68: A limited basement area exists for mechanical equipment and boilers

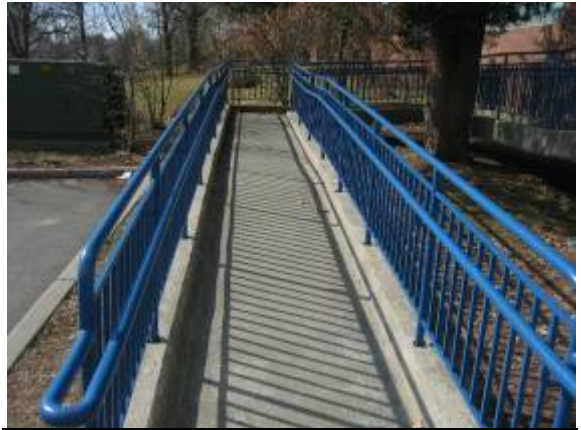
Photo #74: View of concrete entry ramp, which is located adjacent to main entrance.

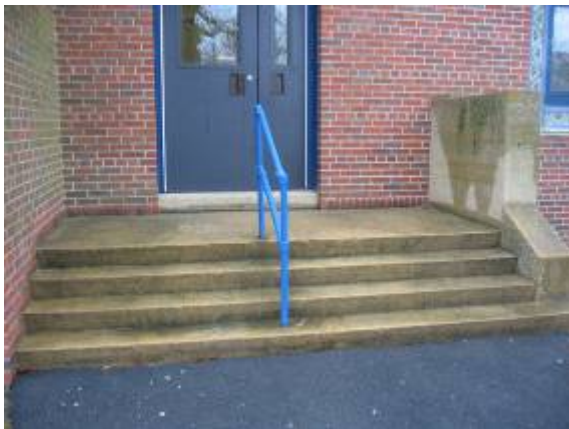
Photo #75: View of cast in place concrete steps, which are located near the SE corner of the building.

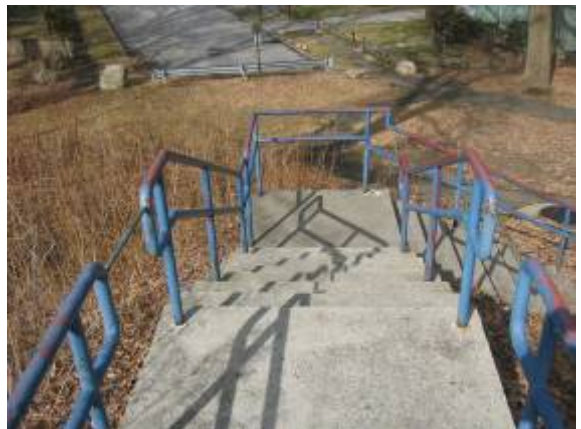
Photo #76: View of cast in place concrete steps, which connect the rear paved lot to adjoining public streets.

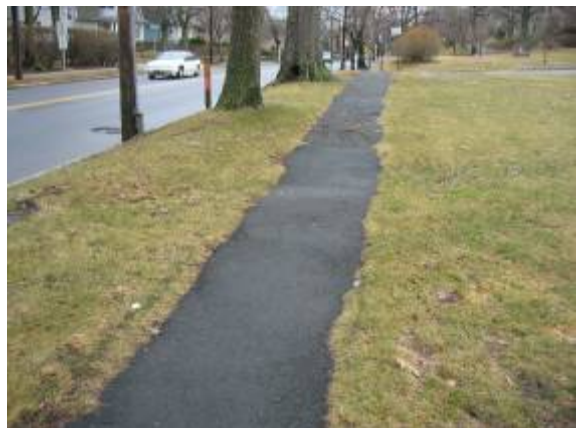
Photo #78: View of asphalt paved sidewalks, which parallel Glenbrook Road.

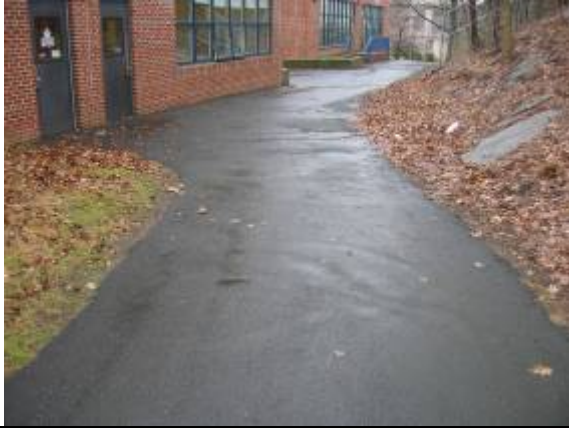
Photo #79: Asphalt paved sidewalks, located along the southern perimeter

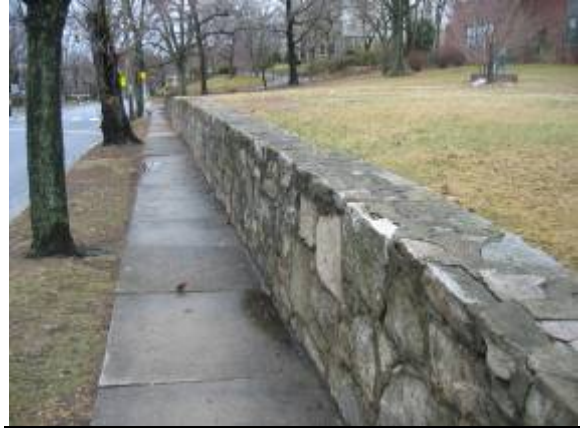
Photo #80: View of stone retaining wall and concrete sidewalks along Glenbrook Road

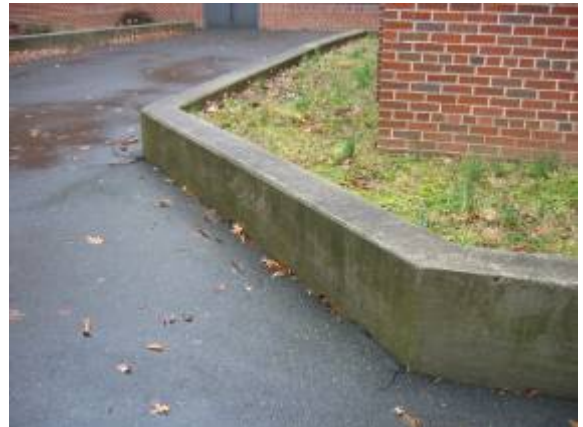
Photo #82: View of concrete retaining walls

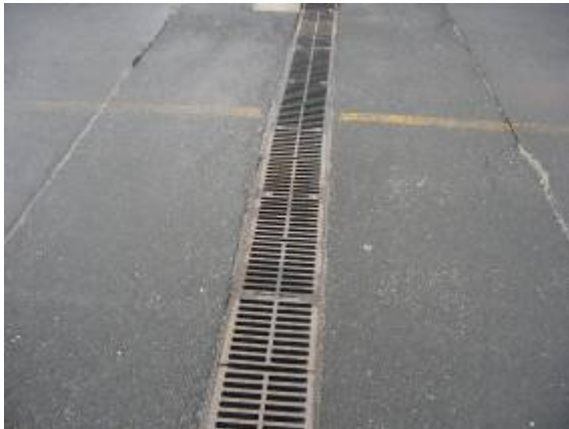
Photo #87: View of trench drain, which is located within rear entry driveway

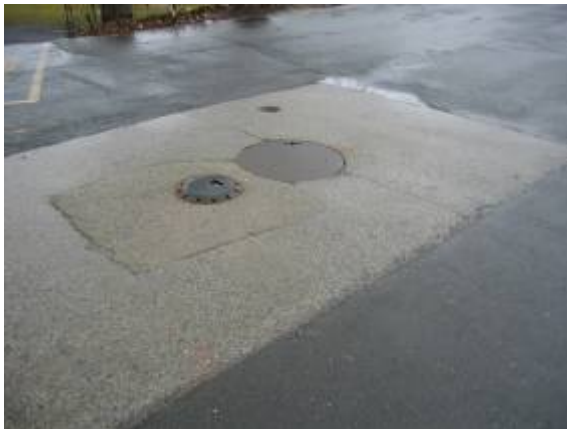
Photo #111: View of underground fuel oil storage tank

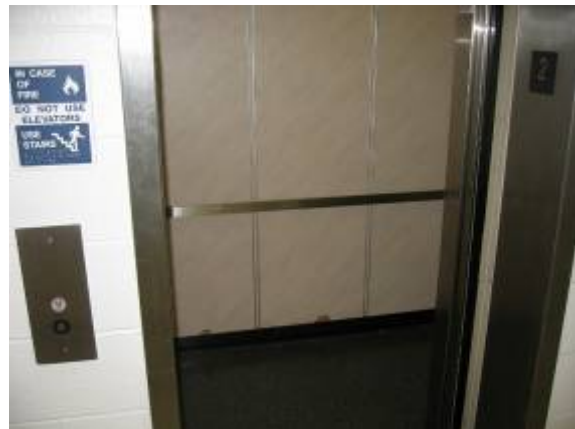
Photo #112: View of passenger elevator cab interior finishes

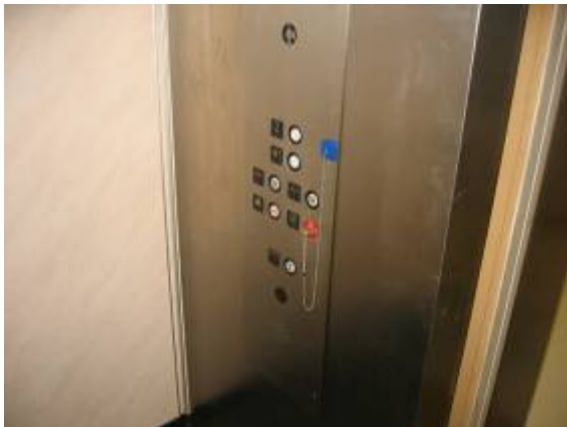
Photo #113: View of passenger elevator cab stainless steel control panel

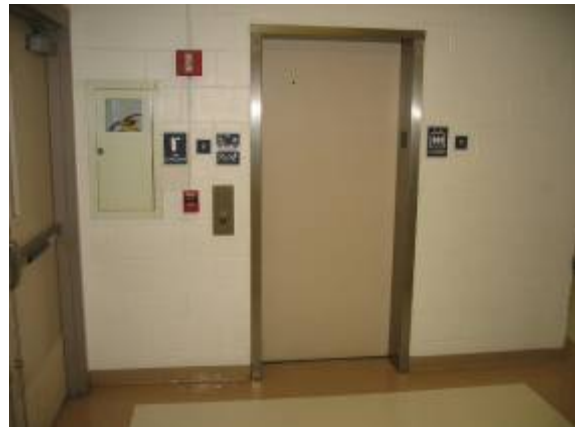
Photo #114: View of passenger elevator cab door

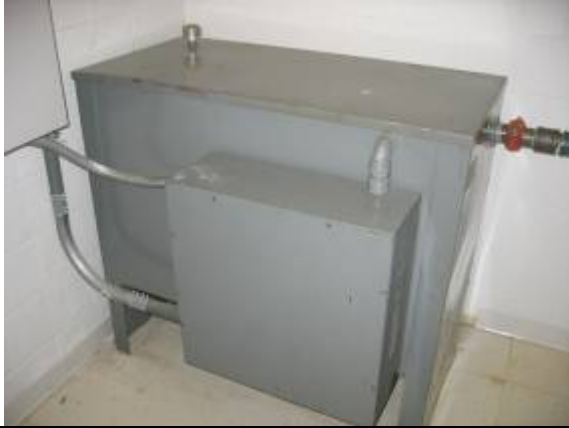
Photo #115: View of passenger elevator equipment

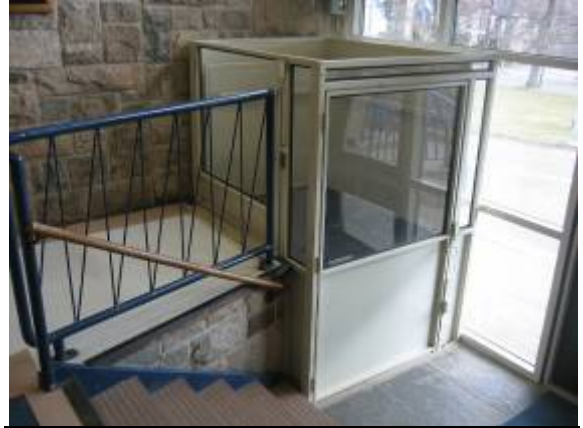
Photo #116: View of wheelchair lift, which is located immediately adjacent to the main entrance

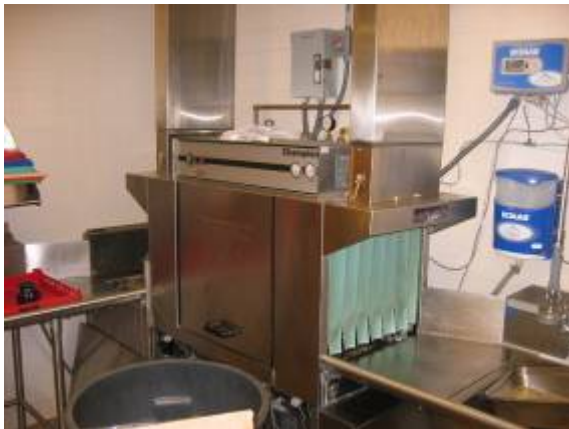
Photo #117: View of dishwashing station

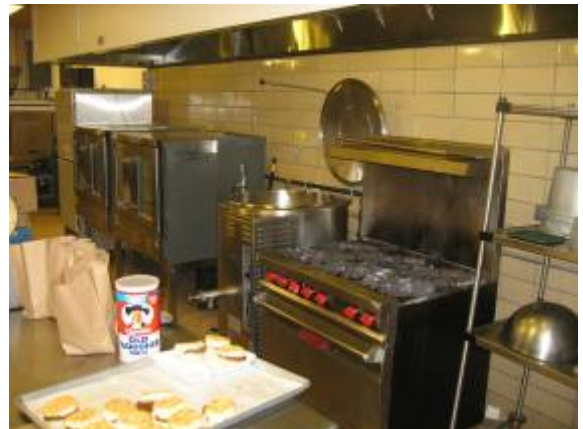
Photo #118: View of commercial kitchen equipment

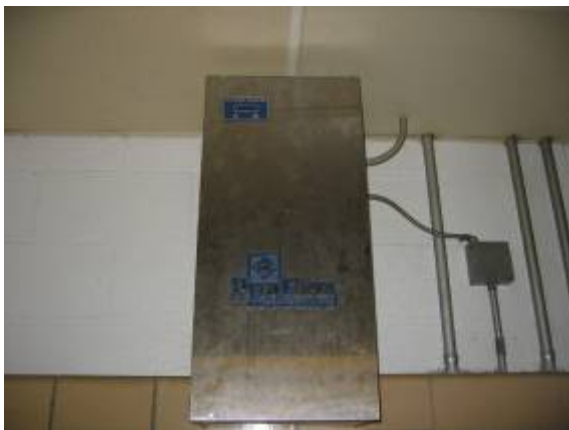
Photo #119: View of kitchen exhaust hood fire suppression system

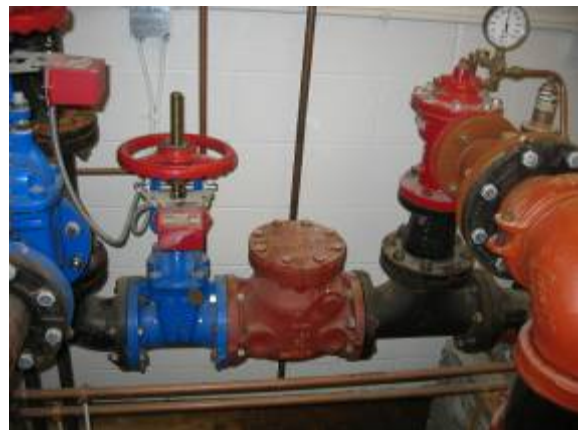
Photo #120: View of fire sprinkler equipment

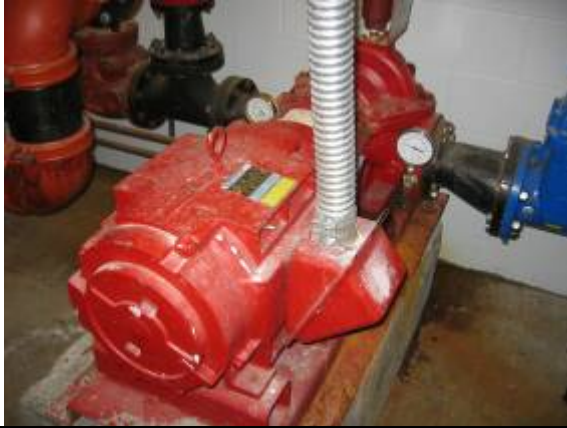
Photo #121: View of fire pump

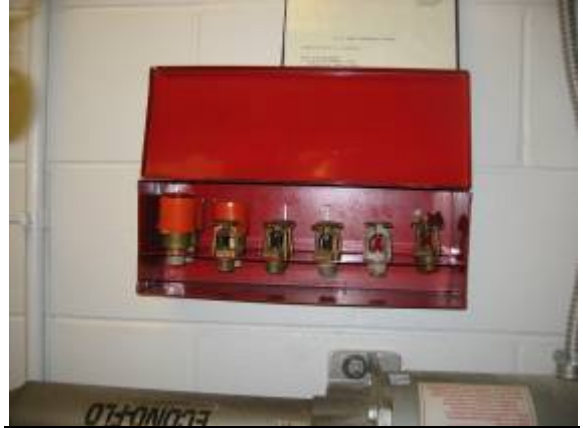
Photo #122: View of spare fire sprinkler heads

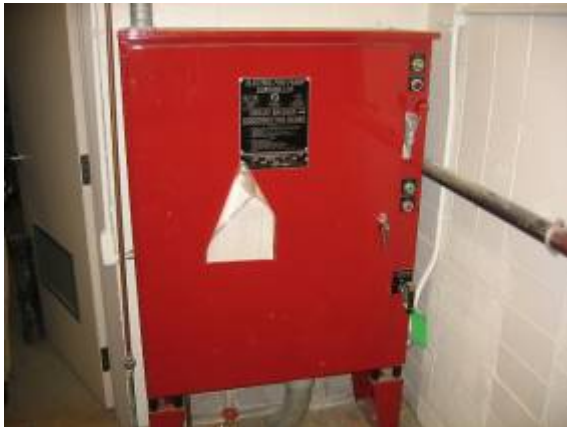
Photo #123: View of transfer switch

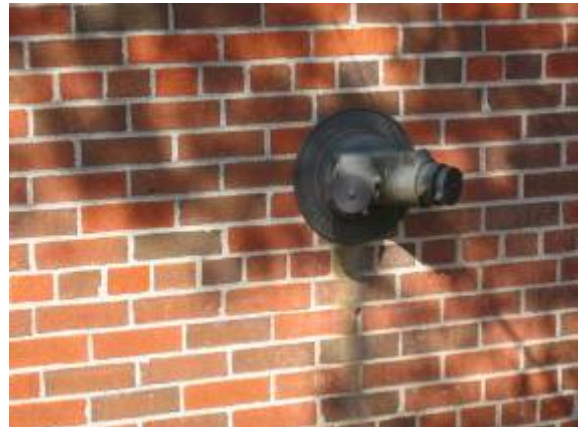
Photo #124: View of fire department Siamese connection
