# FACILITIES NEEDS ASSESSMENT

## FACILITIES NEEDS ASSESSMENT OF NEWFIELD ELEMENTARY SCHOOL

345 Pepper Ridge Road  
Stamford, Connecticut 06905

**EMG Project #:** 88166.09R-012.017  
**Date of Report:** August 29, 2009  
**On site Date:** March 17, 2009

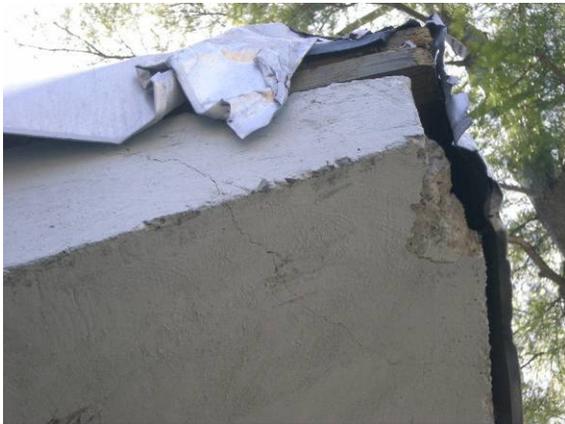
Photo #17: Damaged fascia and canopy at loading dock

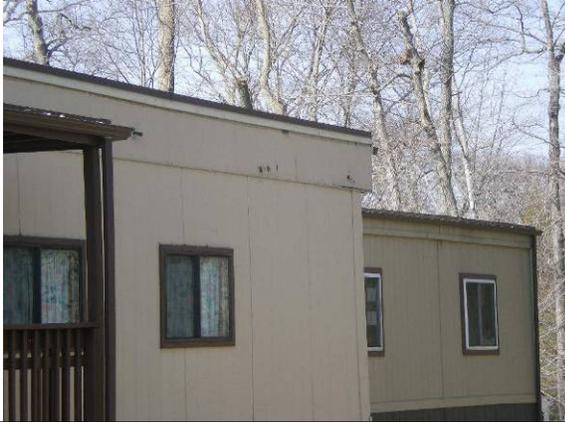
Photo #19: East side of modular – evidence of active nesting and wood damaging birds

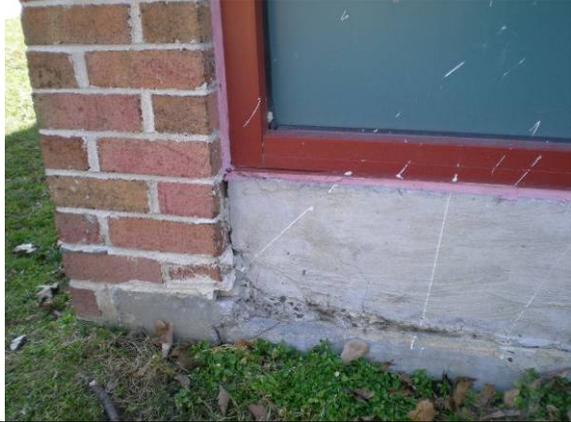
Photo #20: Area needing patching at B wing

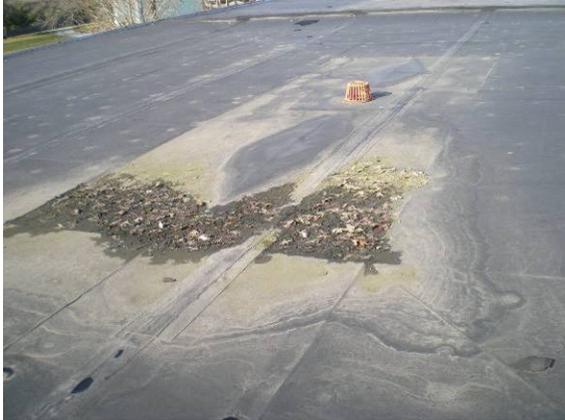
Photo #31: Evidence of ponding and area requiring resloping to existing drainage device

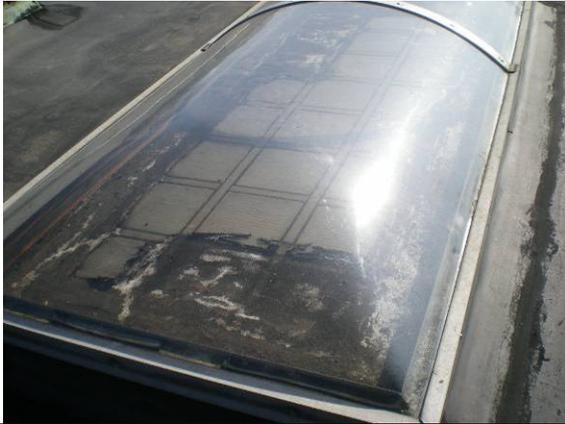
Photo #37: Mastic covered skylight glass blocks

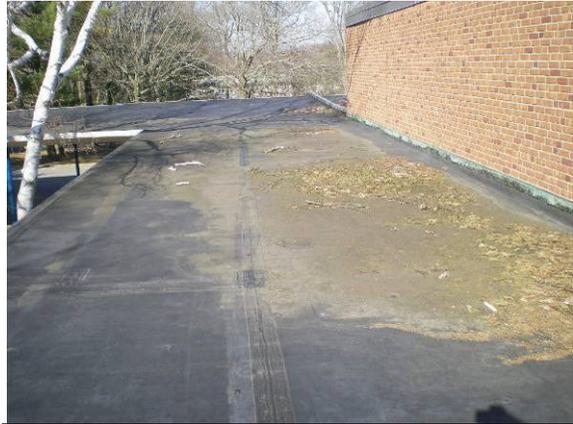
Photo #38: No drainage devices on north side of courtyard roof

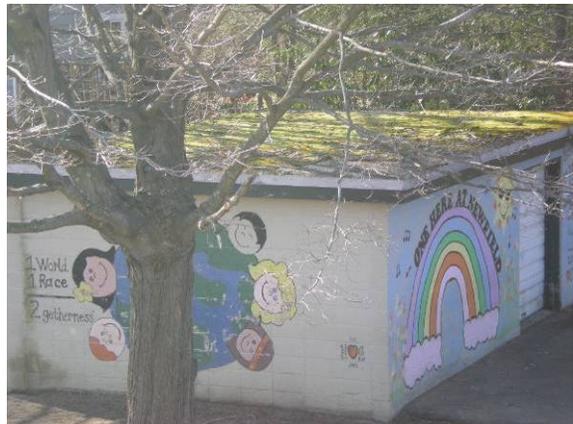
Photo #40: Storage building with moss build up on roof

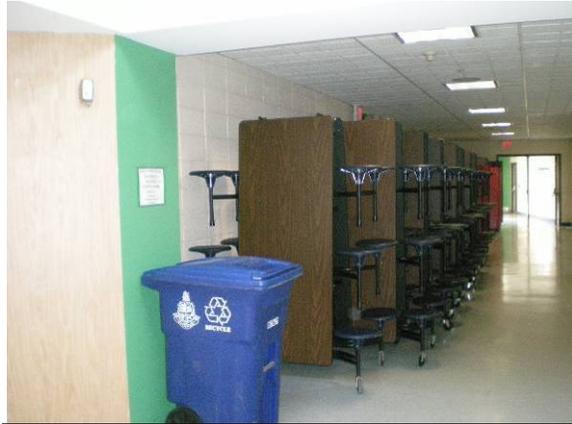
Photo #44: Tables stored in corridor when gymnasium not used as cafeteria

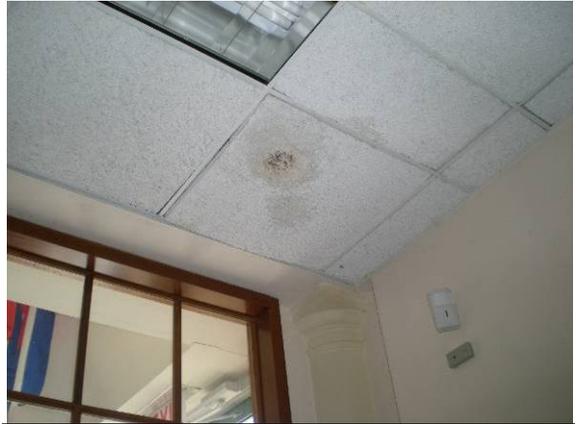
Photo #50: Suspect mold in computer lab

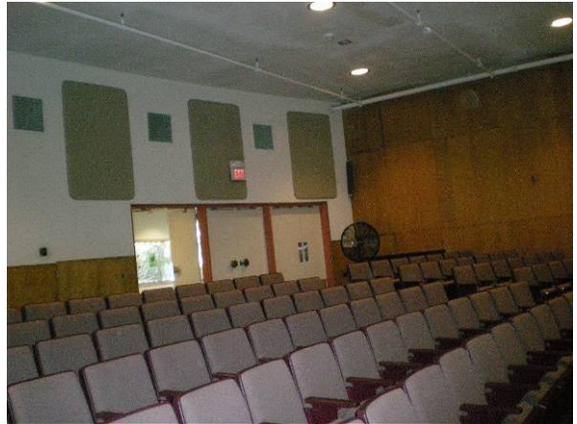
Photo #52: Rear wall of auditorium

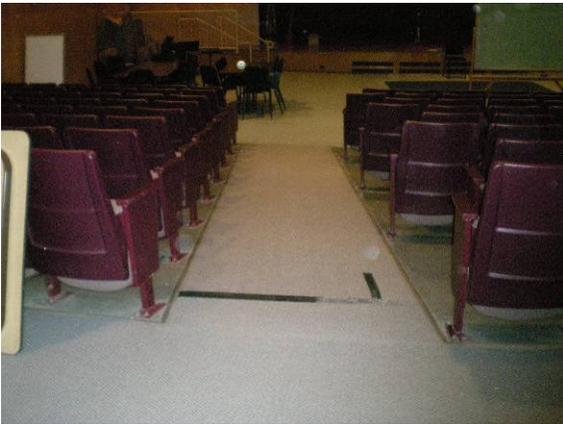
Photo #53: Carpet condition in auditorium

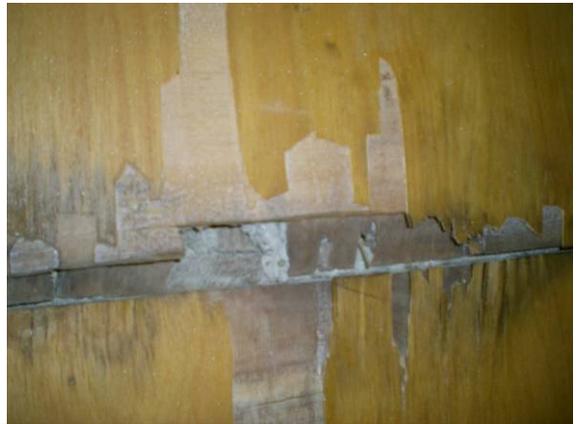
Photo #54: Condition of veneered wood paneling in auditorium

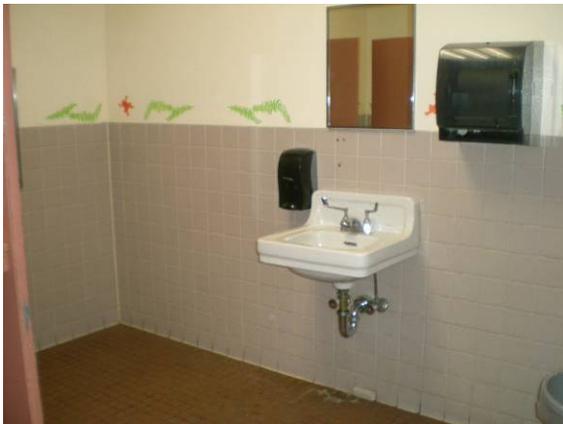
Photo #57: Staff restroom across from Gym

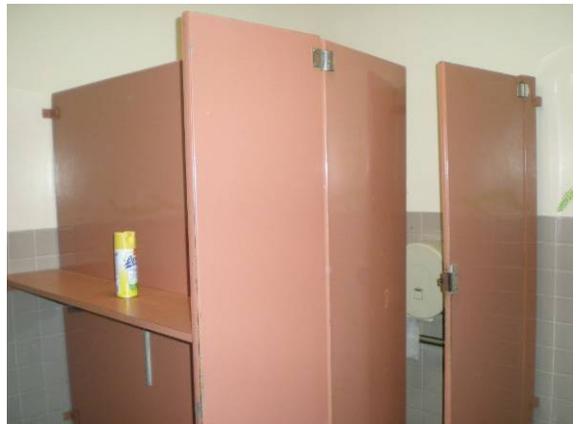
Photo #58: Staff restroom across from Gym

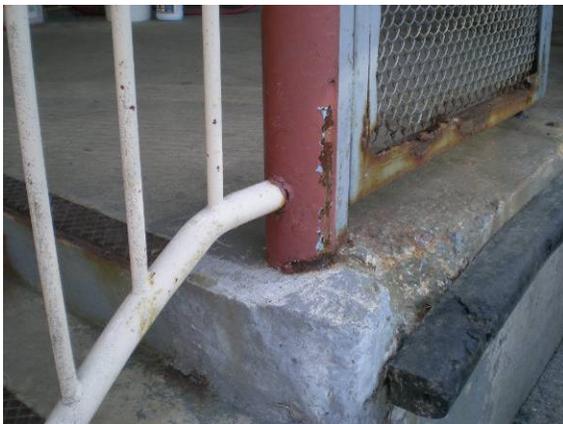
Photo #59: Condition of gate, structure and bumper at loading dock

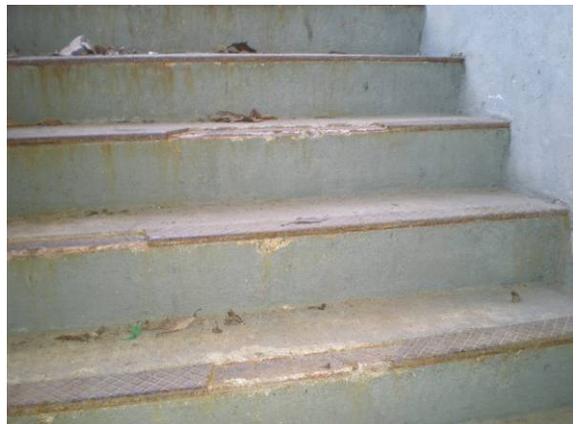
Photo #60: Stair to basement missing steel tread nosings

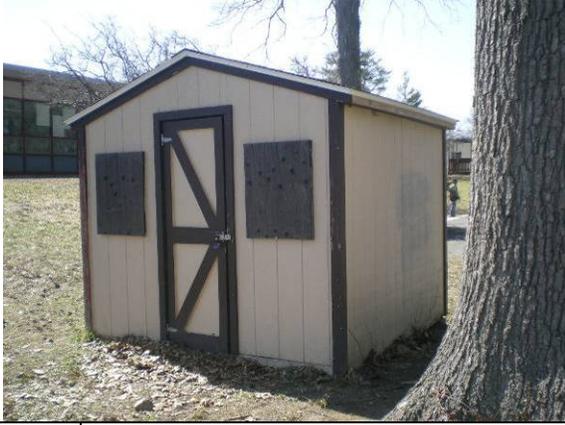
Photo #61: Storage shed in playground area

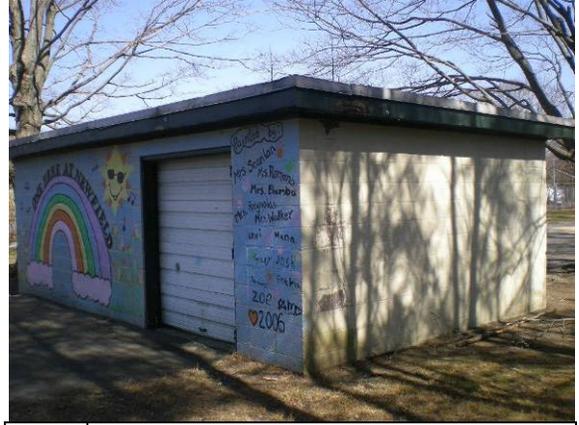
Photo #62: Storage building in playground area

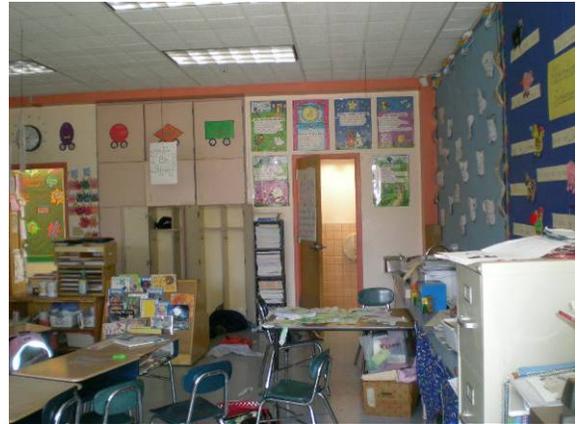
Photo #64: Restroom and storage in classroom

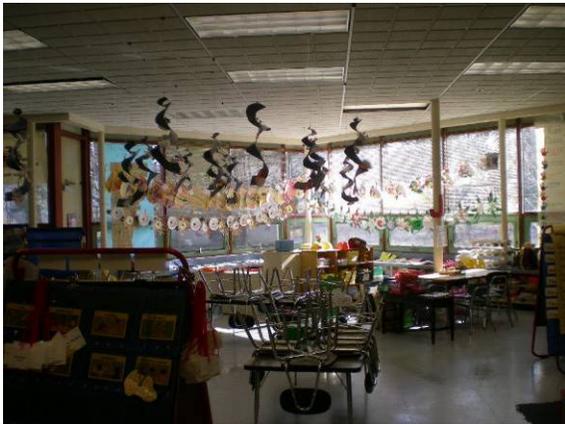
Photo #65: Kindergarten classroom

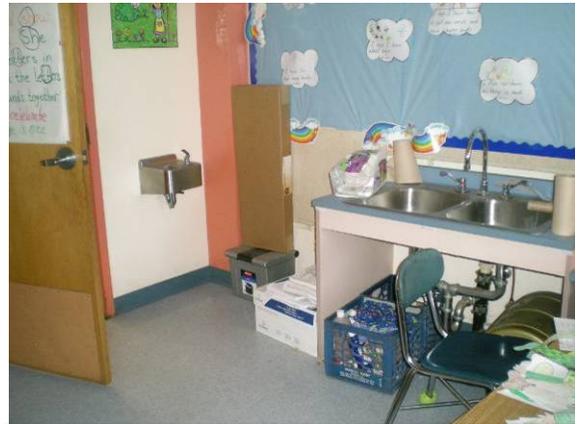
Photo #66: Sink and water fountain in classroom

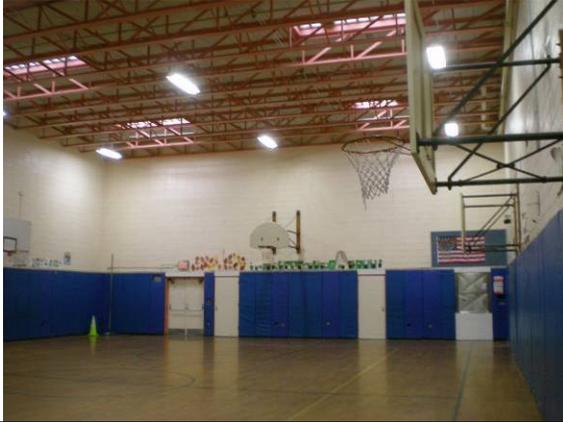
Photo #67: Gymnasium/cafeteria

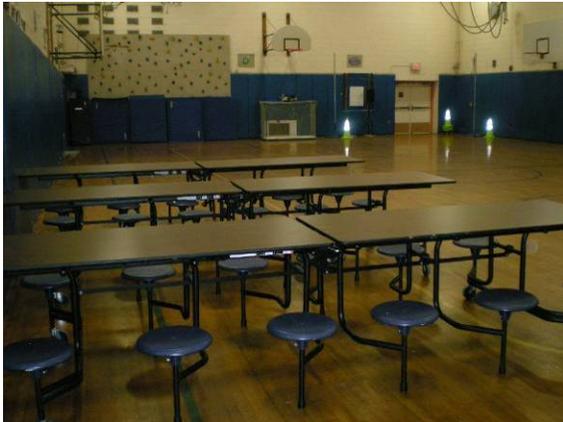
Photo #69: Gymnasium being set up for cafeteria use

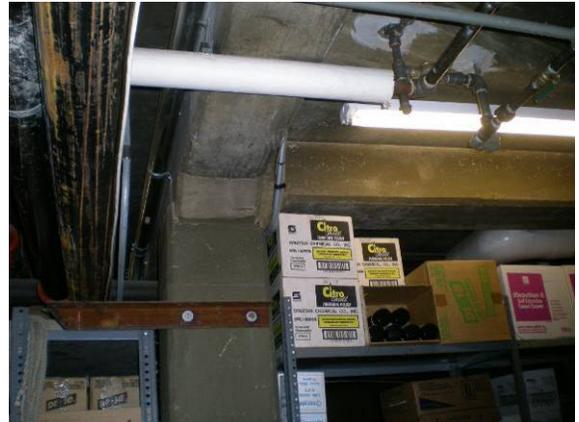
Photo #70: Structure in basement under raised flooring

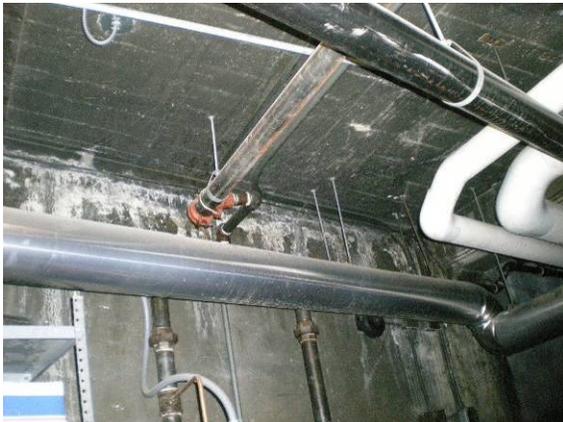
Photo #71: Efflorescence in basement under downspout in corner near transformer

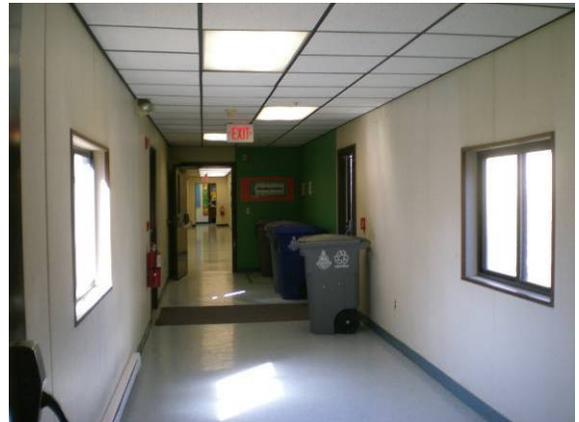
Photo #72: Corridor link to modular wing

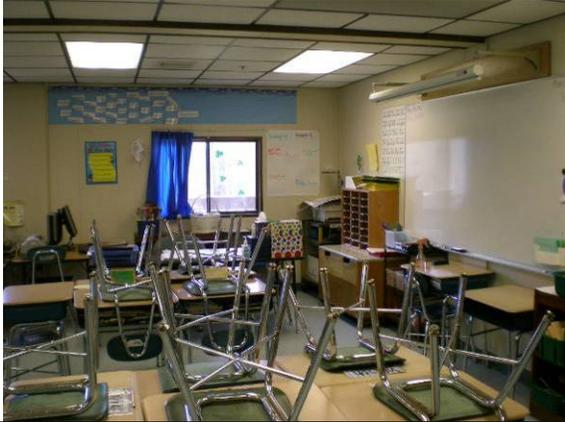
Photo #73: Classroom in modular wing

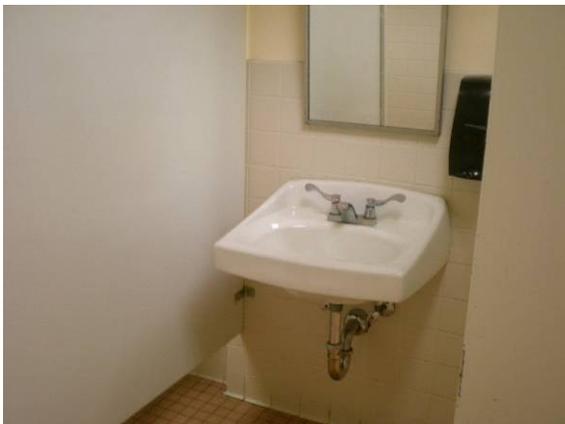
Photo #77: Girls' student restroom

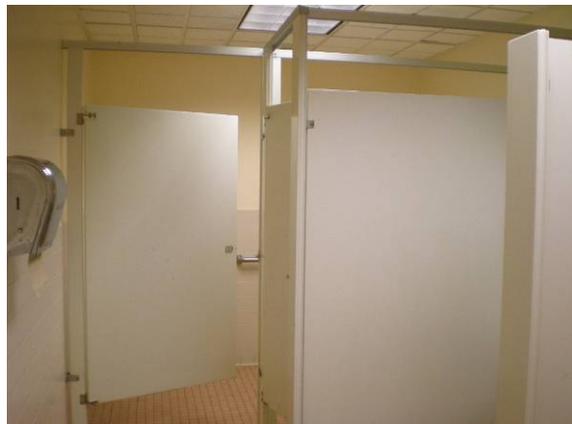
Photo #78: Girls' student restroom

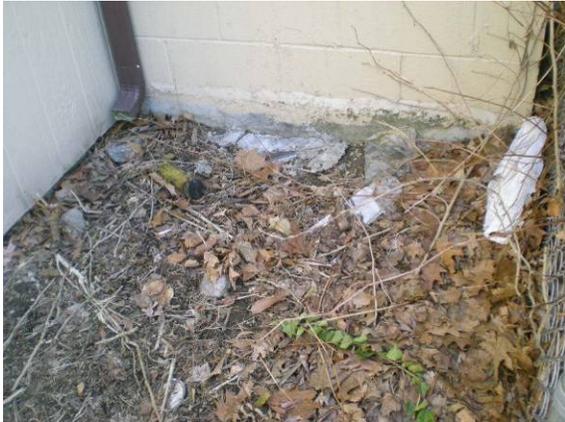
Photo #79: Area above efflorescence in basement – evidence of ponding – near transformer

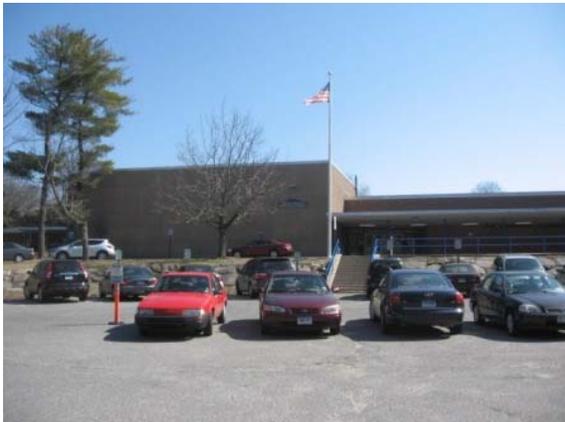
Photo #81: Front elevation of building with building identification signage

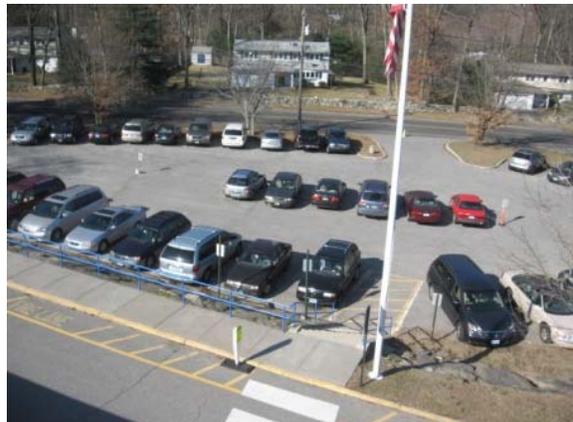
Photo #84: Main parking lot at front of building

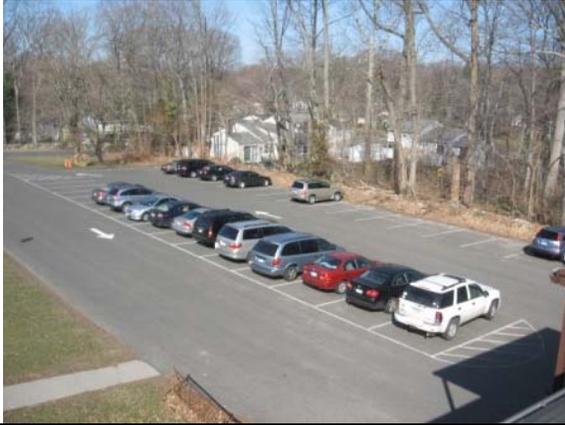
Photo #85: Parking lot at the front of the modular building

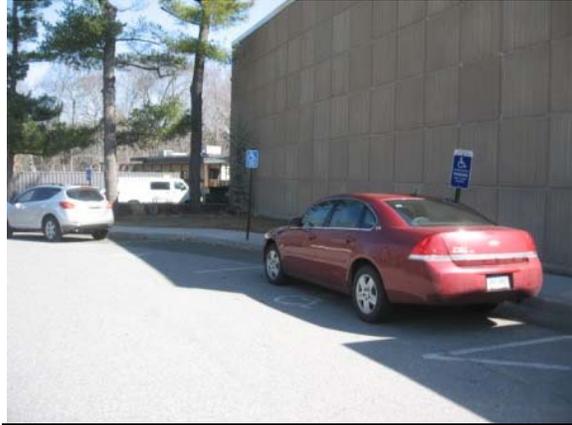
Photo #86: Accessible parking adjacent to building main entrance

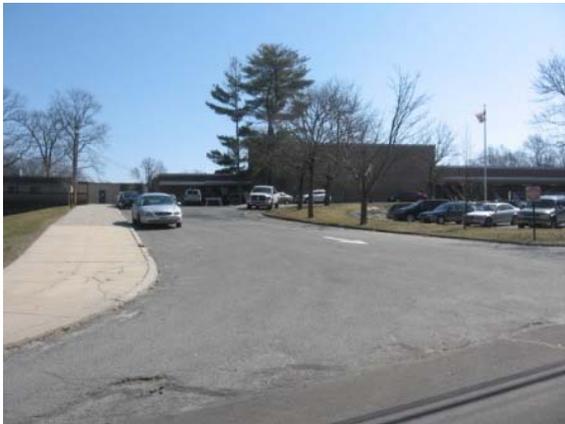
Photo #87: Exit asphalt drive lane

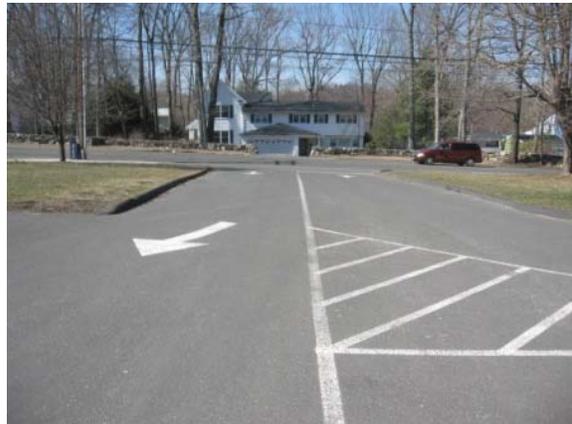
Photo #88: Entrance to parking lot in front of modular building

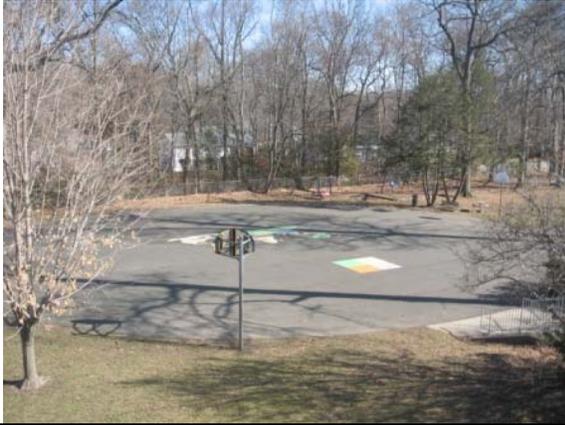
Photo #91: Basketball courts at left side of building

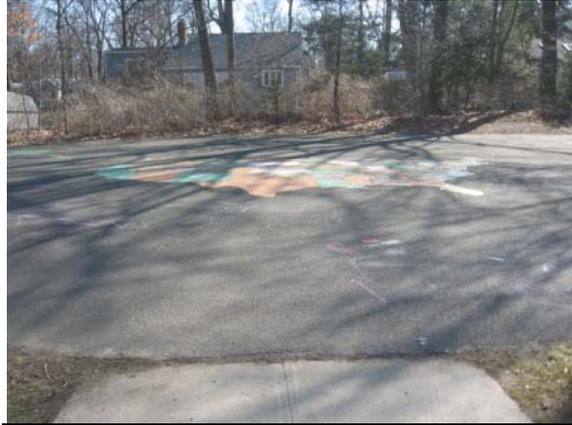
Photo #92: Asphalt play area at right side of building

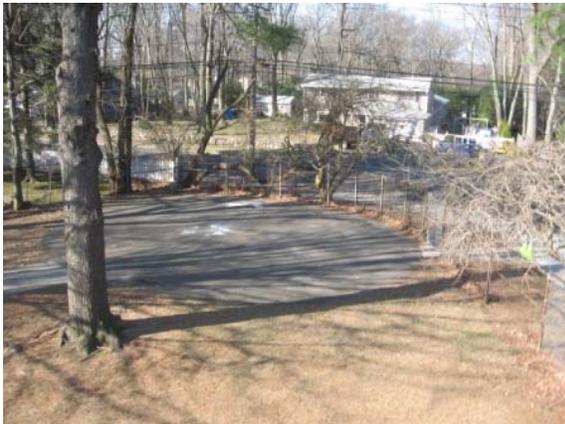
Photo #93: Asphalt play area at right side of building

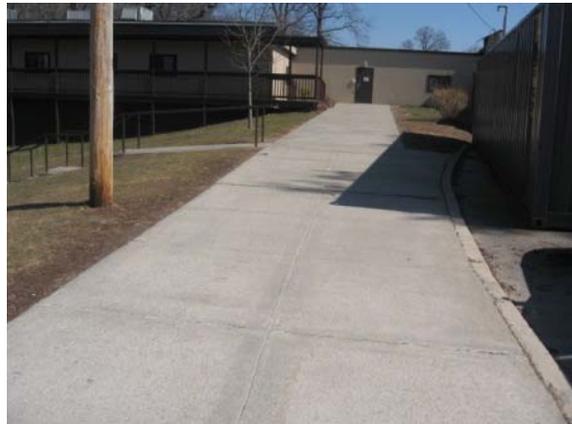
Photo #94: Concrete sidewalk at front elevation

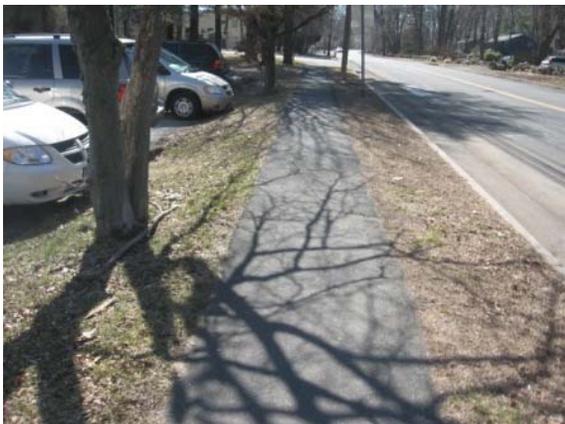
Photo #95: Asphalt sidewalk along Pepper Ridge Road

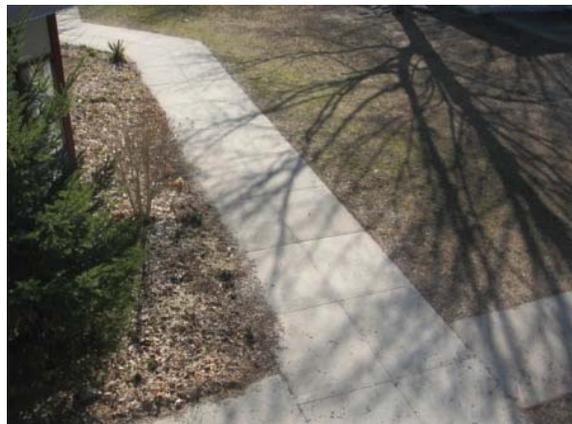
Photo #96: Concrete sidewalk at right side of building

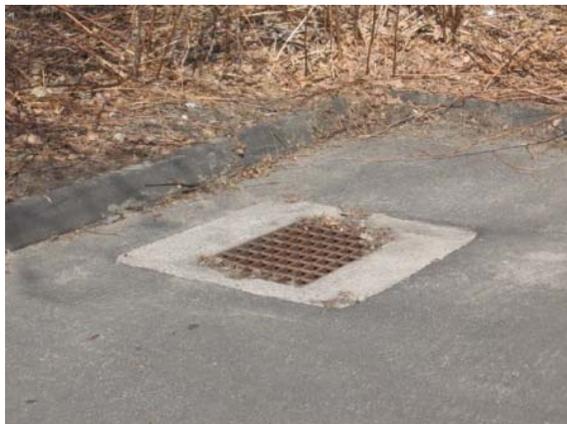
Photo #101: Drainage inlet at parking lot

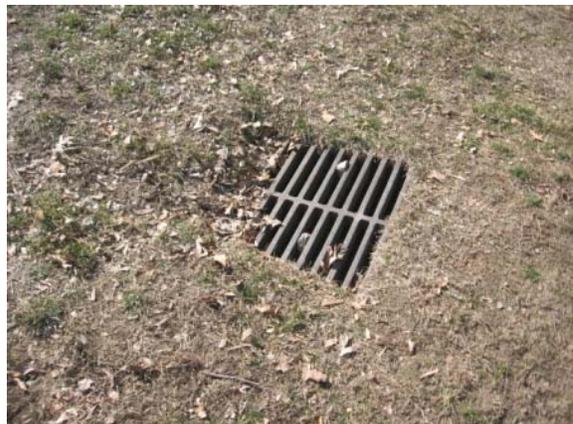
Photo #102: Drainage inlet at landscaping

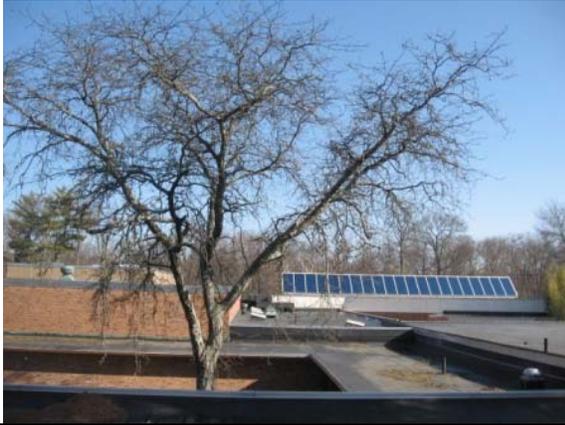
Photo #103:	Tree overgrowing roof surface
-------------	-------------------------------

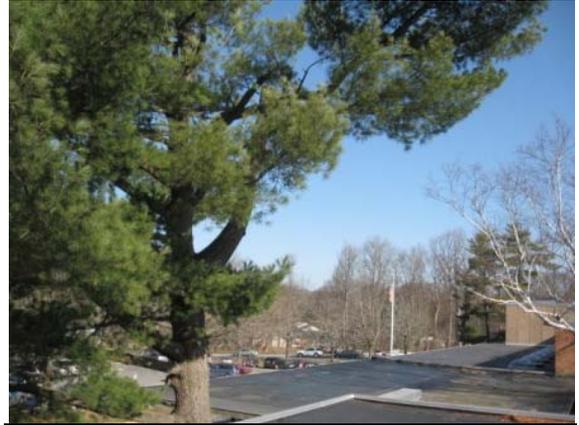
Photo #104:	Tree overgrowing roof surface
-------------	-------------------------------

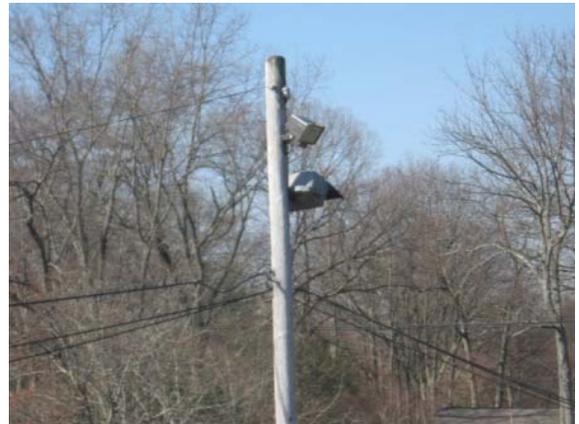
Photo #106:	Wood pole light at parking lot
-------------	--------------------------------

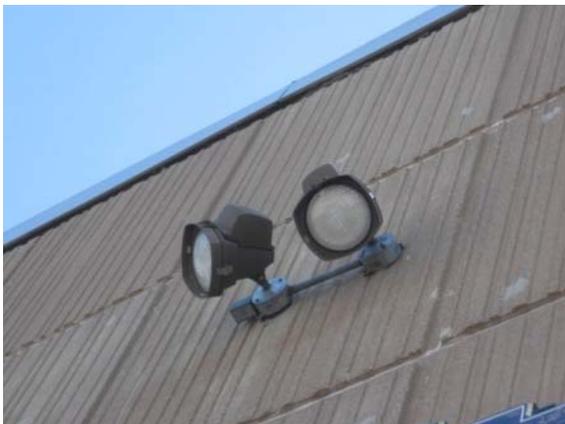
Photo #107:	Building light fixture
-------------	------------------------

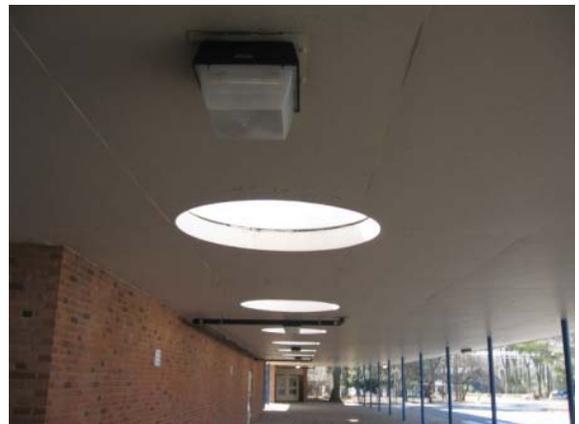
Photo #108:	Surface-mounted light fixtures at front covered walk
-------------	--

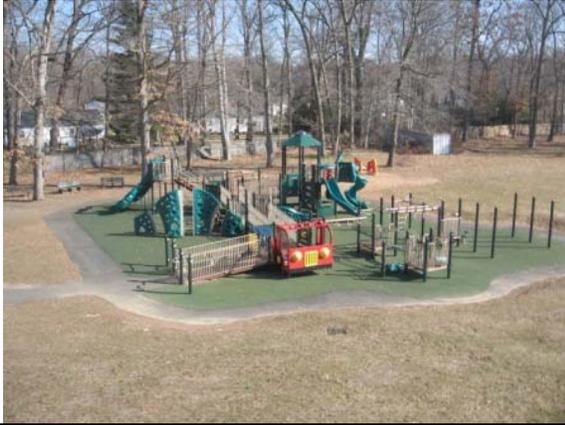
Photo #109: Playground equipment at left side of building

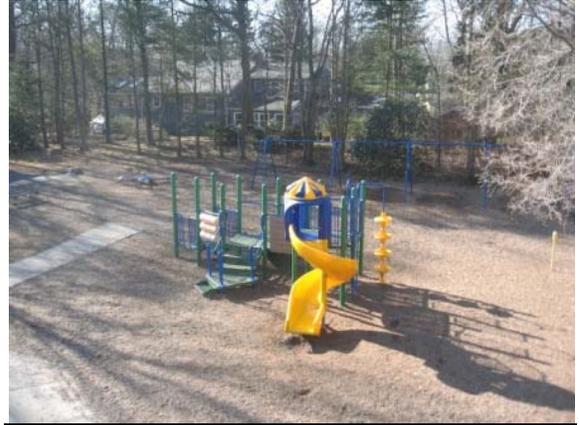
Photo #110: Playground equipment at right side of building

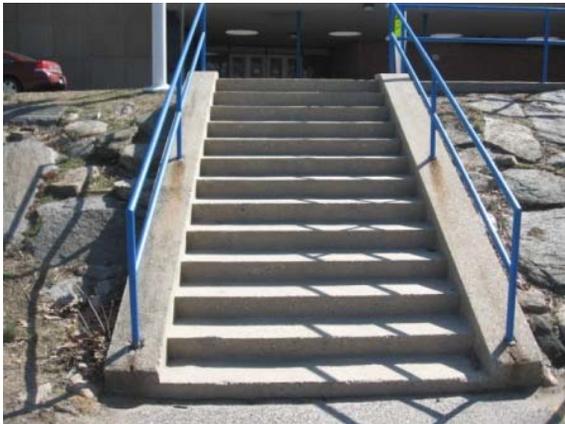
Photo #111: Site concrete steps with metal railings

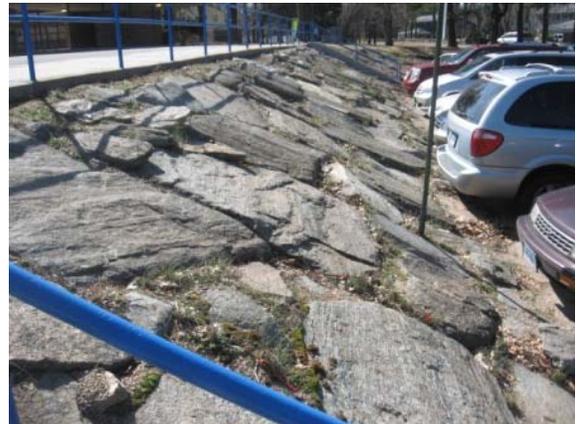
Photo #112: Stone masonry landscaping adjacent to main parking lot

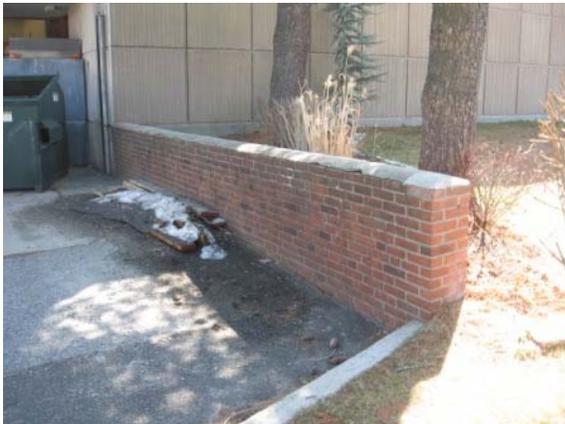
Photo #113: Brick retaining wall adjacent to loading dock

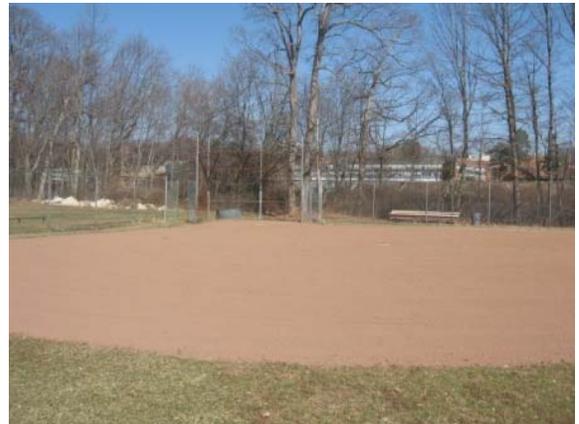
Photo #114: Ball field and chain link fence backstop at rear of school (northeast elevation)

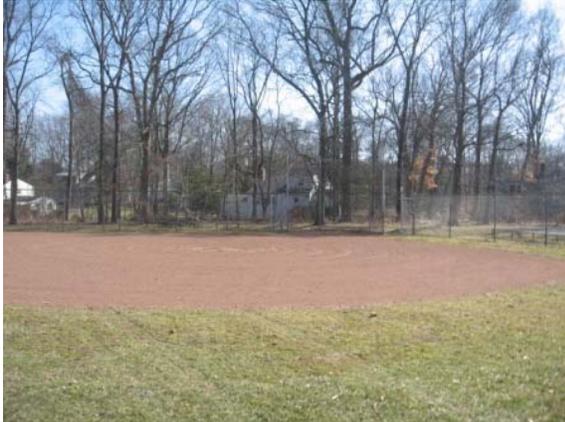
Photo #115: Ball field and chain link fence backstop at rear of school (southwest elevation)

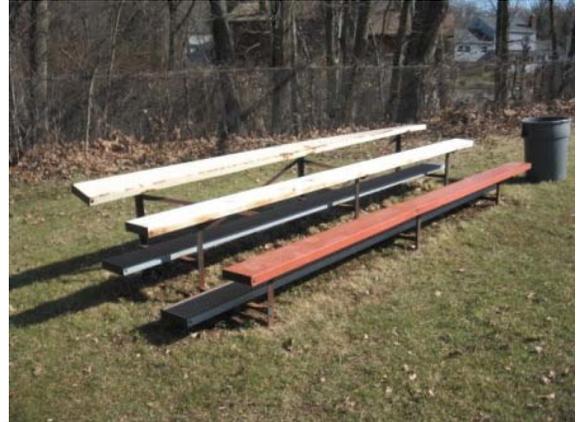
Photo #116: Bleachers at ball field

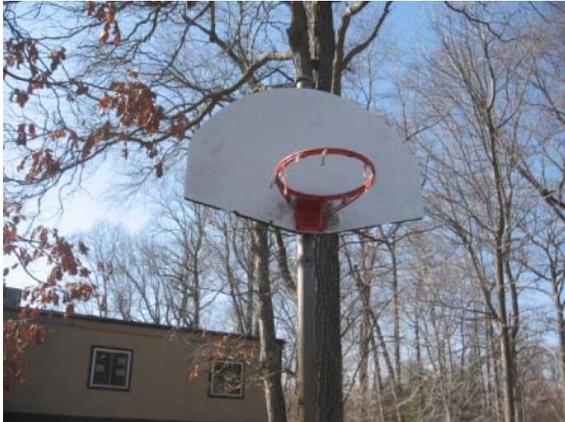
Photo #117: Basketball backstop

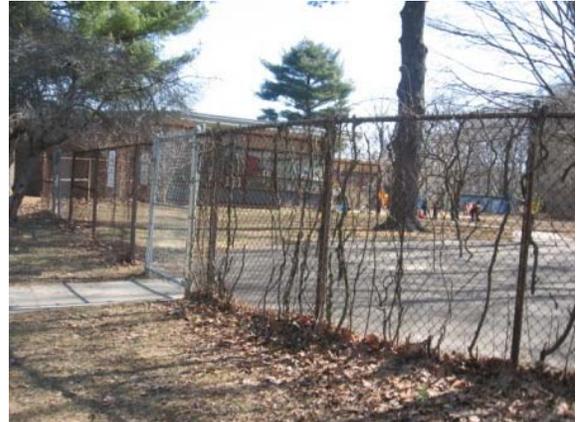
Photo #118: Chain link fencing at south side of building

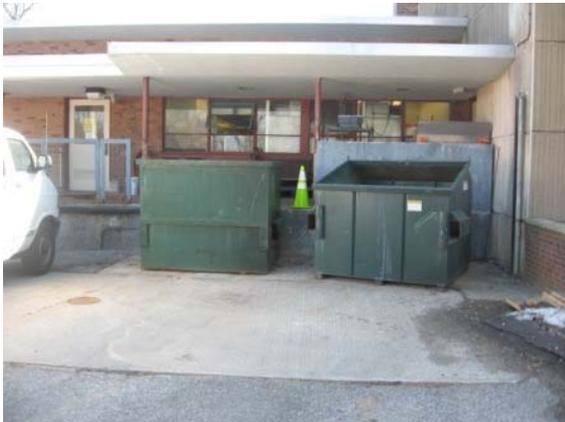
Photo #119: Dumpsters and below-grade UST adjacent to loading dock

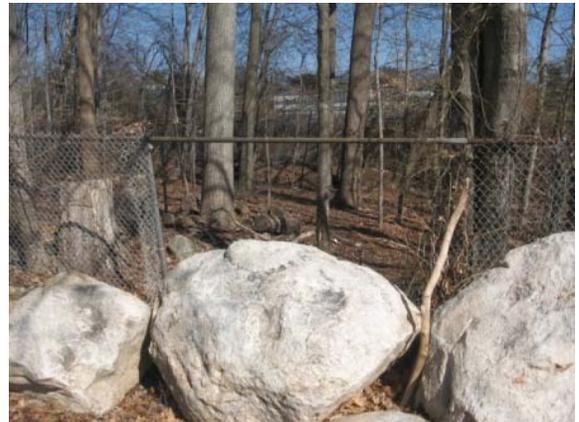
Photo #120: Opening in chain link fence at rear property line

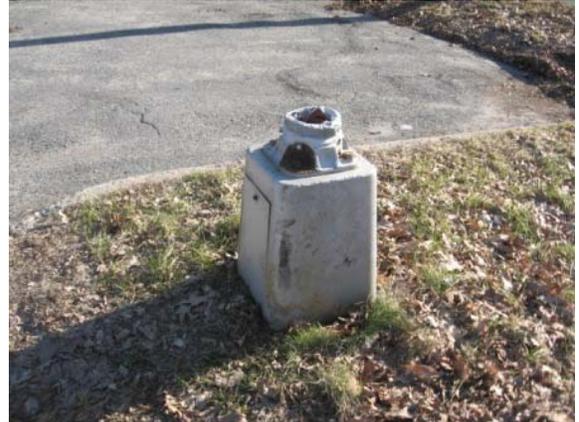
Photo #122: Abandoned pole light concrete base at main parking lot entrance

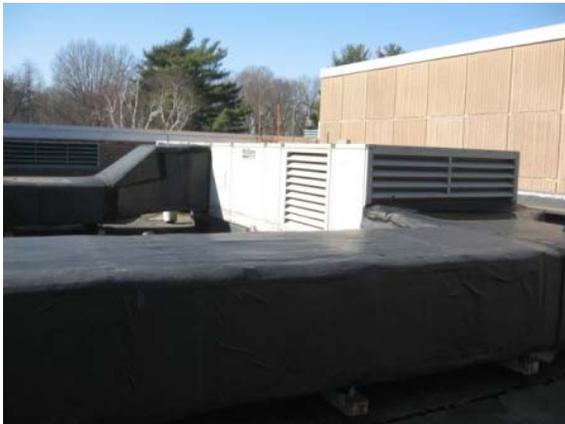
Photo #123: Rooftop package unit (RTU), for media center, with rubber covering HVAC ducting

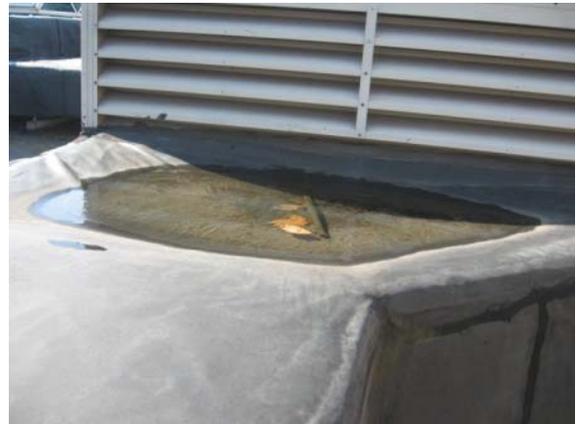
Photo #124: Ponding at HVAC rooftop ducting

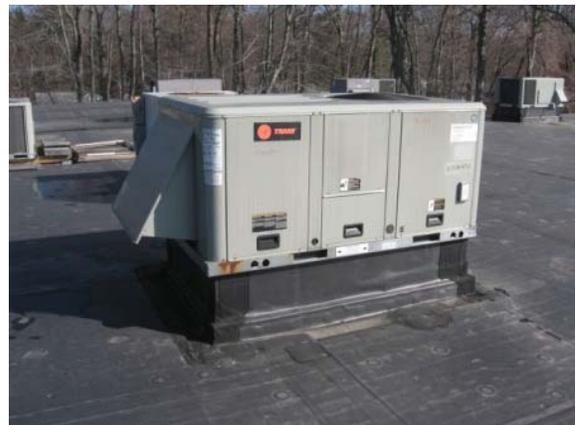
Photo #126: Rooftop package unit (RTU) for modular classrooms

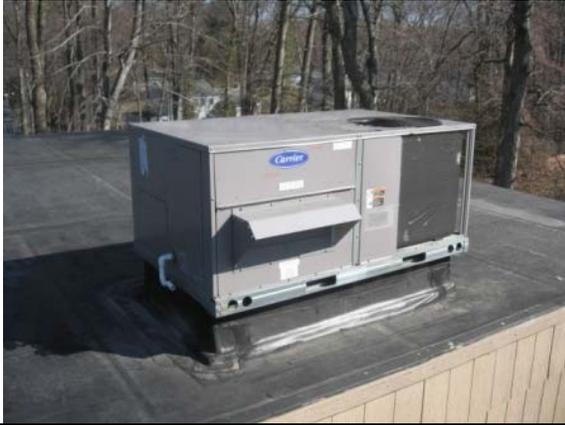
Photo #127: Rooftop package unit (RTU) for modular classrooms

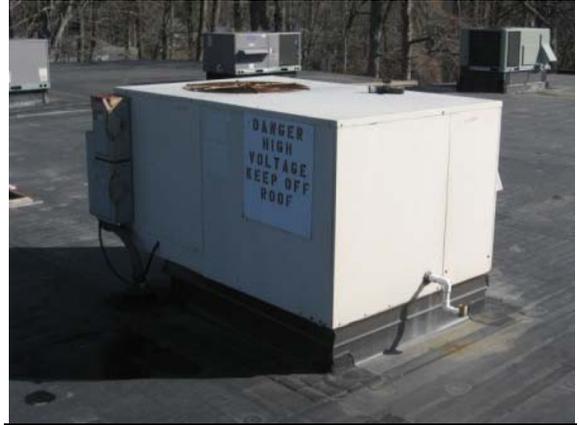
Photo #128: Older rooftop package unit (RTU) for modular classrooms

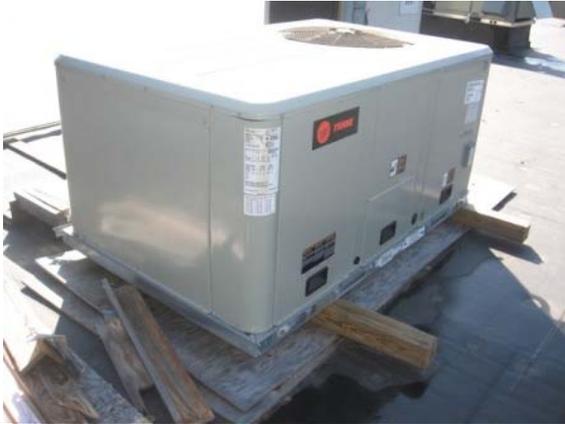
Photo #129: Replacement RTU for older rooftop package unit

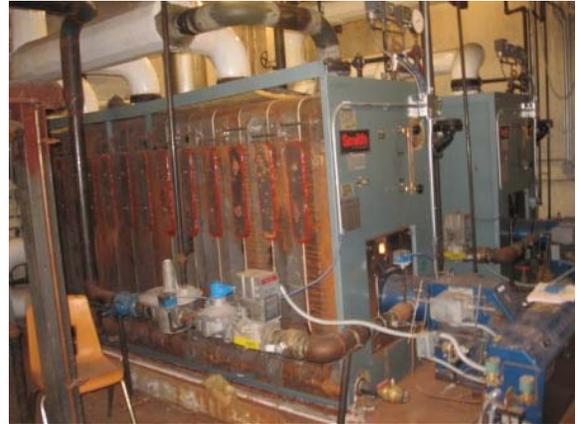
Photo #130: Heating boilers (one with side jackets off the boiler)

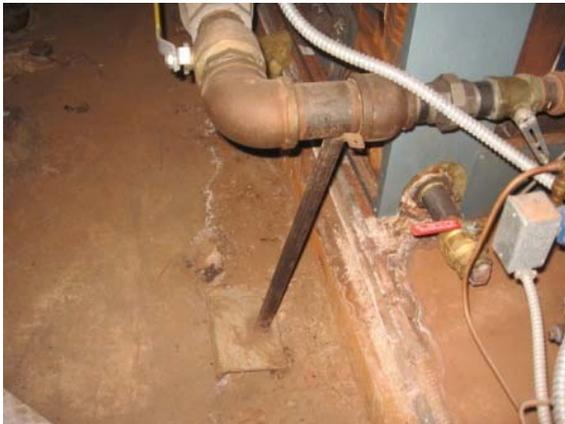
Photo #131: Leaning metal support post at gas piping to boiler

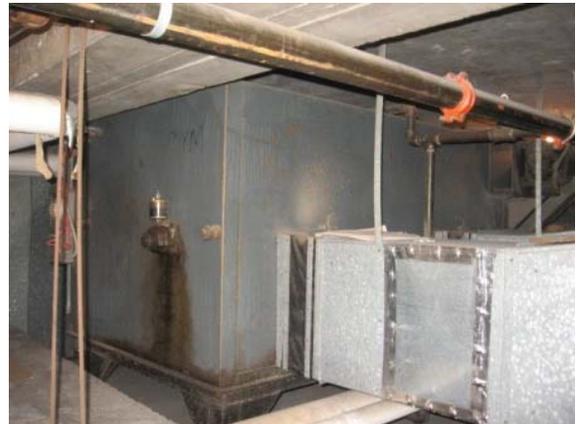
Photo #132: HV-2 High-capacity AHU for Gymnasium/Cafeteria

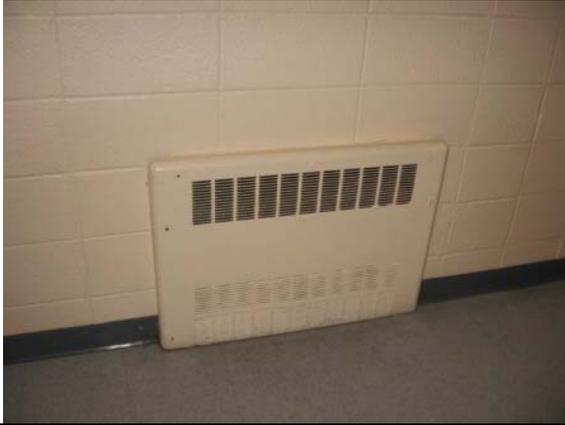
Photo #133: In-wall mounted radiant heat unit at corridor

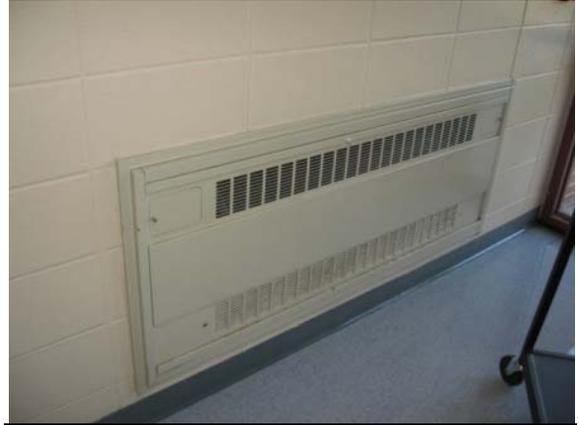
Photo #134: Replacement in-wall mounted radiant heat unit at end of corridor

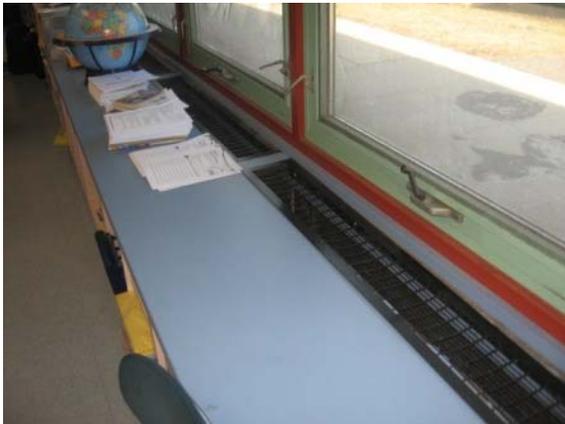
Photo #135: Perimeter radiant heat unit at classroom

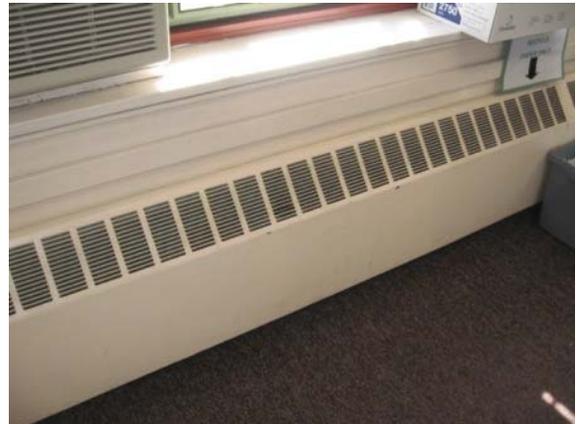
Photo #136: Perimeter baseboard radiant heat unit at office

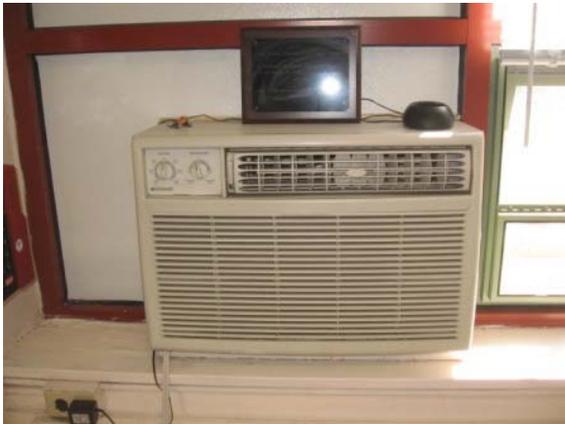
Photo #137: Through-window air conditioner

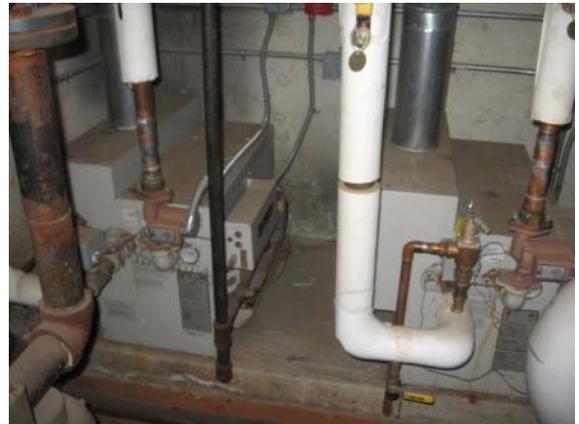
Photo #138: Domestic water boilers

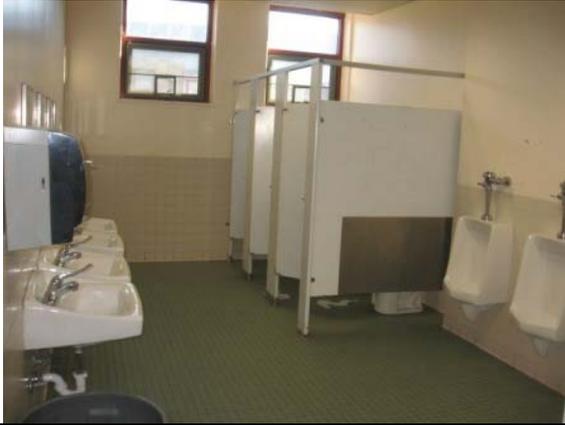
Photo #139: Overview of common area restroom

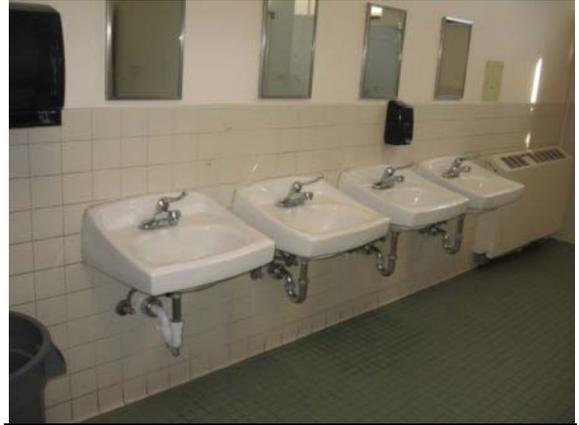
Photo #140: Common area restroom lavatory sinks

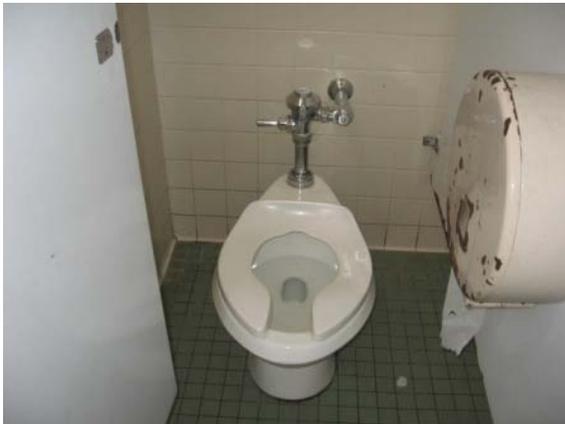
Photo #141: Floor-mounted toilet at common area restroom

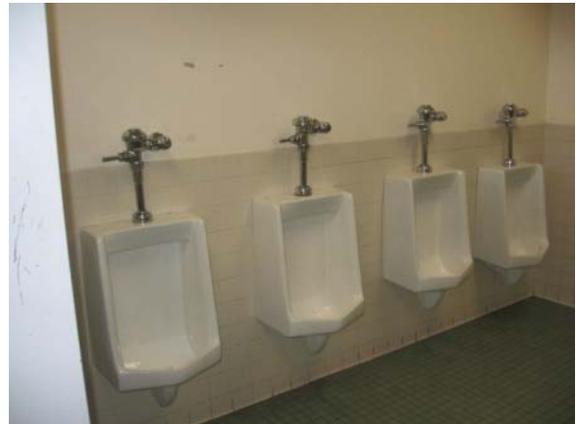
Photo #142: Boys common area restroom urinals

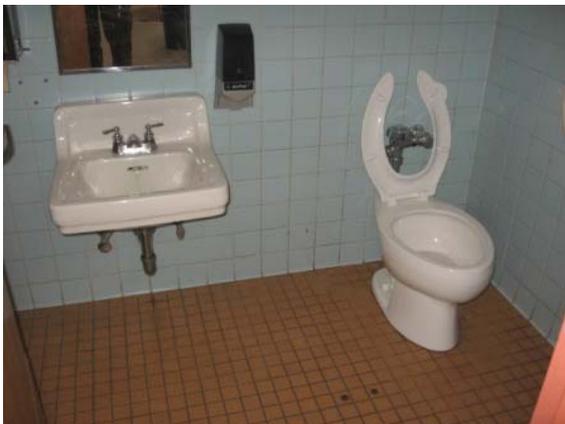
Photo #143: Restroom at classroom on "A" Wing

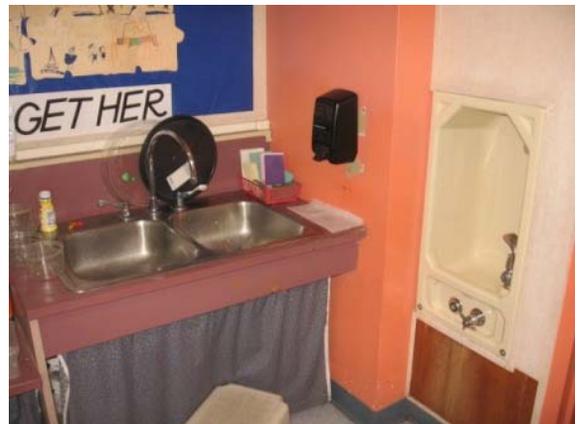
Photo #144: Classroom sink and drinking fountain on "A" Wing

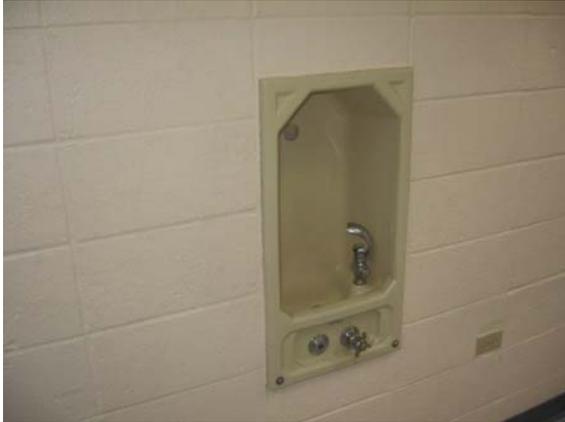
Photo #145: Common area drinking fountain

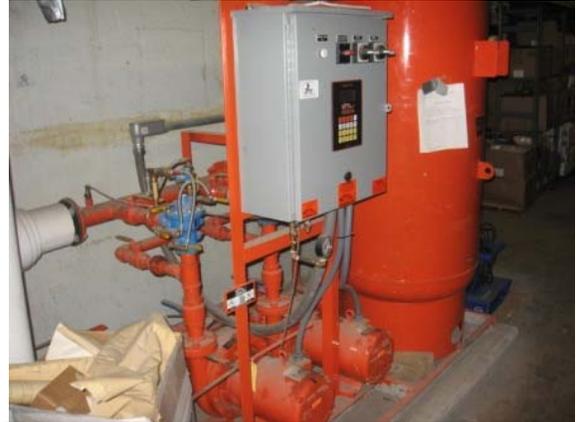
Photo #146: Unused domestic water booster system

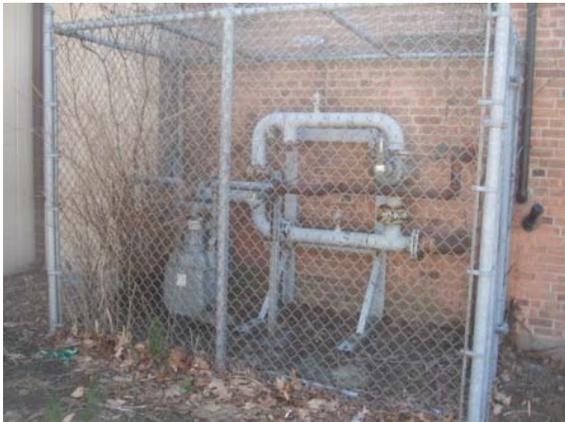
Photo #147: Enclosed gas metering

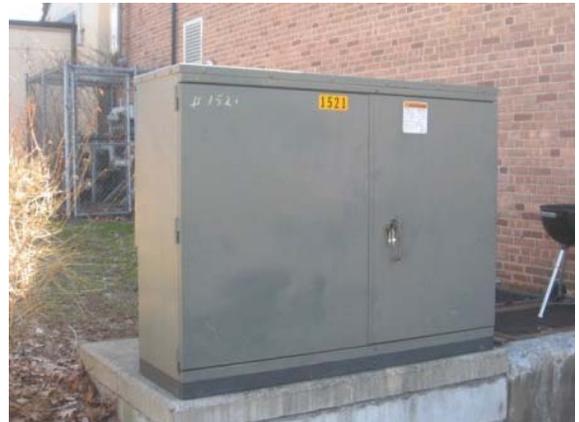
Photo #148: Pad-mounted transformer

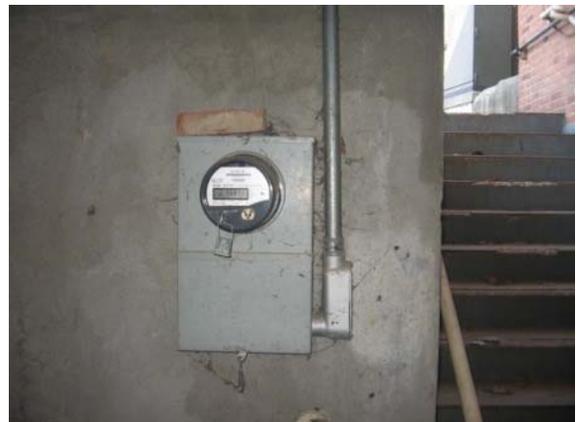
Photo #149: Main electrical switchgear in basement of building

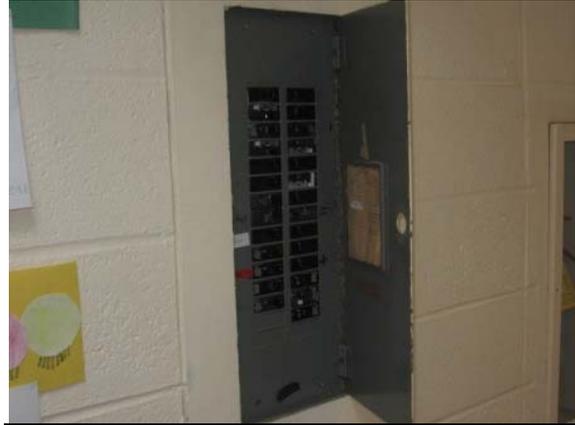
Photo #151: Original and worn circuit break panels at stage

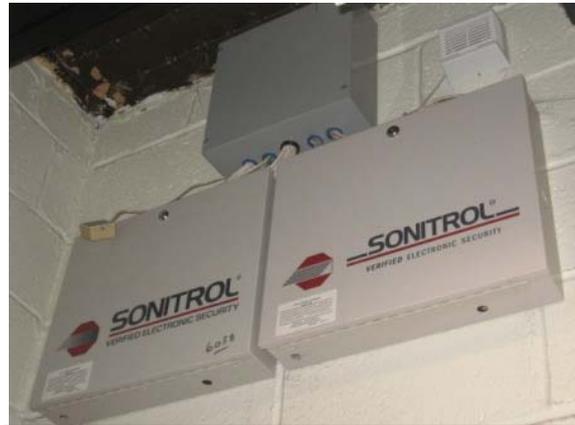
Photo #153: School PA system equipment at office
