# FACILITIES NEEDS ASSESSMENT

## FACILITIES NEEDS ASSESSMENT OF NEWFIELD ELEMENTARY SCHOOL

345 Pepper Ridge Road  
Stamford, Connecticut 06905

**EMG Project #:** 88166.09R-012.017  
**Date of Report:** August 29, 2009  
**On site Date:** March 17, 2009

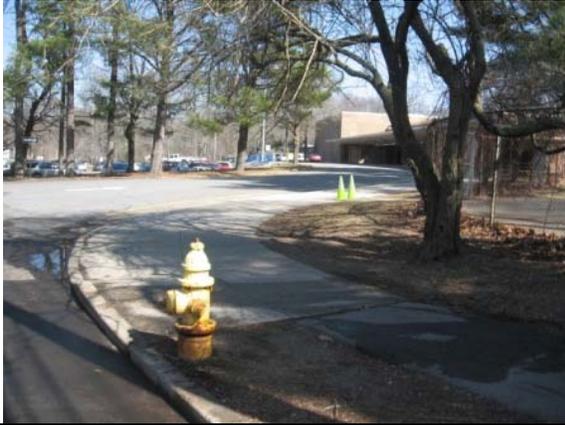
Photo #157: Fire hydrant along Pepper Ridge Road

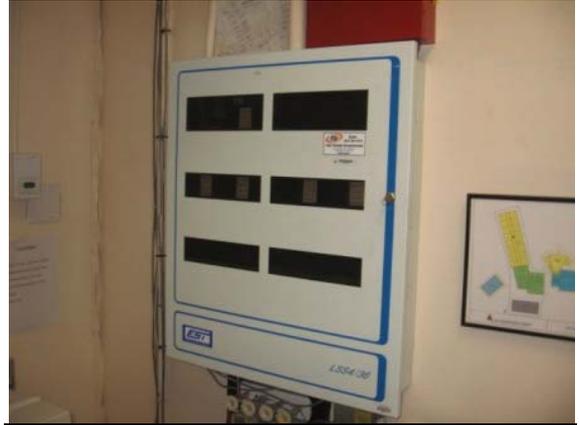
Photo #158: Central fire alarm panel at office

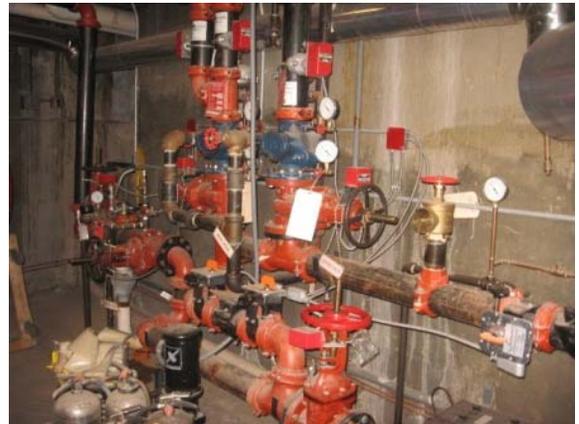
Photo #160: Main fire suppression system at basement

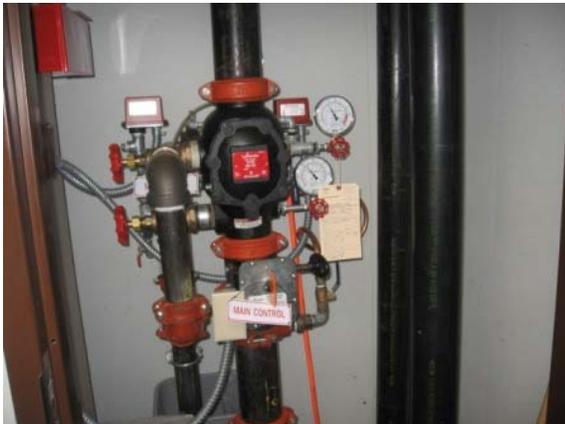
Photo #161: Dry-pipe riser at modular building

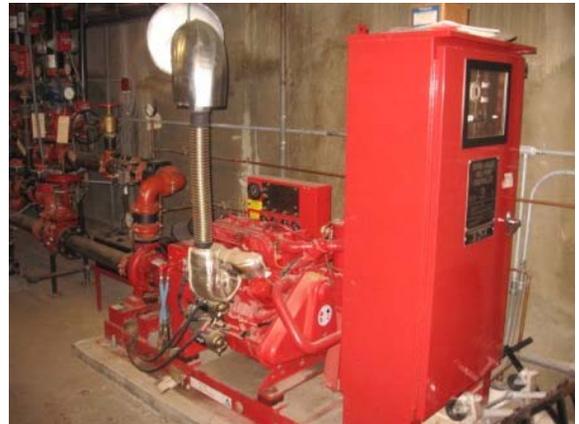
Photo #162: Fire suppression fire pump and controller at basement

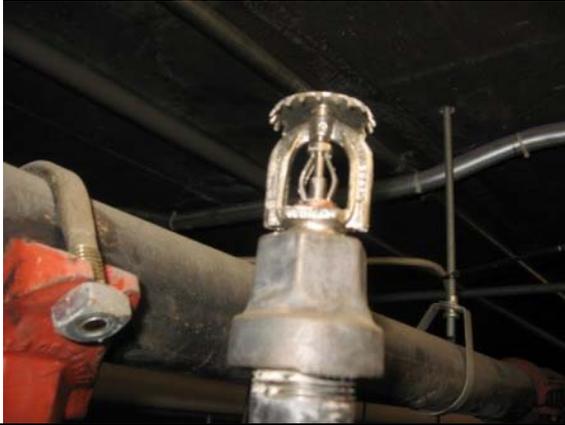
Photo #163: Central sprinkler head installed in fire suppression system at basement

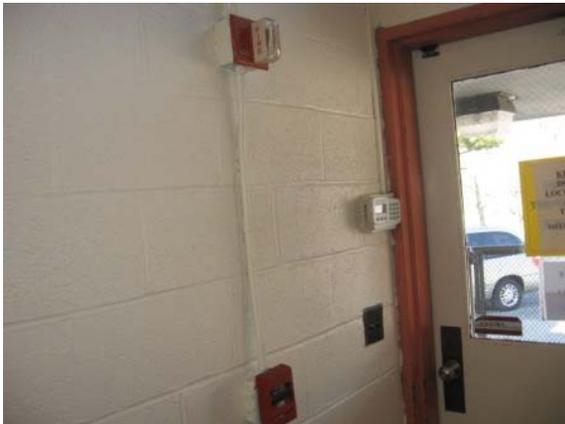
Photo #165: Fire pull station, strobe alarm and building security code pad

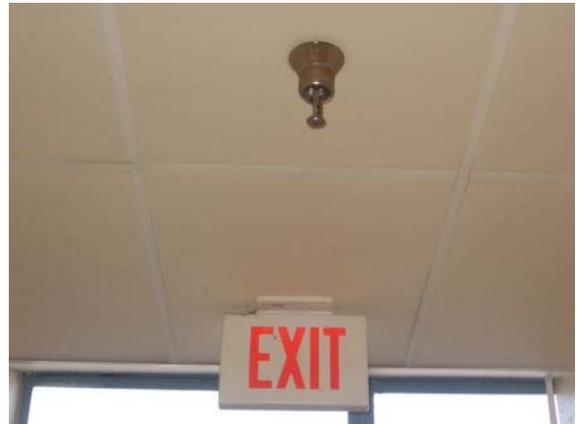
Photo #166: Illuminated exit sign and fire sprinkler head

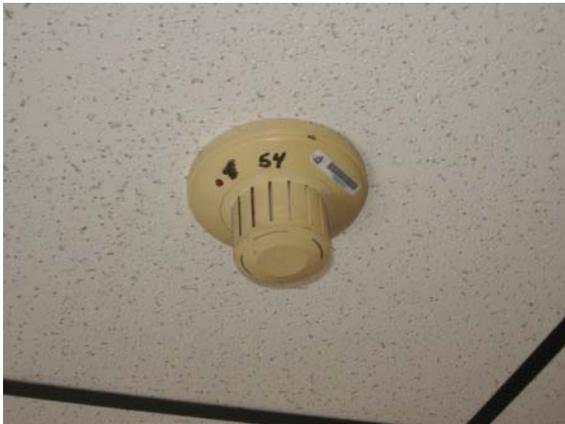
Photo #167: Smoke detector at common area

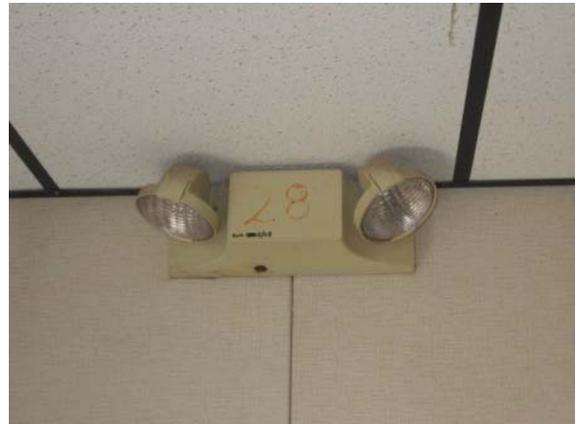
Photo #168: Emergency backup lights at common area

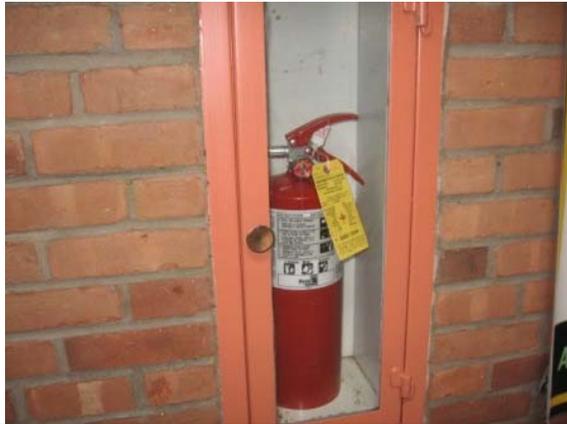
Photo #169: Cabinet-mounted fire extinguisher in common area

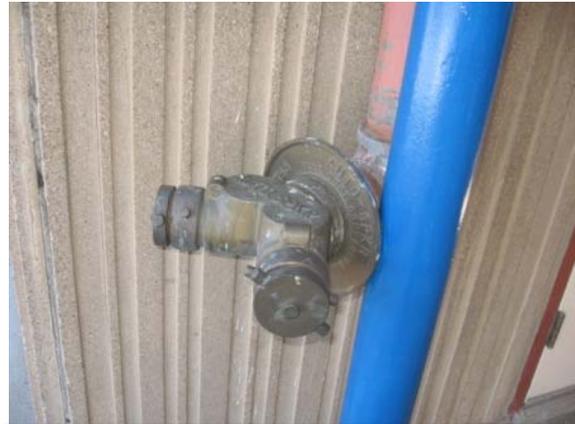
Photo #170: Siamese hose connector at front of building

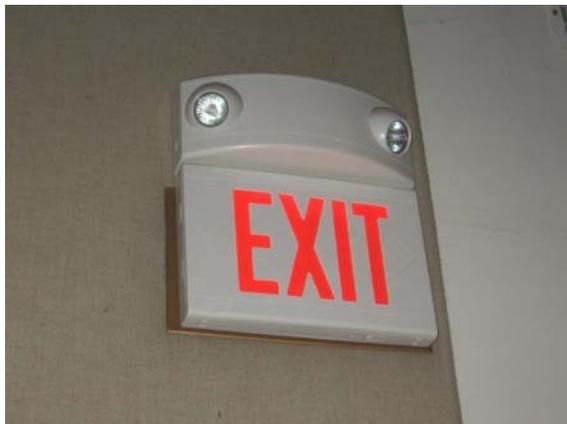
Photo #171: Combination emergency lights/illuminated exit sign

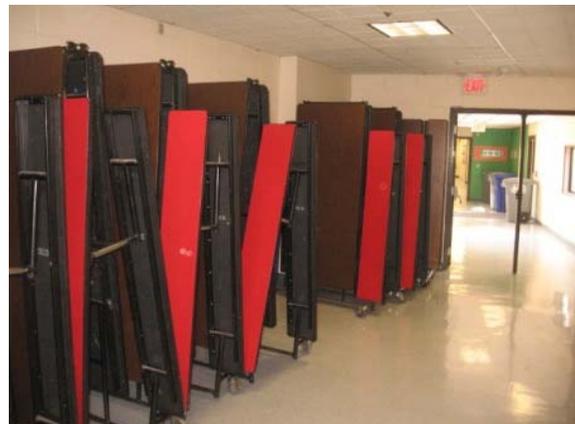
Photo #172: Storage of folding tables in corridor adjacent to Gym/Cafeteria

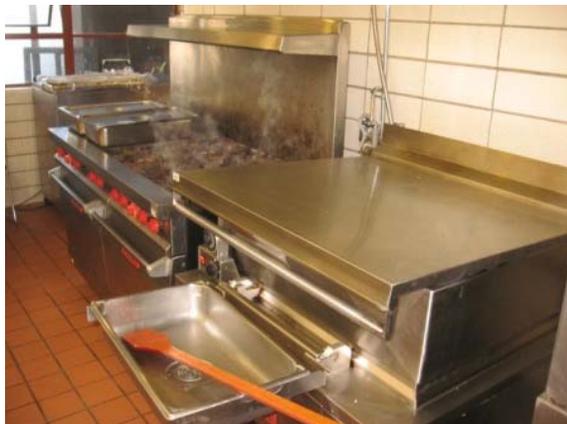
Photo #173: Kitchen gas range

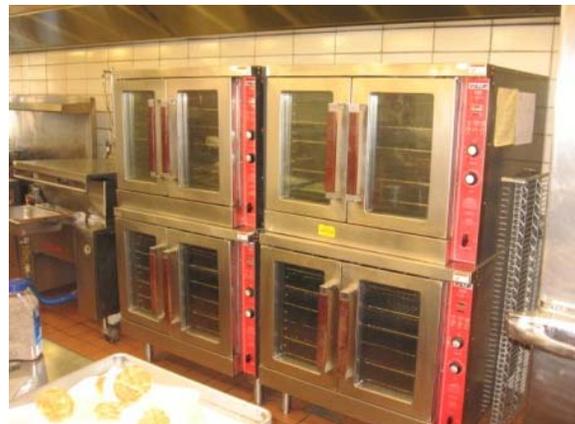
Photo #174: Convection ovens in kitchen

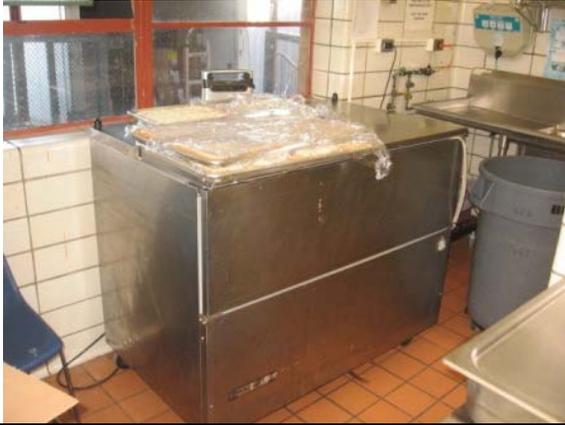
Photo #175: Chest cooler in kitchen

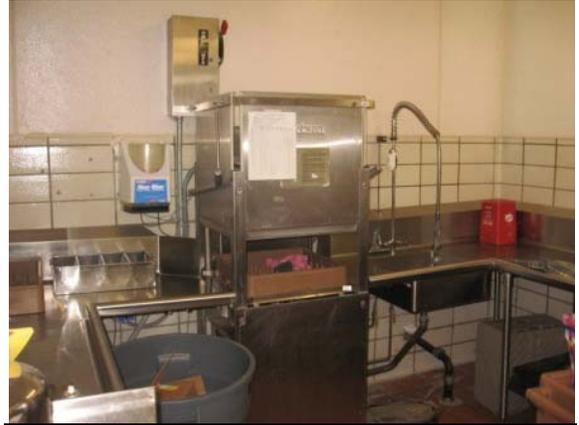
Photo #176: Kitchen dishwasher

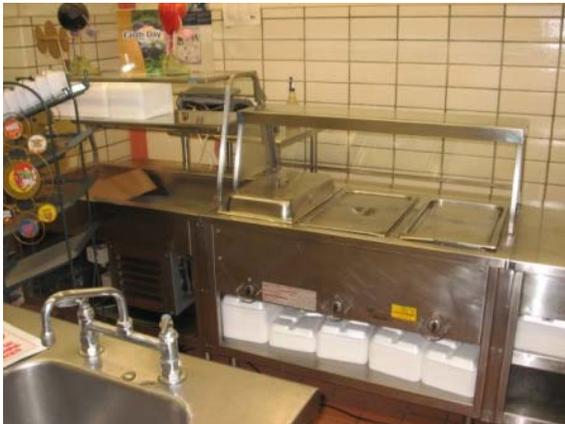
Photo #177: Steam table in kitchen

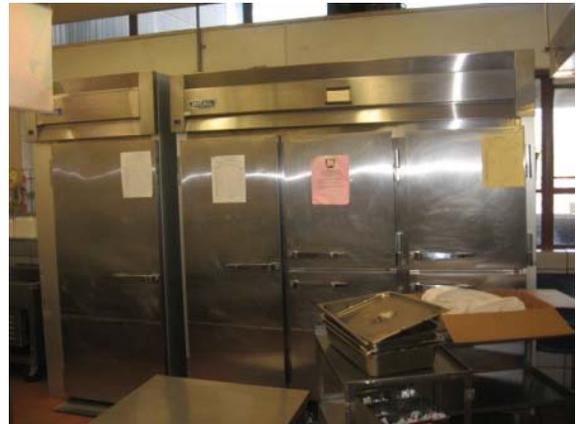
Photo #178: Refrigeration units in kitchen

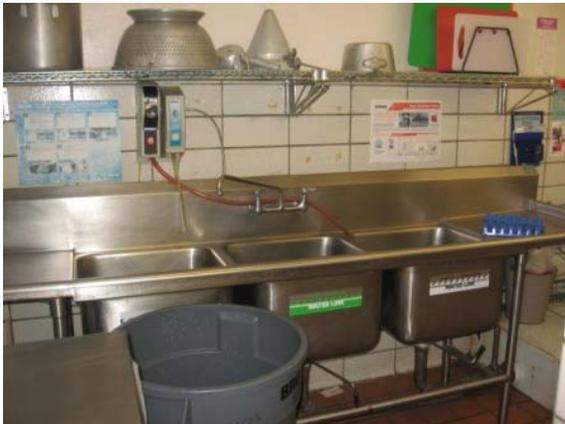
Photo #179: Three-compartment sink in kitchen

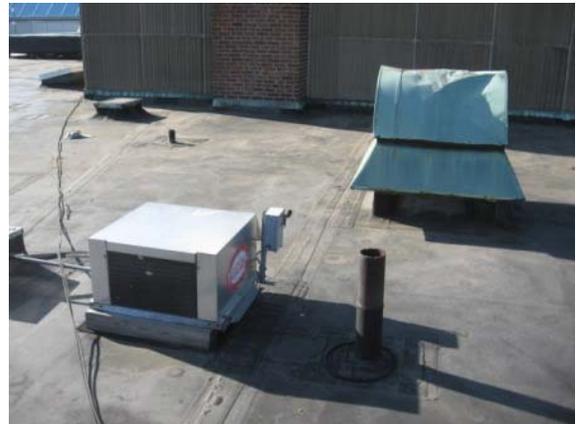
Photo #180: Rooftop refrigeration unit and exhaust hood
