FACILITIES NEEDS ASSESSMENT

STILLMEADOW ELEMENTARY SCHOOL

EMG

Date of Report: August 27, 2009

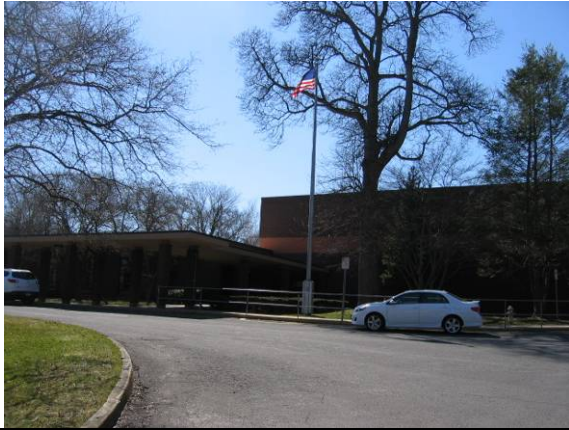
Photo #1: View of the front façade and continuous carport.

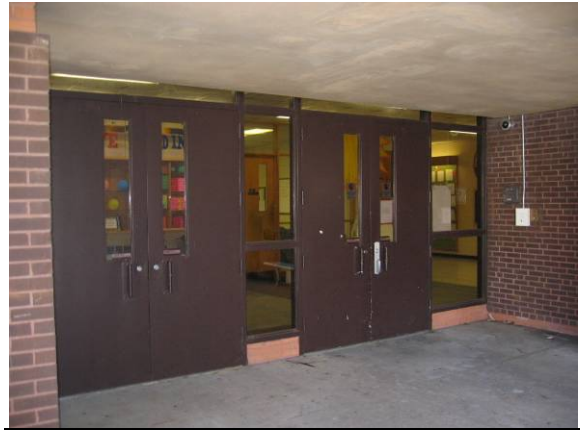
Photo #2: Detail view of the main office entrance doors.

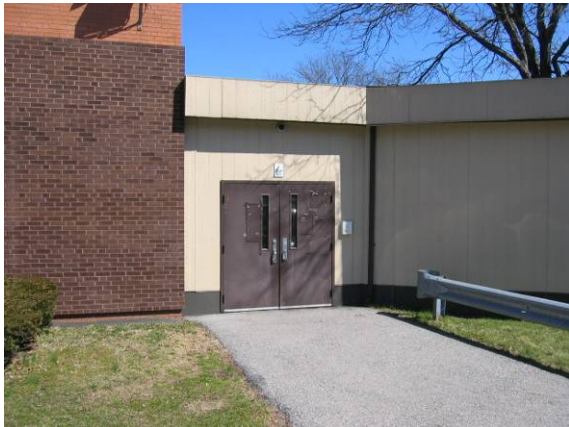
Photo #3: Typical exterior entrance doors. Most doors have rusting and require replacement.

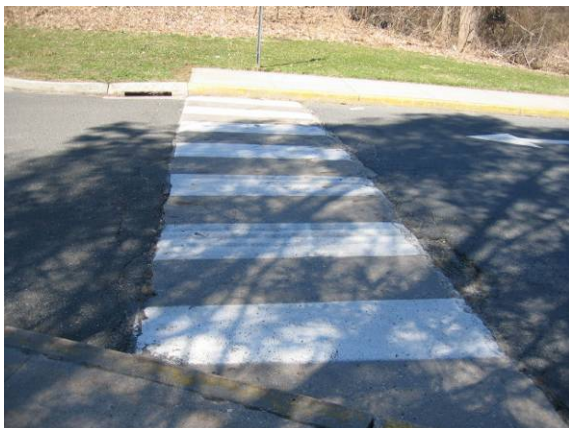
Photo #5: Two ADA dropped curbs are required at the north sidewalk crosswalk.

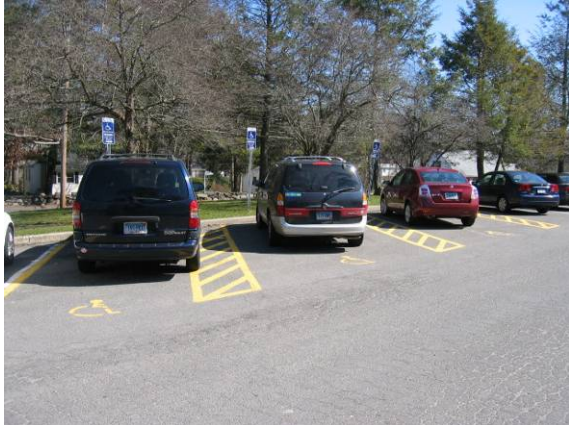
Photo #7: Eight ADA parking stalls are provided on-site. Four have posted signs.

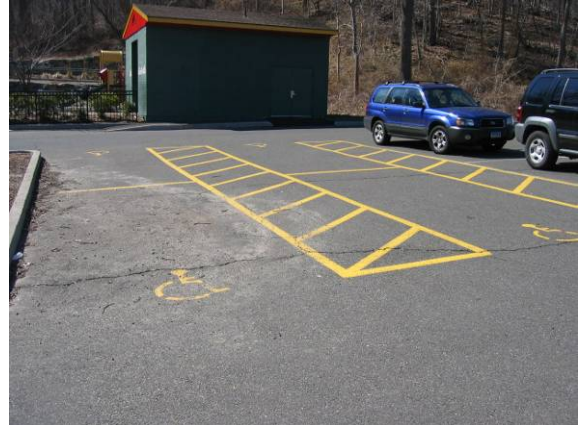
Photo #8: Four ADA parking stalls within the rear parking lot have no posted signs.

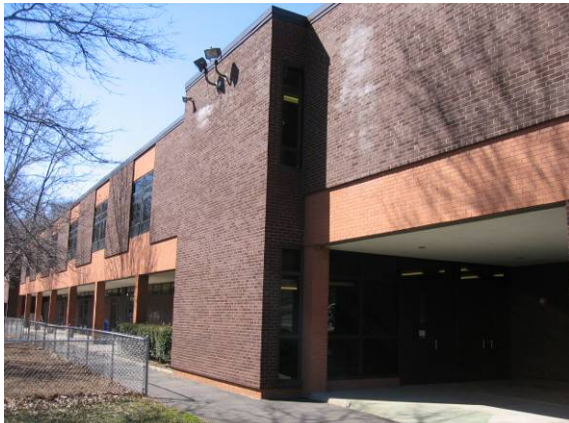
Photo #9: View of the south elevation.

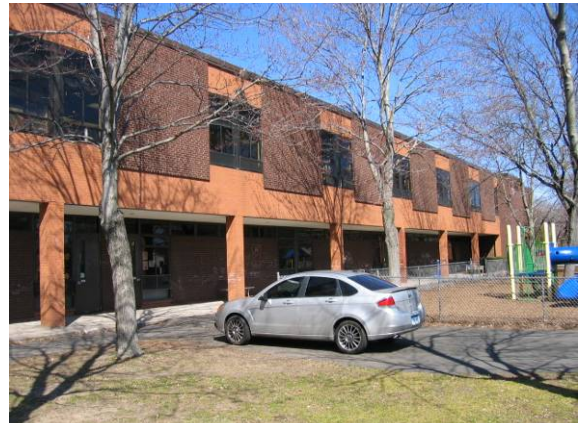
Photo #10: Second view of the south sidewall.

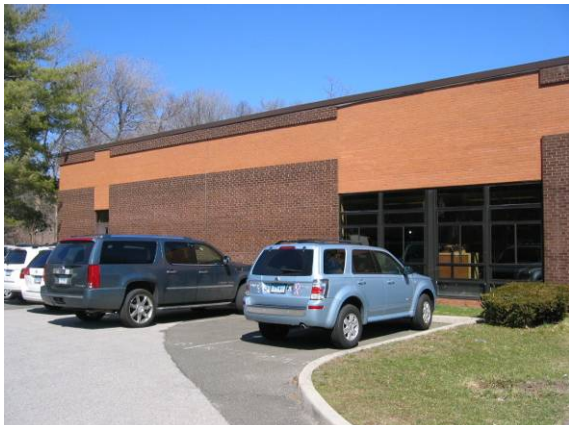
Photo #11: View of the rear façade.

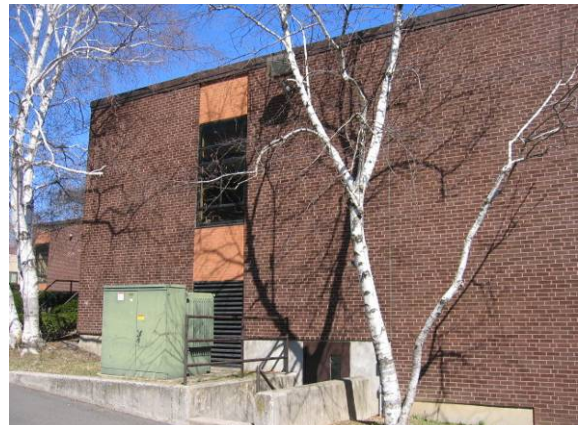
Photo #12: Second view of the rear façade near the gymnasium.

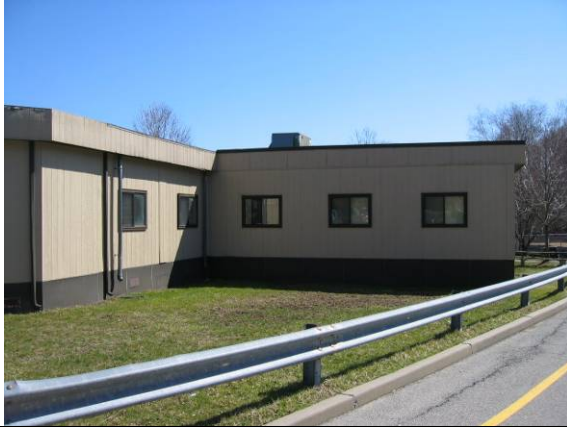
Photo #13: View of the two modular classrooms.

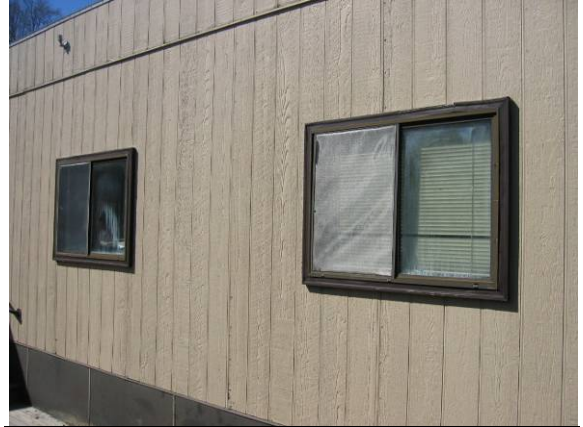
Photo #14: All of the modular classroom windows have failed (fogging).

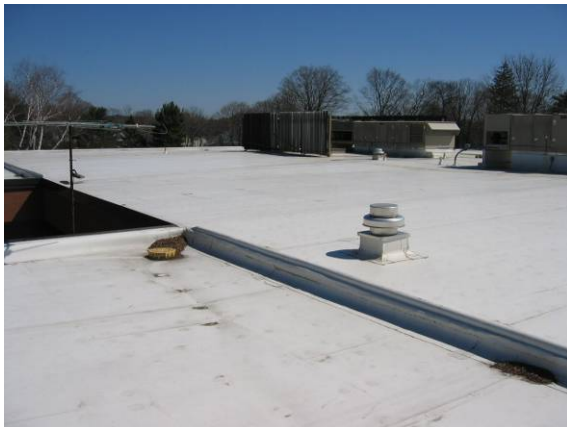
Photo #17: Overview of the main flat, fully adhered EPDM roof system.

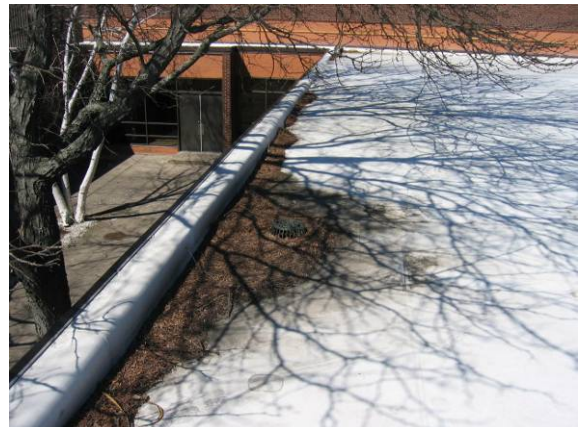
Photo #18: Isolated areas of roof debris and fallen organic matter require maintenance.

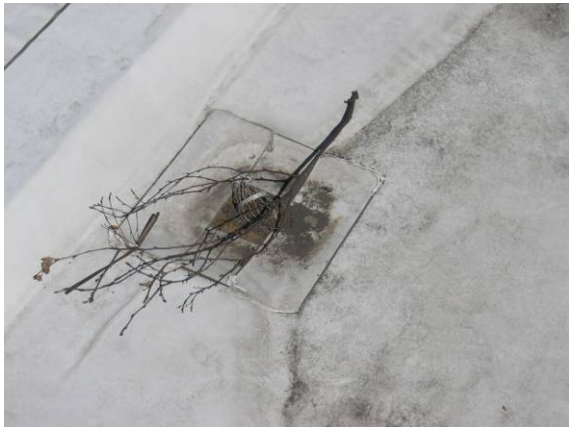
Photo #21: Several of the flat roof drain strainers were missing or damaged.

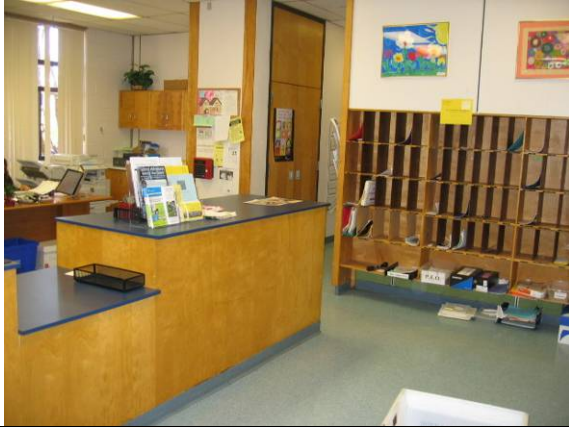
Photo #25: View of the main office interior. Note faculty mail slots are on public side of front desk.

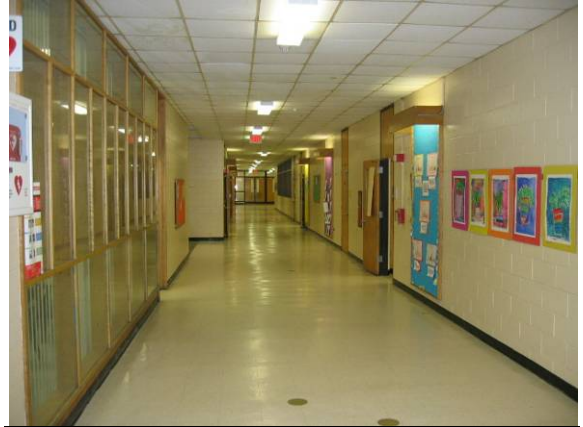
Photo #26: View of a typical common corridor interior. Finishes are VCT floor tiles, painted CMU walls and ATC ceilings.

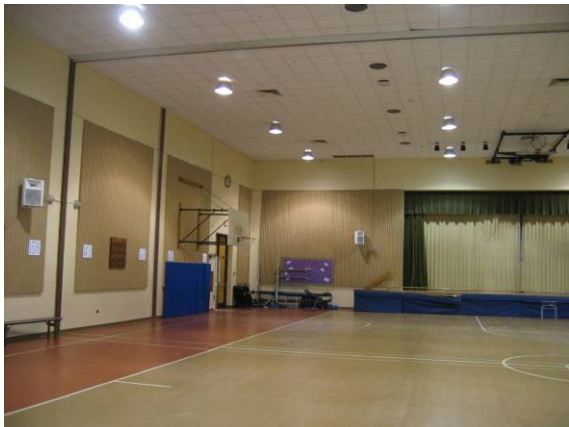
Photo #27: View of the combined gymnasium and auditorium interior.

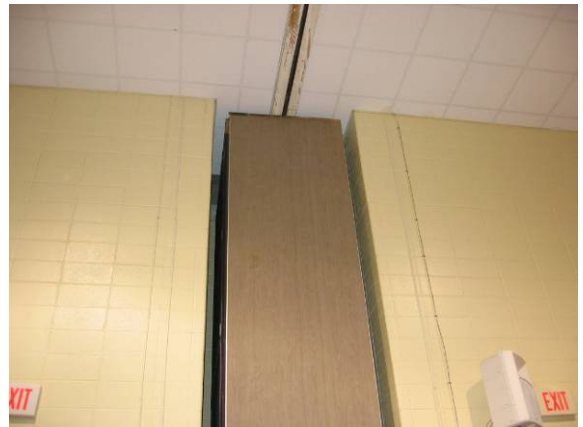
Photo #28: The gymnasium is equipped with a powered "air wall" to divide the space.

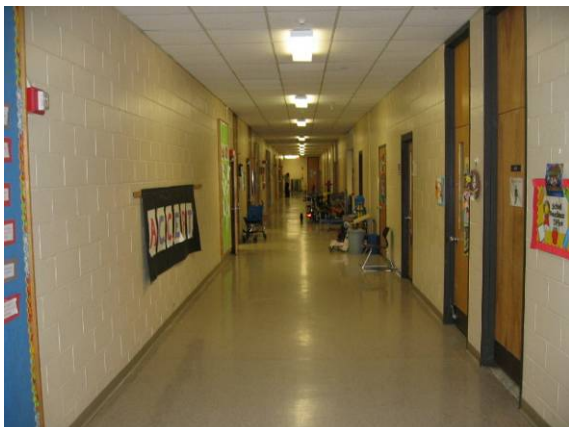
Photo #29: Second view of a common corridor.

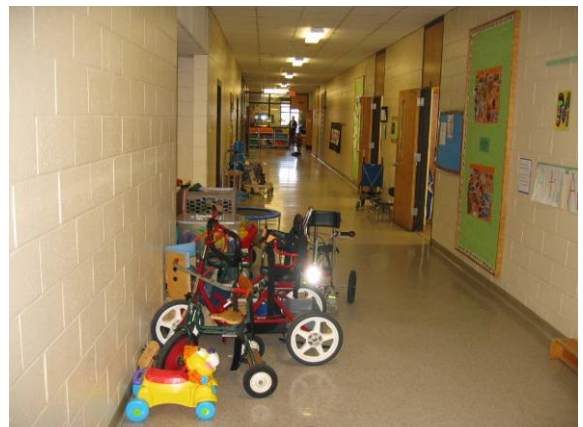
Photo #30: Some special education equipment is stored in the hallways.

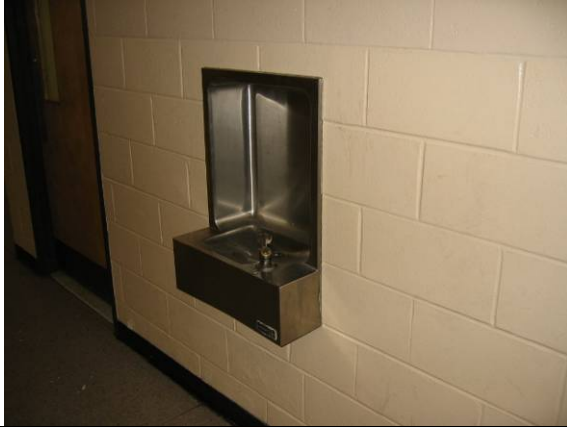
Photo #31: All of the water fountains project 4 inches into the corridors and gym.

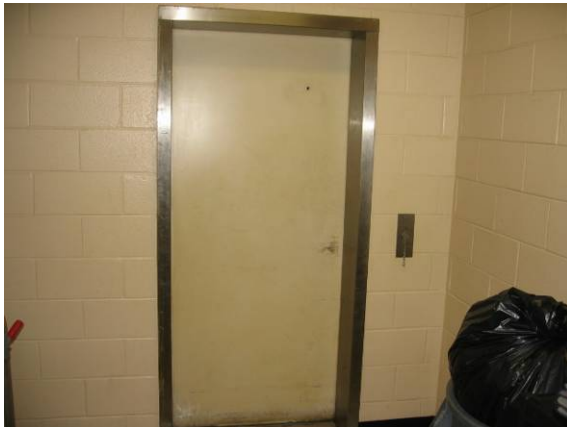
Photo #33: The school is equipped with a single hydraulic passenger elevator.

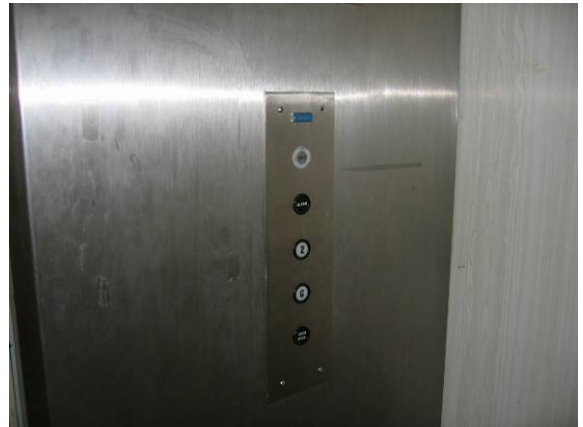
Photo #34: Numerous ADA modifications are required at the elevator cab.

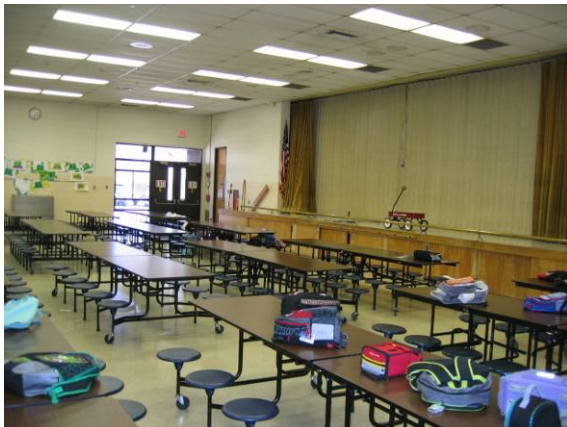
Photo #35: View of the cafeteria interior and rear of shared stage.

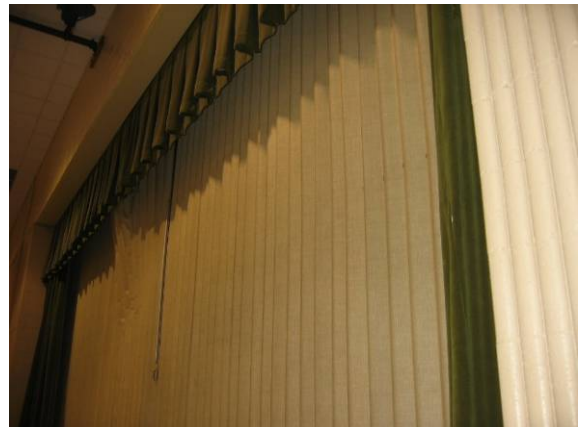
Photo #36: Poor conditions were noted at the stage curtains.

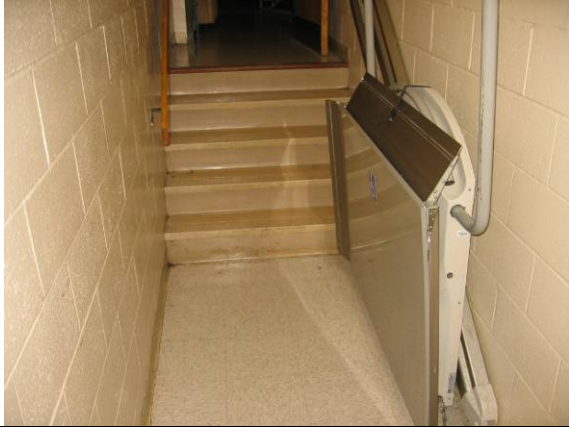
Photo #37: The stage is handicapped accessible via a wheelchair stair lift.

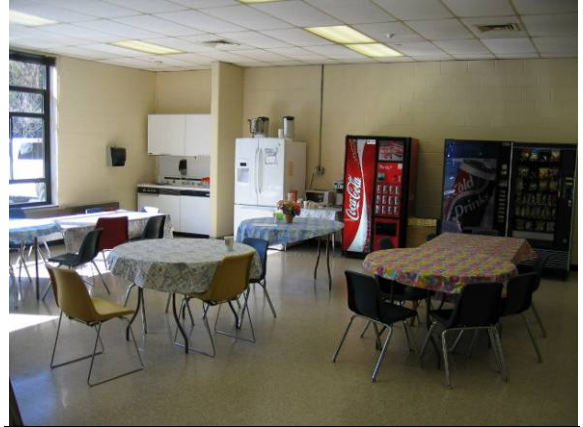
Photo #38: View of the faculty dining room.

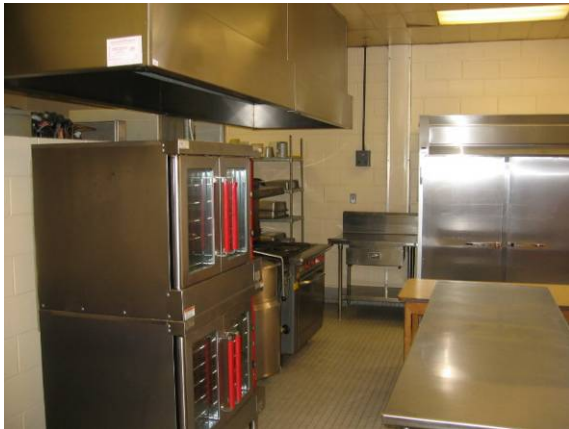
Photo #39: View of the central cafeteria kitchen.

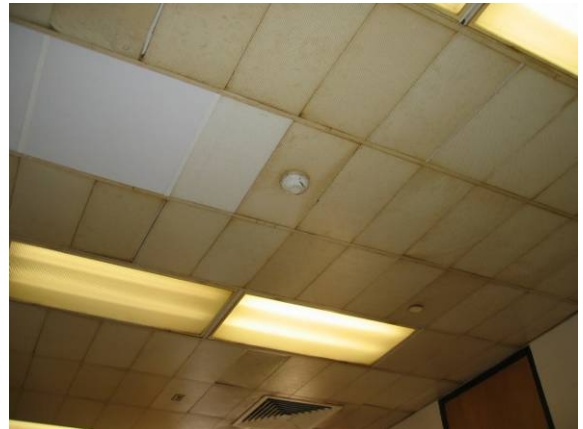
Photo #40: Poor conditions were noted at the kitchen ceilings.

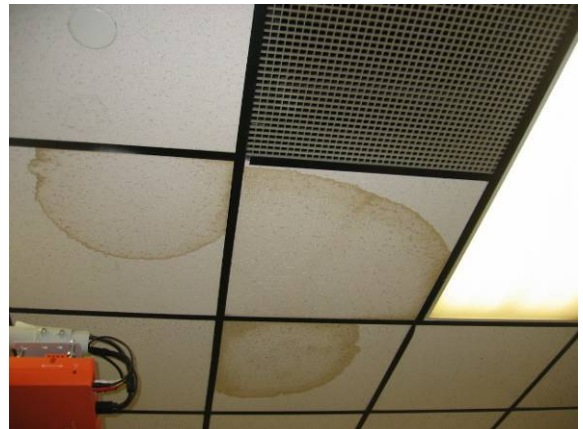
Photo #42: Isolated stained suspended ceiling tiles were observed.

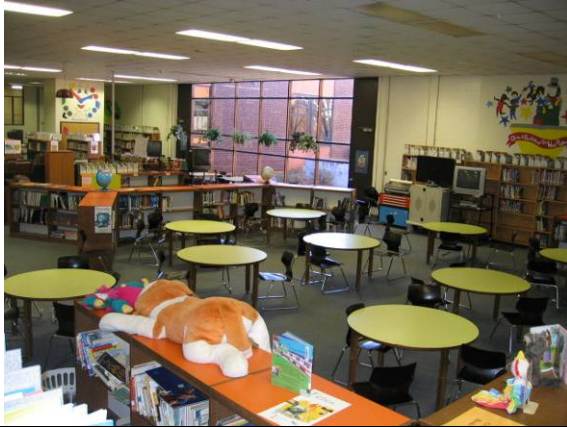
Photo #43: View of the media center. The windows are single paned.

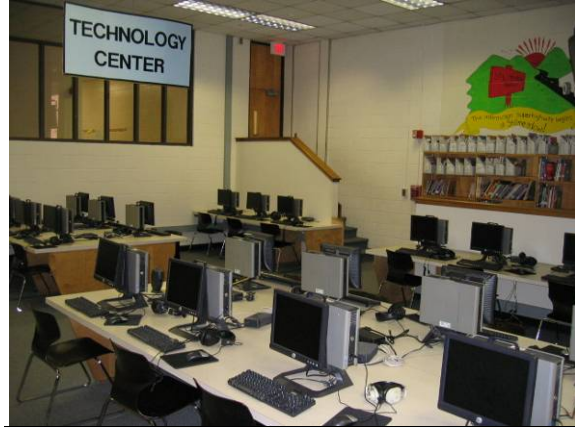
Photo #44: View of the computer lab portion of the media center.

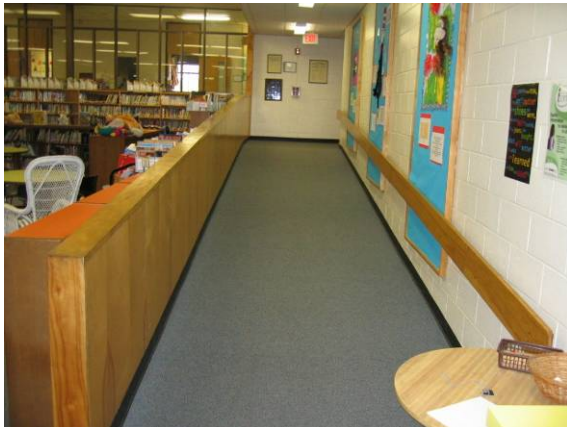
Photo #45: The ramp down from the corridor to the media center is equipped with only one handrail.

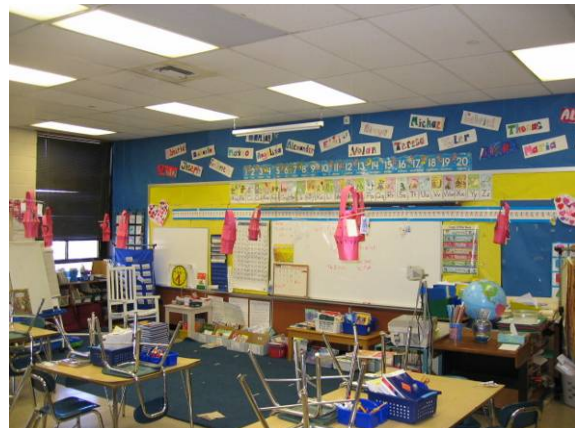
Photo #48: View of a typical classroom interior.

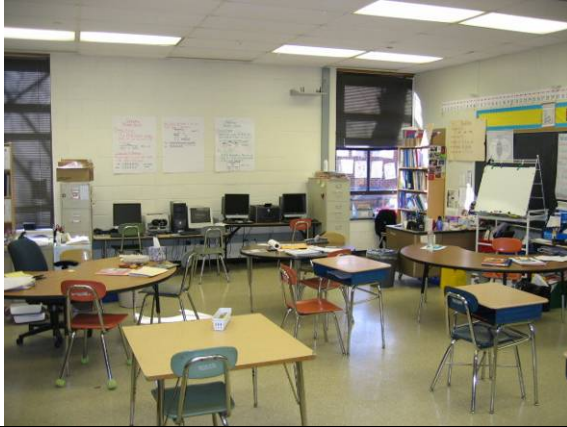
Photo #49: View of a typical classroom interior.

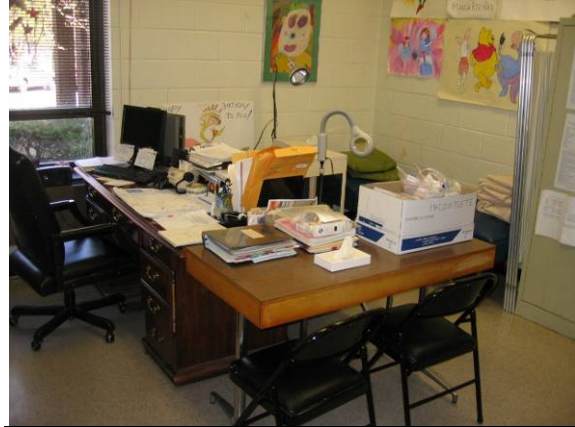
Photo #50: View of a typical faculty office interior.

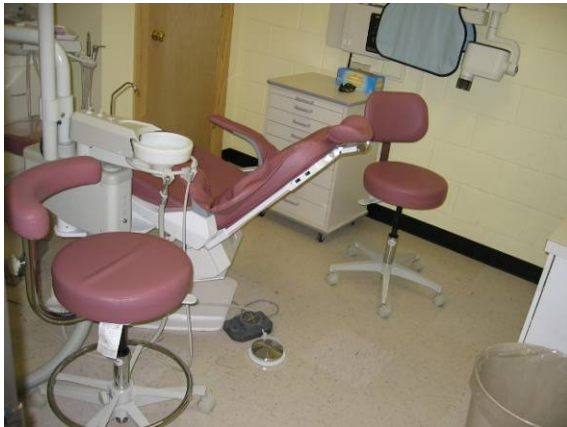
Photo #51: View of the nurse's office and dental room.

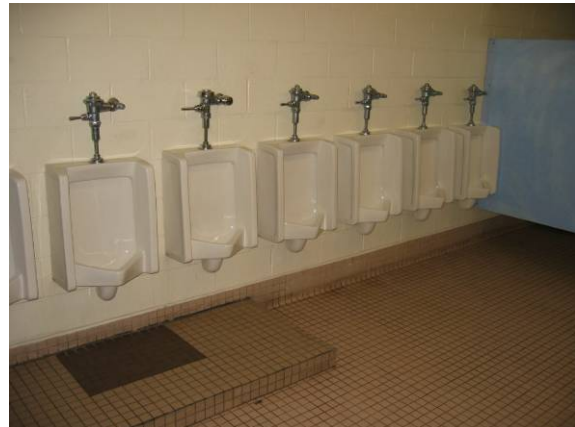
Photo #52: A pair of boy's / girl's multi-user toilet rooms is provided on each floor.

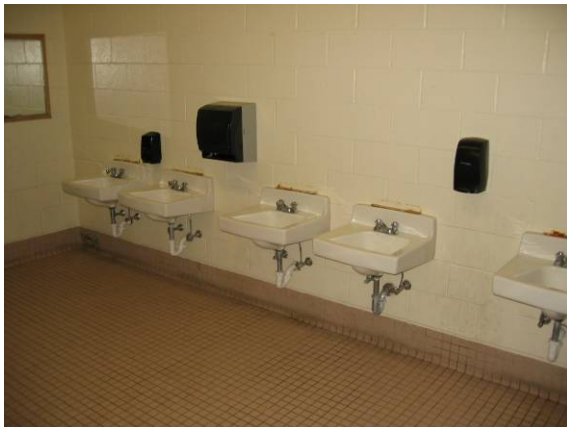
Photo #53: Major modifications are required at each common toilet room to achieve ADA accessibility.

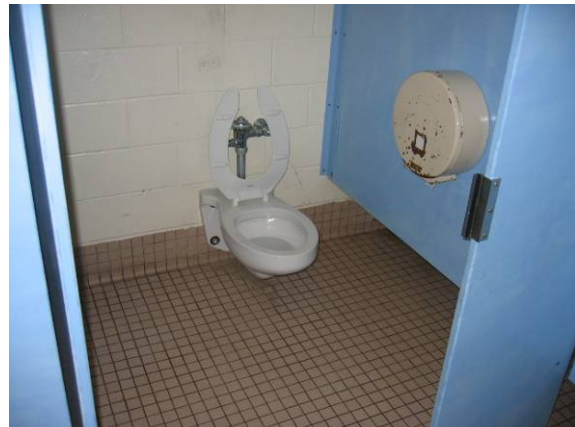
Photo #54: Grab bars are required at the larger stalls.

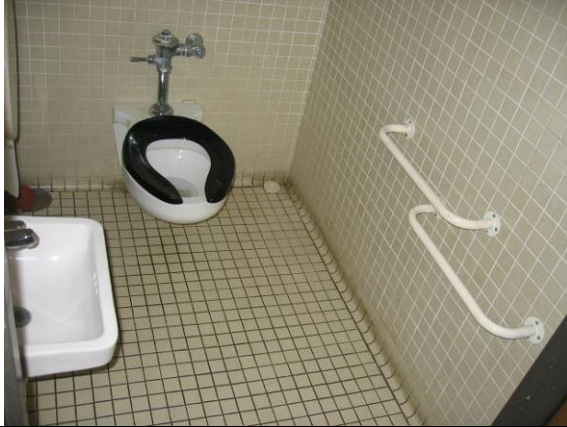
Photo #55: The only grab bars are provided within a single user toilet room in the nurse's office.

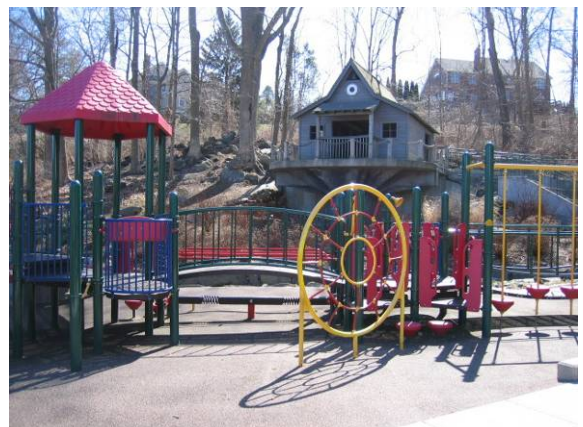
Photo #60: Full handicapped accessibility was noted at the rear playground.

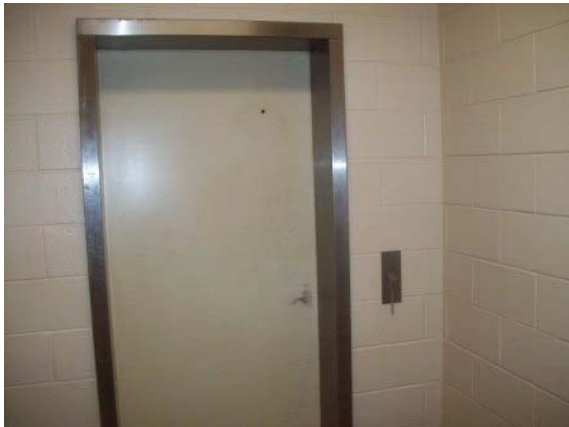
Photo #93: Elevator cab door

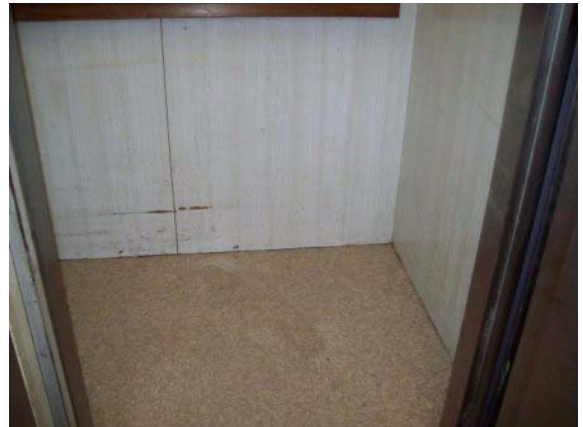
Photo #94: Interior of elevator cab

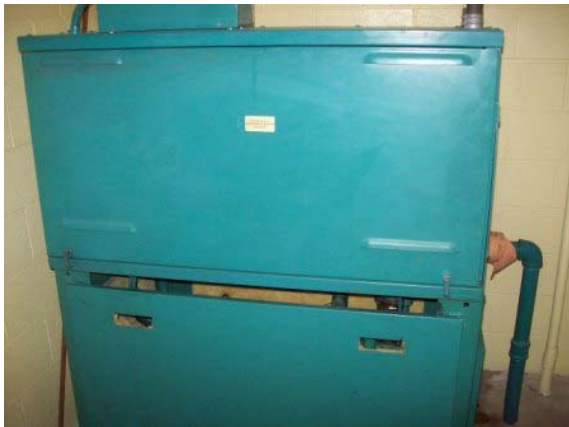
Photo #95: Hydraulic elevator equipment

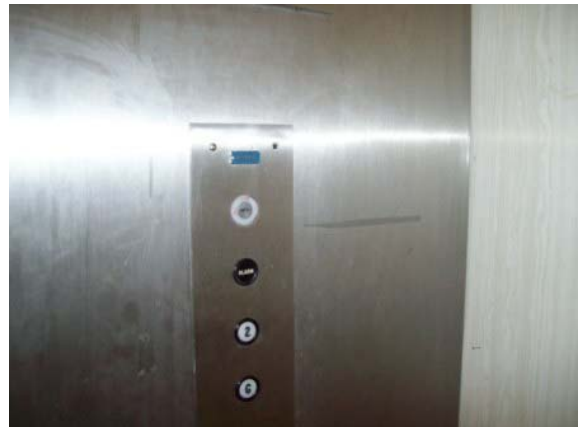
Photo #96: Elevator control panel

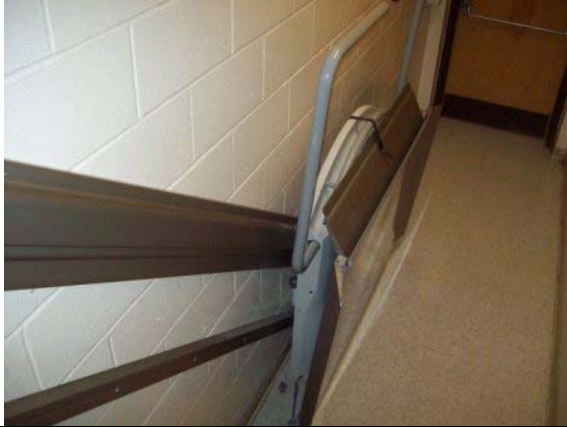
Photo #97: Wheelchair lift at stage

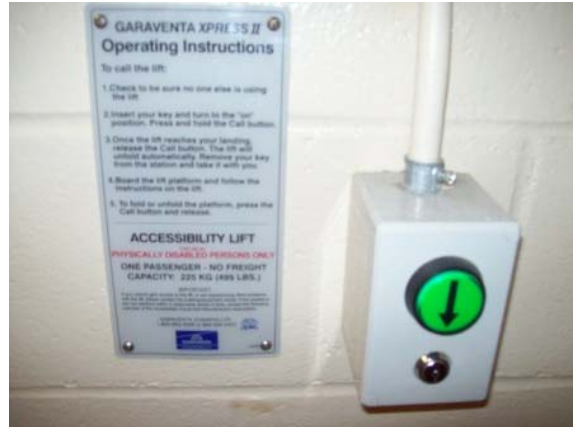
Photo #98: Lift controls

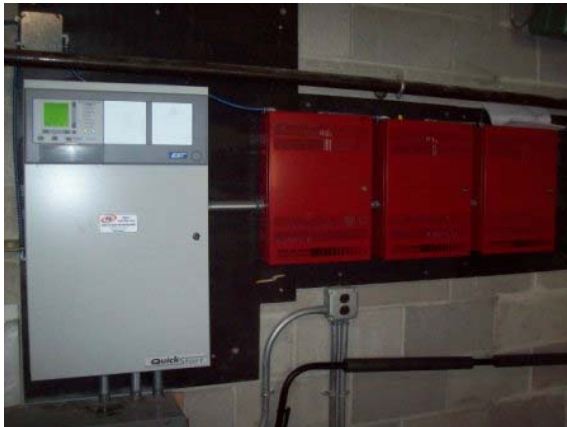
Photo #99: Fire alarm panel

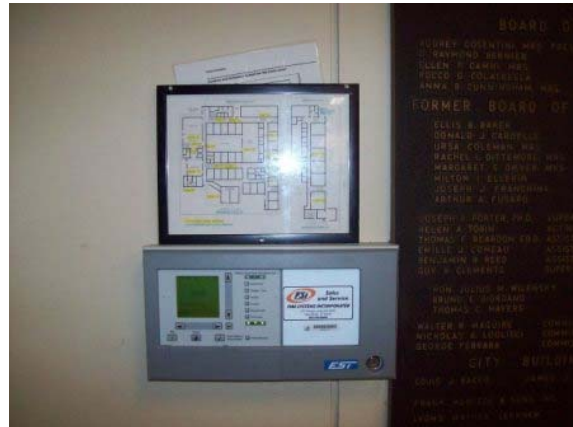
Photo #100: Fire alarm annunciator panel

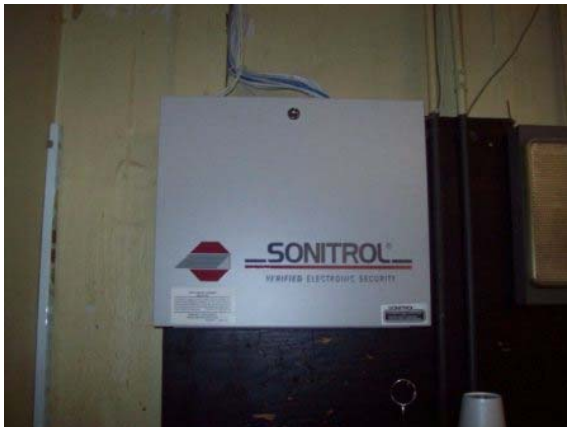
Photo #101: Security panel

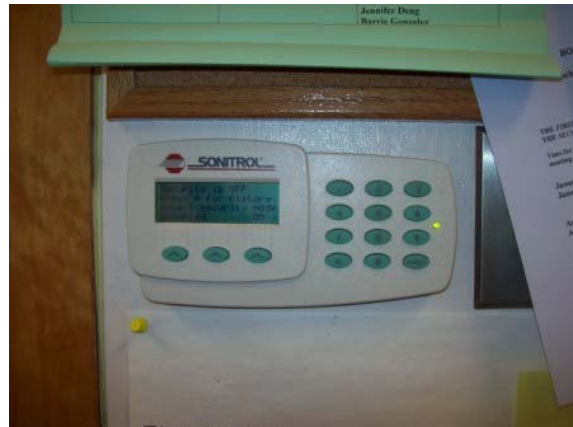
Photo #102: Security interface panel

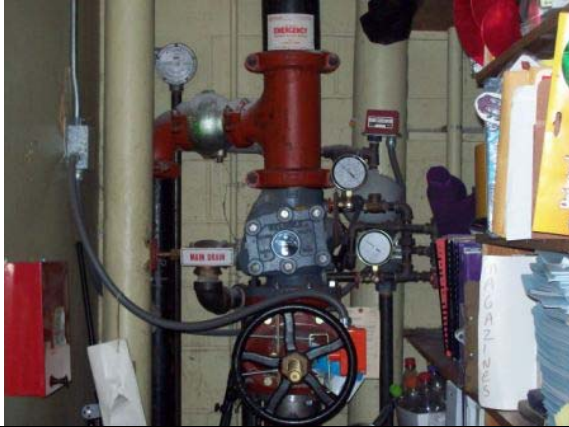
Photo #103: Wet-pipe sprinkler riser

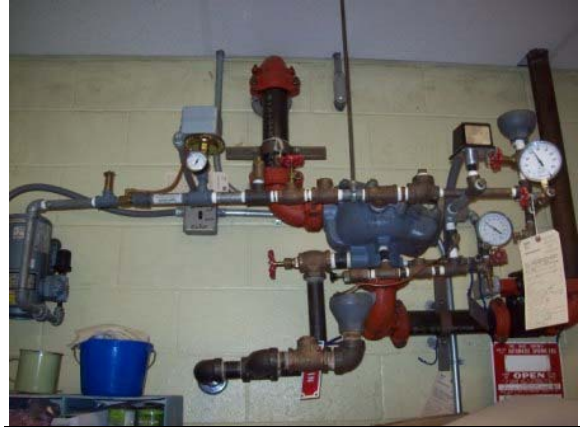
Photo #104: Dry-pipe sprinkler riser

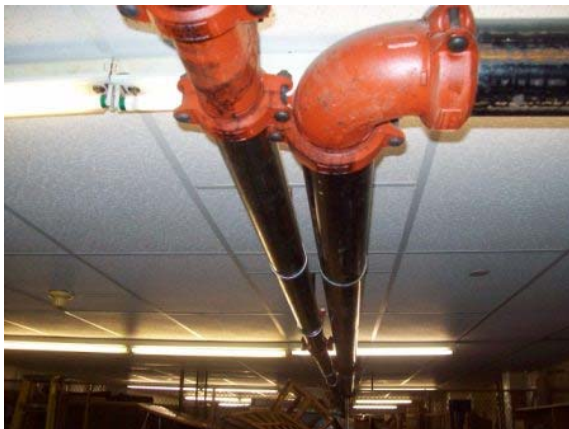
Photo #105: Typical sprinkler lines

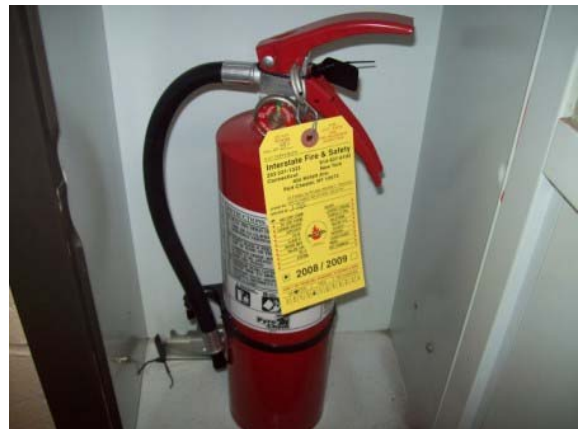
Photo #106: Fire extinguisher

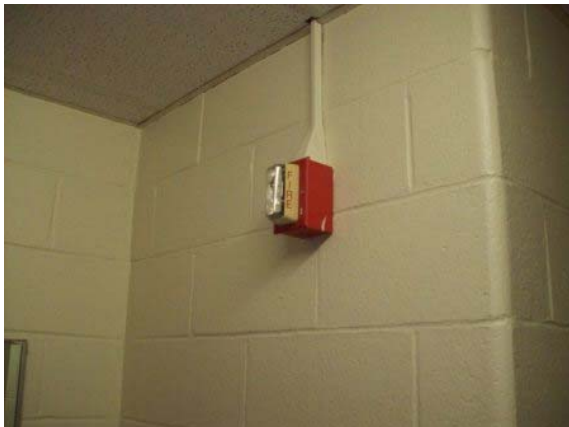
Photo #107: Fire alarm strobe light

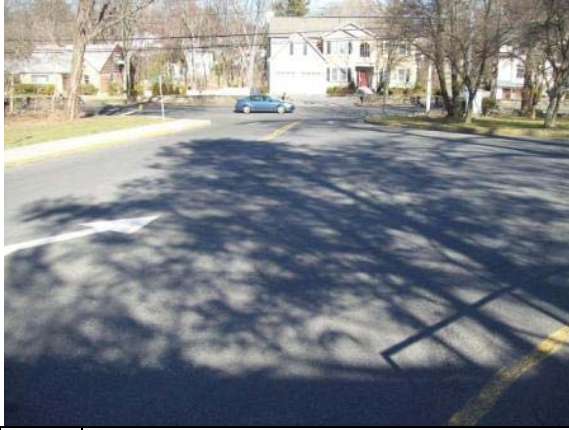
Photo #109:	Main entrance drive
-------------	---------------------

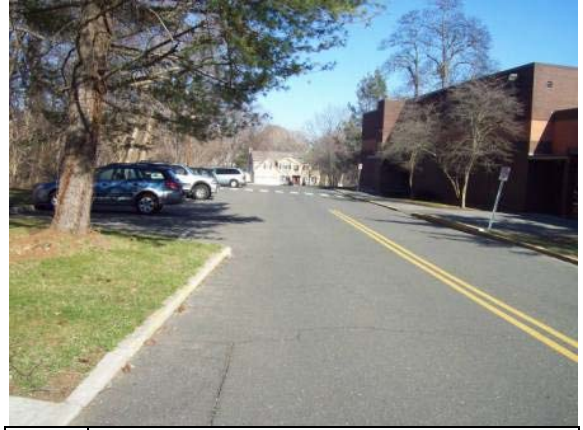
Photo #110:	North parking lot
-------------	-------------------

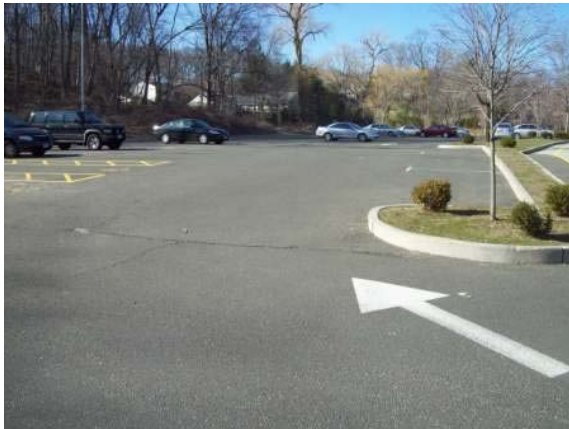
Photo #111:	West parking lot
-------------	------------------

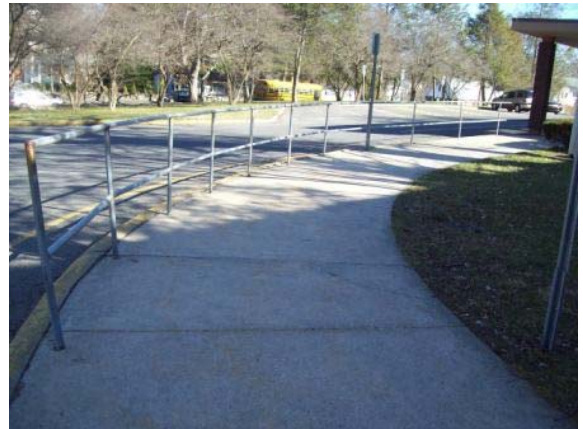
Photo #112:	Pedestrian sidewalk and east parking lot
-------------	--

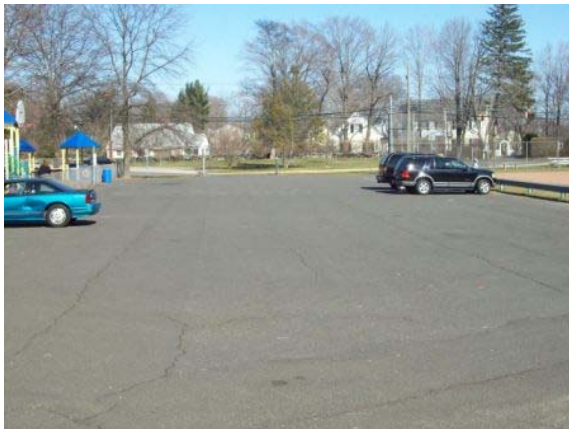
Photo #113:	South parking lot
-------------	-------------------

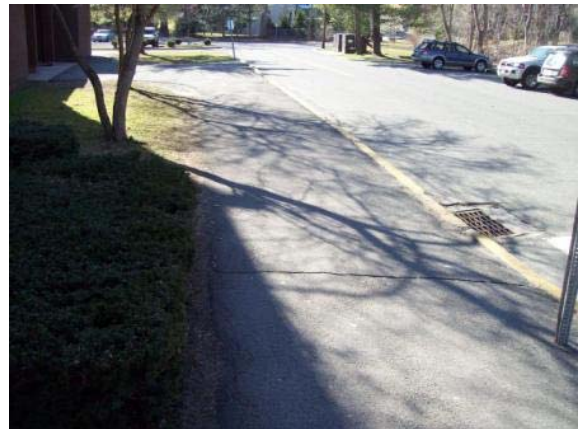
Photo #114:	Asphalt pedestrian path
-------------	-------------------------

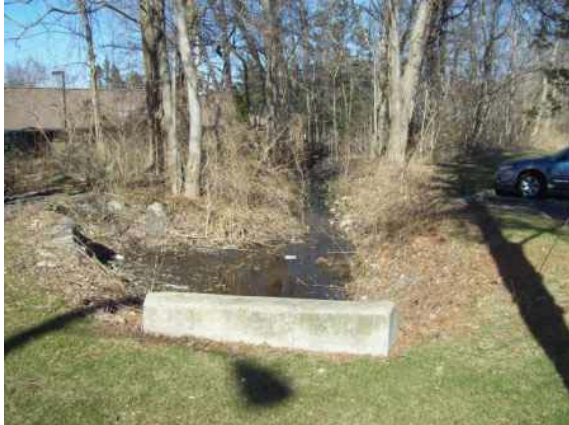
Photo #121: Drainage culvert at northwest corner of property

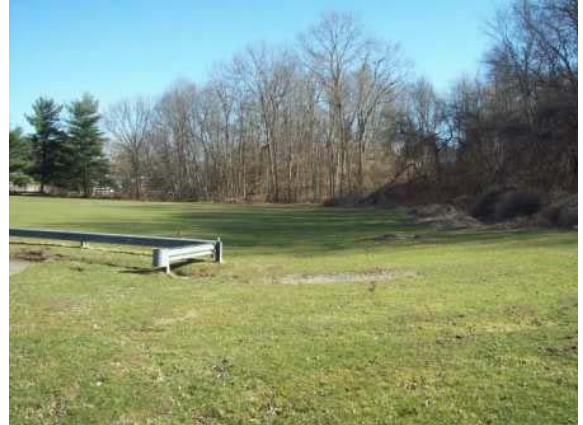
Photo #122: Area of heavy ponding and drainage runoff

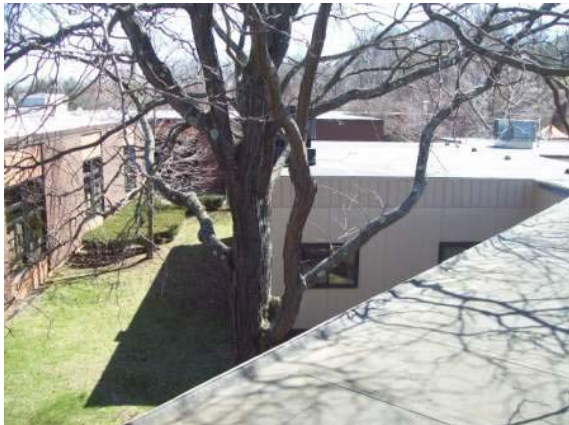
Photo #123: Trees growing close to building

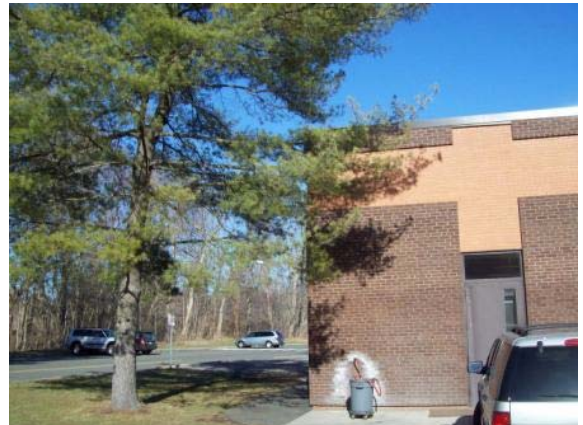
Photo #124: Trees growing close to building

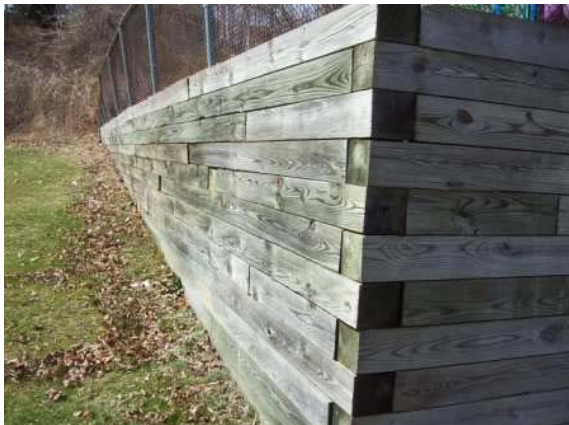
Photo #125: Timber retaining wall out-of-plumb

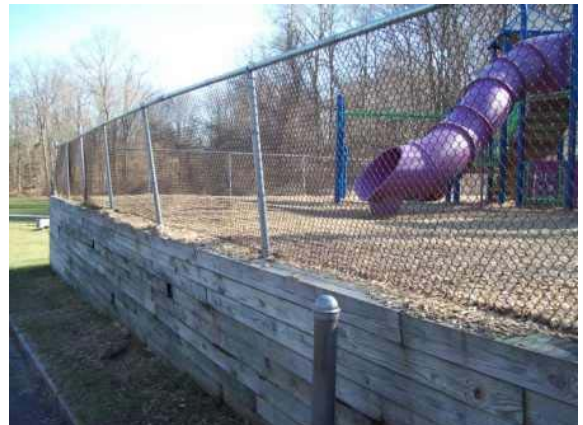
Photo #126: Timber retaining wall out-of-plumb

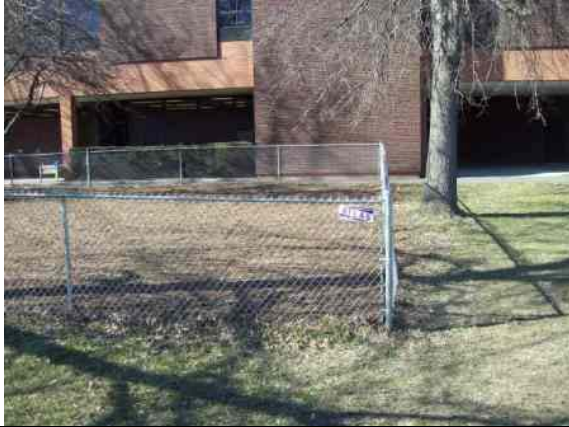
Photo #127: Typical playground fencing

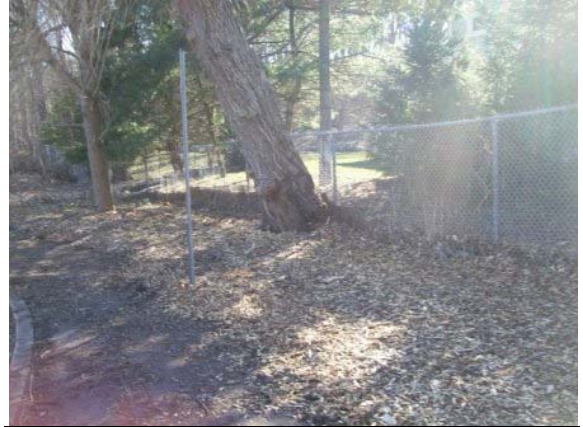
Photo #128: Perimeter fencing at north property line

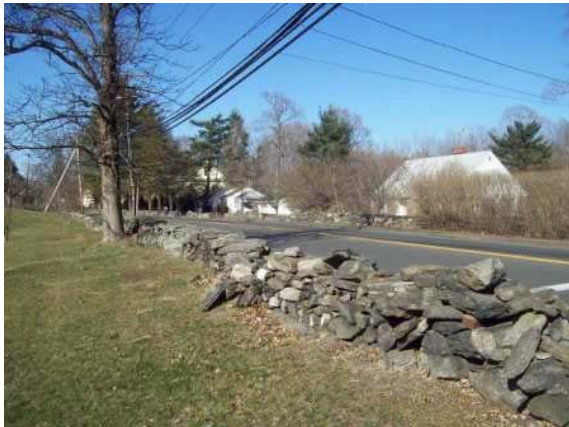
Photo #129: Stone wall along Stillwater Avenue

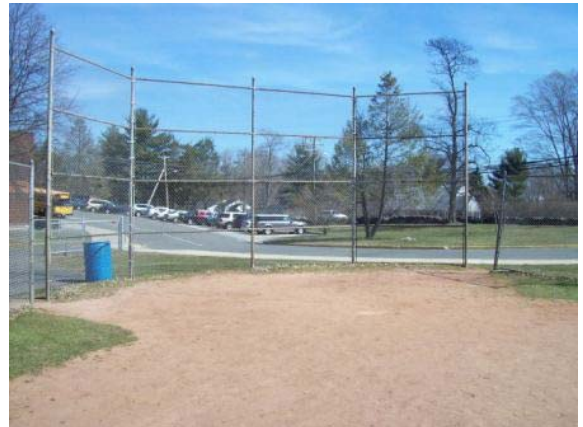
Photo #130: Baseball field and backstop

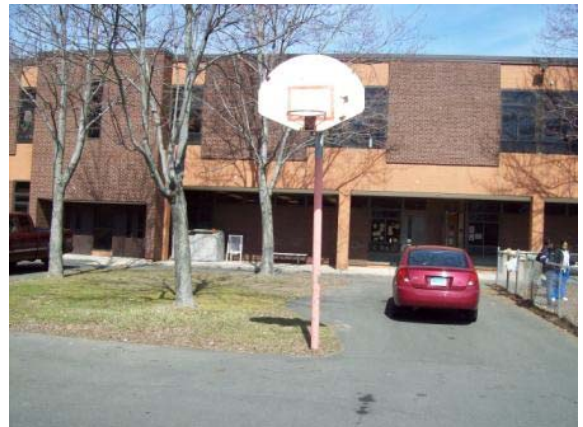
Photo #132: Basketball goal

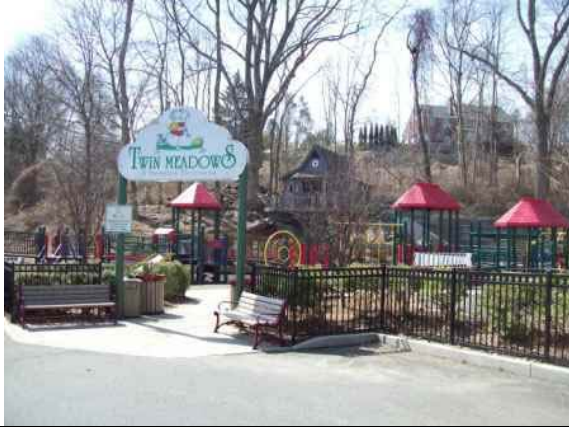
Photo #133: Twin Meadows Boundless Playground

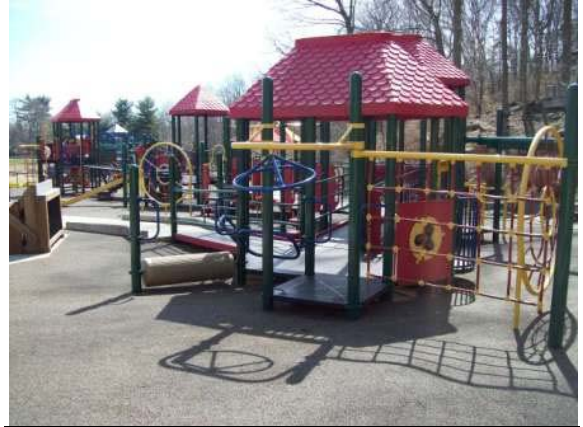
Photo #134: Playground equipment

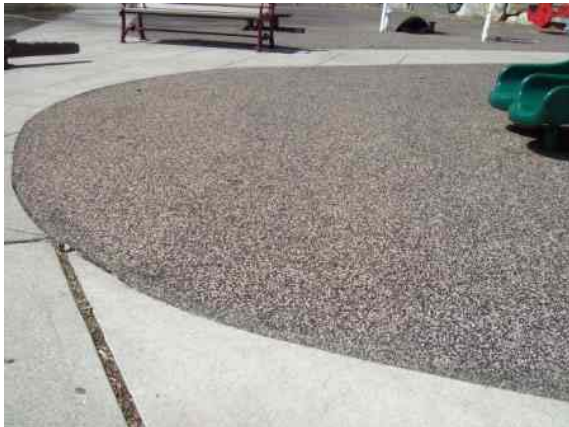
Photo #135: Playground surface

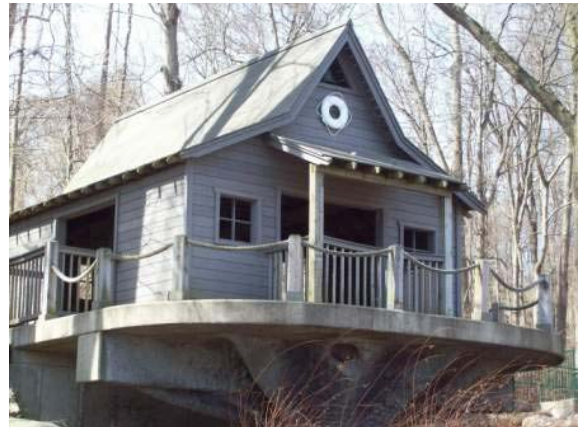
Photo #136: Tree house at Twin Meadows playground

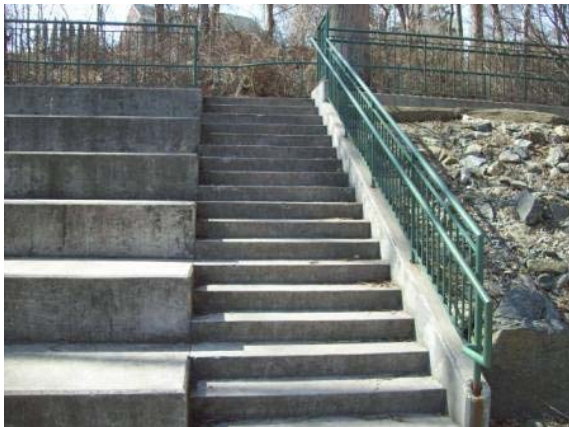
Photo #137: Concrete steps and seating at playground

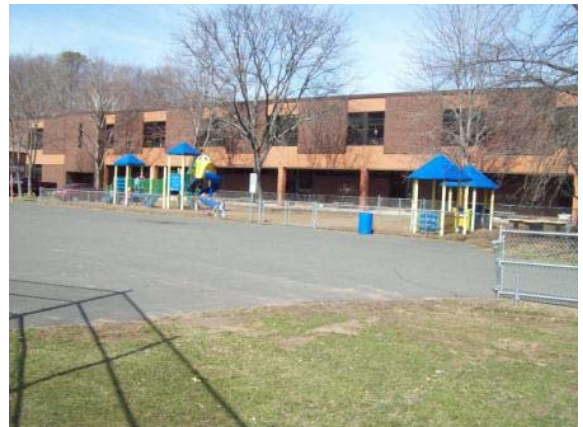
Photo #138: Small playground at south side of school

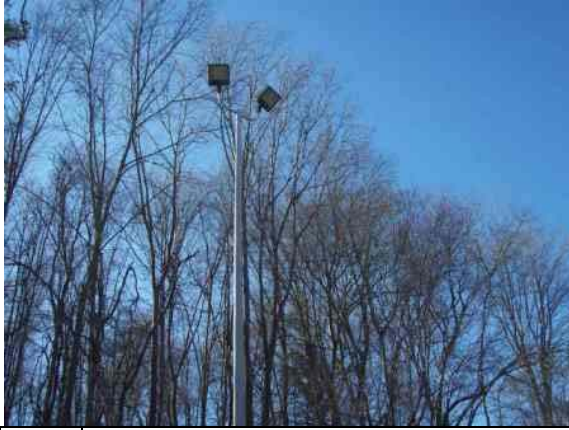
Photo #139: Pole-mounted site lighting

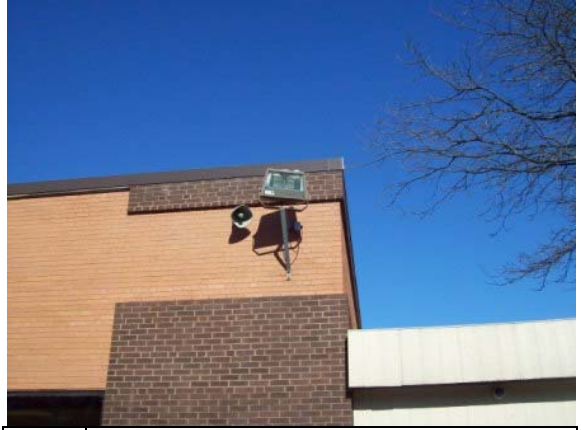
Photo #140: Building-mounted lighting

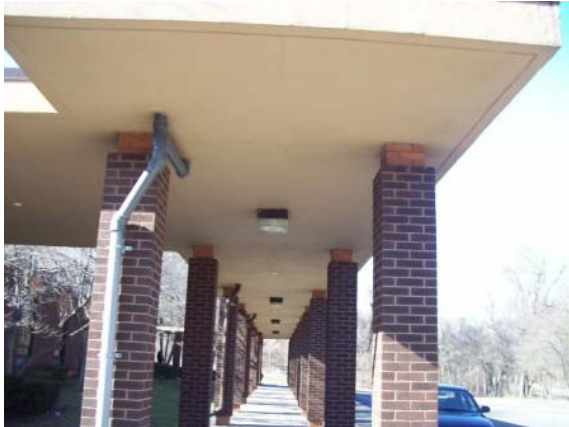
Photo #141: Canopy-mounted lighting

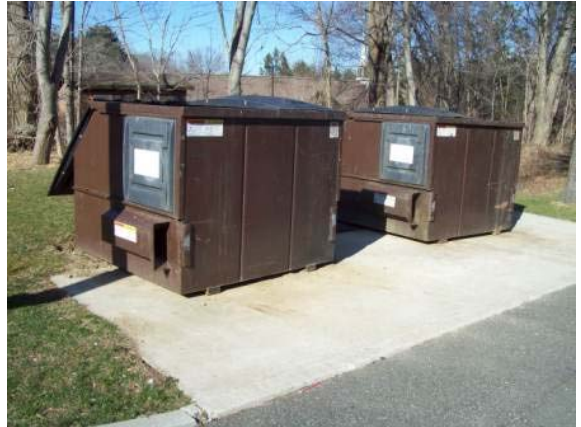
Photo #142: Dumpsters on concrete pad

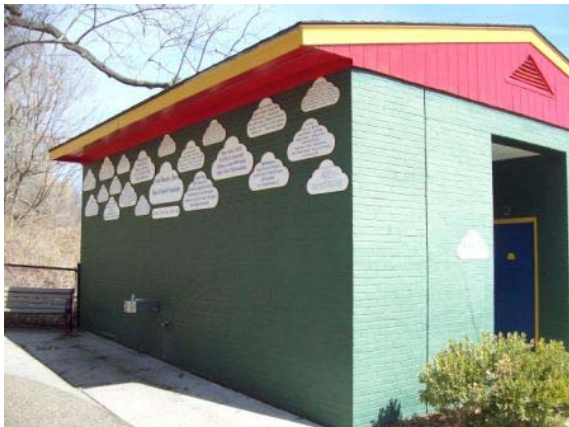
Photo #143: Restroom building at Twin Meadows playground

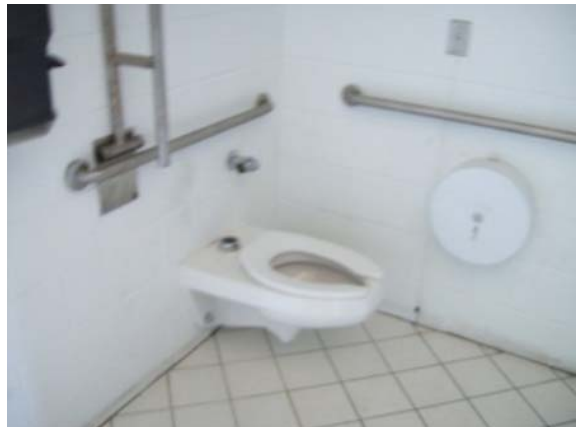
Photo #144: Interior of restroom building
