PLAYGROUND SAFETY INSPECTION REPORT

DATE: May 16, 2019

SITE: K T Murphy Elementary School
19 Horton Street
Stamford, CT 06902

DATE OF INSPECTION: April 26, 2019

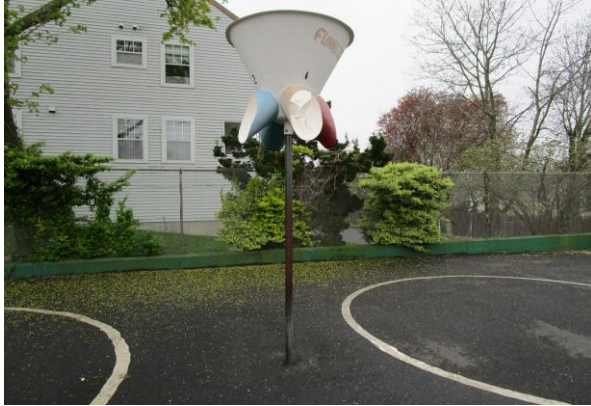
Funnel Ball
BCI Burke

Funnel Ball - Bucket very loose at bolts - MAINTENANCE

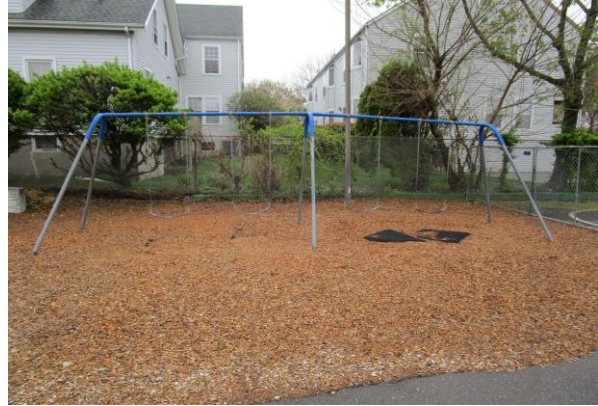
8ft. Swing Set (2Bays/4Belt Seats)
Unknown

Condition	Hazard Priority	Recommendation
8ft. Swing Set #1(2 Bays/4 Belt Seats (Unknown)			Good		
Surfacing	EWF 9-12"		Good		
Use Zone		Light post in use zone 12ft. from center		B	Relocate post outside of use zone
Structural Stability		Frame not level, pitched up at center		Maint.	Monitor
9ft. Swing Set #2 (2 Bays/4 Belt Seats (Unknown)			Good		
Surfacing	EWF 6-12"	Low in spots		B	Add EWF & level
Use Zone		Overlaps with composite structure, 22 ft. to composite, 13ft. to wall & 15ft. to bench		B	Relocate swing set & create clear 18ft. use zone at front & back & 6ft. at sides
Structural Stability		One post bent		Maint.	Monitor

8ft. Swing Set #1 (2Bay/4Belts)(Unk) - Light post in use zone, 12ft. from center -
CLASS B HAZARD

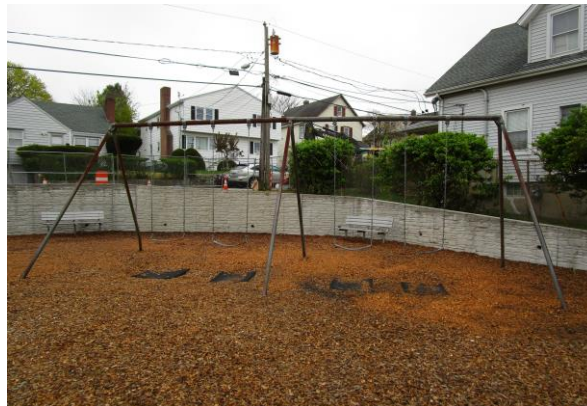
9ft. Swing Set (2Bay/4Belt)

9ft. Swing Set - Use Zone overlaps with composite structure use zone - CLASS B HAZARD
